An Assessment of Remote Visual Methods to Detect Cracking in Reactor Components

**6th International Conference on NDE in Relation to
Structural Integrity for Nuclear and Pressurised
Components**

**October 8-10, 2007
Budapest, Hungary**

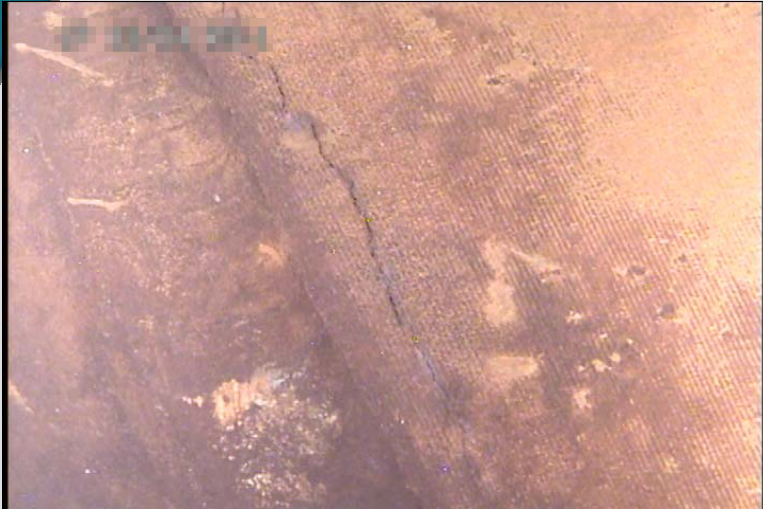
Definite Cracks

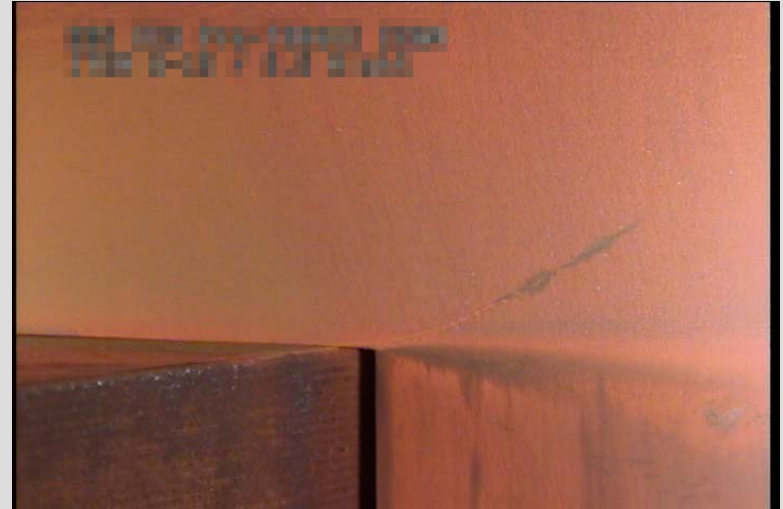
Possible Cracks

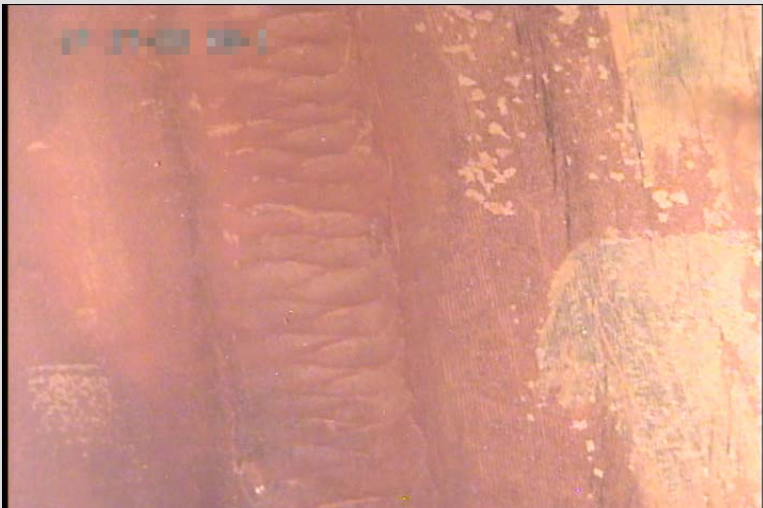
Topography and
Surface Conditions

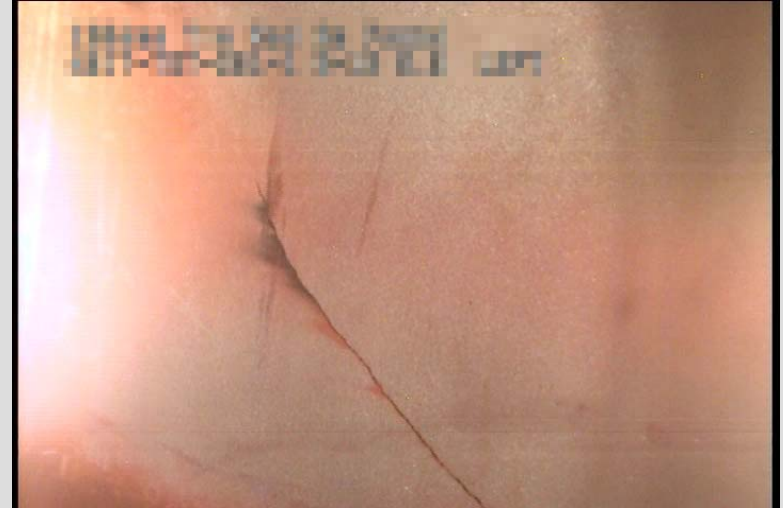
Discolorations at Crack Surface
