**SUBJECT: ADDITIONAL INFORMATION CONCERNING APPLICATION FOR
AMENDMENT TO LICENSE, CONTROL NO. 139009**

SAFETY INSPECTION REPORT AND COMPLIANCE INSPECTION

Laboratory room Fe-119
Survey readings:

Laboratory room Fe-120
Survey readings:

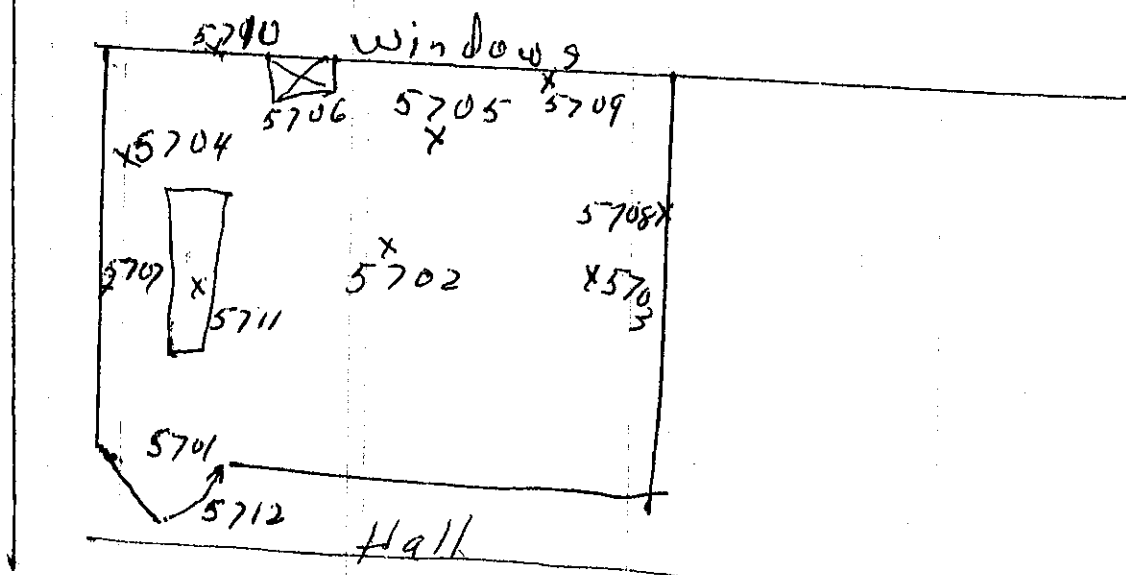
Room 120 - Smears for C-14, H₃ evaluation

Sample Num:	Location I.D.
5701	Floor door entrance
5702	Floor Center
5703	Floor Right
5704	Floor Left
5705	Floor Rear
5706	Sink
5707	Left wall
5708	Right wall
5709	Rear wall
5710	Rear windows
5711	Working Table Top
5712	door entrance
