FSAR UPDATE

DIABLO CANYON ISFSI

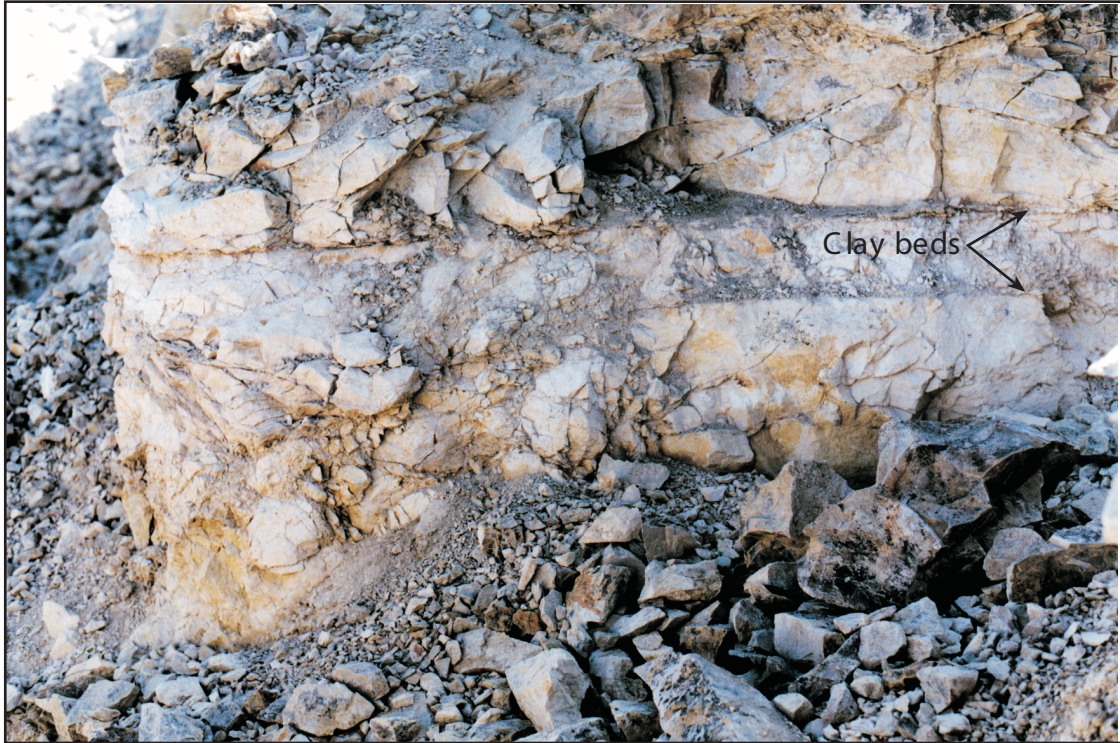
**FIGURE 2.6-24
CLAY BEDS AND DOLOMITE IN
TRENCH T-11C**

Typical dolomite Tof_{b-1} and thin clay beds exposed in trench T-11C. Clay beds are subhorizontal and define bedding. Photo roll 01JLB-1.

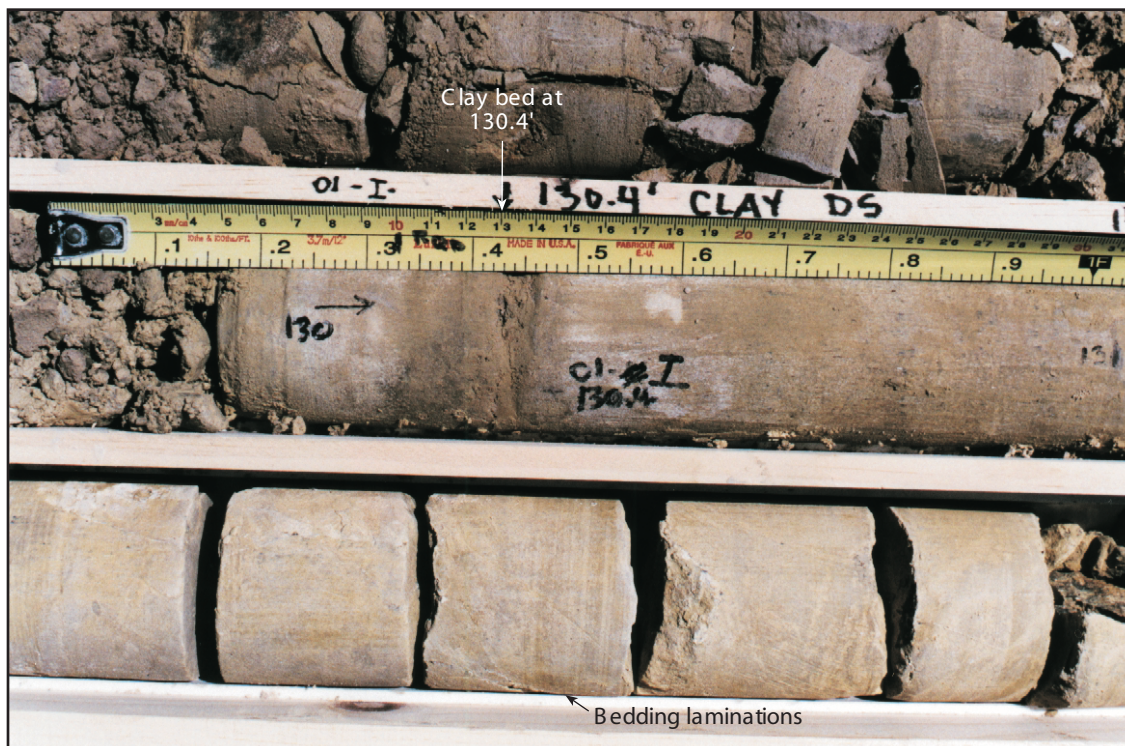
FSAR UPDATE
DIABLO CANYON ISFSI
FIGURE 2.6-26
CLAY BED AT 130 FEET IN BORING 01-1

Typical appearance of clay bed and bedding laminations in a section of core at 130 feet from boring 01-I, south of the ISFSI. Clay bed occurs within Tof_{b-1} .
