SEABROOK UPDATED FSAR

APPENDIX 2J

SEISMIC SURVEY

APPENDIX 2E  
SEISMIC SURVEYS

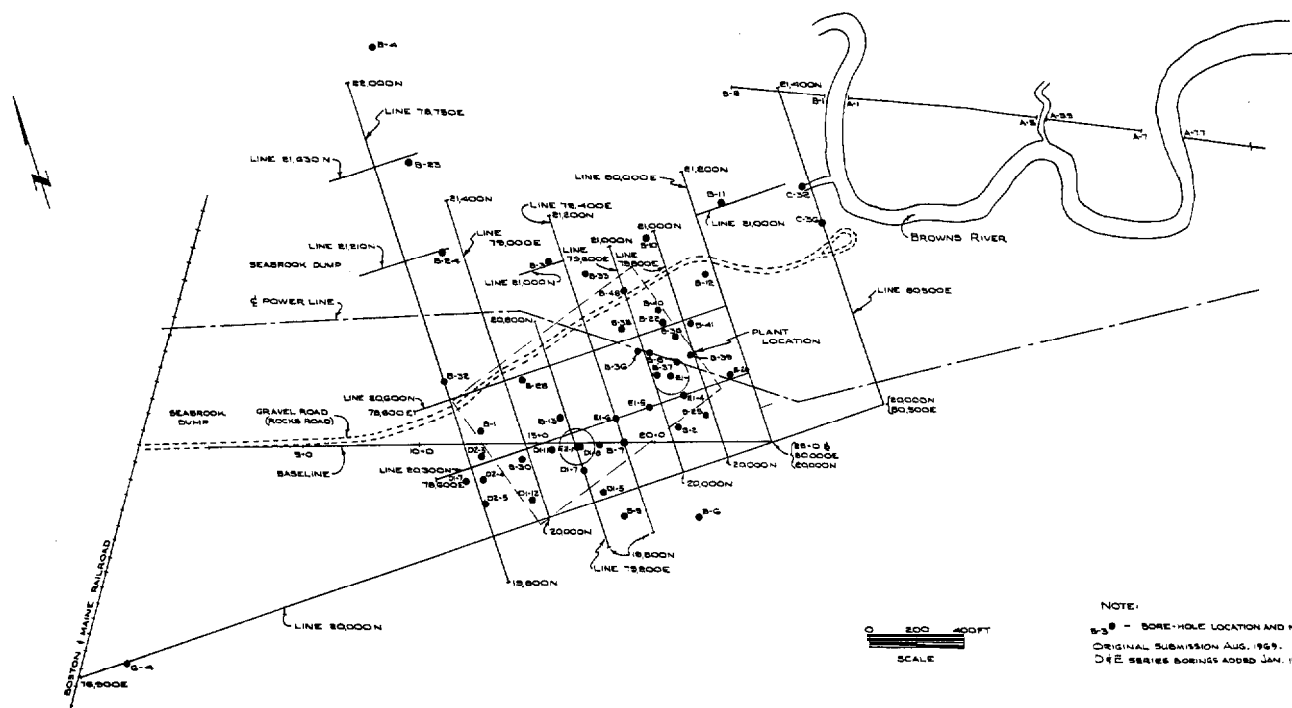
FIG. 2E-1

PLANT SITE AREA PLAN MAP  
SEISMIC SURVEY

The plan of the seismic lines of investigation, in the plant site area **is** shown on Figure **2E-1**. In addition to the previously stated purpose, Line **20,000N** was extended west to provide supplementary data for the groundwater hydrology study. Other lines were extended north for the purpose of exploring the contact zone between the Newburyport quartz diorite in the site area and the Merrimack Formation to the north of the site.

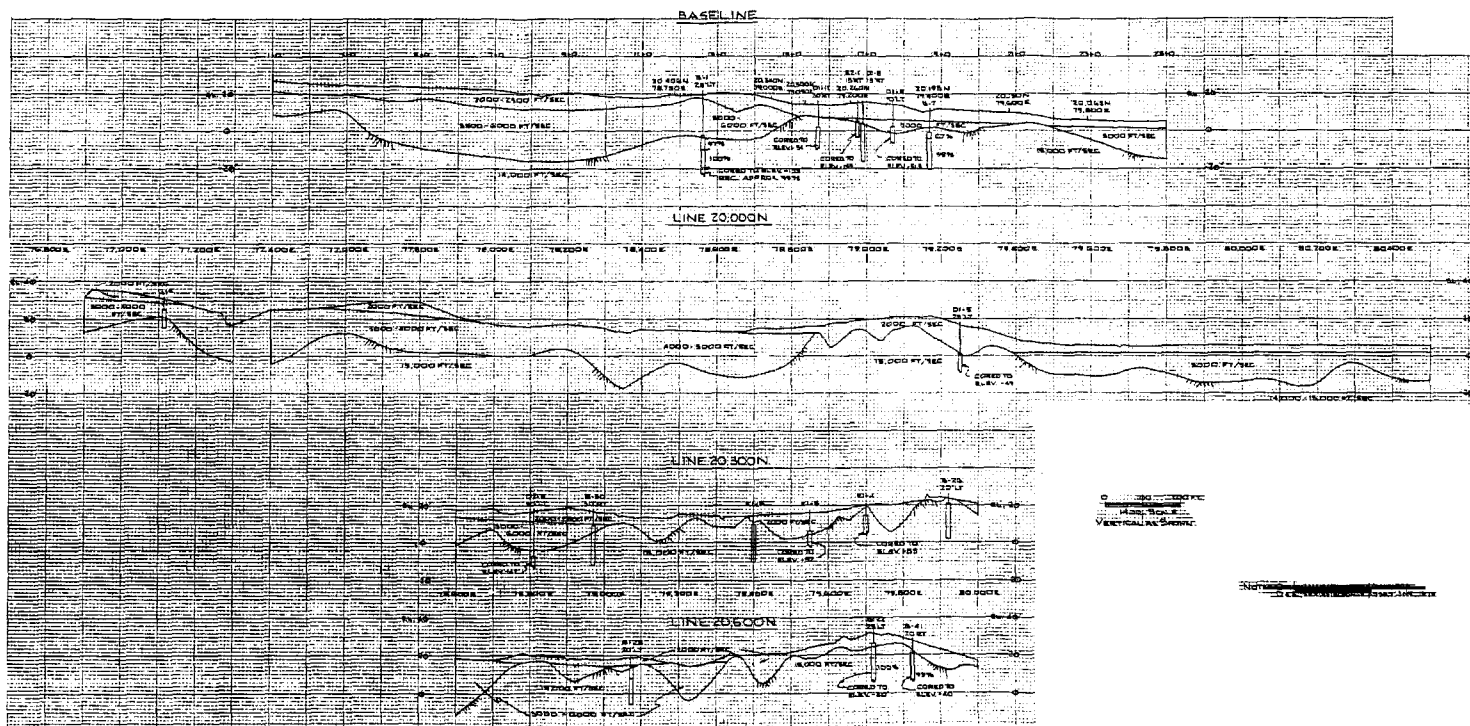
FIG. 2E-2 SH.1 SB.1 & 2

PLANT SITE AREA PROFILE  
SEISMIC SURVEY

The results of refraction surveys in the plant site area are shown on Figure **2E-2** (Sheets 1, 2, and 3). In general, the seismic survey showed that hard rock was shallow in the vicinity of the selected plant location, with dense till along the north side of the site and less dense till and possible other overburden materials west of the plant location. There is good correlation between seismic and boring data.

The bedrock velocities measured by surface refraction techniques ranged between 13,000 **and** 16,000 ft/sec; this is indicative of sound bedrock conditions.

Overburden materials can be tentatively identified by their respective seismic velocities. Velocities for the overburden materials ranged from 2,000 ft/sec for loose, unconsolidated overburden materials to 6,500 to 6,800 ft/sec for dense glacial till. In general, overburden materials with velocities in excess of 5,500 ft/sec and in excess of 3,000 ft/sec for unsaturated materials are indicative of glacial till.

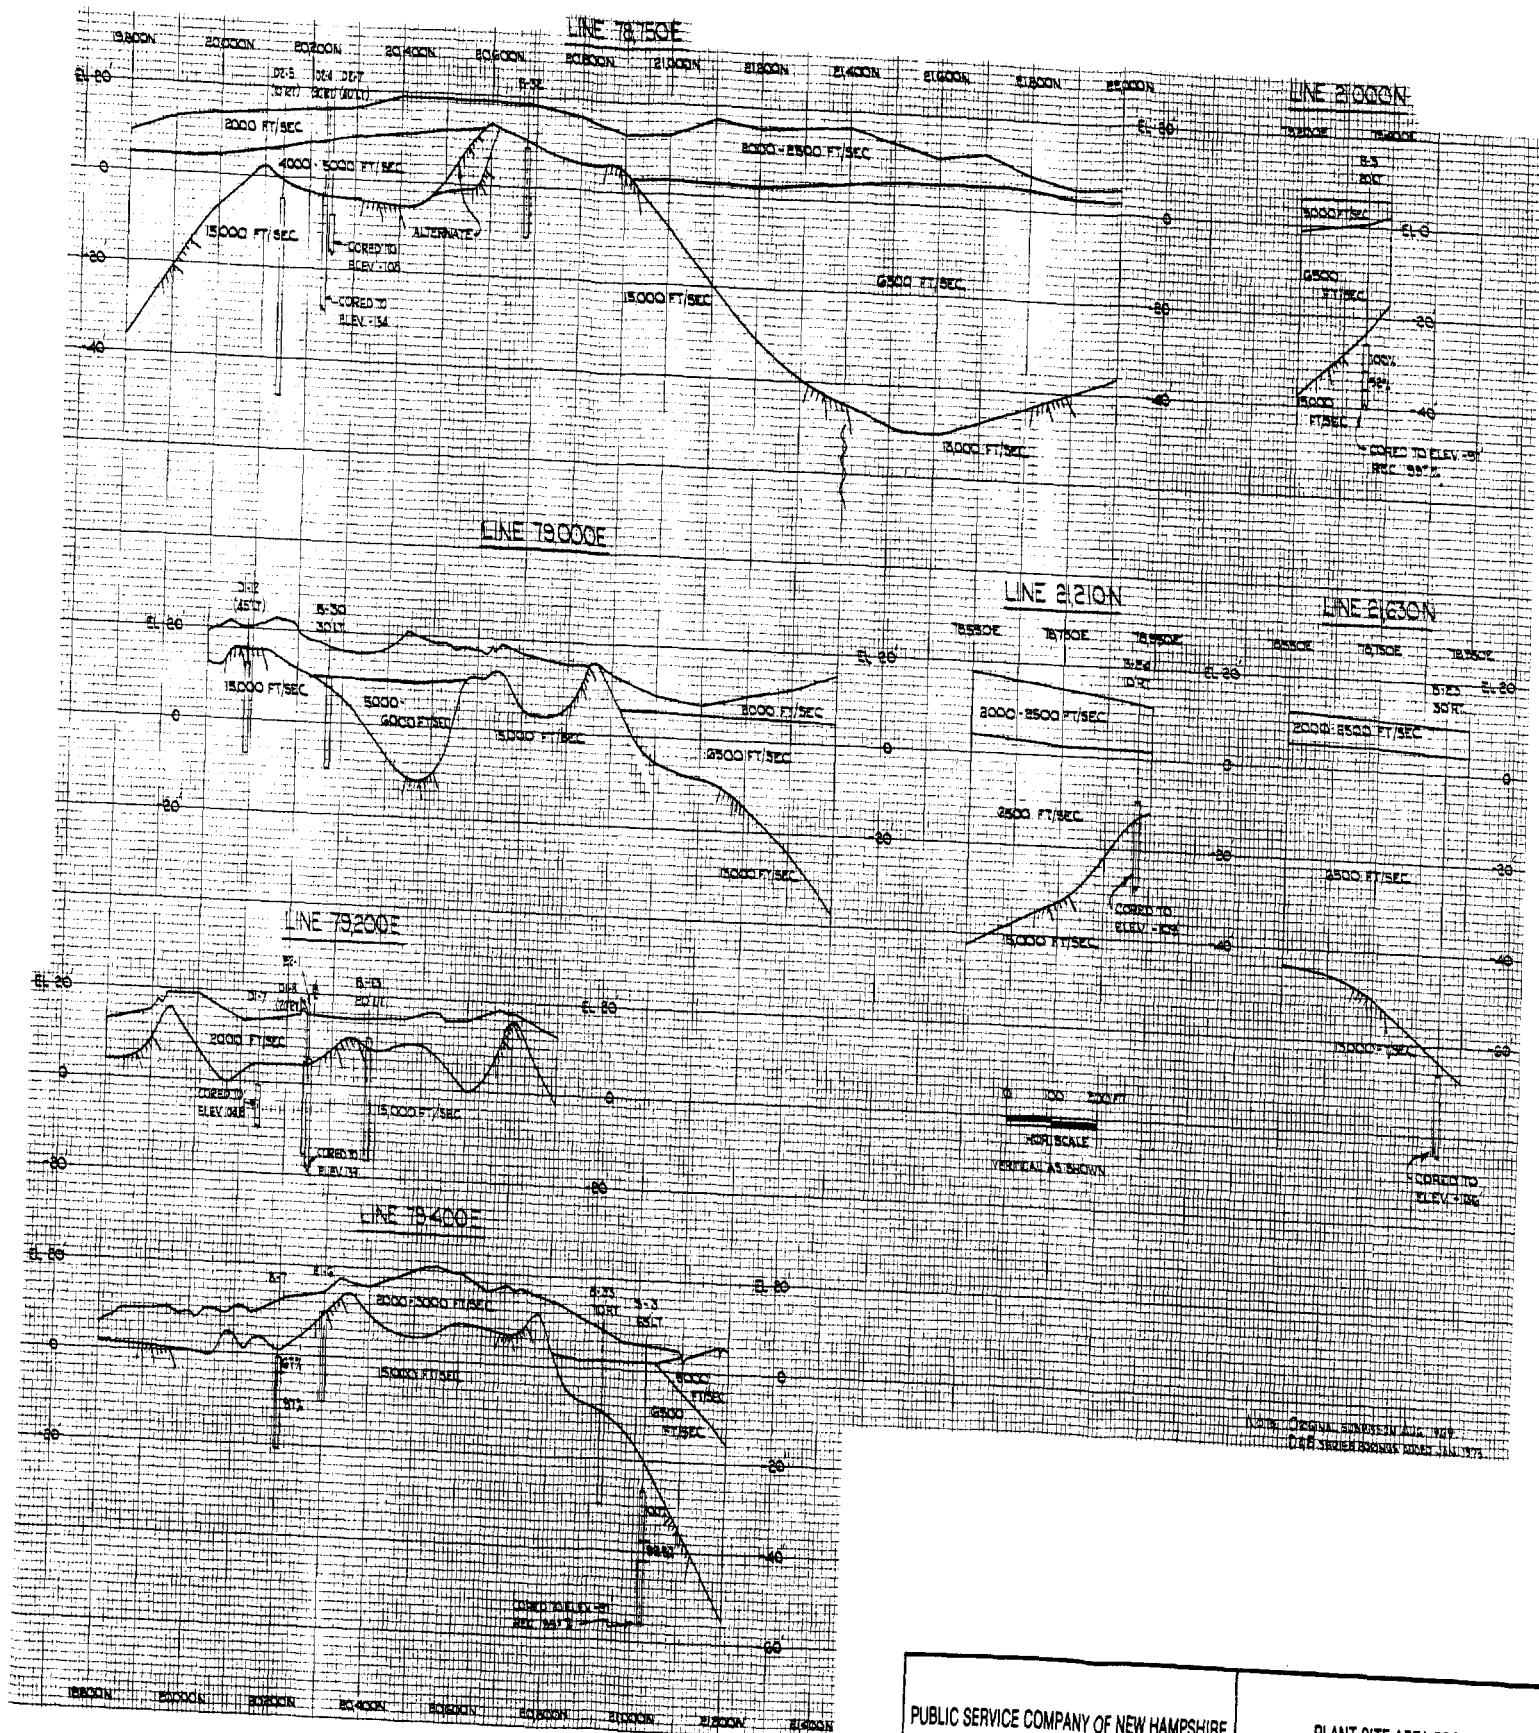
FIG. 2E-2

PLANT SITE AREA SURVEY

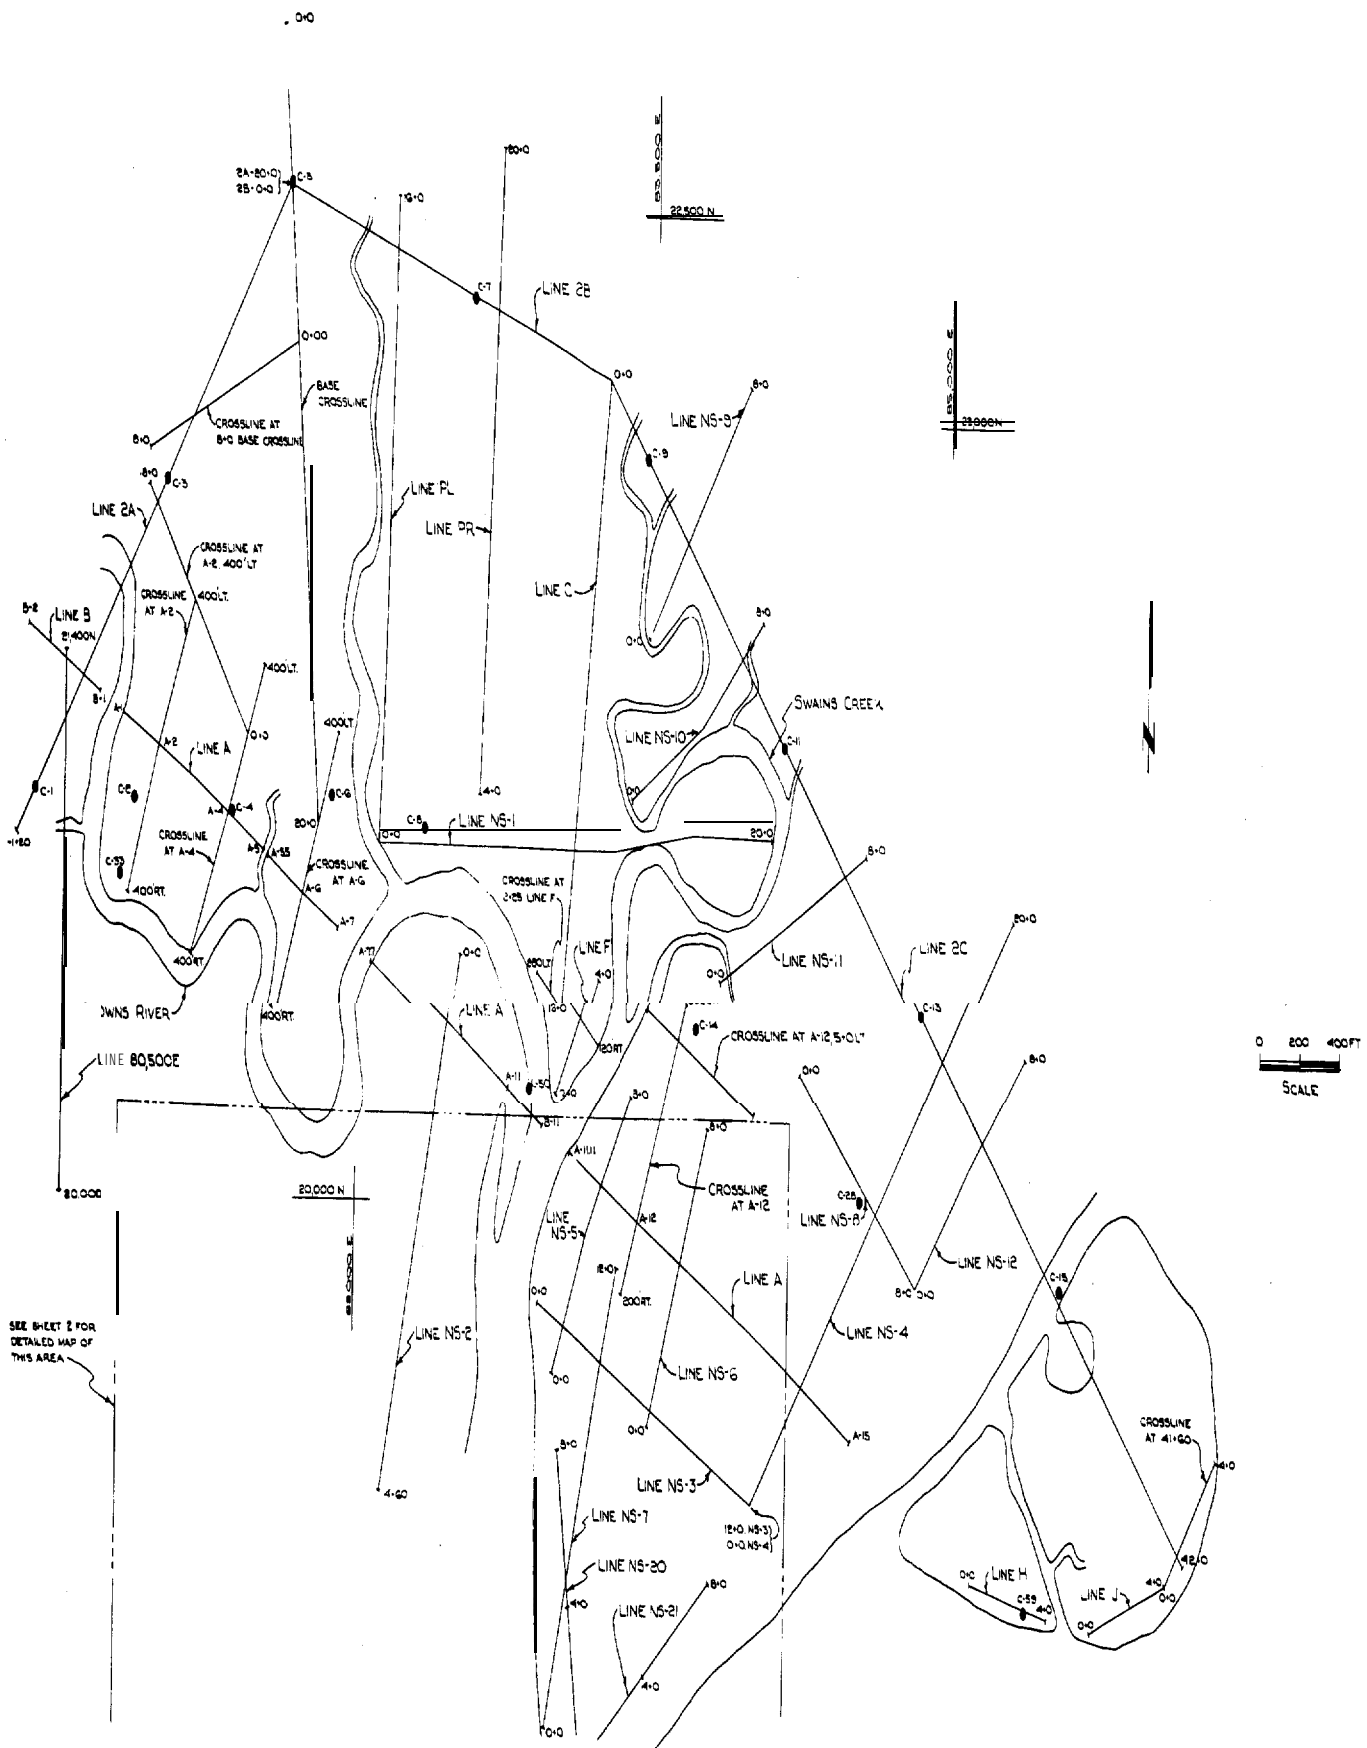
FIG. 2E-3

TIDAL MARSH AREA PLAN MAP  
 SEISMIC SURVEY

The plan map of the seismic lines in the tidal marsh area is shown on Figure **2E-3**. The basic program of investigation consisted of Line A and Lines **2A, 2B**, and 2C across the tidal marsh area with a number of crosslines between. The location and orientation of the crosslines were determined by depths to bedrock and the numerous small streams and man-made canals which crisscrossed the area. Detailed investigations were made along **Browns** River (600 series of seismic lines) and then westward to the site passing north of Hunts Island (Line NS-2 and the **700** and 800 series). A detailed plan map of the seismic lines in this area is shown on Figure **2E-3**. The 600 series of seismic lines were operated as a marine refraction survey. Elevations of the bottom of Browns River were provided by **McKenna** Associates.

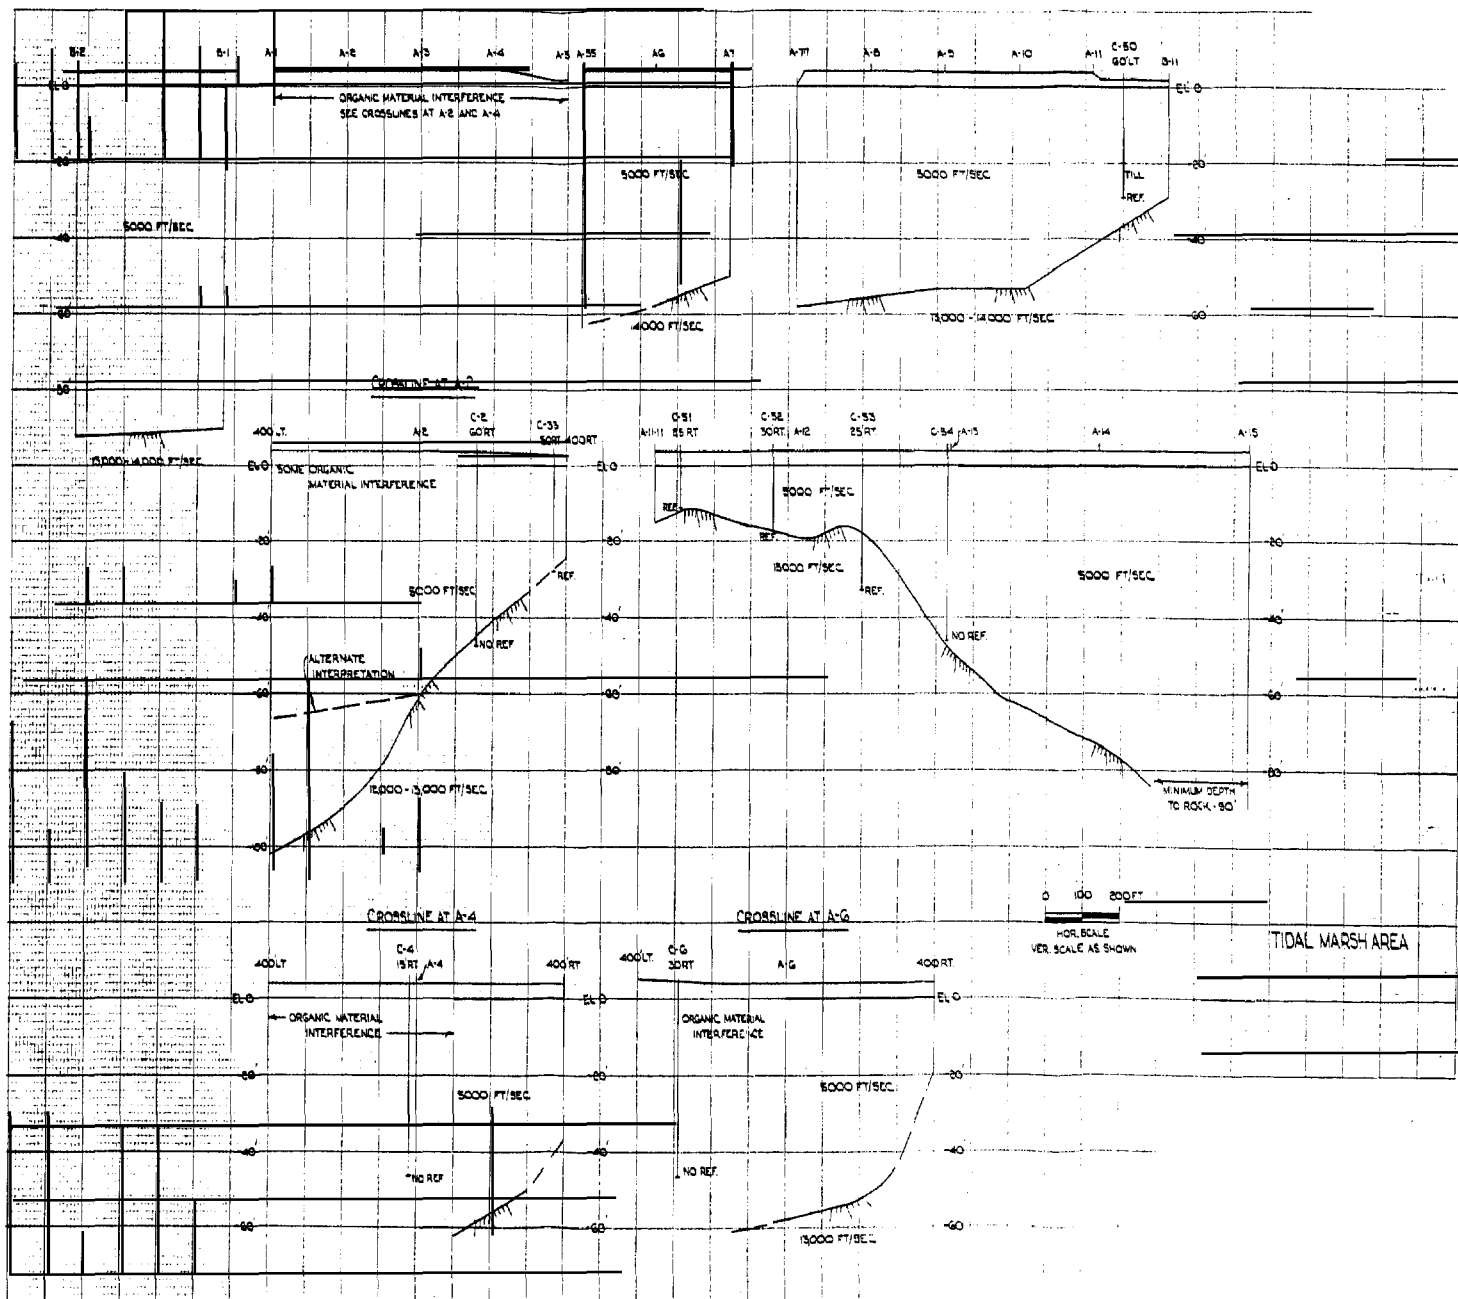
FIG. 2E-4

TIDAL MARSH AREA PROFILE  
SEISMIC SURVEY

The results of the seismic survey in the tidal marsh area are shown on Figure **2E-4** (Sheets 1 through **10**). In general, the bedrock surface in the tidal marsh is more than 50 feet below ground surface although a few sharp rises in the bedrock surface were noted in the vicinity of Browns River, where some outcrops were noted. Although Boring C-68 encountered refusal at an elevation of -28 feet, the bedrock surface rises to an

elevation of -10 feet along Lines 805 and NS-24, about 50 to 70 feet northeast of the boring. **Another** example of the sharp changes in bedrock depths occurs in the vicinity of Line A where Boring C-52, **25** feet right of Line A, encountered refusal at the elevation of -33 feet, while the seismic data along Lines A and **NS-6** indicate that a ridge of shallow rock (approximately Elevation -18 feet) occurs along or just to the north of Line A.

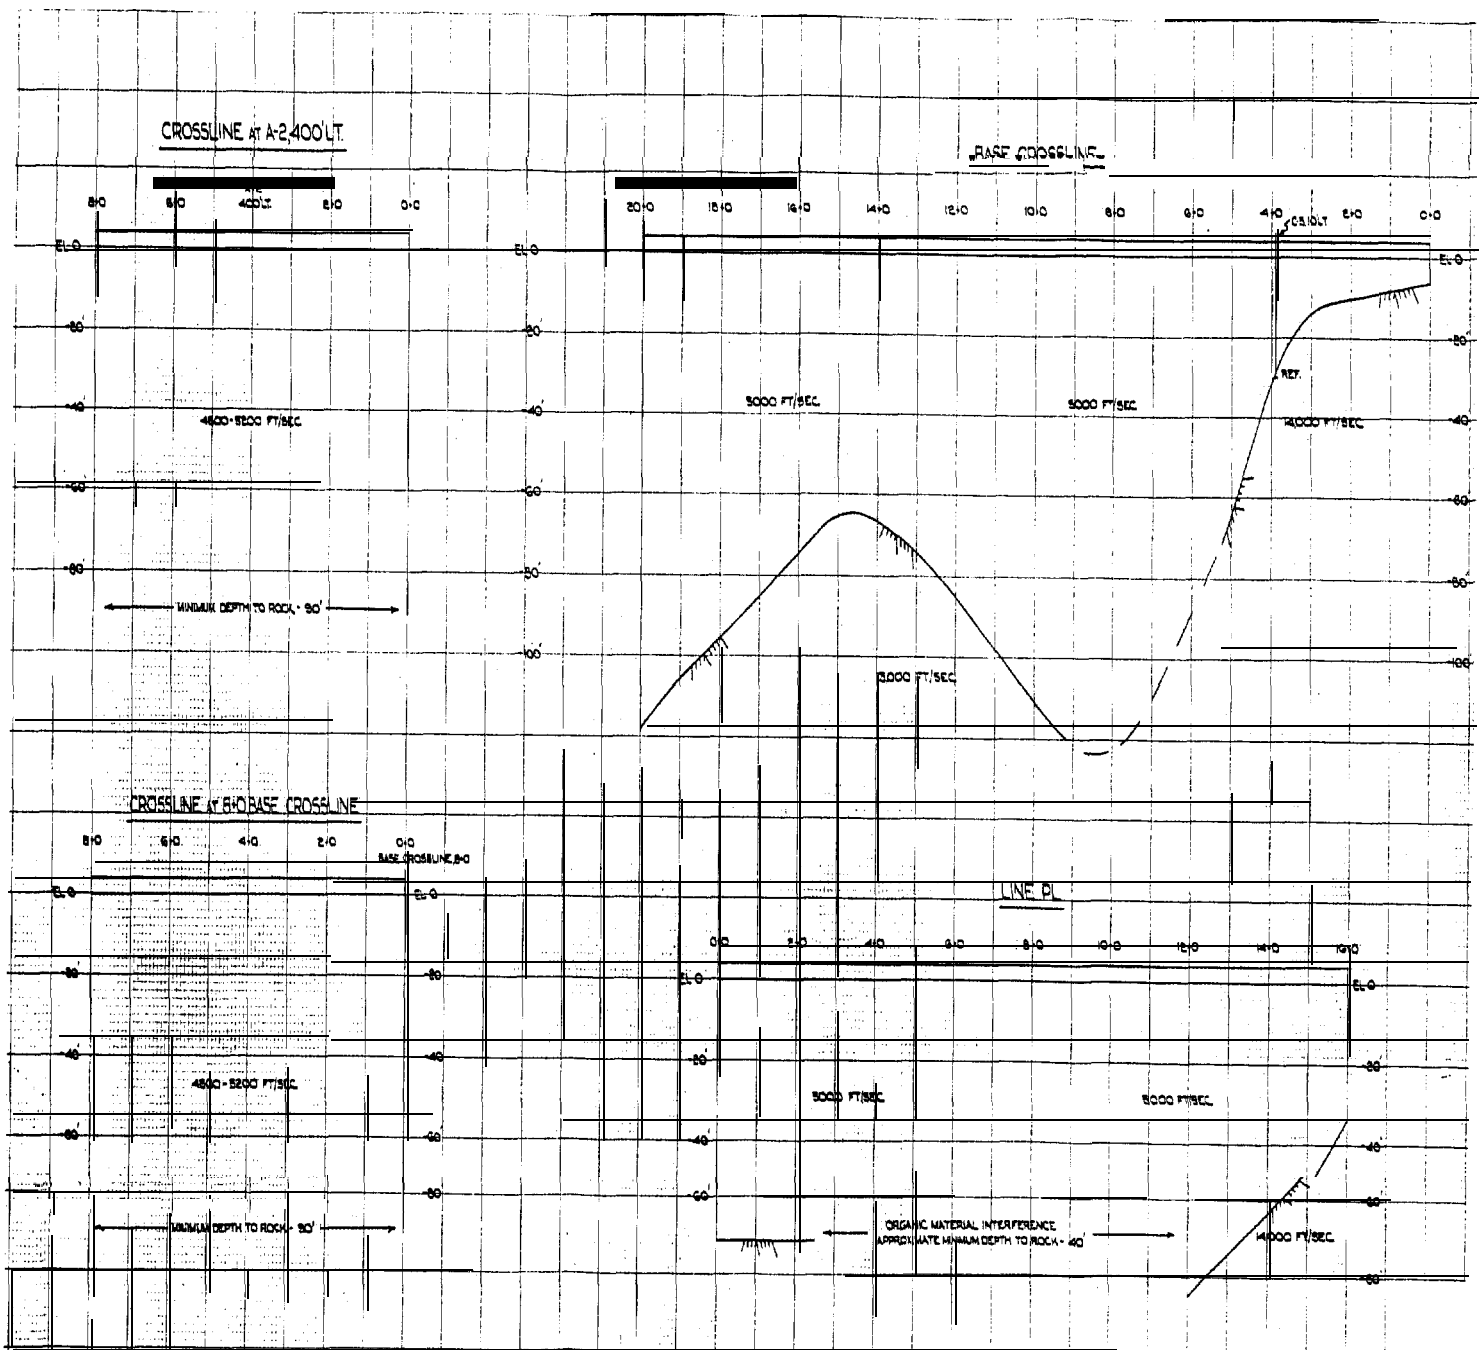
FIG. 2E-4

TIDAL MARSH AREA PROFILE  
SEISMIC SURVEY

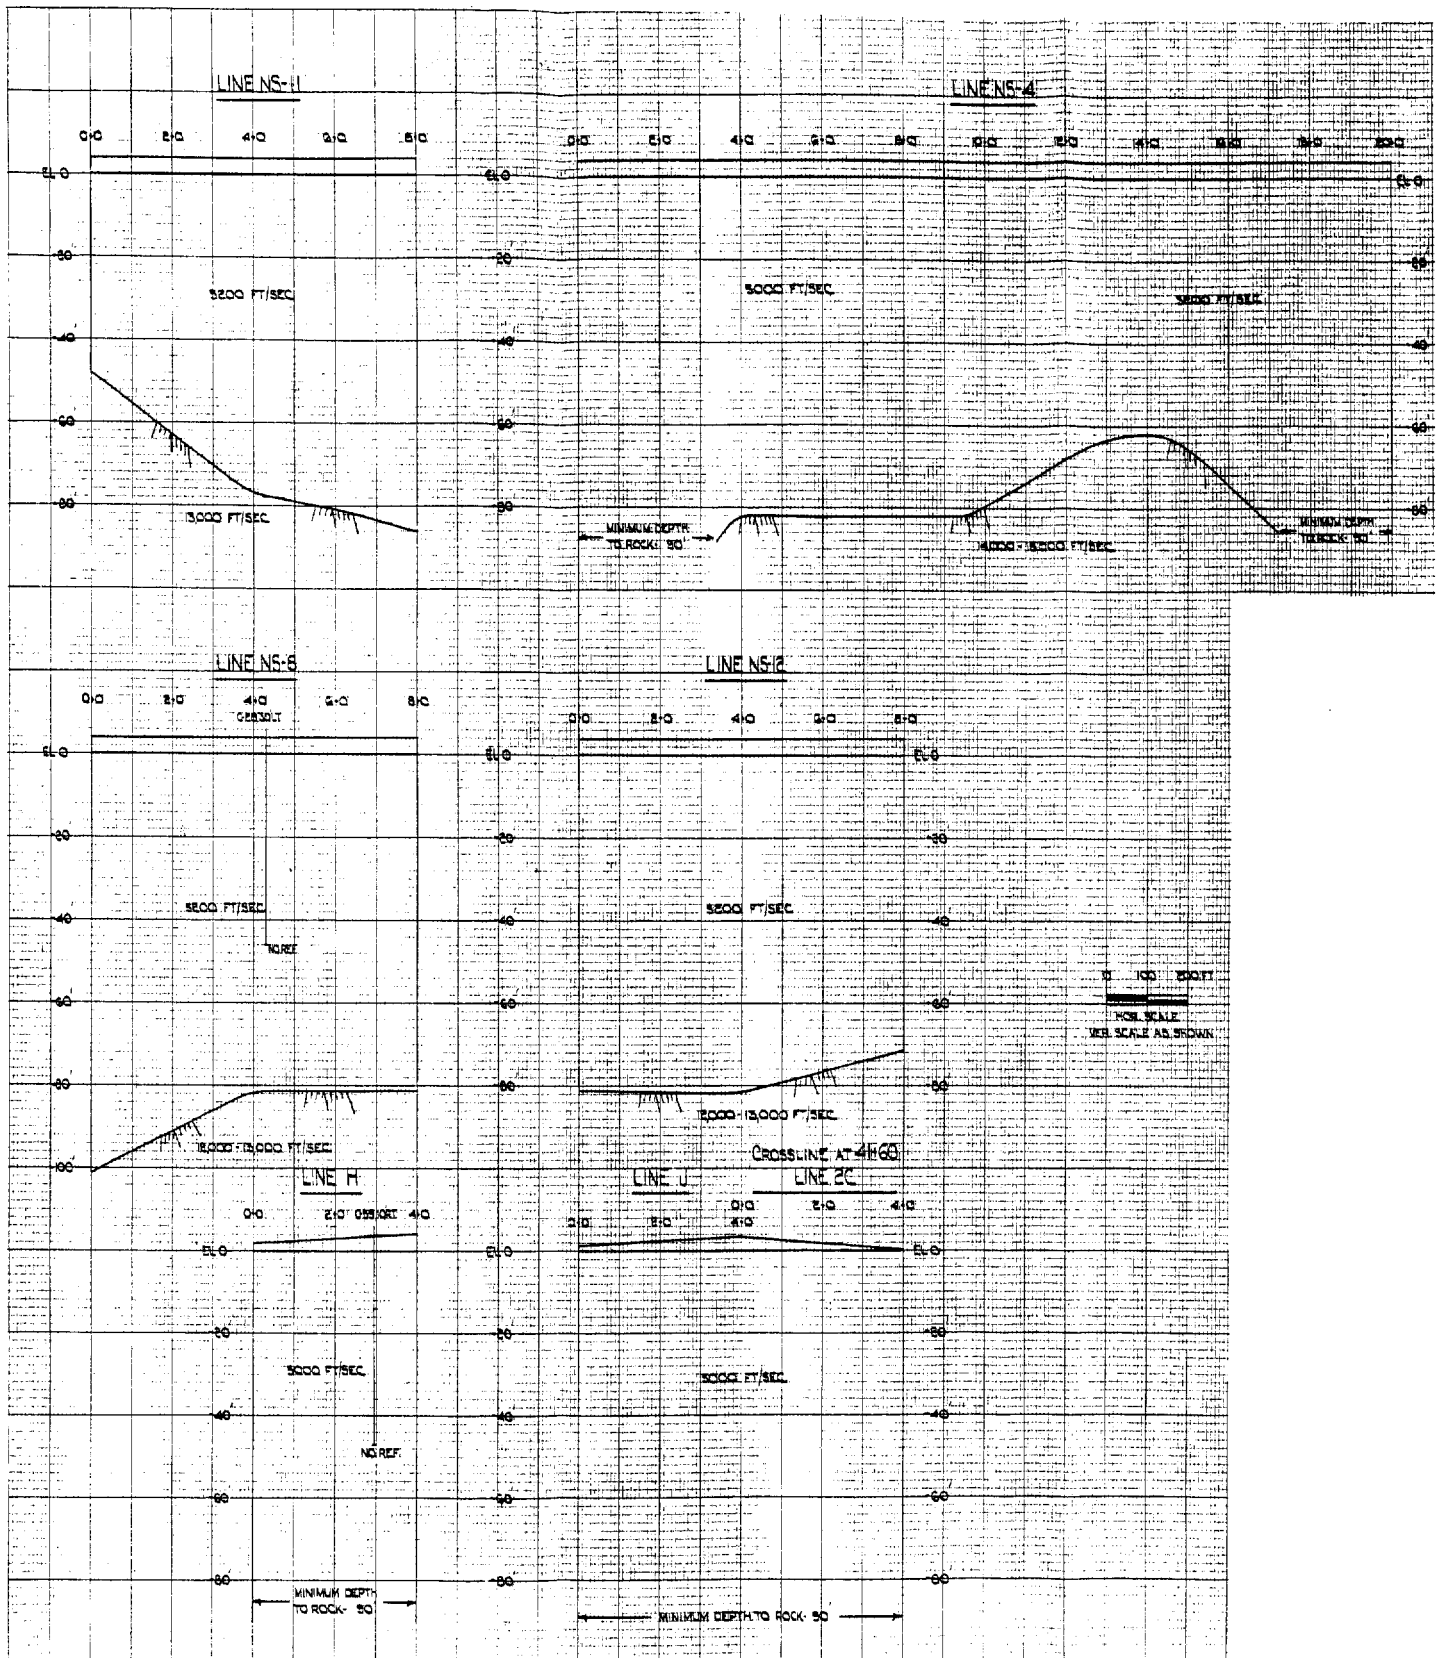
FIG. 2E-4

TIDAL MARSH AREA PROFILE  
SEISMIC SURVEY

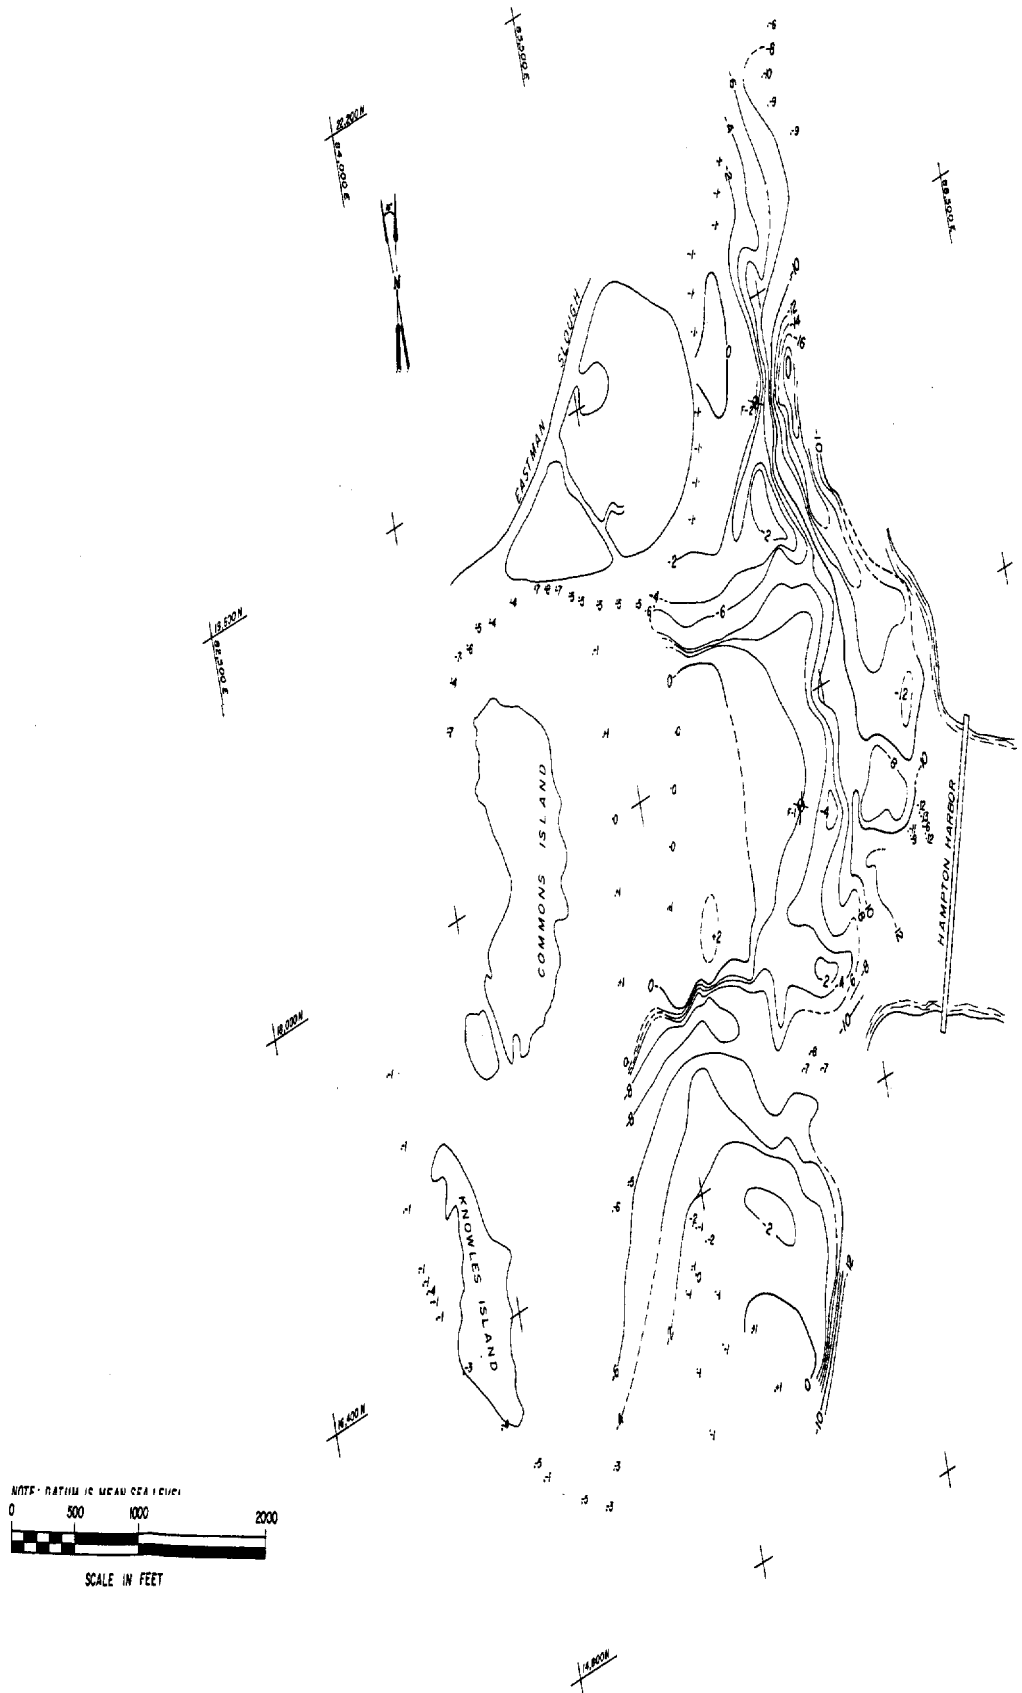
FIG. 2E-5

HAMPTON HARBOR AREA  
BOTTOM CONTOUR MAP  
SEISMIC SURVEY

The results of the fathometer **survey** which took place during **March** and April 1973 are shown in the **form** of a bottom contour

map (Figure **2E-5**). The results of the seismic investigations are shown in the **form of** a bedrock contour map (Figure **2E-6**). The contours are based on seismic reflection and seismic refraction surveys conducted during March and April 1973 and augmented by the data obtained from **a** seismic refraction survey conducted in the fall of 1968. The 1968 data were obtained in the northern half of the area shown on Figure **2E-6** and mainly consisted of information on the minimum depths to a bedrock with only a few computed bedrock **depths**. The track maps for the 1973 reflection and refraction surveys are shown on Figures **2E-7** and **2E-8**, respectively.

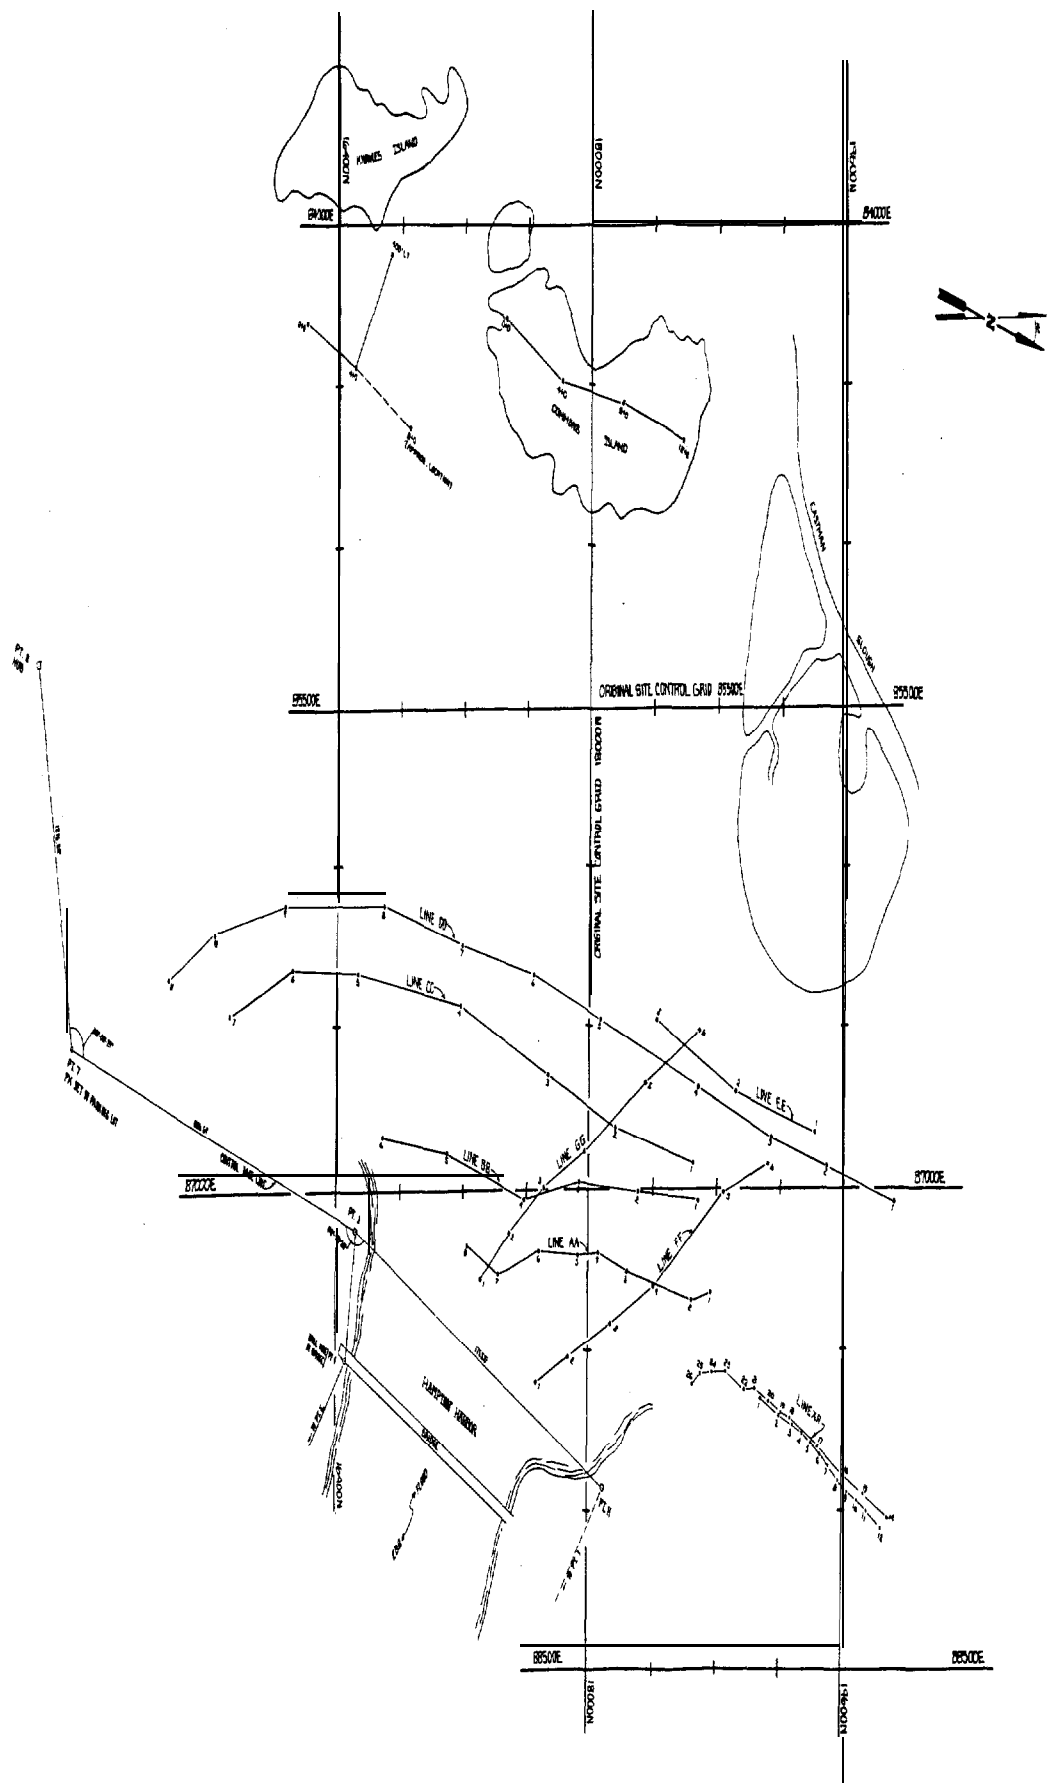
FIG. 2E-8

HAMPTON HARBOR AREA  
TRACK MAP - REFRACTION  
SEISMIC SURVEY

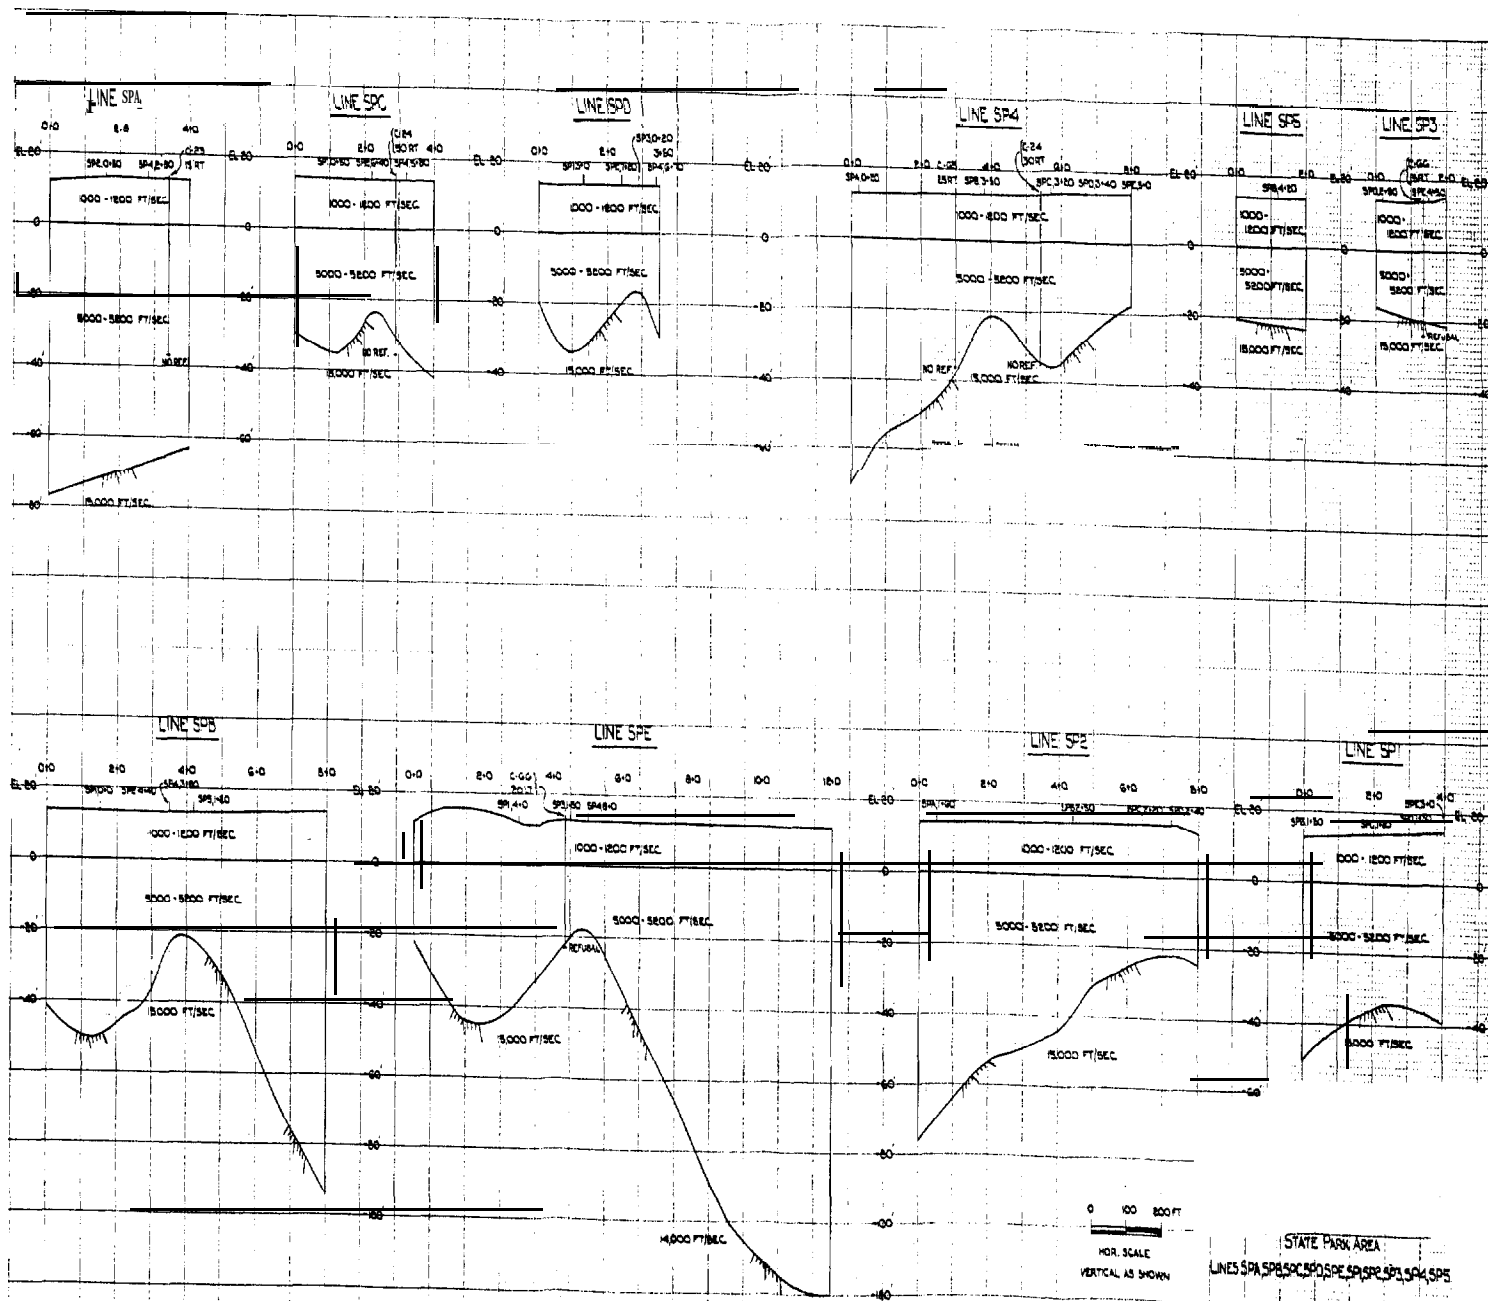
FIG. 2E-10 SH.1 SB 1 & 2

STATE PARK  
STATE BEACH AREA PROFILE  
SEISMIC SURVEY

The location plan of the seismic lines in this area is shown on Figure 2E-9 and the seismic results are shown on Figure 2E-10 (Sheets 1, 2, and 3). Two relatively shallow areas in the bedrock surface were detected in the State Park: one in the vicinity of Lines SPS and SPB, just north of Boring C-56; the second, in the vicinity of Lines SP3, SP4, and SPE, just north of Boring C-66. Boring C-24 confirmed the fact that a depression in the bedrock surface exists between the two high areas of rock.

In the State' Beach area, a thin layer of glacial till was encountered by Boring P-1, but was not detected seismically. The seismic overburden velocity of 5,500 **ft/sec**, as detected on the more easterly lines of the State Beach area, may be indicative of a dense sand.

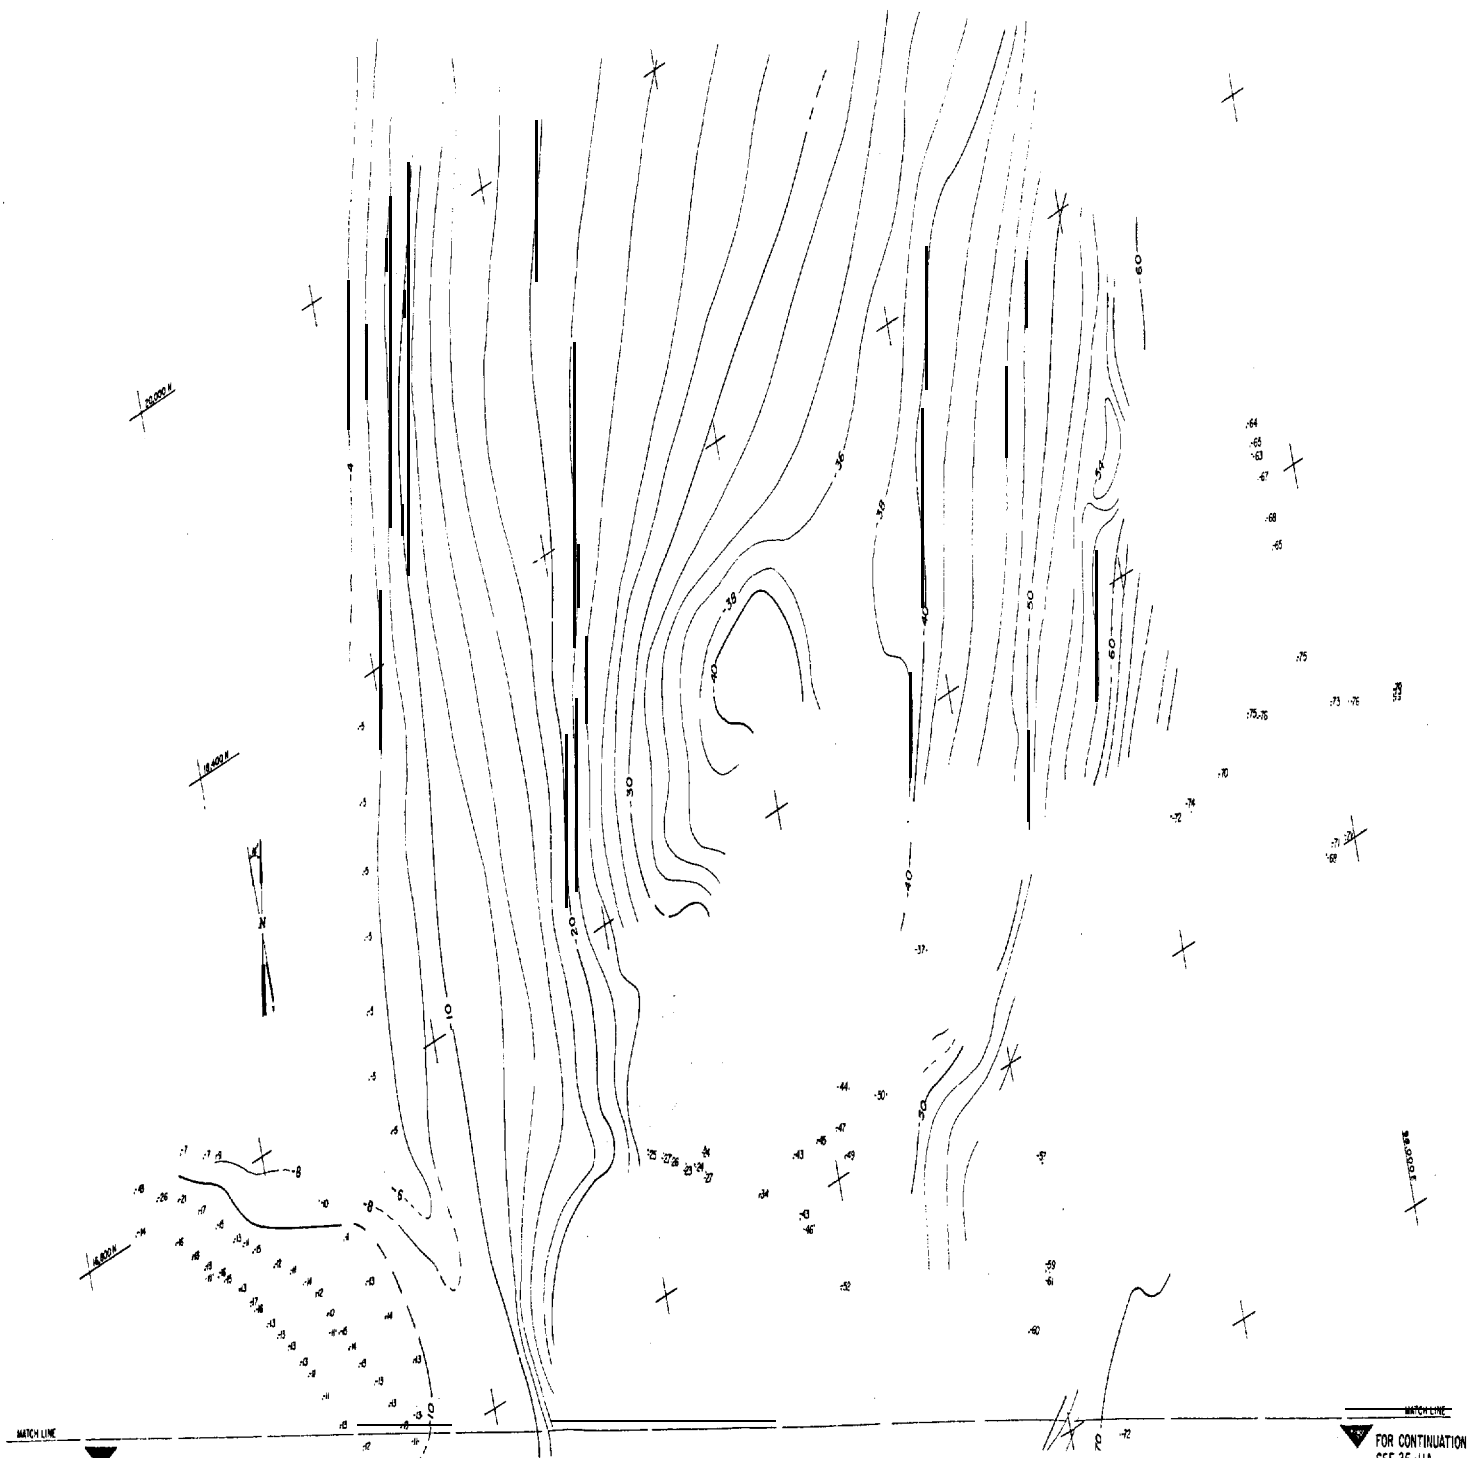
OFFSHORE AREA  
 BOTTOM CONTOUR MAP  
 SEISMIC SURVEY

The results of the fathometer survey which took place in **March** and April 1973 are shown on Figure **2E-11**. The bedrock contour map, **Figure 2E-12**, was constructed from seismic reflection and refraction data obtained in March and April 1973, and from a seismic refraction survey conducted during the fall of 1968. The track map for the 1973 reflection and refraction surveys is shown on Figure **2E-13**. The 1968 seismic refraction survey was conducted in an area extending in an east-northeasterly direction for a **distance** of about a mile from the Hampton State Beach.
