SEABROOK UPDATED FSAR

APPENDIX 2J

SEISMIC SURVEY

APPENDIX 2E  
SEISMIC SURVEYS

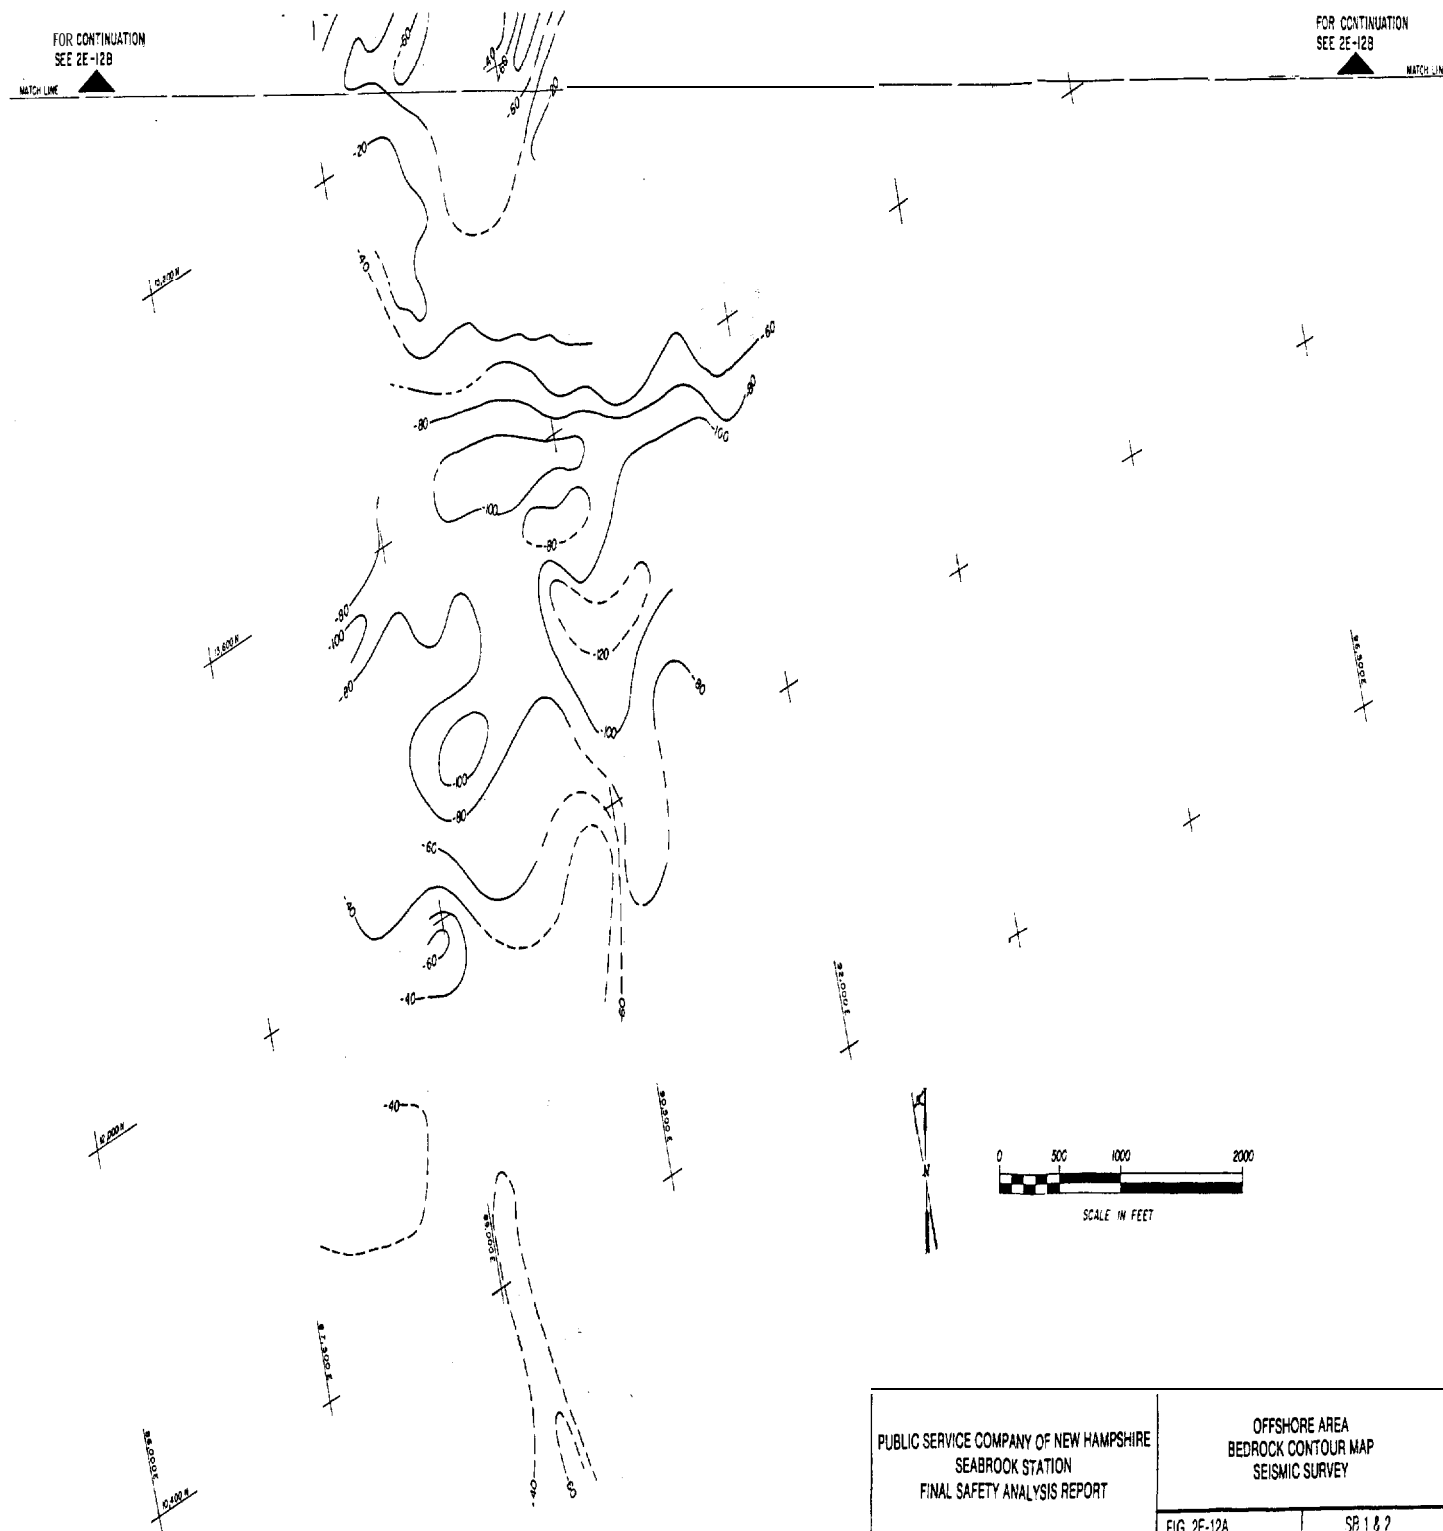
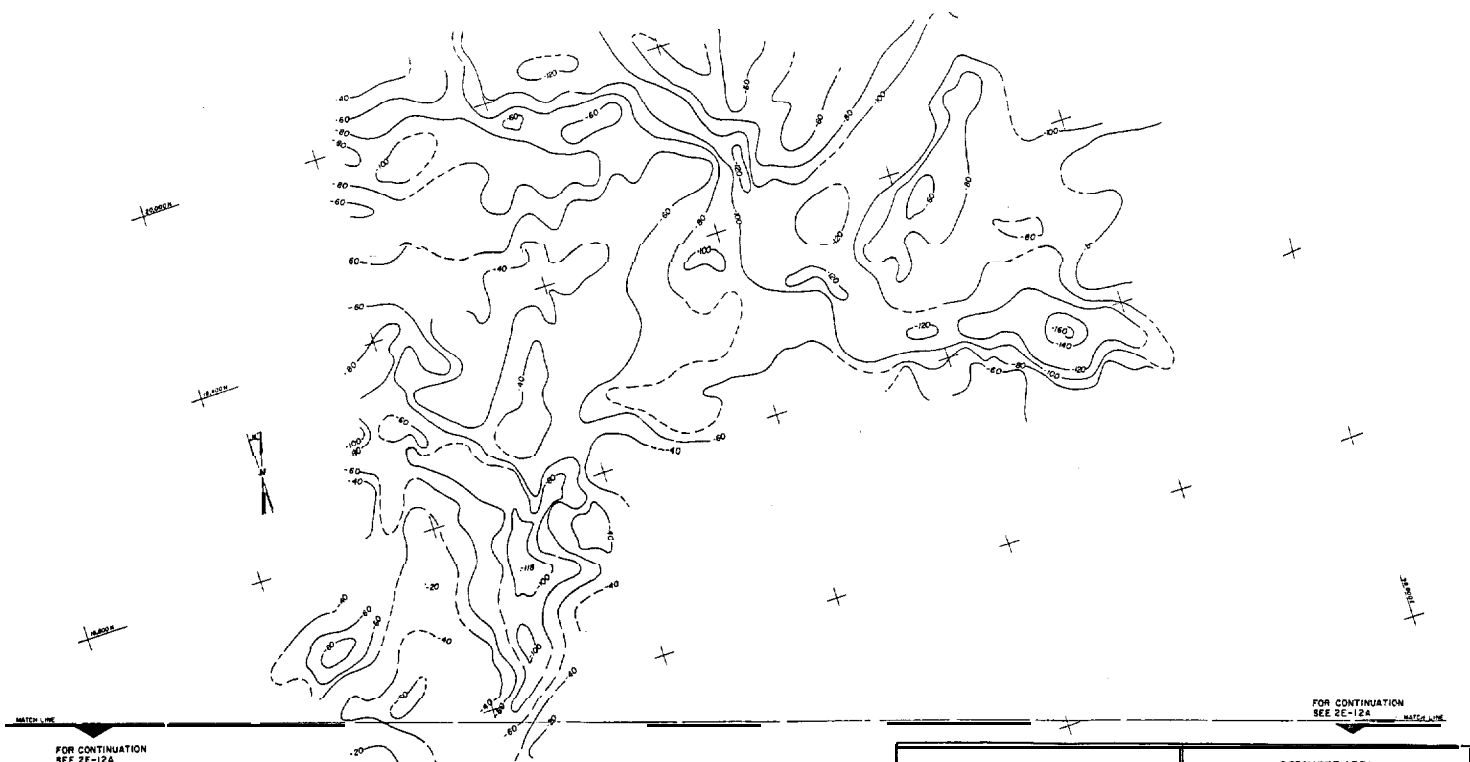
FIG. 2E-12B

OFFSHORE AREA  
BEDROCK CONTOUR MAP  
SEISMIC SURVEY

The results of the fathometer survey which took place in **March** and April 1973 are shown on Figure **2E-11**. The bedrock contour map, **Figure 2E-12**, was constructed from seismic reflection and refraction data obtained in March and April 1973, and from a seismic refraction survey conducted during the fall of 1968. The track map for the 1973 reflection and refraction surveys is shown on Figure **2E-13**. The 1968 seismic refraction survey was conducted in an area extending in an east-northeasterly direction for a **distance** of about a mile from the Hampton State Beach.

The contour maps show that much of the ocean bottom **offshore** consists of highly irregular bedrock outcrops. A denser material, possibly glacial till as indicated by the seismic refraction velocities, was found along the northern and western sides of the ledge outcrops. Refraction velocities in the 5,500 to 5,700 **ft/sec** range were found in this area, while away from the area, velocities generally ranged between 5,100 and 5,400 **ft/sec**. The seismic reflection data showed both glacial till and bedrock, although in some areas, reflections were only obtained from the till. **In** these latter cases, the refraction data provided the basis for the bedrock contours. **Borings P-2** through P-10 conformed to the general picture shown by the seismic data.

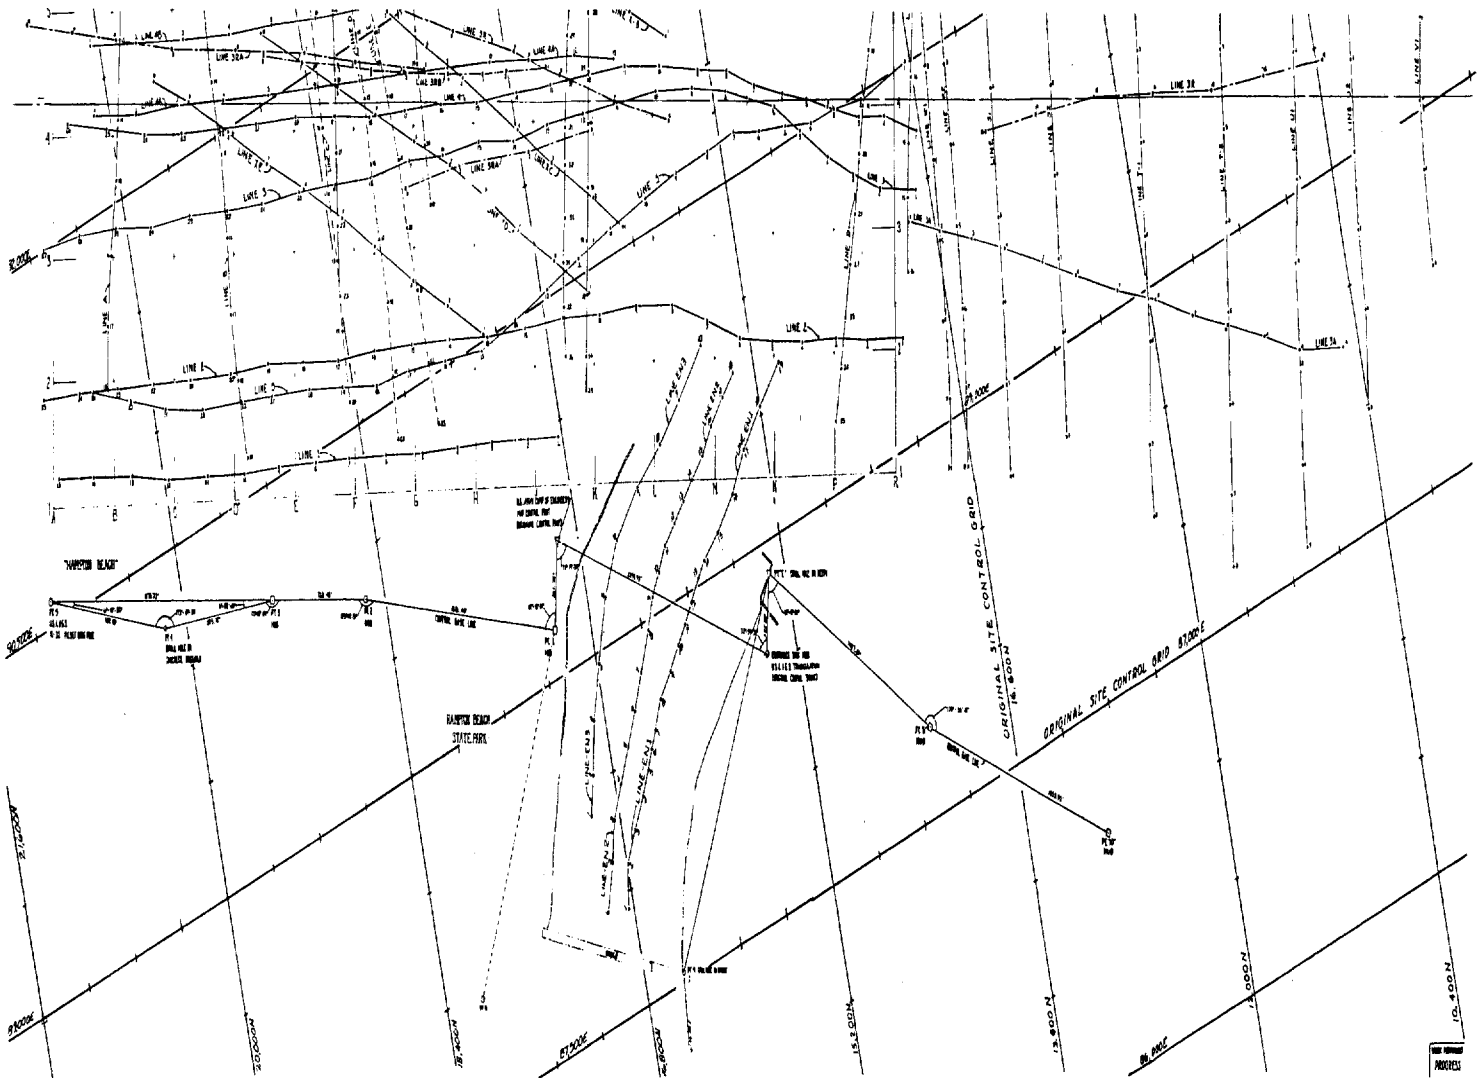
FIG. 2E-13A

OFFSHORE AREA TRACK MAP  
REFLECTION AND REFRACTION  
SEISMIC SURVEY

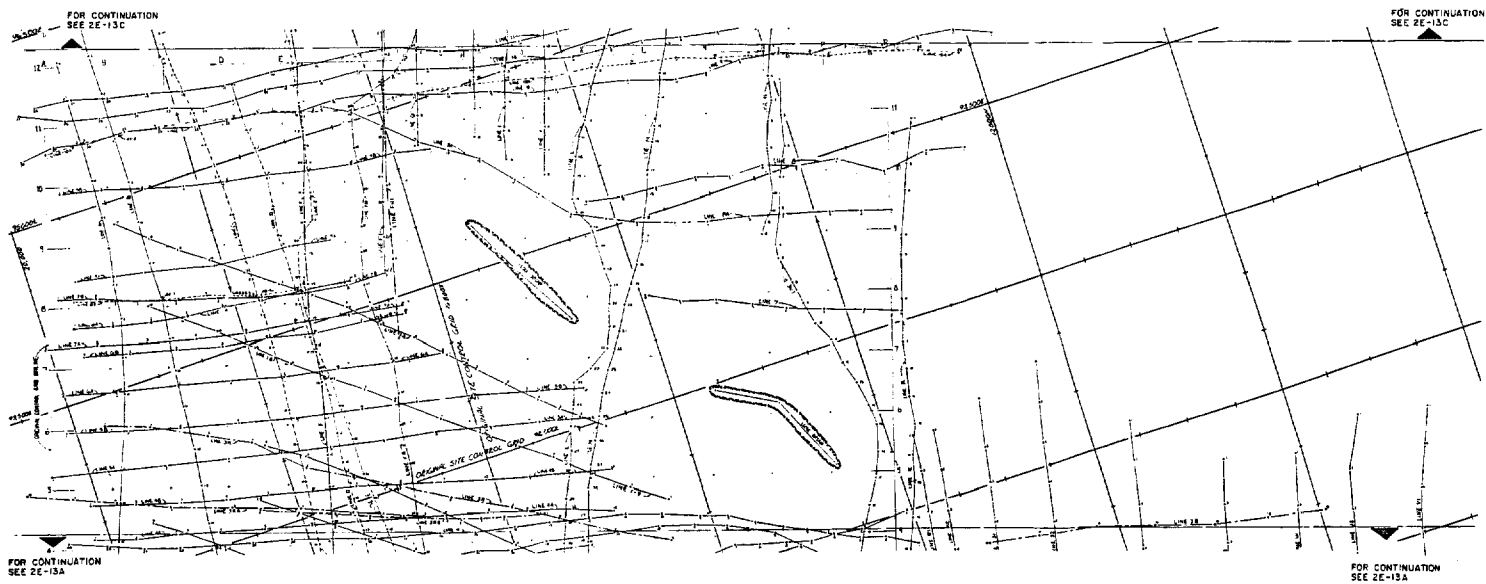
PUBLIC SERVICE COMPANY OF NEW HAMPSHIRE SEABROOK STATION FINAL SAFETY ANALYSIS REPORT	OFFSHORE AREA TRACK MAP REFLECTION AND REFRACTION SEISMIC SURVEY FIG. 2E-13B SB 1 & 2
---	---
