SEABROOK STATION
UPDATED FINAL SAFETY
ANALYSIS REPORT

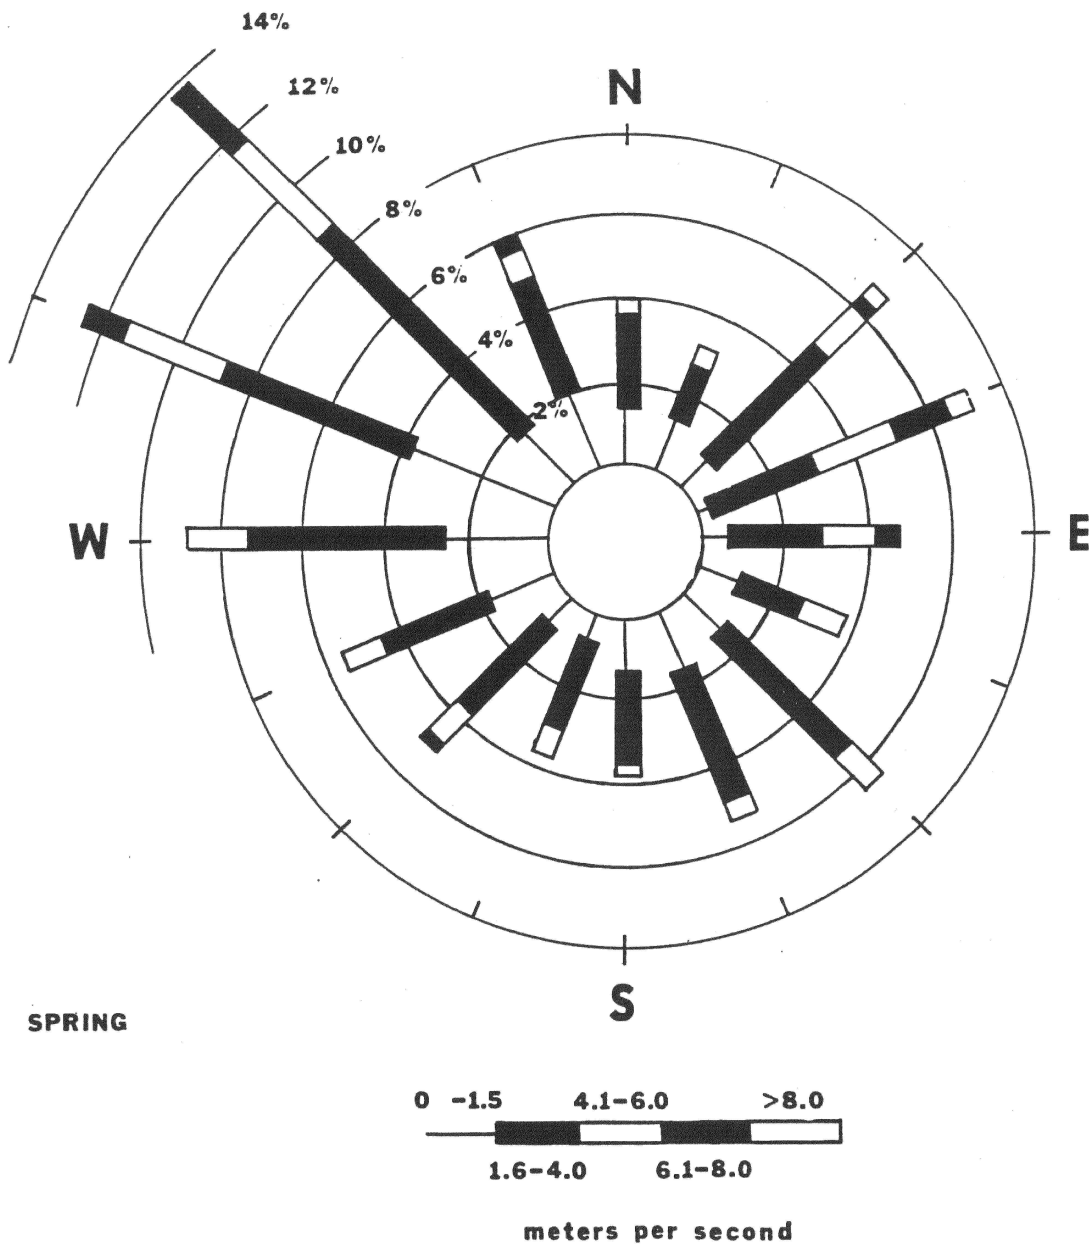
SEABROOK STATION UPDATED FINAL SAFETY ANALYSIS REPORT	Spring Wind Rose for the 30 ft. Level (March 1972 – May 1972)	
		Figure 2.3-2

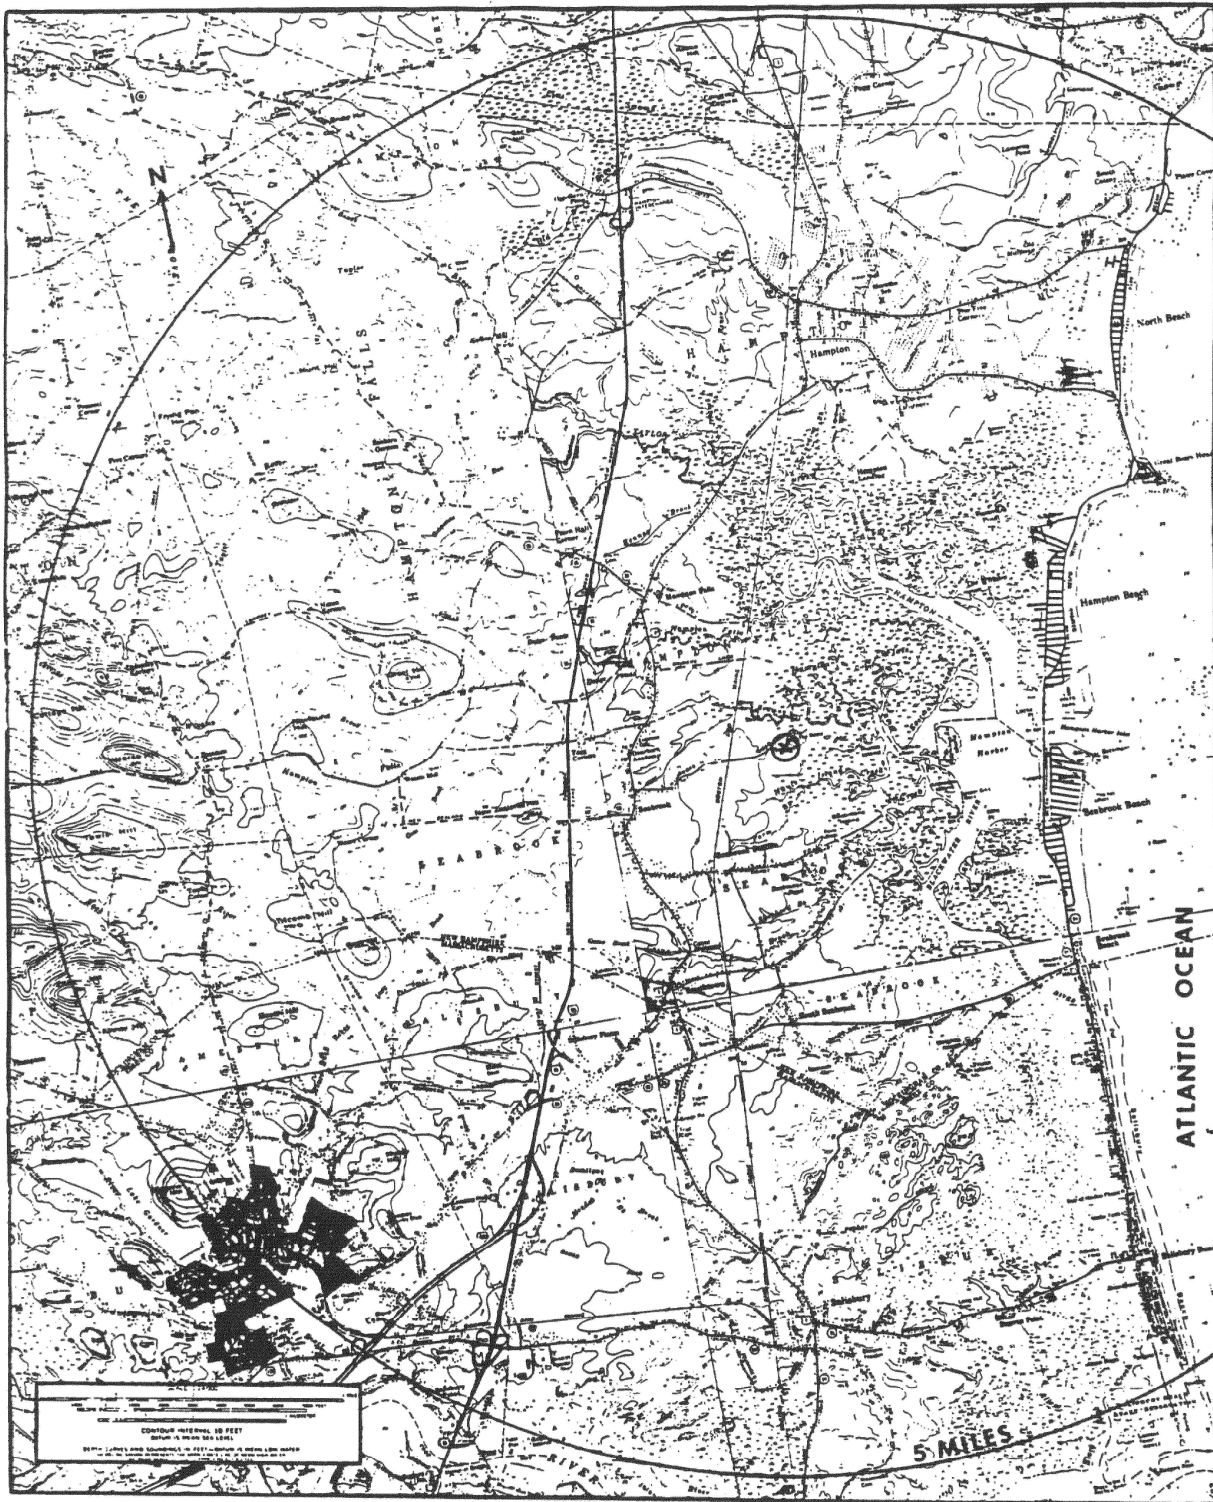
Figure 2.3-7

Topographic Map within a Five Mile Radius of the Seabrook
Site

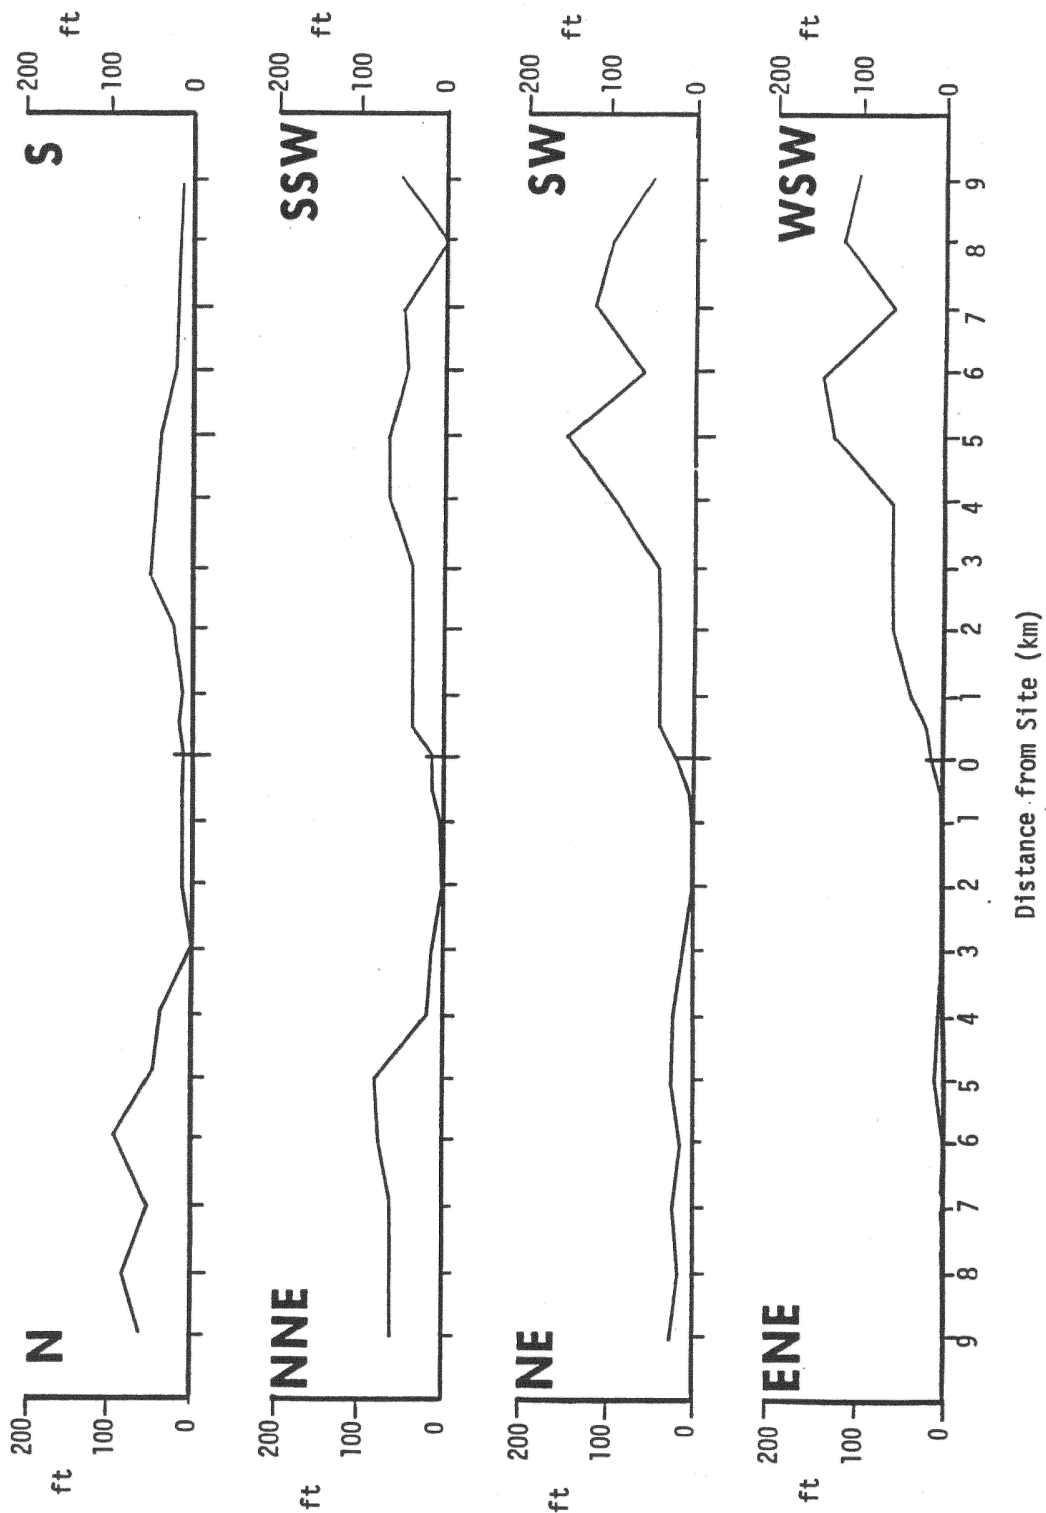
SEABROOK STATION UPDATED FINAL SAFETY ANALYSIS REPORT	Terrain Cross Section [2 Sheets]	
		Figure 2.3-8, Sh. 1 of 2
