# DAMES & MOORE

We are pleased to submit herewith copies of our report entitled, "Geotechnical Investigation of the Ramapo Fault System in the Region of the Indian Point Generating Station", Volumes I & II, prepared for Consolidated Edison Company of New York, Inc.

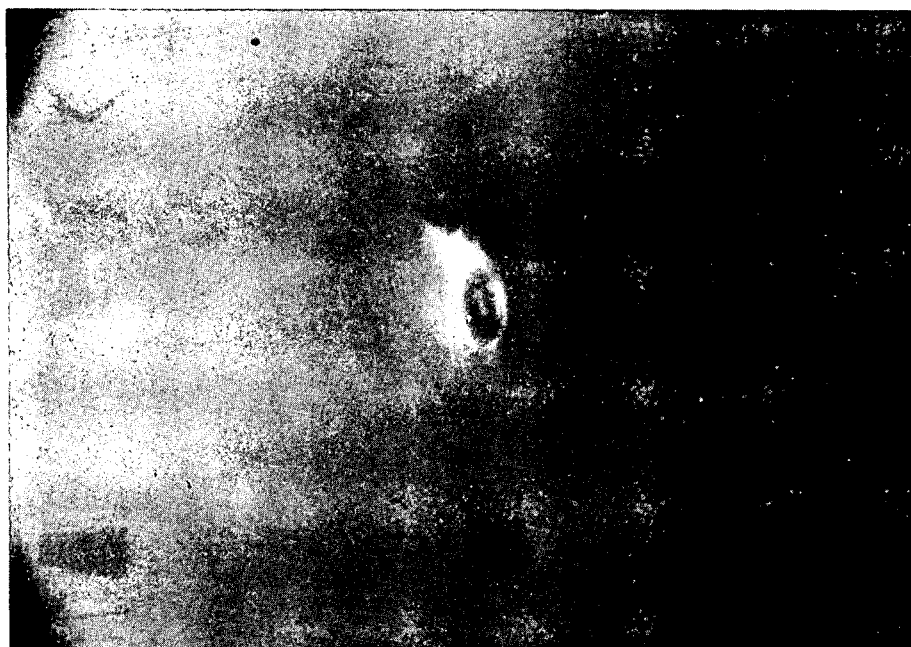
PHOTOS 2 AND 3; FS-4;  
EXAMPLES OF INCLUSIONS  
WHICH LEAKED BEFORE  
HOMOGENIZATION.

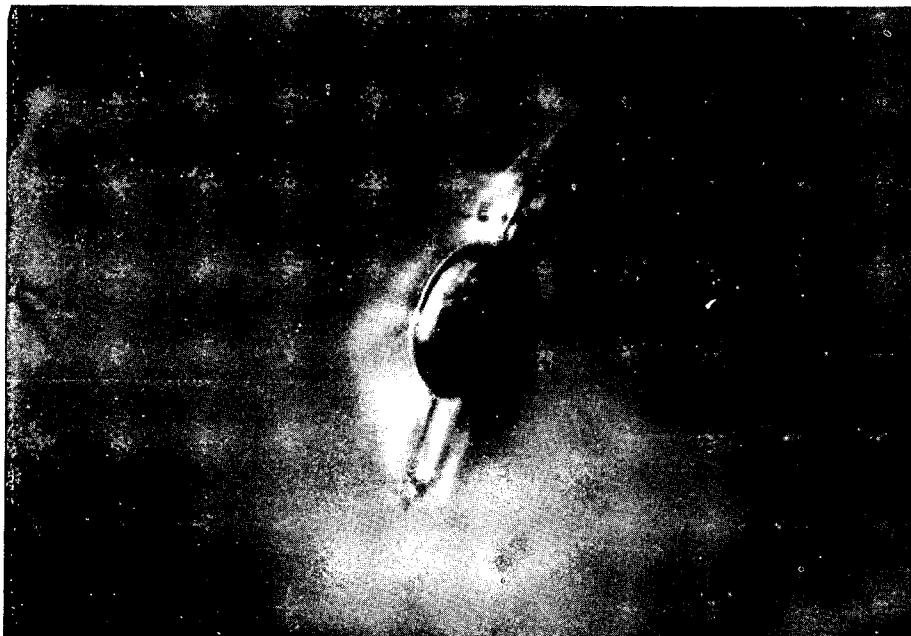
PHOTO 2, GA 1.3; INCLUSION  
WITH LARGE VAPOR/LIQUID  
RATIO RESULTING FROM LIQUID  
LEAKAGE. NOT SUITABLE FOR  
FILLING TEMP.

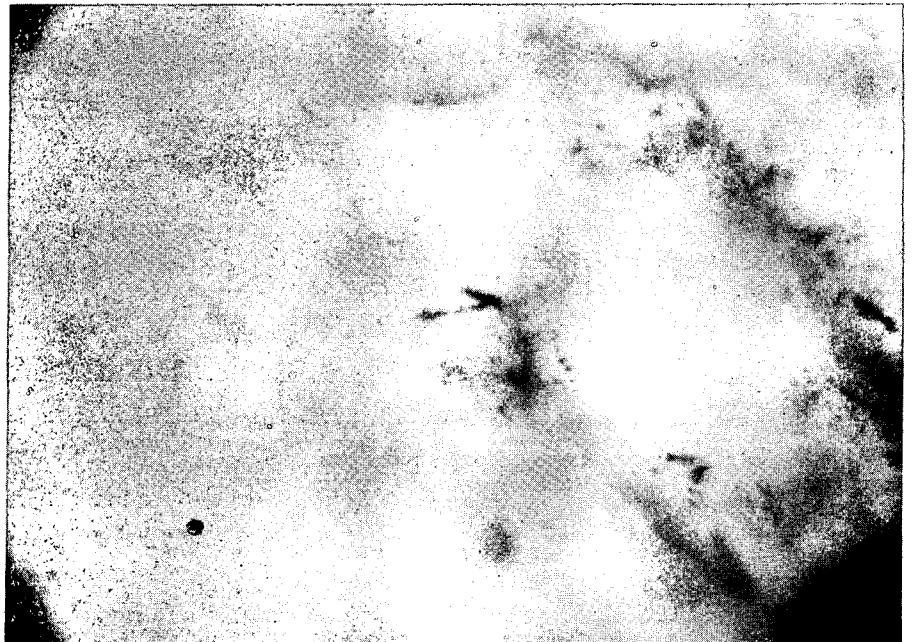
PHOTOS 2 AND 3 , GA 4.1;  
NEGATIVE CRYSTALS CONTAINING  
TWO PHASES ; NOTE TAILS  
AT CORNERS OF INCLUSIONS.

Pyramidal shaped negative crystals are fairly common (see photos). These inclusions always have tails found at some or all corners of the inclusion. Often the inclusion is found at intersections of fractures and is generally empty. Some two-phase inclusions (photo 2 and 3) were observed but leaked when heated.

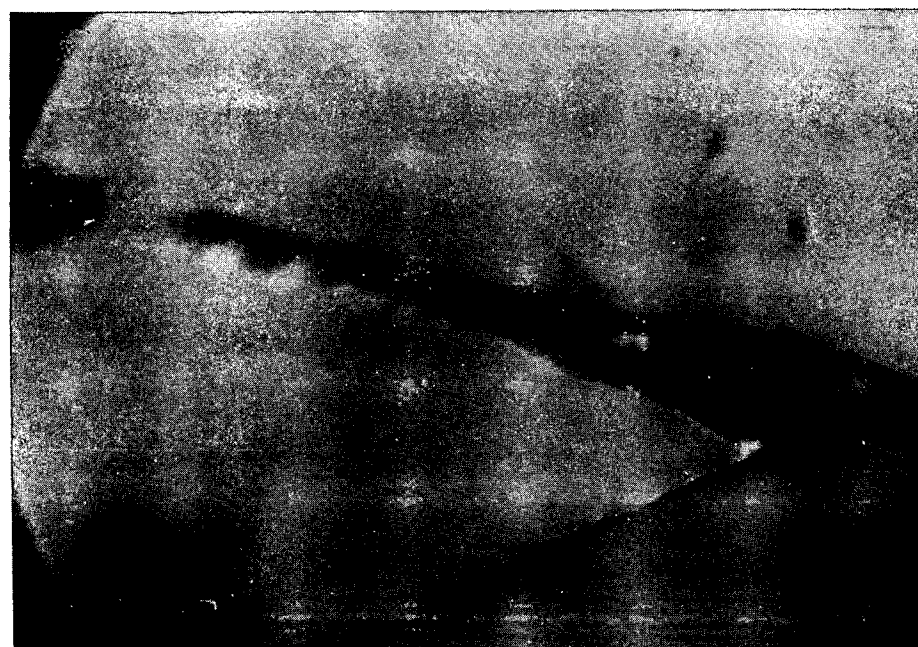
PHOTO 3, MW67D-1, CHIP 5.  
INCLUSION 5; NOT SUITABLE  
FOR HOMOGENIZATION TEMP.;  
SEE SKETCH.

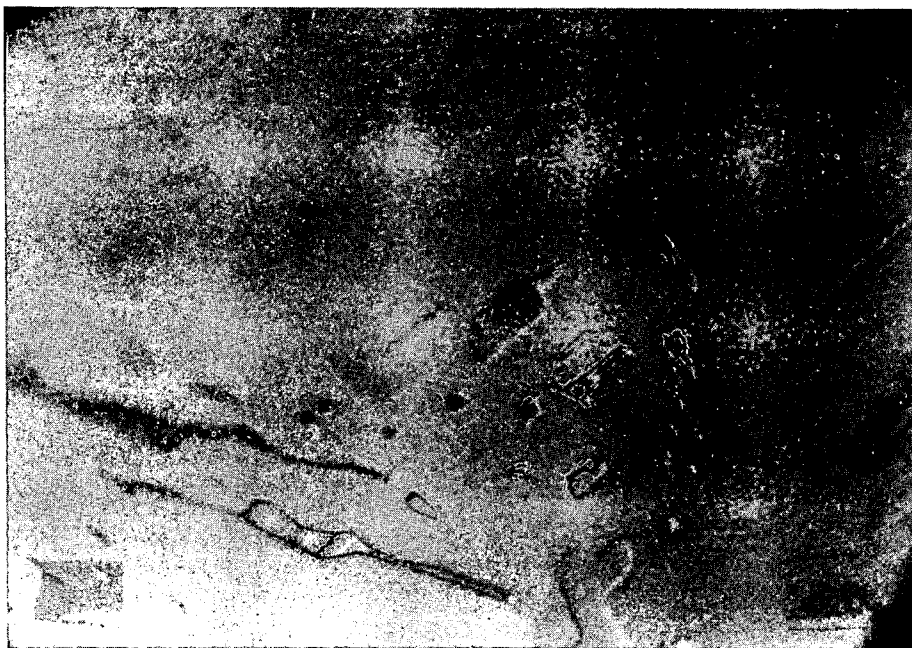
PHOTO 3, MW106-2, CHIP3,  
SAME AREA AS PHOTO 2,  
DIFFERENT DEPTH OF FOCUS;  
LARGE INCLUSION WAS PROBABLY  
ORIGINALLY A FLUID-FILLED  
INCLUSION WHICH LEAKED.

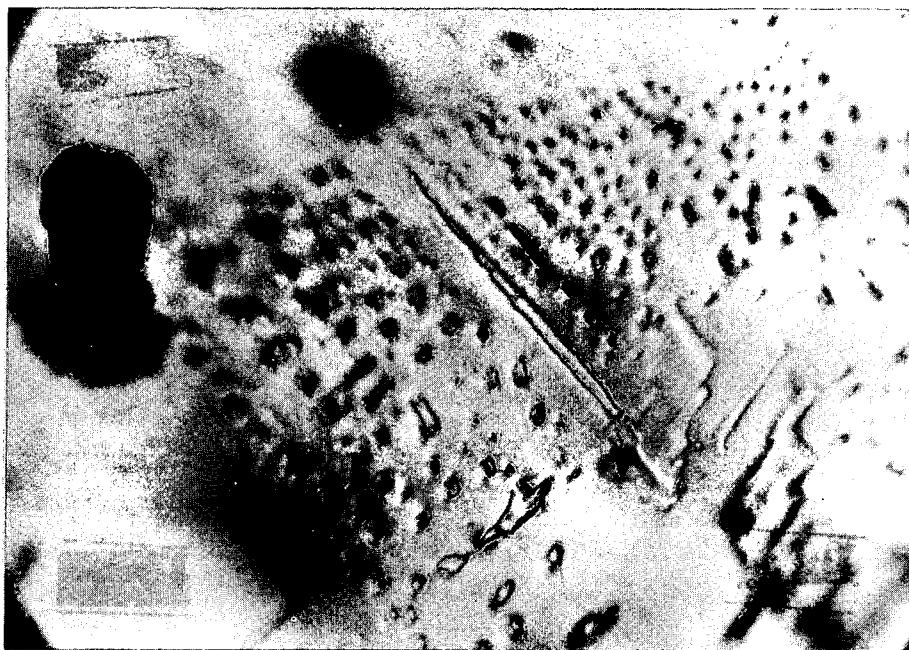
PHOTO 3, GA 11.2, CHIP 2;  
SERIES OF SECONDARY  
INCLUSIONS CONTAINING ONLY  
A VAPOR PHASE; LARGE DARK  
PATCHES ARE PYRITE.

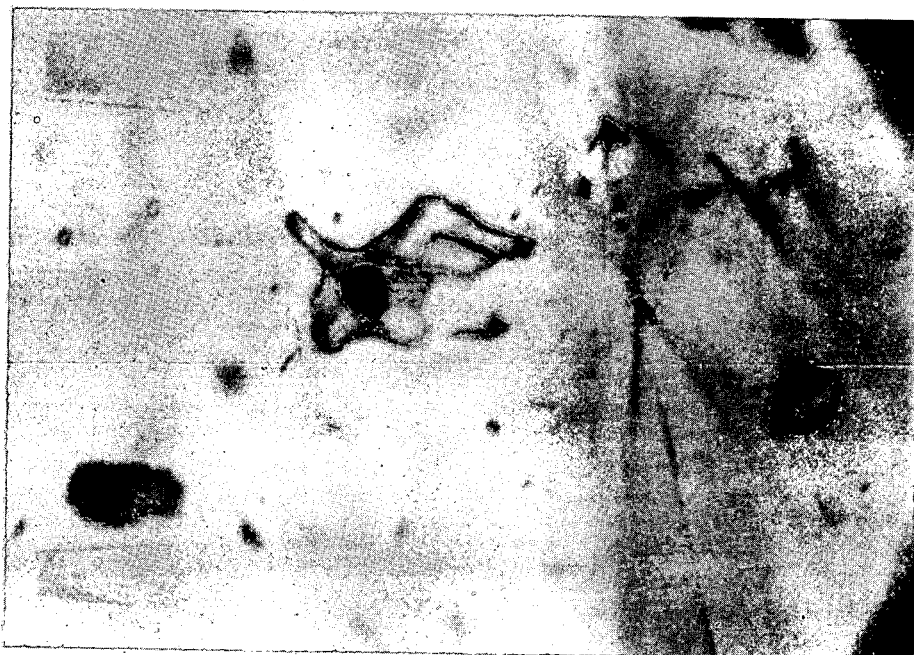
PHOTO 2, GA 7.1, CHIP 3,  
PRIMARY INCLUSIONS 4, 5  
AND "LEAKED" INCLUSION;  
SEE SKETCH
