**Comanche Peak Nuclear Power Plant, Units 3 & 4
COL Application
Part 2, FSAR**

Figure 2.5.1-226 Photos of Roadcuts along Highway 56

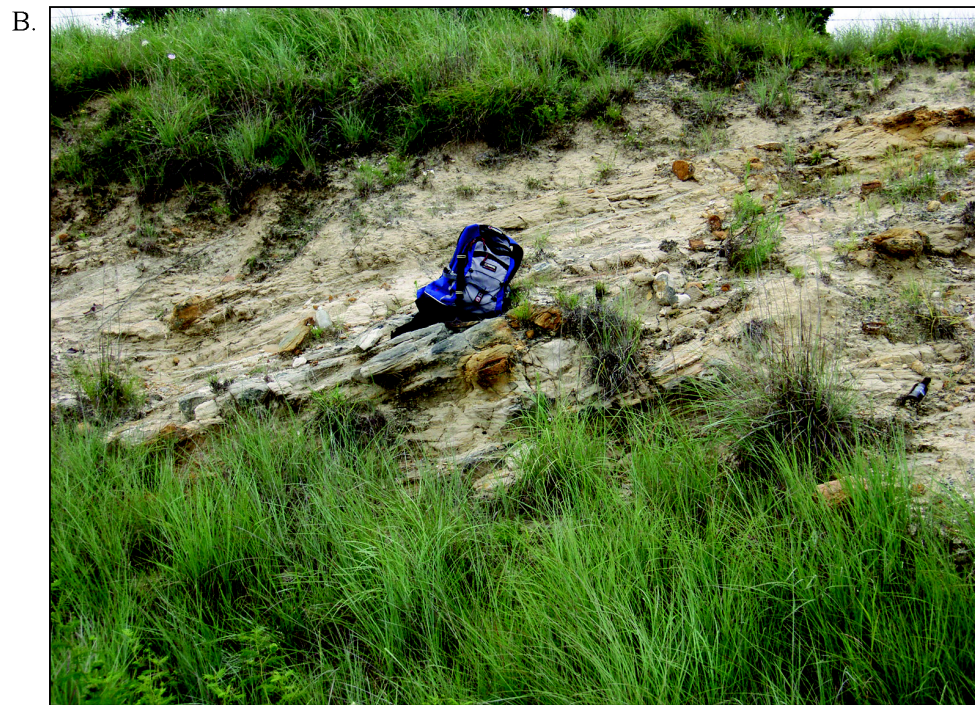
Field photos of (A) typical bedding in the Paluxy Formation and (B) more steeply dipping bedding associated with feature along Highway 56
