**Comanche Peak Nuclear Power Plant, Units 3 & 4  
COL Application  
Part 2, FSAR**

**Figure 2.5.1-227 Ground Based LiDAR Outcrop near CPNPP Dam**

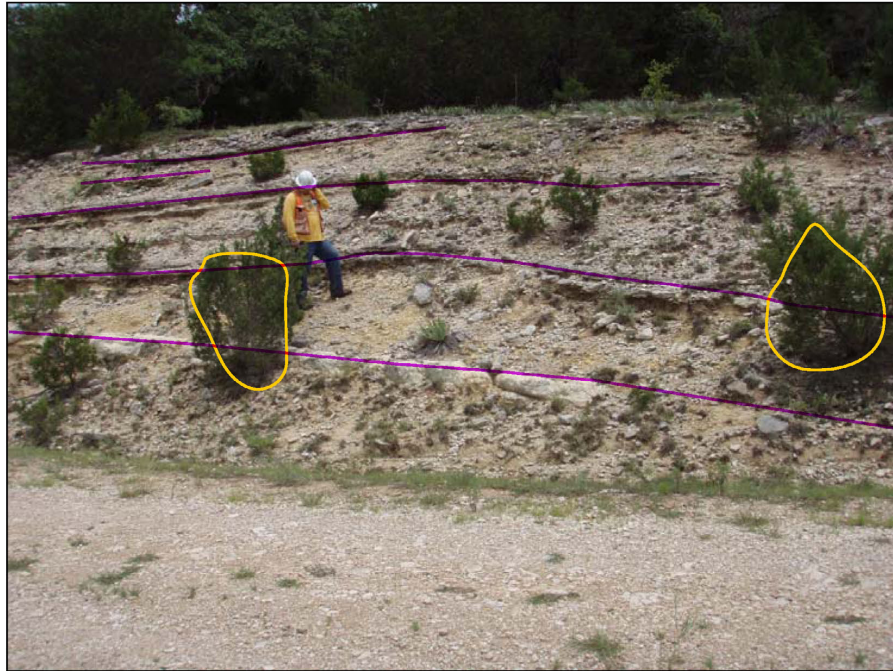
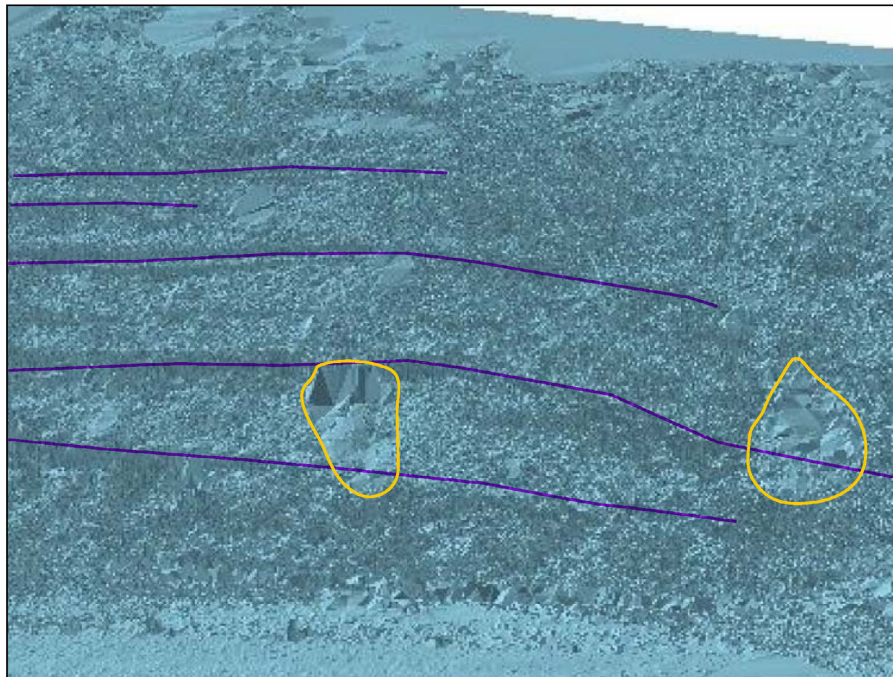
- (Purple lines) are overlain of exposed bedding to show the comparison between the LiDAR image (lower) and the photograph (above).
- (Yellow lines) show poor imaging areas due to vegetation.
