Pressurized Water Reactor
B&W Technology
Crosstraining Course Manual

Chapter 16.0

Davis-Besse Loss of All Feedwater

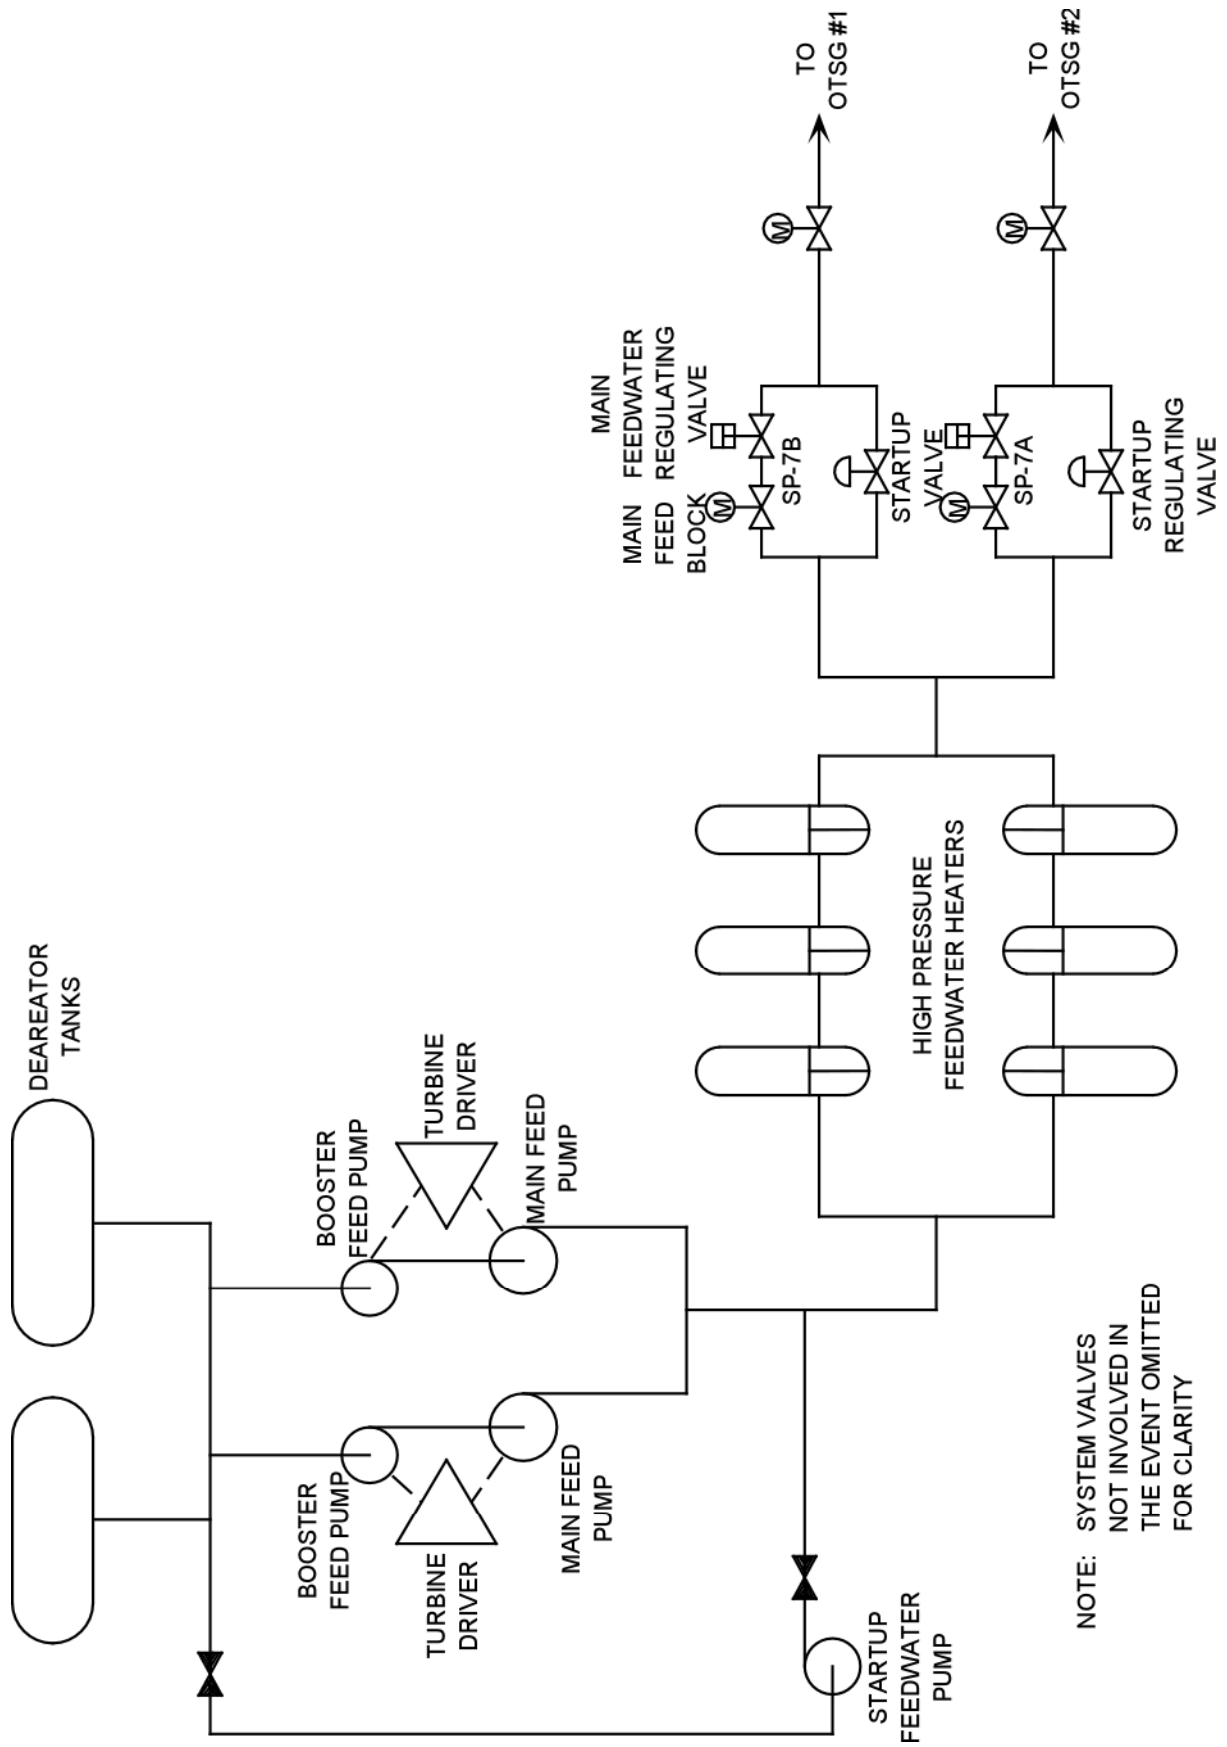
Figure 16-3 Main Feedwater System

The main feedwater system, Figure 16-3, begins with the cross-connected deaerator storage tanks. Each of these tanks has a capacity of 64,000 gallons and provides the required net positive suction head (NPSH), i.e. pressure, for the booster feedwater pumps. The booster feedwater pumps are driven through a gear reducer by the main feedwater pump turbines and function to increase system pressure to satisfy the suction requirements for the main feedwater pumps. The direct-driven main feedwater pumps increase feedwater pressure to a value greater than steam generator pressure and discharge through the high pressure feedwater heaters to the feedwater regulating valves.

Two parallel valves are used to govern the flow of feedwater to each OTSG. The first of the two valves is called the startup control valve and regulates feedwater flow from 0% power to approximately 15% power. Startup control valve SP-7B supplies the #1 OTSG,

and startup control valve SP-7A supplies the #2 OTSG. When the startup control valves reach the 80% open position, the main feedwater regulating block valves open, and flow is also controlled by the main feedwater regulating valves. The main feedwater regulating valves control feedwater flow during the power escalation from 15% to 100%. The pressure drop across the valve network is monitored and used to control main feedwater pump turbine speed. From the outlet of the feedwater regulating valves, the feedwater travels to the OTSGs via a motor-operated main feedwater isolation valve. Main feedwater is added to the OTSG through the external main feedwater ring and the main feedwater nozzles.

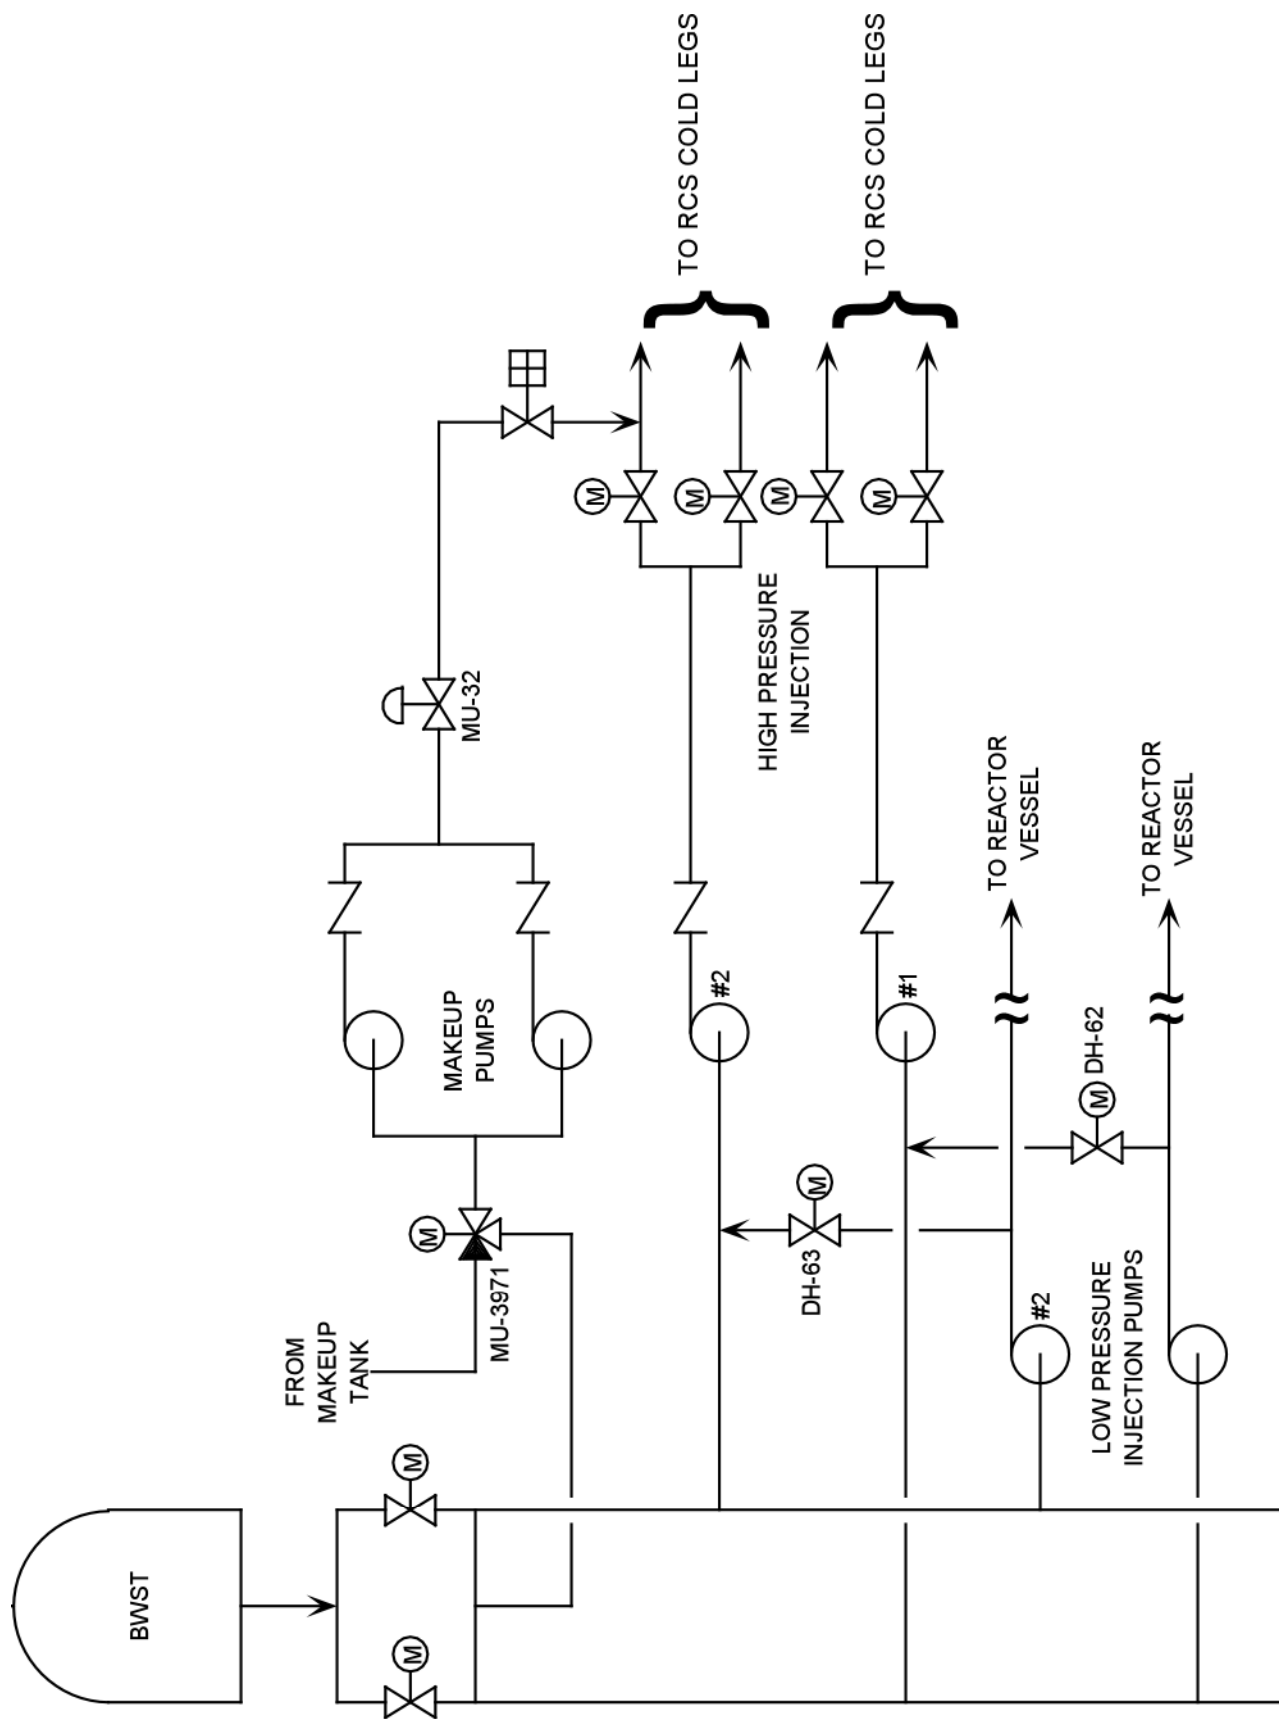
Figure 16-5 Emergency Core Cooling Systems

The high-pressure injection pumps (HPI) are a part of the emergency core cooling system and are not in service during normal operations. The system consists of redundant pumps and four injection paths into the cold legs of the RCS. The pumps receive their suction from the BWST and have a shutoff head of 1630 psig. When these pumps are used in the feed and bleed mode of core cooling, both pumps are started, and the discharge of the low-pressure injection pumps can be aligned to the HPI pump suctions as described below.

The low-pressure injection (LPI) pumps are also a part of the emergency core cooling systems. The LPI pumps receive a suction from the BWST and discharge via the decay heat removal coolers (not shown in Figure 16-5) into the reactor vessel. The pumps are rated at 3000 gpm with a discharge pressure of approximately 150 psig. The shutoff head of the pumps is about 200 psig. Plant procedures allow the discharge of the LPI pumps to be aligned to the suction of the HPI pumps by opening valves DH-62 and DH-63. This alignment increases the discharge pressure of the HPI pumps from 1630 psig to approximately 1830 psig and allows HPI flow at a higher RCS pressure.
