**Levy Nuclear Plant
Units 1 and 2
Part 2, Final Safety Analysis Report**

Diagrams Illustrating the Orientation of
A) Fracture Sets in Bedrock Exposures
and B) Lineaments in the LNP Site Location

Figure 2.5.3-224

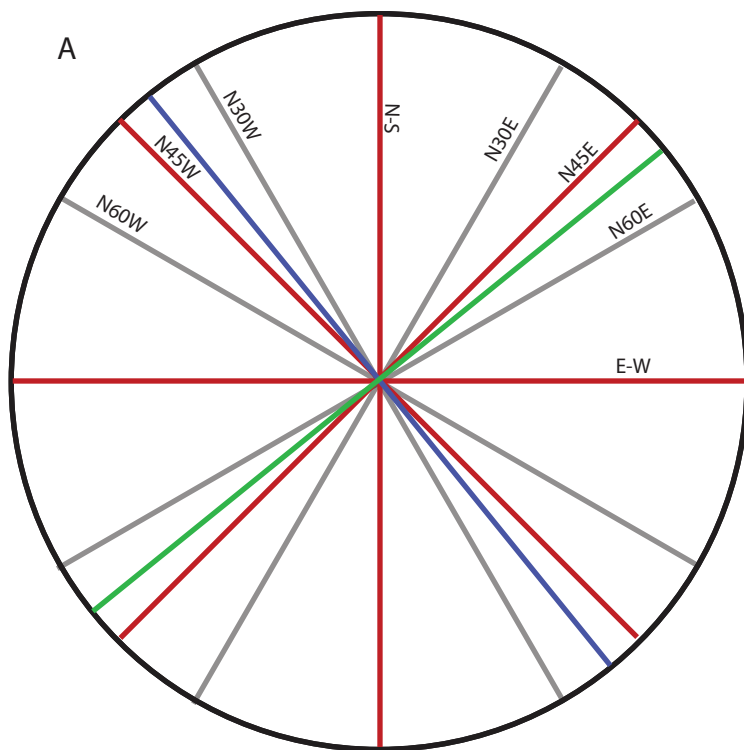
A: Joint orientations observed in Crystal River Unit No. 3 Excavation (no information on frequency or number of observations) (CR3 FSAR, 1973).

- Primary orthogonal joint systems
- Secondary orthogonal joint systems

Gulf Hammock Quarry and Wacasassa River Exposures

- Primary set
- Orthogonal set

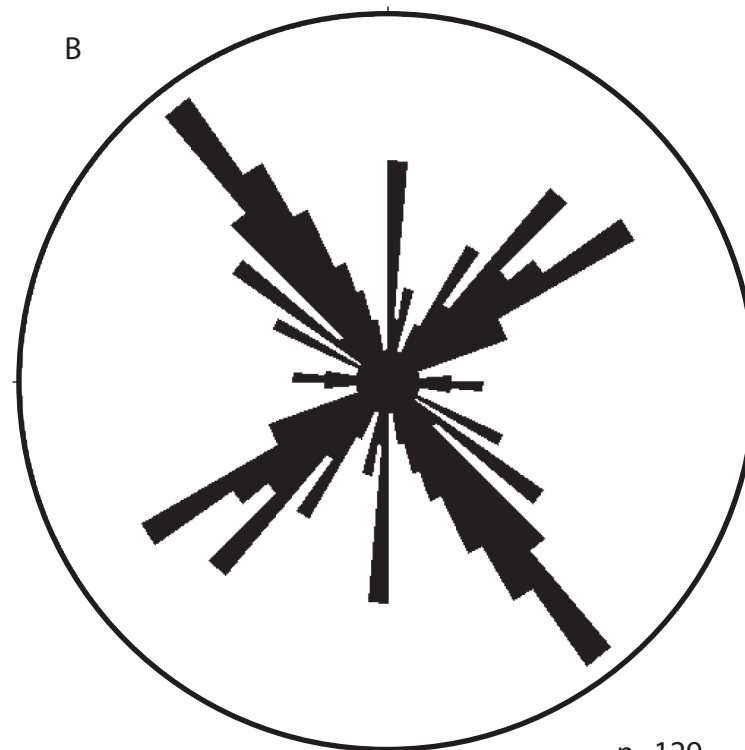
n=129

B: Rose diagram showing orientation and frequency of mapped lineaments within the site location (1-km [0.6-mi.] radius)
