Response: Updates for License No. 24-15595-01

**Decommissioning Plan
Aptuit Scientific Operations
Aptuit, LLC
Kansas City, Missouri**

**Decommissioning Plan
Aptuit Scientific Operations
Aptuit, LLC
10245 Hickman Mills Drive
Kansas City, Missouri**

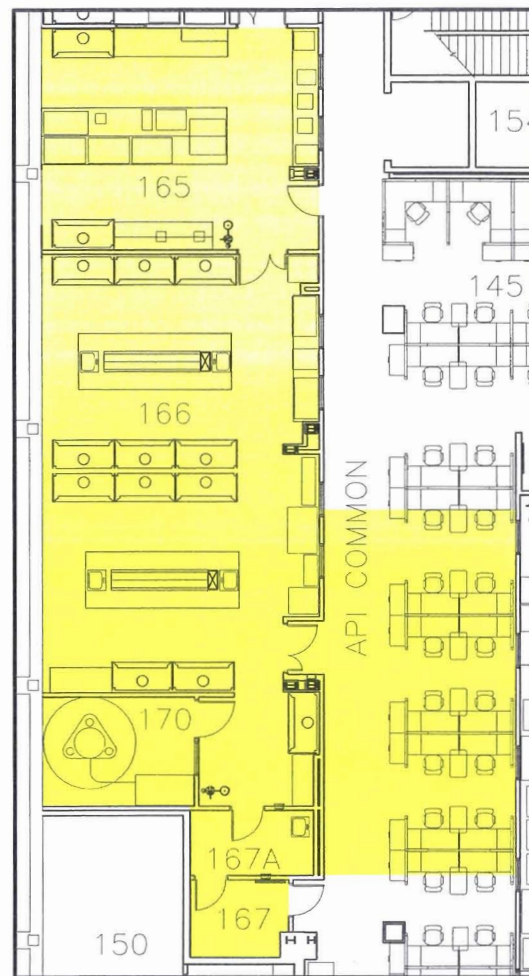
ENLARGEMENT OF SPILL AREA

APPROXIMATE AREA OF SPILL

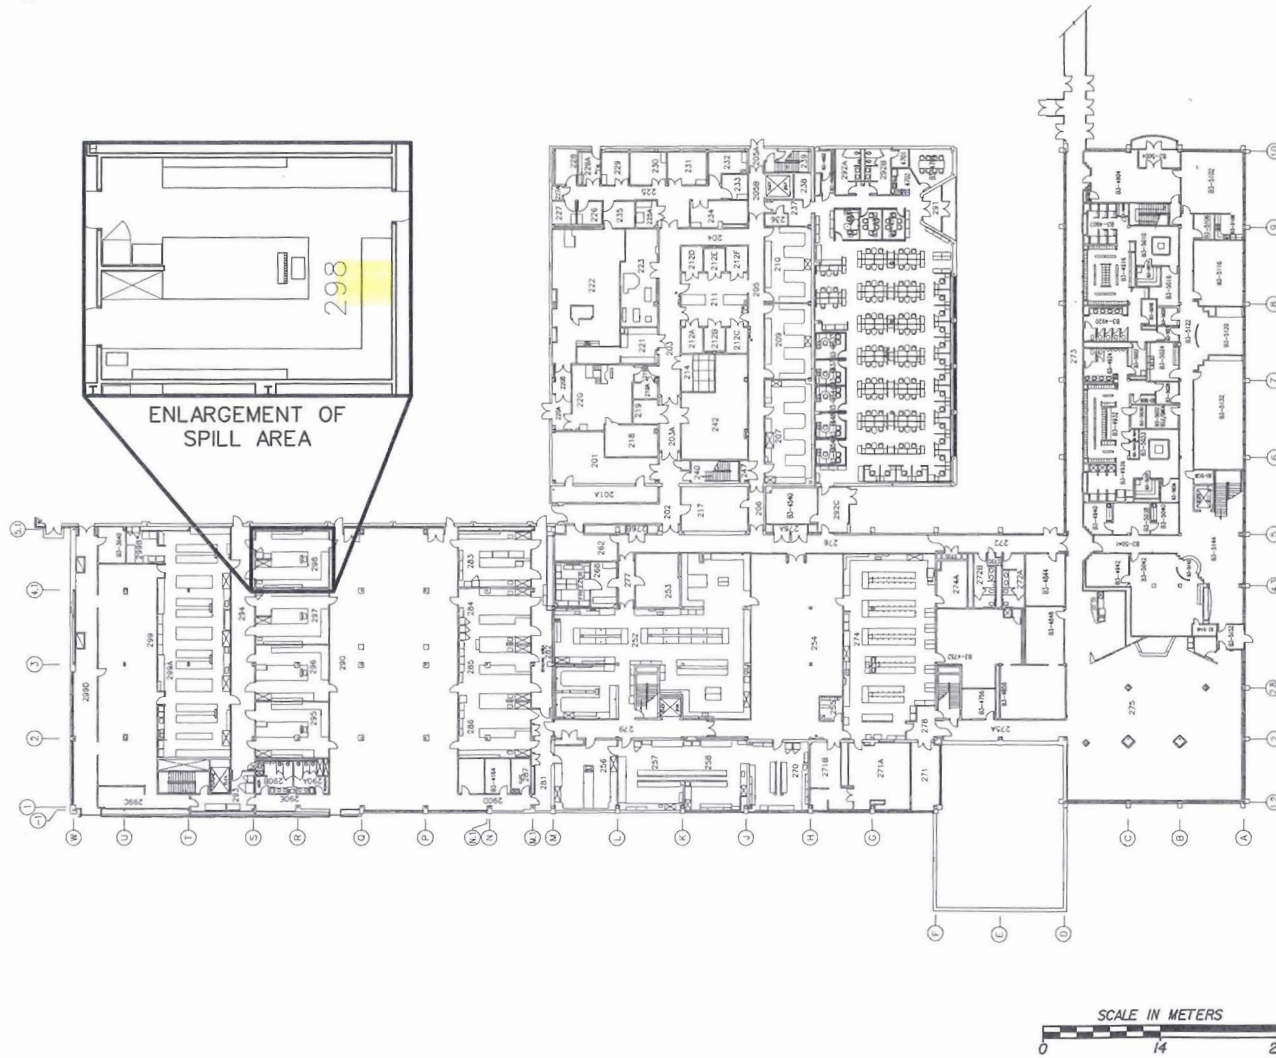
FIGURE 1-3
 LOCATION OF SPILL
 B BUILDING B3

On April 4, 2007, it was discovered that the tubing from a detector on a high-performance liquid chromatograph in B3-298 had become detached and had dripped on the floor. Surveys conducted after the tubing was reconnected indicated some ^{14}C contamination on a corner of the cabinet and on the floor. Attempts to decontaminate the area were unsuccessful. The contaminated areas were taped and labeled as radioactive. No contamination was found outside the immediate area of the spill. Contamination levels exceeded 100,000 dpm/100 cm².

On July 26, 2010, the deionized water system in B3-298 leaked into the contaminated area under the bench. Water that leached from under the bench was contaminated. Water also leaked under the wall into the adjacent hallway. No contamination was found on the carpet in the hallway.

Analytical Laboratory (B3-298). There are two documented incidents in B3-298 that resulted in ^{14}C contamination or the further spread of contamination on a lab bench and a section of the floor. Contamination levels of 100,000 dpm/100 cm² were noted from the first spill. The second incident was a release of water into the contaminated area, which resulted in removable contamination levels of up to 8,000 dpm/100 cm². These areas are marked as contaminated, and

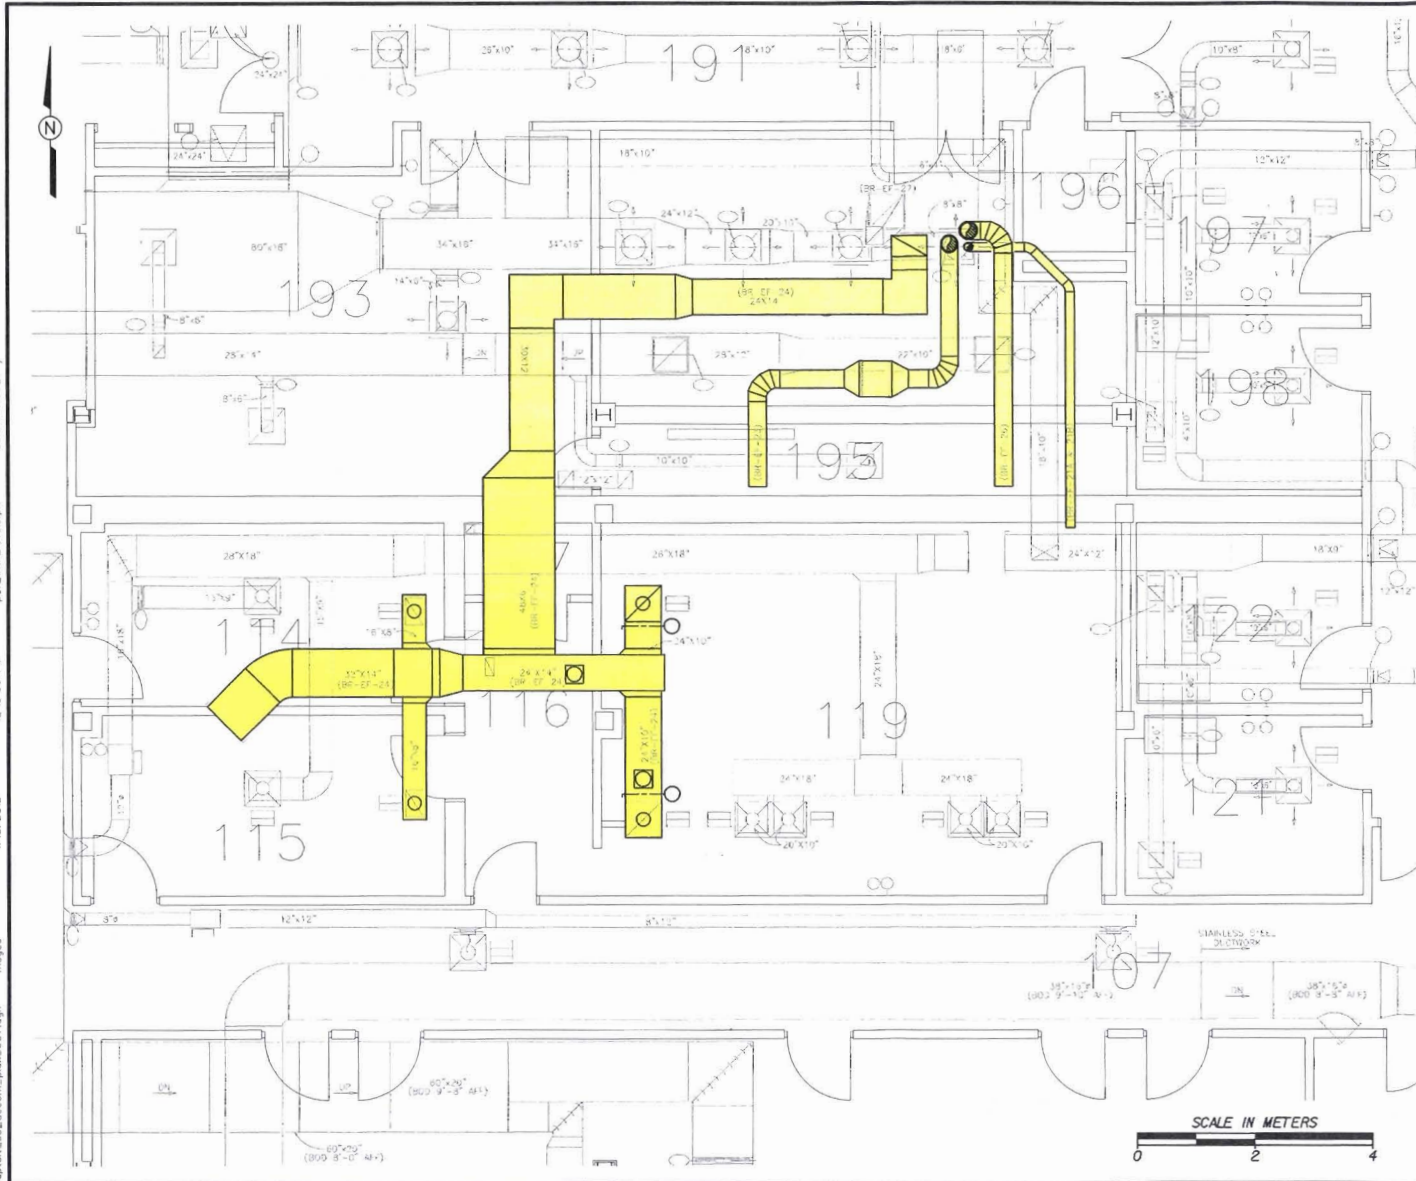
FIGURE 1-7
LEGACY DUCTWORK OF
POTENTIAL CONCERN,
B BUILDING B2

LEGEND:
AREA OF POTENTIAL CONCERN

A description of all historical and current radioactive material use and storage areas is contained in Appendix C. Facilities and systems that are being decommissioned under this DP include legacy ductwork in B Building, the incinerator (B2-103A), Dock 5 (B Building), the API filter room (B2-112), the API laboratories (B2-155 through B2-170), the API exhaust, drain, and vacuum systems, an analytical laboratory (B3-298), the waste storage building, and the health physics (HP) support areas (B2-116, 117, 119). The owner of these areas is noted in Appendix C as "SO." These areas of concern are shown on Figures 1-4 through 1-10, and photographs of the areas to be decommissioned are included in Appendix D.

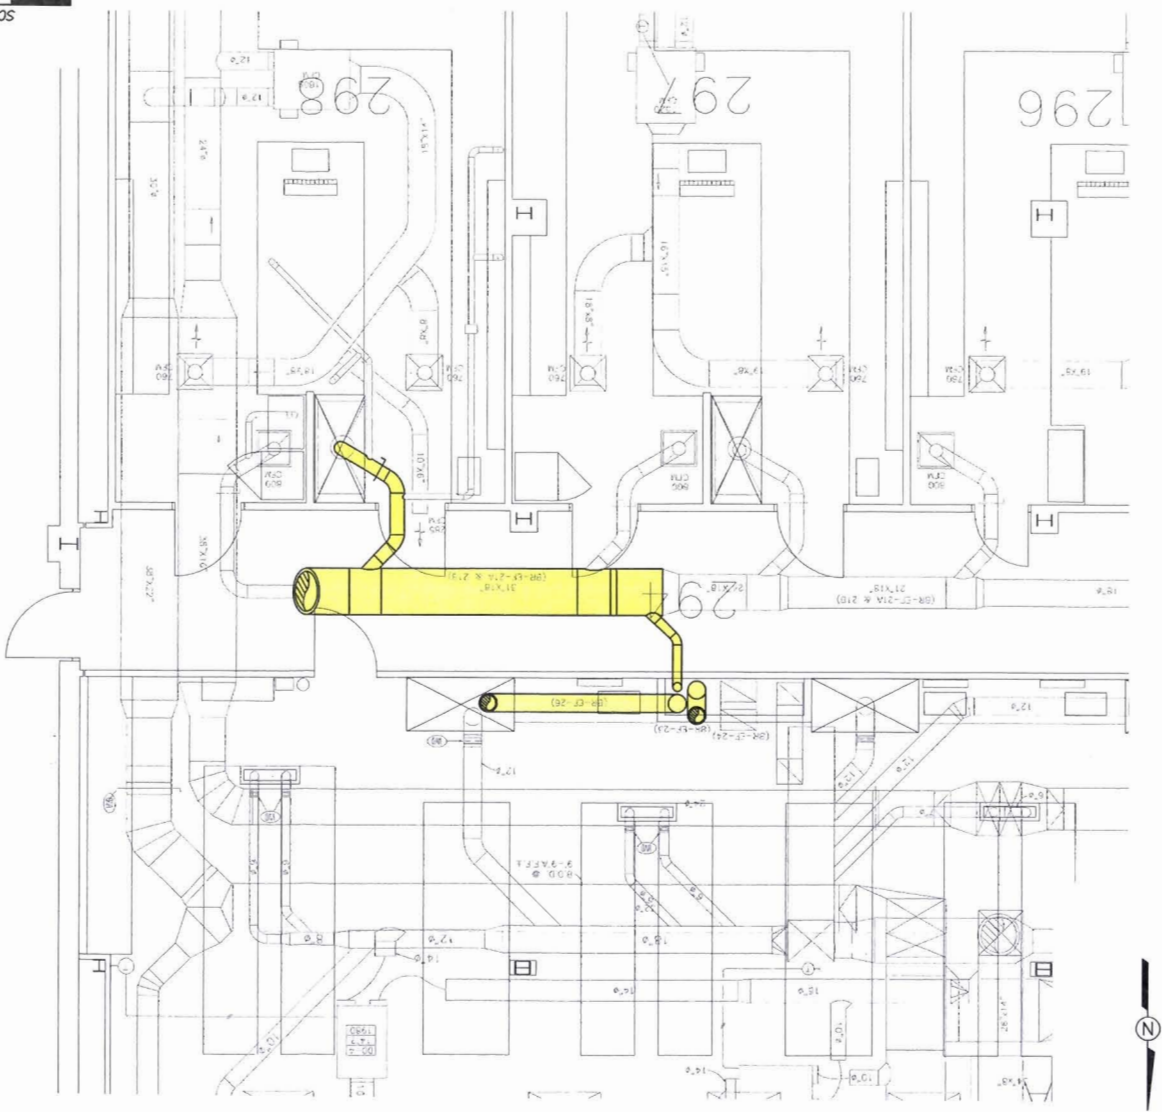
FIGURE 1-8
LEGACY DUCTWORK OF
POTENTIAL CONCERN,
B BUILDING B3

LEGEND: AREA OF POTENTIAL CONCERN

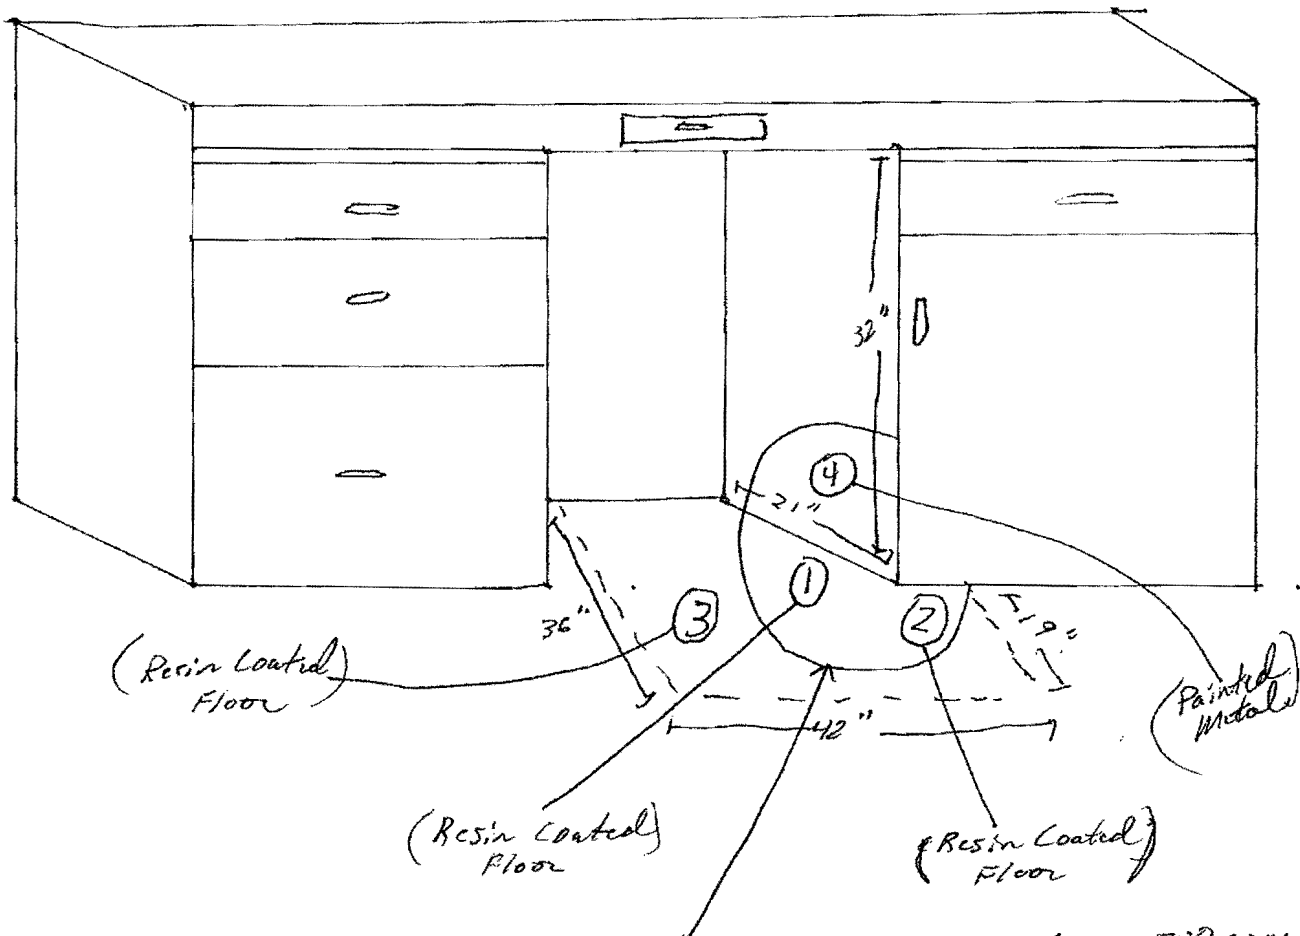
Area inside solid line was above 200 cpm
at 1.5 m, model 3/44-9.

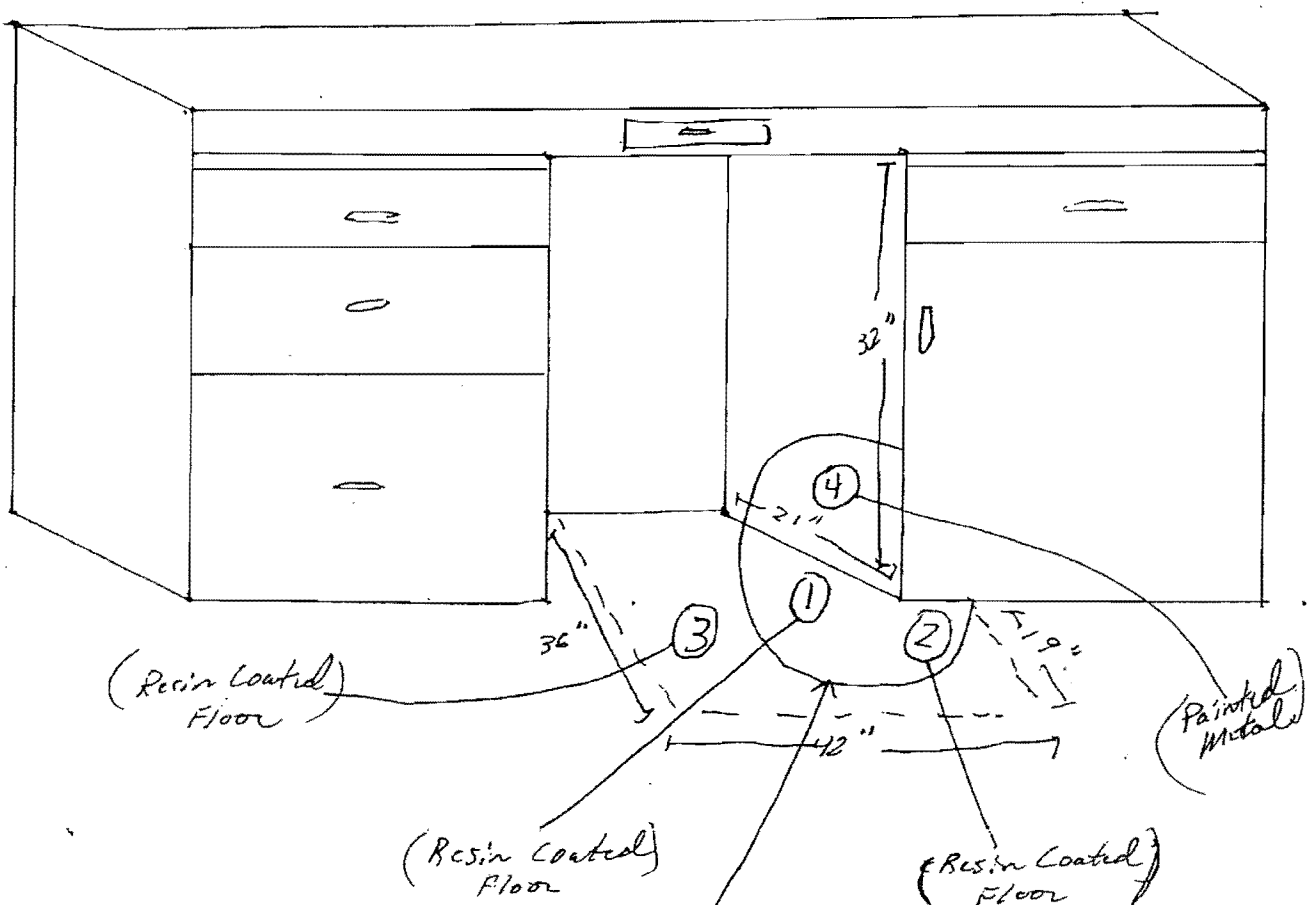
Area inside solid line was above 200 cpm
 utilizing model 3144-9.

Post Decon Survey
 South Wall Casework
 and Floor

Gross Static Counts
 1) LSC BKG
 2) 14,795
 3) 11,422
 4) 1478
 5) 14,587

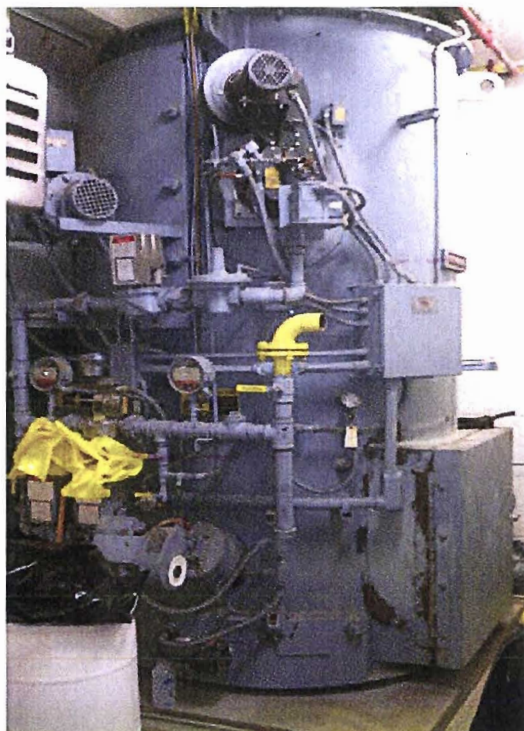
Photo Number: 1

Description: B3-103A
incinerator

Incinerator (B2-103A). Radioactive waste containing ^3H and ^{14}C was burned in an on-site incinerator until 2005. The incinerator is located on the B2 level in Room B2-103A. The incinerator was vented through a dedicated stack, which was left in place when the incinerator was removed from service. B2-103A contains the incinerator and is also currently used for accumulation of radioactive waste. Surveys performed indicate elevated readings (up to 5,000 dpm/100 cm² total) on the refractory lining of the incinerator attributable to naturally occurring radioactive material in the fire brick. Removable contamination surveys were performed in the incinerator burn chamber, in the stack and blower access ports, and on the concrete pad underneath the stack access port. All results were below 50 dpm/100 cm². An ash sample from the burn chamber was collected and analyzed in 2006. All results were below the sample specific

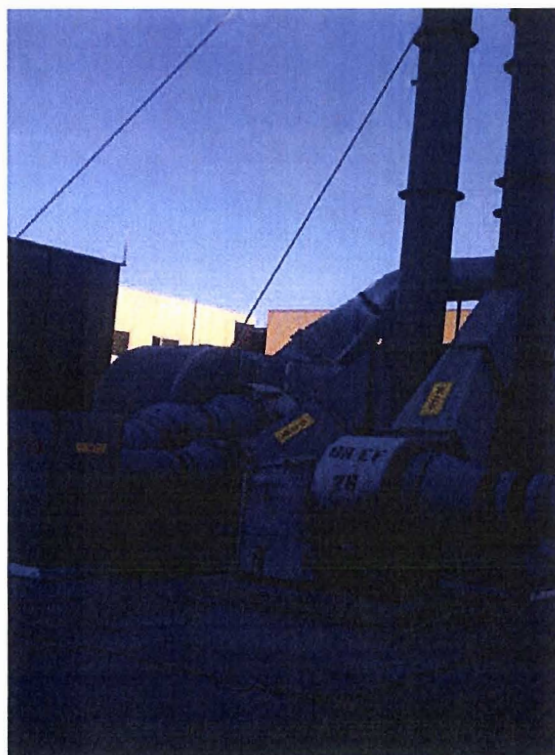
Photo Number: 12

Description: Roof – Legacy
stack and fans looking north

- Five fan assemblies located on the rooftop of B Building will be surveyed for radiological contamination and removed if found to be contaminated. The fan assemblies to be surveyed are designated BR-EF 21A, BR-EF 21B, BR-EF 23, BR-EF 24, and BR-EF 26. The fan assemblies may be removed using a crane. All openings on the fan assemblies will be blanked or sealed prior to moving them. Trained and qualified personnel will perform the rigging and crane operation procedures.

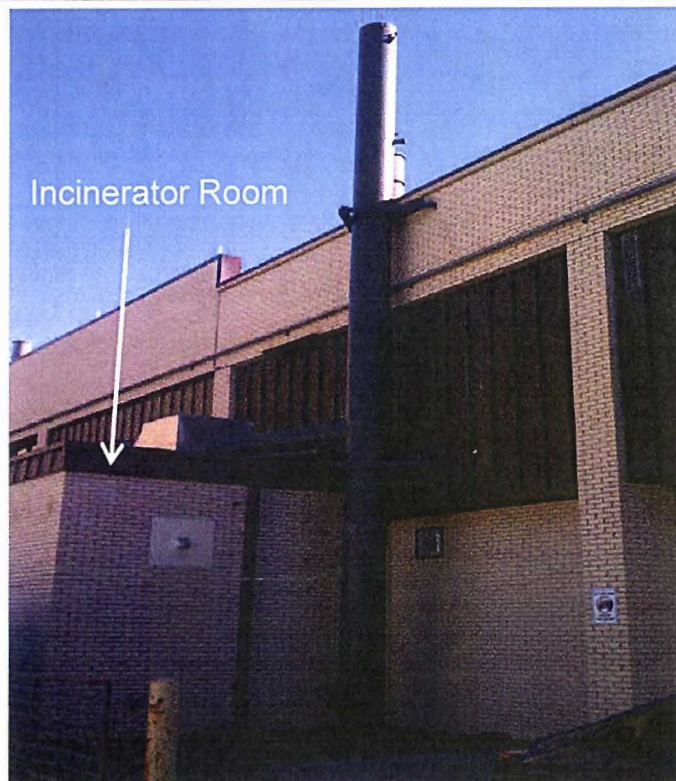
Photo Number: 16

Description: B2-103A –
Incinerator stack looking
northeast

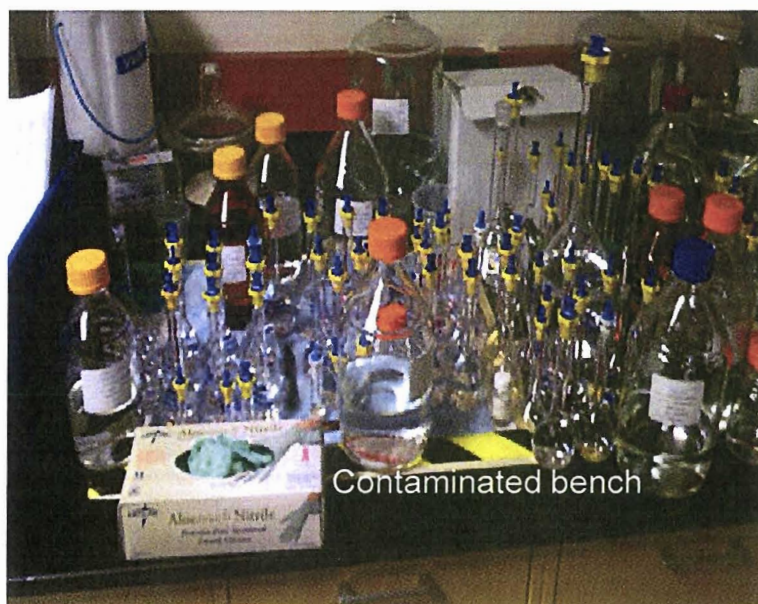
Photo Number: 18

Description: B3-298 lab
bench

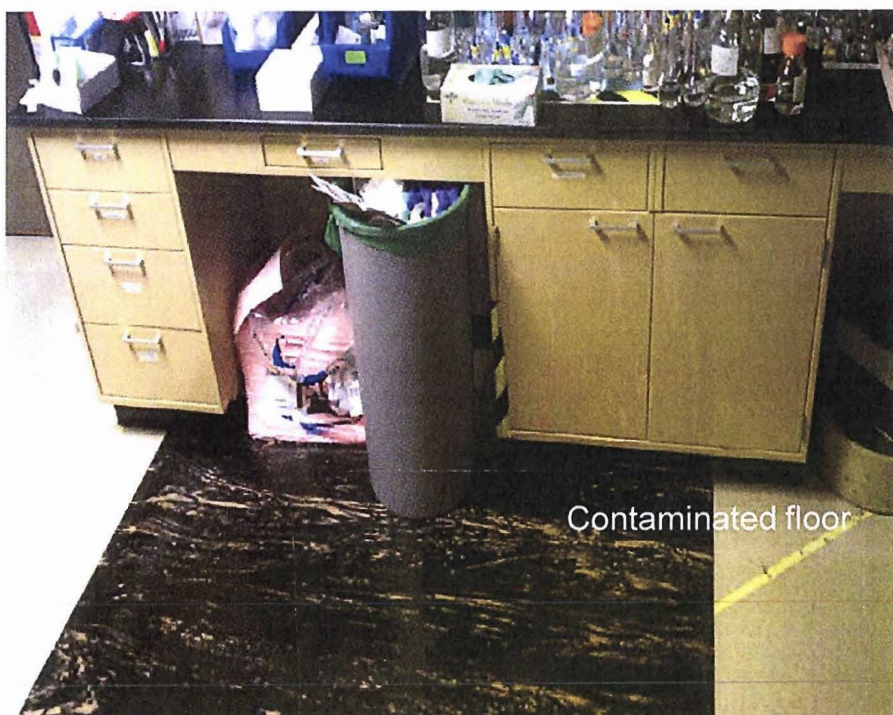
Photo Number: 19

Description: B3-298 lab
bench and floor

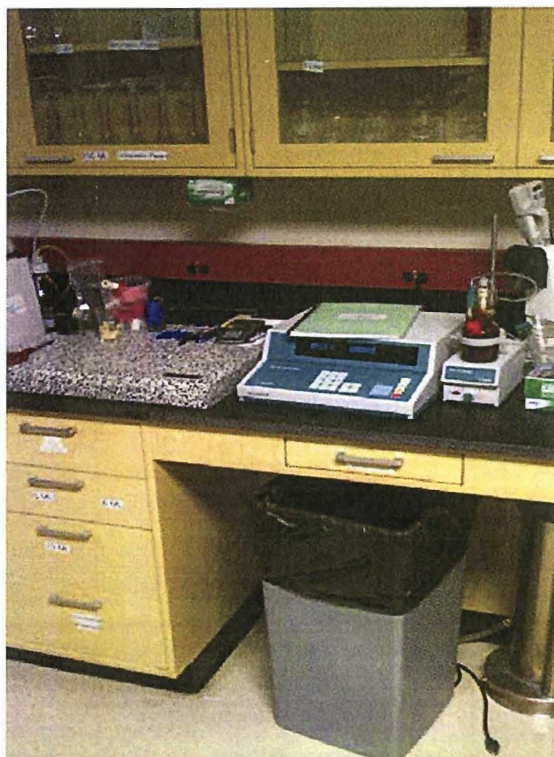
Photo Number: 20

Description: B3-298 bench

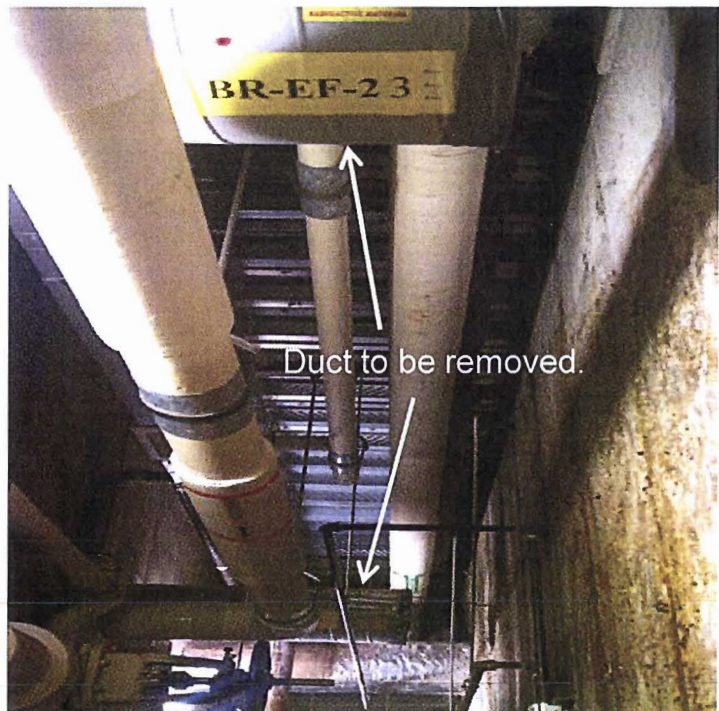
Photo Number: 21

Description: Legacy
ductwork

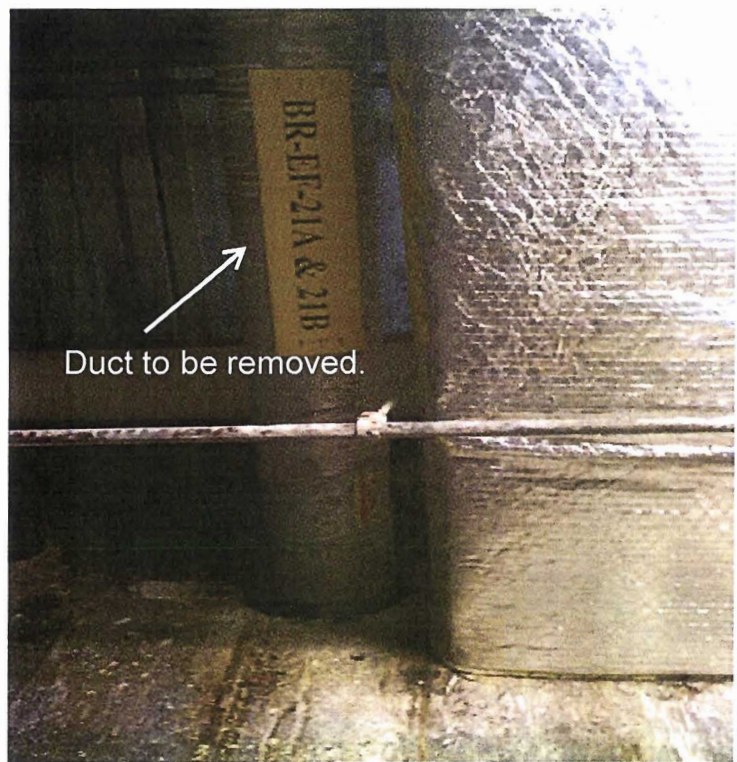
Photo Number: 22

Description: Legacy
ductwork
