Safety Analysis Report for the Century Industries Versa-Pac Shipping Container

**Application for License
Docket No. 71-09342**

**Revision 6
January 24, 2012**

**Century Industries
Bristol, Virginia**

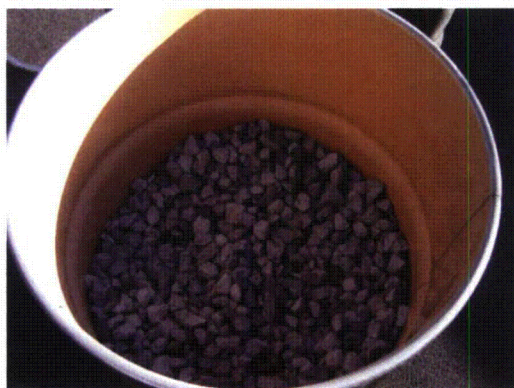
30 Gallon Drum Loaded With 260 Pounds of Loose Gravel

The 30 gallon drums were closed and the bolt closure ring of each container was torqued to 60 ft/lbs. and lowered into the containment cavity and the loose sand placed onto the top of the drum within the containment cavity. The 1/8" thick silicone coated fiberglass gasket and 3/16" thick containment flange were placed into position and the bolts inserted and hand tightened. The flange bolts were then tightened using an alternating method and torqued to 40 ft/lbs. The top gasket and outer closure, which includes the attached encased polyurethane foam insulation top plug, was installed on each of the test articles and the top outer bolts installed and torqued using the same alternating method to a tension of 40 ft/lbs. The outer drum closure rings were then installed and tightened to a torque of 60 ft/lbs.

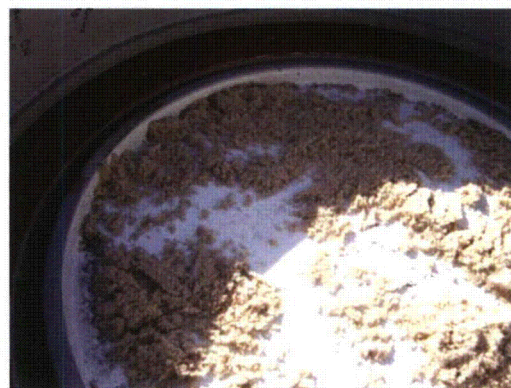
1-1/2 Pounds of Sand on Top of Containment Payload

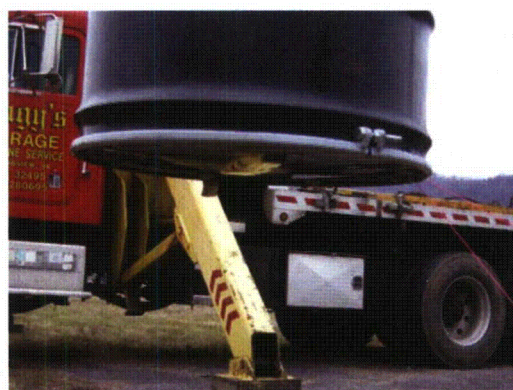
Damage from NCT 4' Drop

There were no tears or openings to the drum surface. All bolts remained in tact.

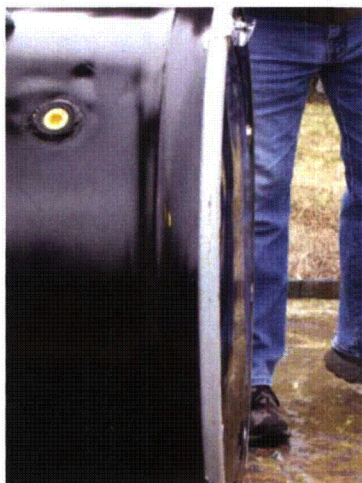
Upon impact to the top end of the package the overall height was reduced by 1/4" inch and the diameter was increased by 1/16 inch. The closure ring and all bolts remained in tact and secure.

Side View – Top End Drop Damage
Century Industries
Bristol, Virginia

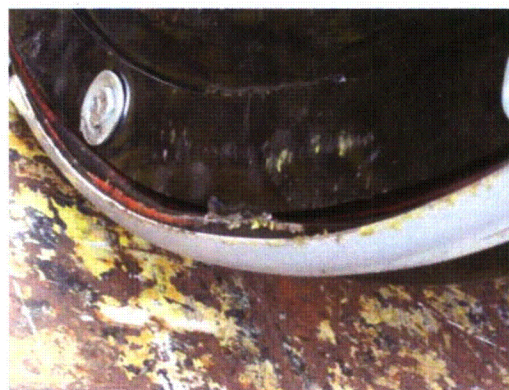
Close-up – Damage to Closure End
Versa-Pac Shipping Container Test Report
March 25, 2009

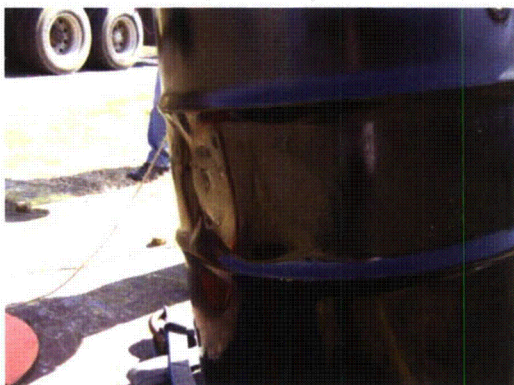
Upon impact a deformation in the side of the test article was measured at a depth of 3/8 inch. There were no tears as a result of the puncture drop. The results were recorded and photographed.

**Close-up Damage from Puncture
Between the Vertical Stiffeners**

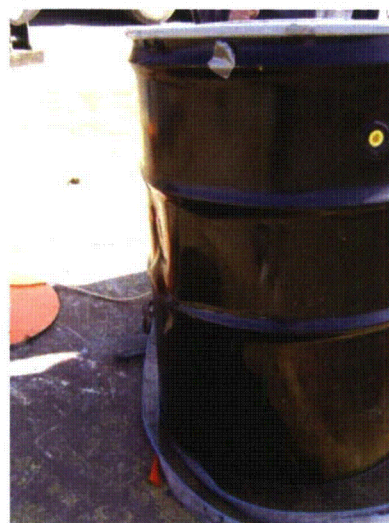
**Side View – Horizontal Puncture
Damage**

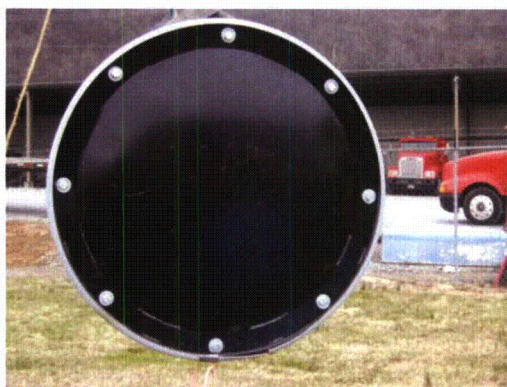
The resultant impact to the exterior surface allowed the bolted closure ring to push into the side wall approximately 5/8 inch deep. There was no reduction in the diameter or height of the package. No bolts were broken and there were no tears or broken welds. Damage was documented and photographed.

**Post-Test – End View of Damage**

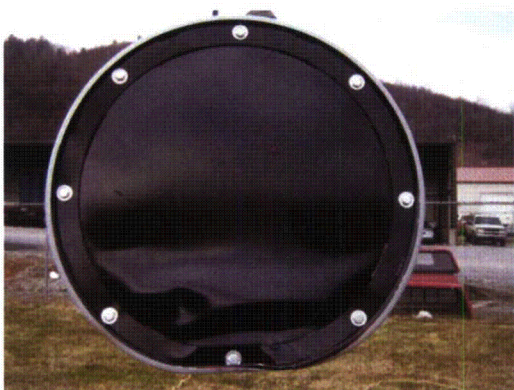
The damage from this drop produced a buckle around the closure bolt area and on the lid, along with a decrease in the diameter of 1 inch in the direction of impact through the bolt. There was no loss of bolts or closure and all welds remained in tact. The damage was recorded and photographed.

**Post-Test HAC 30' Drop
End View of Damage**

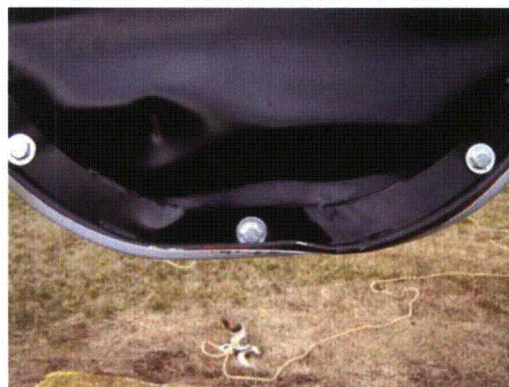
**Close-Up HAC 30' Horizontal Side Drop
Damage**

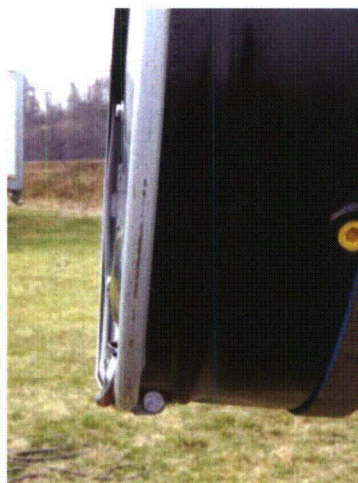
**Side View – Top End Closure Ring Bolt
30' HAC Horizontal Drop Damage**

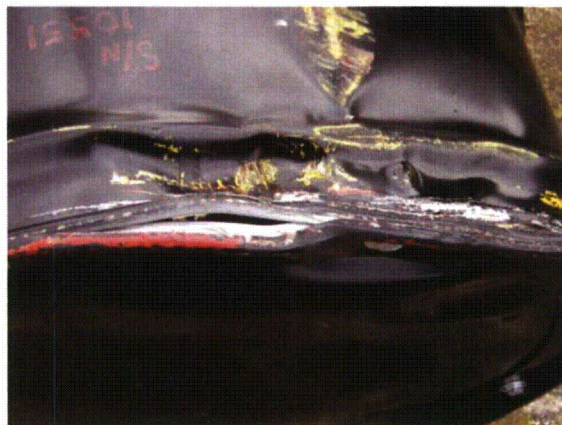
**Close-up Top End Damage 1/4" x 1-1/14"
Gap – Metal to Metal Seal No Opening**

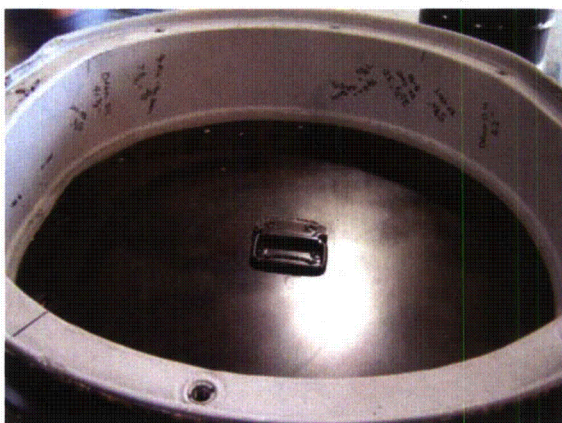
As result of this series of testing the outer closure bolts were torqued prior to removal and found to be at a reading of 25 ft/lbs. Upon removal of the outer closure lid a slight deformation of the inner wall was noted. There was no loss of containment contents found within the inner well area. The inner containment blind flange remained in good condition and sealed. The interior bolts were torqued with readings at 25 ft/lbs. The gaskets were intact with minimal damage. The payload drum did exhibit some crumpling at the lid but all of the payload materials remained within the drum and payload cavity as required. The inner cavity upon inspection showed no visible damage. The results of this series proved to be acceptable.

Post Test – No Loss of Payload Contents

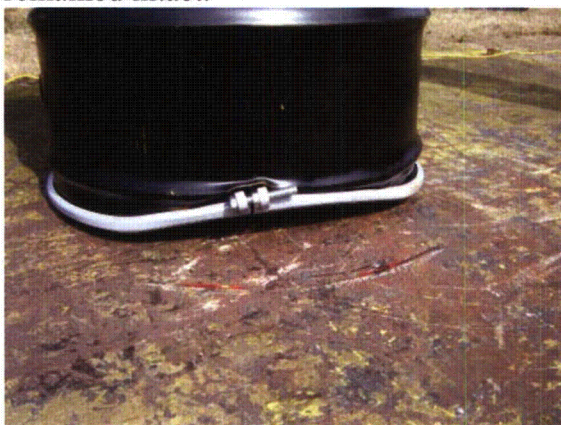
The impact resulted in a depression 11/16 inch deep into the lid and caused additional side deformation totaling 2-1/2 inches deep by 20 inches long. All welds, bolts and closures remained intact.

Accumulated Damage – Top Closure

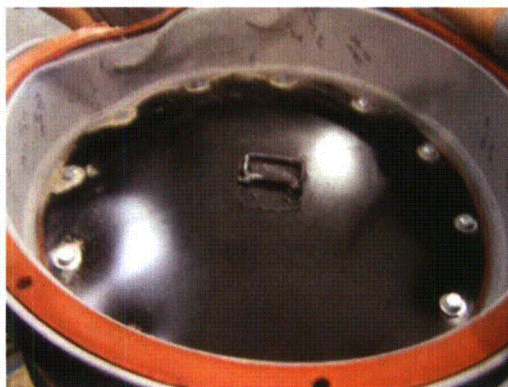
As a result of this series of testing the outer closure bolts recorded a torque at less than 20 ft/lbs. Upon removal of the outer closure lid a bulge in the containment blind flange was discovered with some sand from within the containment cavity found. A deformation at the impact point to the inner wall was also recorded. The bolts of the inner containment flange were torqued with a reading of less than 20 ft/lbs recorded. Once the flange and payload had been removed inspection of the inner containment cavity found no visible damage. The inner gaskets were in good condition with only minimal damage to the outer closure gasket.

Bulge in Containment Blind Flange Showing Loose Sand from Containment Cavity

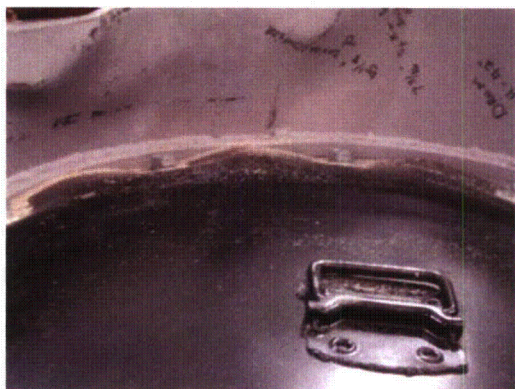
**Side Wall Damage and
Bulge of Containment Flange**

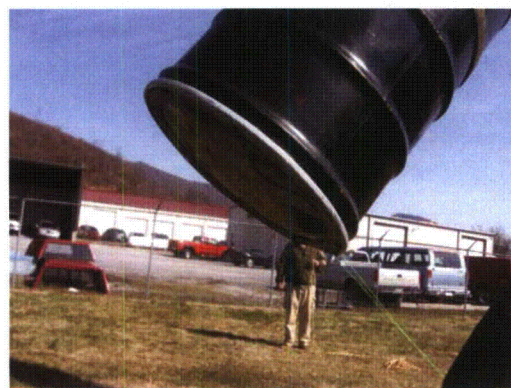
The impact resulted in a deformation on the closure bolt area with measurements of 1-3/16 inch deep by 2-1/4 inches long. All welds, bolts and closures remained intact. Damage was recorded and photographed.

NCT Post Test Damage View

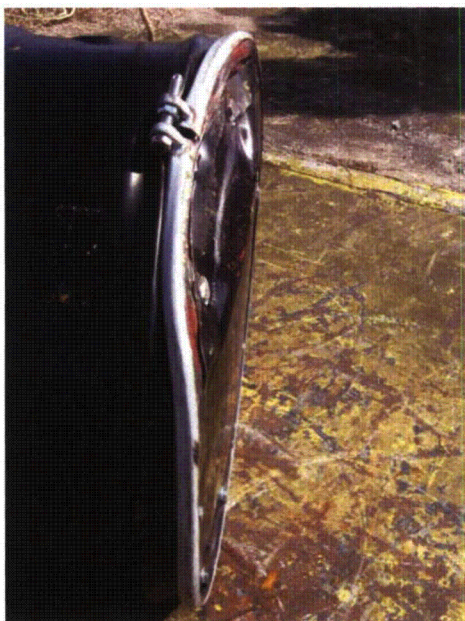
As a result of the impact a deformation on the closure bolt area totaling 2-9/16 inches deep by 20-1/2 inches long was recorded. The diameter of the package was reduced by 5/16 inch. All welds, bolts and closures remain in place. There were no tears or openings found on the package.

**Side View – Impact Damage from
30' Center of Gravity Drop**

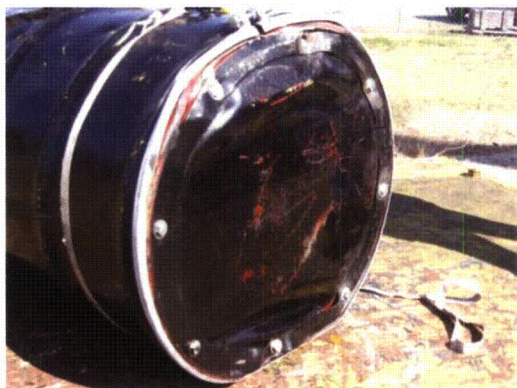
The damage to the exterior surface produced deformation on the initial top closure, measuring 2-5/16 inches deep with a 1 inch crumple of the outer closure lid. The secondary impact produced damage measuring – on the bottom rim of the test article. The diameter of the package in the direction of the impact was reduced by approximately 1 inch. There was no damage to any bolts, welds or closures and there were no tears found on inspection of the package.

End View of Top Damage from Initial Impact of Shallow Angle Drop

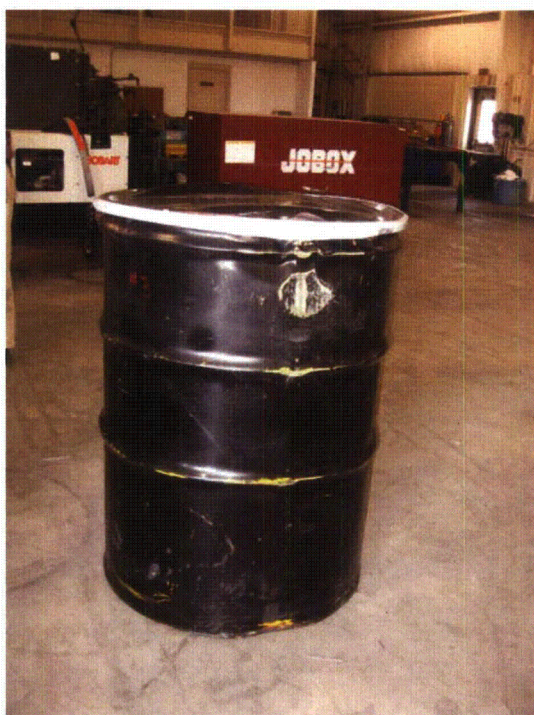
The conclusion of this series is that again, the design changes of increasing the flange thickness, increasing the torque requirement and the reinstallation of the flange inside pad were found to provide acceptable results.

**Post Series Side View—Package Drop Total
2- NCT Drops, 3-HAC 30' Drops &
1-Puncture Drop**
