Fukushima Nuclear Accident

Radiological Monitoring and Consequences
April 1, 2011

East Japan Great Earthquake Damage Report

Japan Defense Intelligence
Headquarters

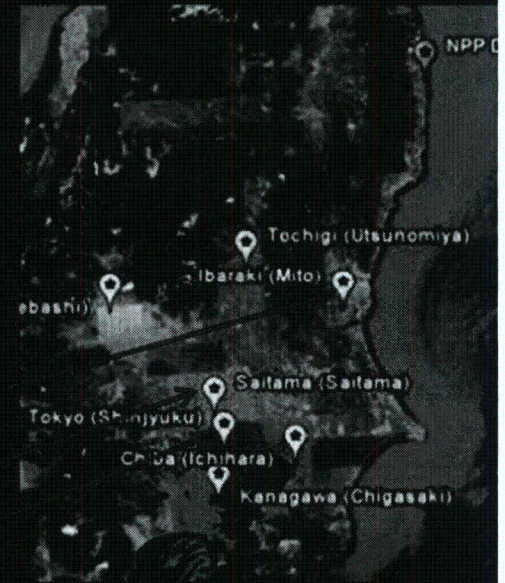
Gamma Dose Rates in $\mu\text{Sv}/\text{hour}$

14-31 March
