Electrical Cable Test Results and Analysis During Fire Exposure (ELECTRA-FIRE)

**A Consolidation of Three Major
Fire-Induced Circuit and Cable
Failure Experiments Performed
Between 2001 and 2011**

Draft Report for Comment

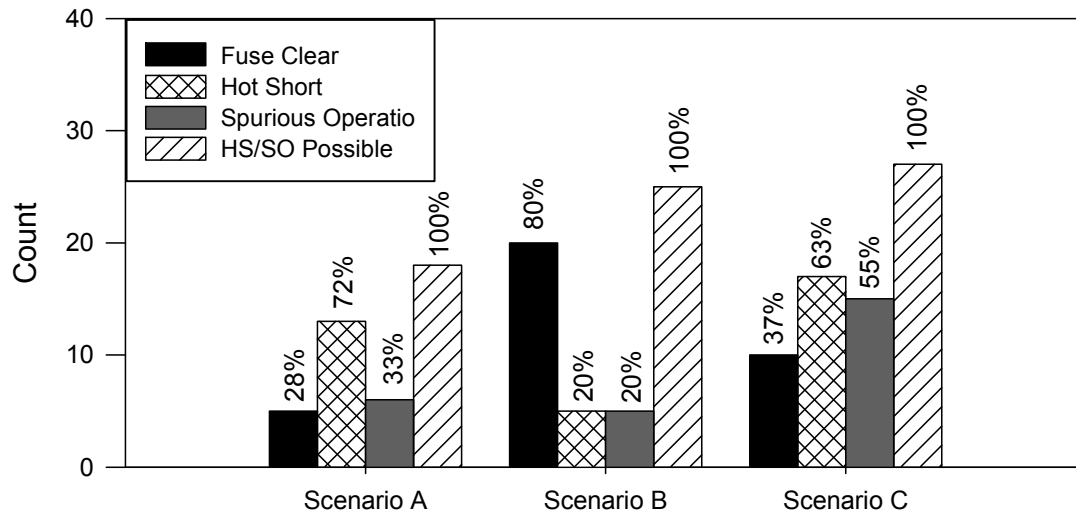
Figure 1-1. Examples global approach failure mode column plot

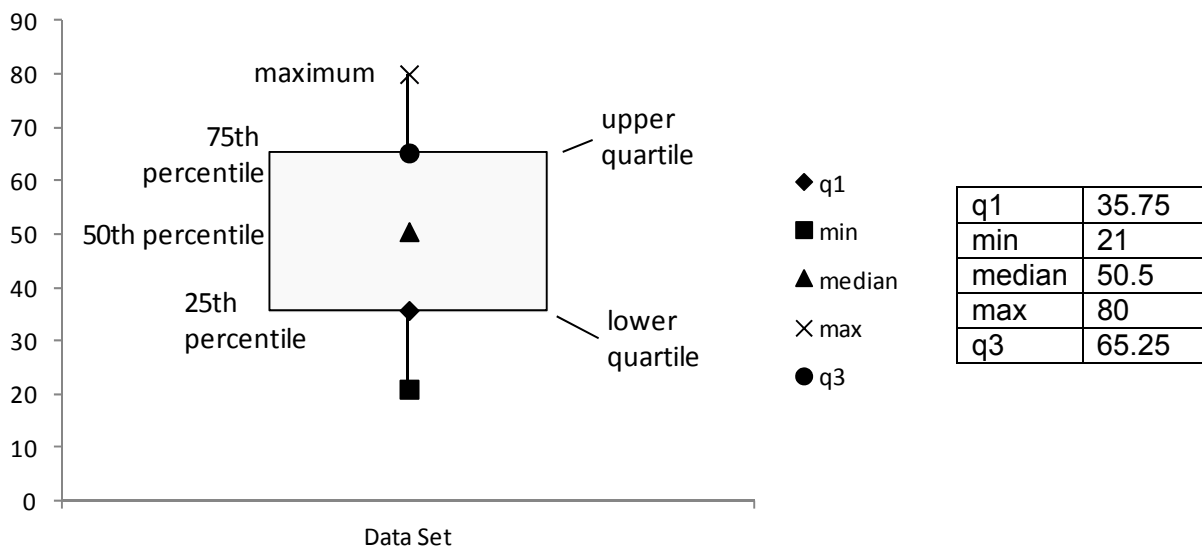
To provide a realistic and simple graphical representation of the duration data set, this report provides hot short and spurious operation duration box plots, also known as box and whisker plots. An example of a box and whisker plot is provided in Figure 1-2. The example data set used to prepare this example plot is a continuous set of integers ranging from 21 to 80.

Figure 1-2. Box and whisker plot example

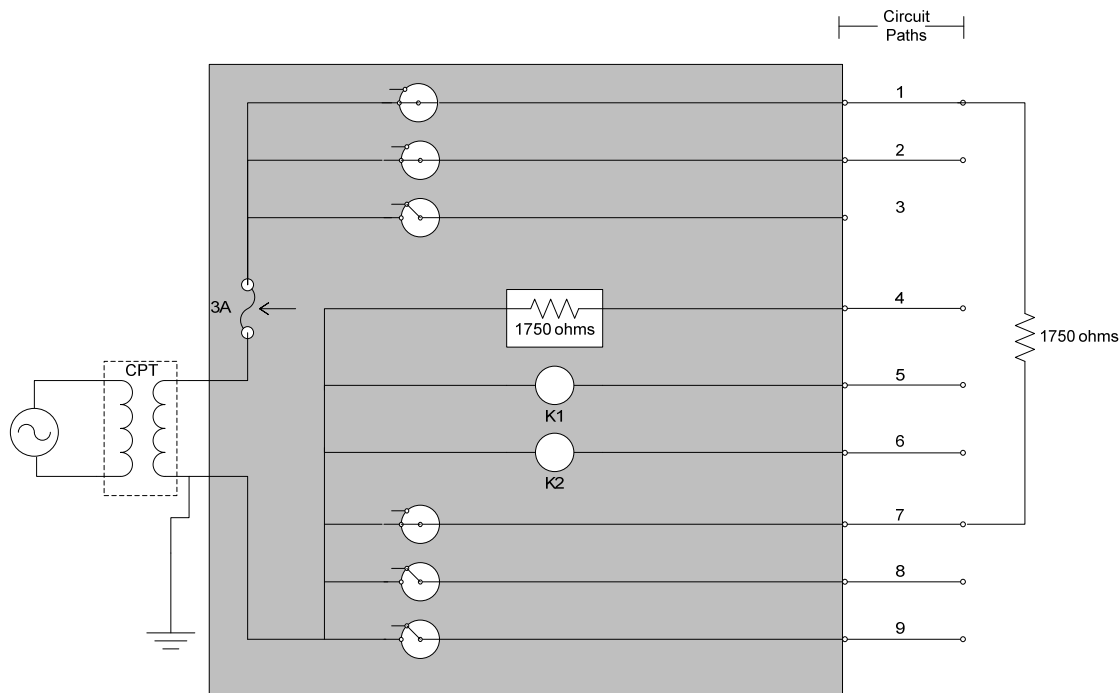
Figure 2-1 is a schematic of the surrogate circuit diagnostic unit (SCDU) used in CAROLFIRE to represent an ac MOV motor starter circuit. Similar circuits were used in the EPRI/NEI and DESIREE-FIRE testing projects. In Figure 2-1, there are two energized source conductors, shown as circuit paths 1 and 2. A resistor used to represent an indication lamp is considered to be a passive target (PT), and is connected to circuit path 4. Circuit paths 5 and 6 are connected to the forward and reverse motor starter contactors, "K1" and "K2." These two paths are considered active targets (AT). Circuit path 7 is connected to the common power supply return, and circuit path 8 is considered to be an ungrounded spare conductor.

Figure 2-1. CAROLFIRE ac MOV circuit

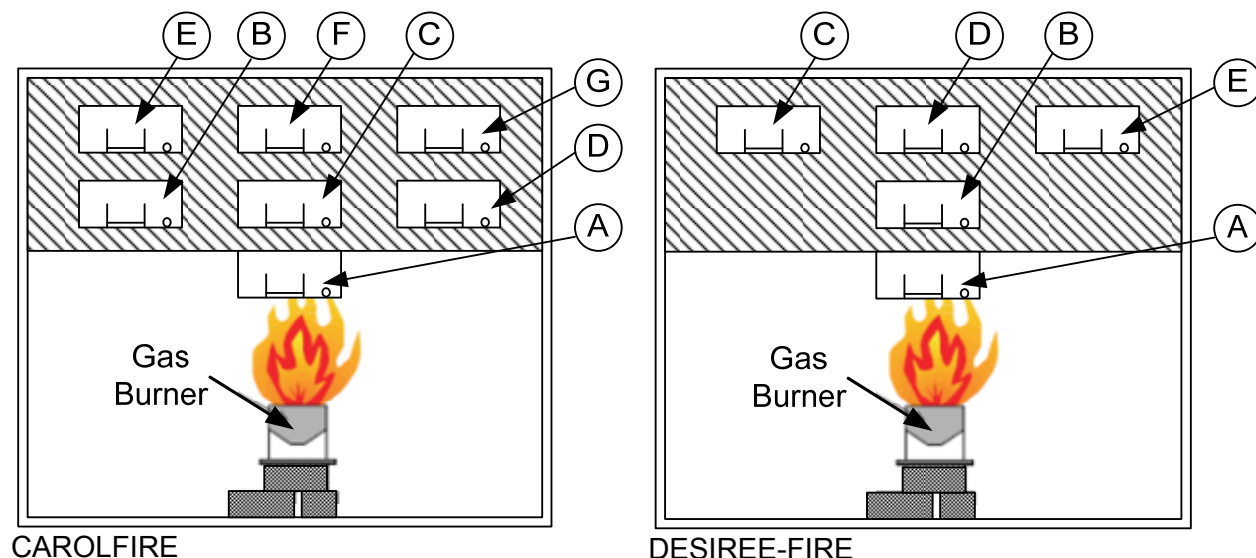
data is separated into an individual bin labeled “radiant.” The exposure conditions classification used in the EPRI test report were adopted as reported.

Figure 2-4. Intermediate-scale cable raceway location

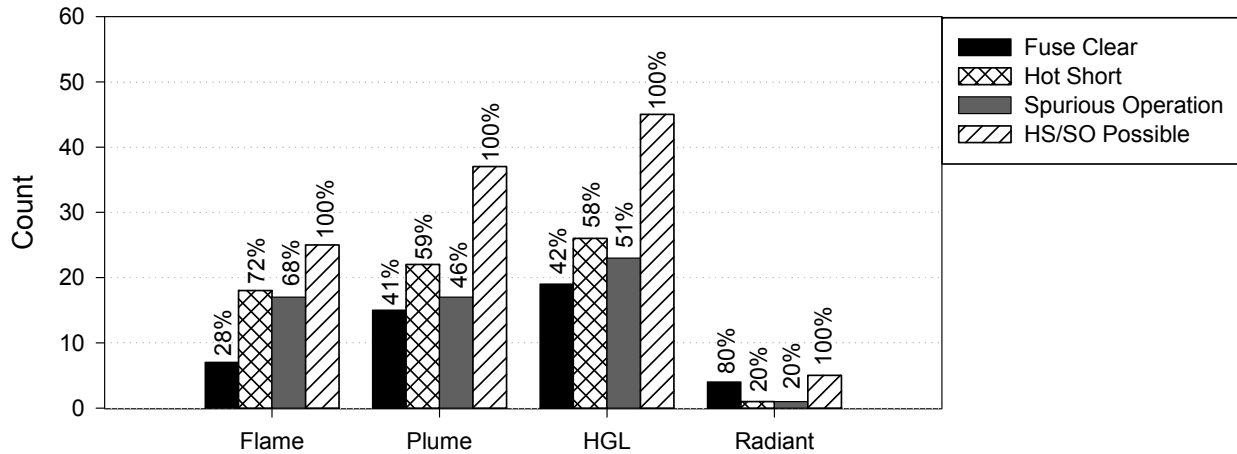
Figure 2-5. Thermal exposure conditions, global approach, ac tests

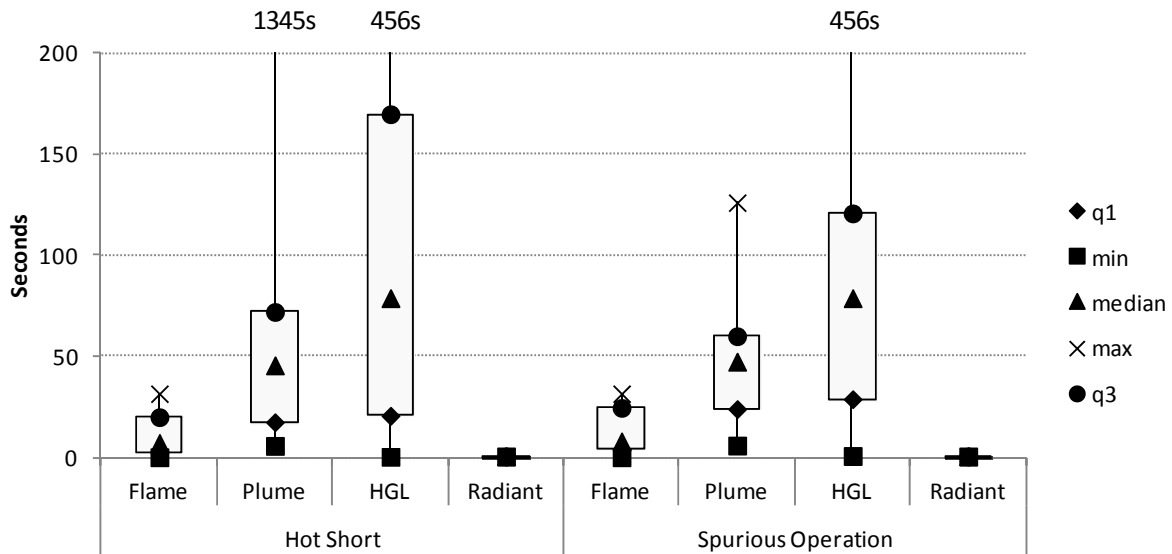
³ Note that one duration for the hot short plume data set was 1345 seconds. This data point has been removed from the generalized discussion, but is important when considering maximum test data durations.

Figure 2-6. Thermal exposure conditions box plot, duration, ac tests

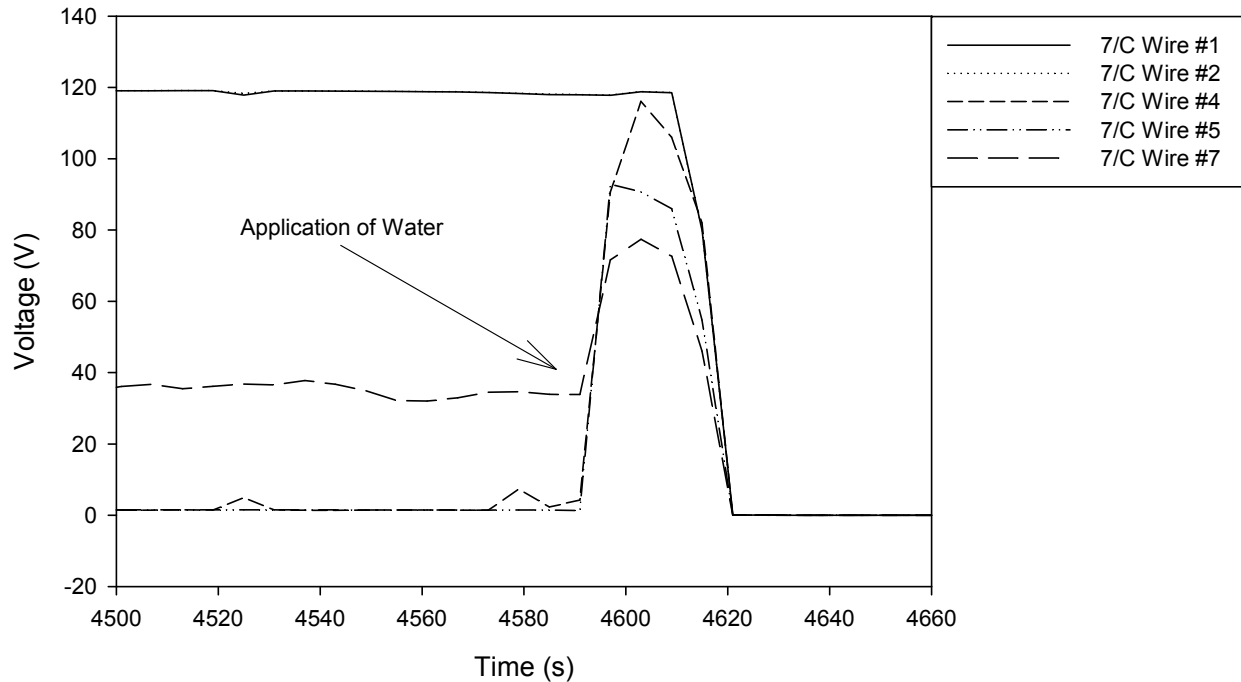
Water spray was observed to cause spurious operations in only one EPRI/NEI test, Test 3. In this case, a spurious operation did coincide with water spray, and persisted for approximately 24 seconds before a fuse clear occurred. This test cable was located at the center of the top layer of a two-layer cable fill test. Figure 2-30 provides a voltage plot of test circuit 3 for EPRI/NEI Test #3, showing the spurious operation on the target conductor, Wire #4 but only hot shorts on non-spurious operation target Wire #5 and Wire #7.

Figure 2-30. EPRI/NEI Test 3 voltage plot - water spray

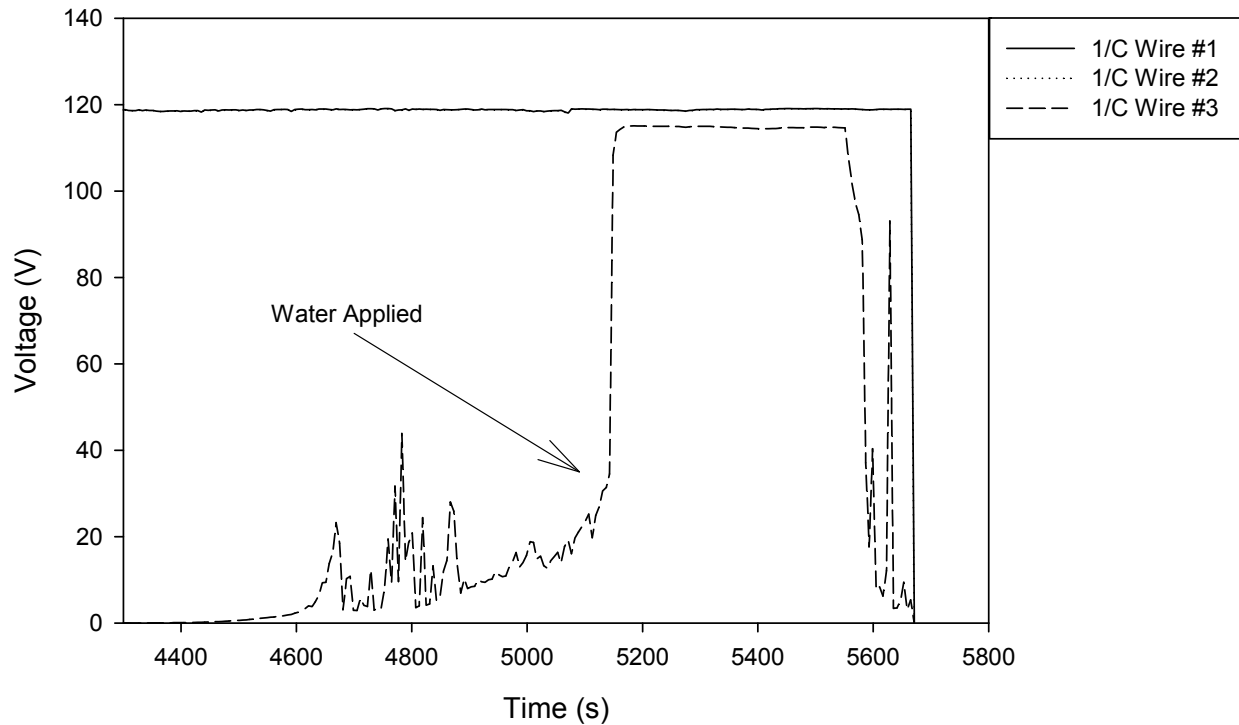
In Test 10 of the EPRI program, water spray was applied during an ongoing spurious operation. The application of water terminated the spurious operation (cleared for 42 seconds), followed by a brief operation of a target conductor (6 seconds), followed by a fuse clear failure. These electrical interactions are shown in Figure 2-31. In two other tests, water spray showed marginal effects on the cable electrical response. In one case, an induced voltage had built upon the spare conductor. When water spray was initiated, the induced voltage was rapidly lost. In the other case, very minimal current spikes (~ 0.05 amps) were observed in the 1/C cables, coincident with water application. The reader is encouraged to refer to the EPRI test report for more information.

Figure 2-31. EPRI/NEI Test 10 voltage response following water spray

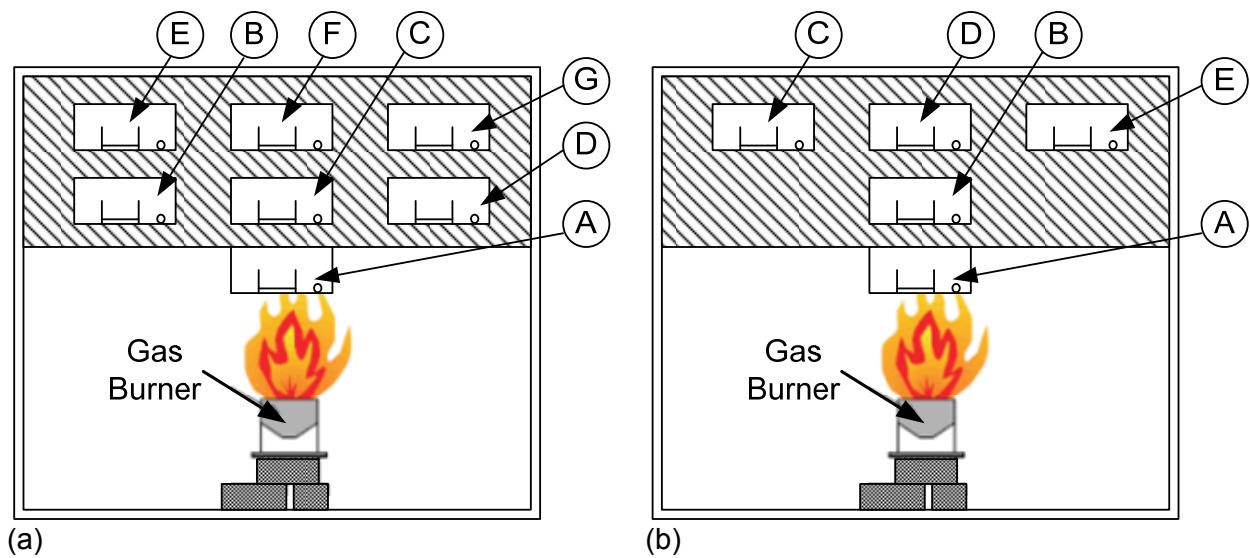
To complete this comparison, the intermediate-scale test data from CAROLFIRE and the intermediate-scale ac test data from DESIREE-FIRE were combined and separated by location. As shown in Figure 2-32, the locations were labeled differently between projects, so care was taken to ensure that labeling differences did not lead to binning errors. Symmetrical cable locations were grouped together as one location because of identical exposure conditions. For example, in the CAROLFIRE configuration in Figure 2-32(a), locations E and G were grouped together, as well as locations C and E of the DESIREE-FIRE configuration in Figure 2-32(b). However, locations C and F of CAROLFIRE and locations B and D of DESIREE-FIRE were not grouped together because the plume transition zone near the top location (F in CAROLFIRE, D in DESIREE-FIRE) likely has different exposure conditions than the location directly below. Trays grouped by location would be exposed to the same fire conditions, heat release rate, and location relative to the wall. The data was then analyzed to find times when hot shorts occurred in the same location at the same times (i.e., concurrence).

Figure 2-32. (a) CAROLFIRE and (b) DESIREE-FIRE intermediate-scale exposure location designation

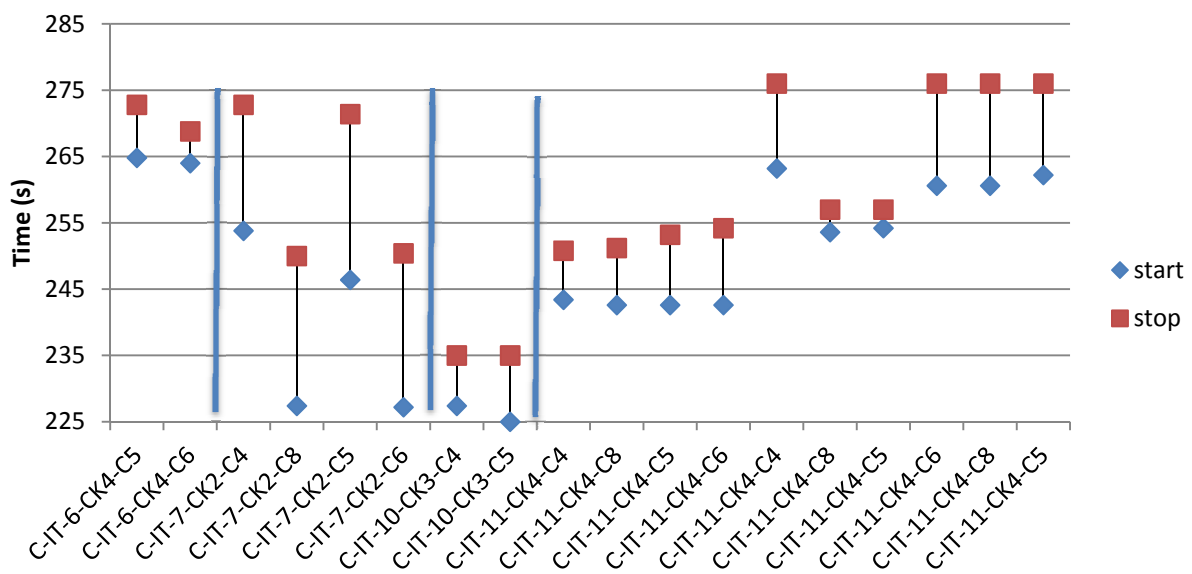
Analyzing the data in this way shows that concurrent hot shorts were observed in CAROLFIRE/DESIREE-FIRE location A and CAROLFIRE location G/E (DESIREE-FIRE location C/E), “upper hot gas layer,” when the individual test data was grouped together. At location A, two sets of concurrence were identified, as shown in Figure 2-33 and Figure 2-34.

Figure 2-33. Concurrent hot shorts - location a - 4 cables

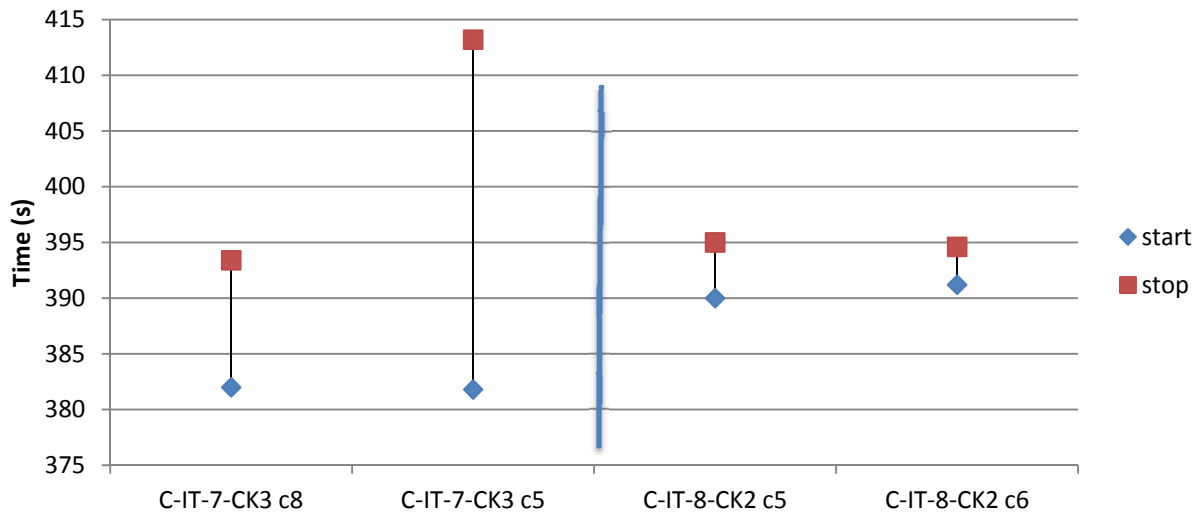
Figure 2-34. Concurrent hot shorts - location A - 2 cables

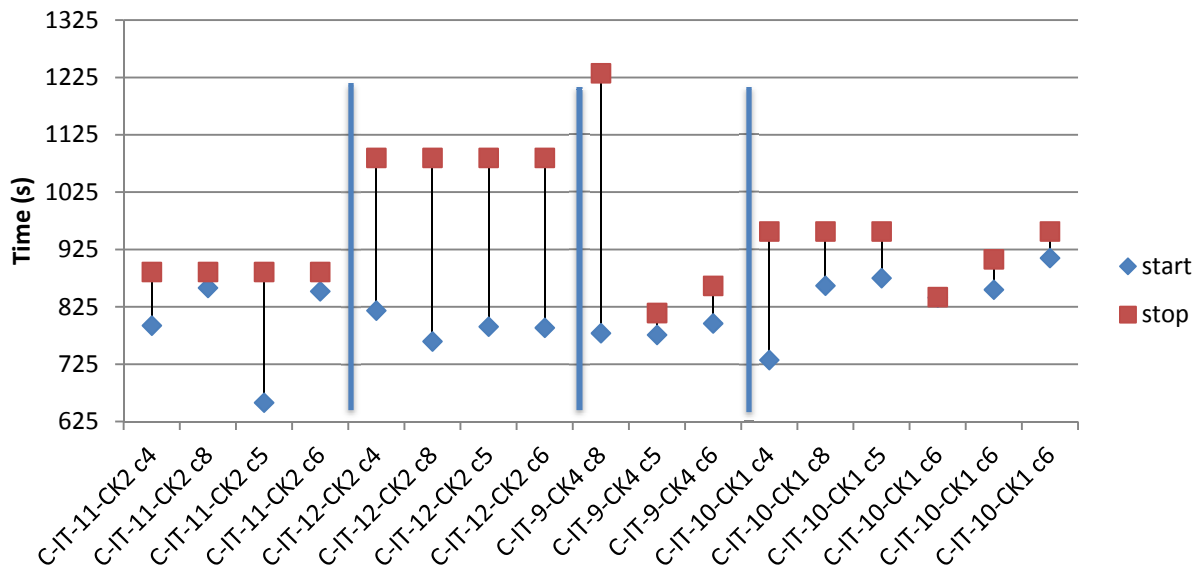
The other instance in which concurrent hot shorting was identified in this analysis was in the upper hot gas layer exposure locations (CAROLFIRE location G/E, DESIREE-FIRE location C/E). Again, two sets of concurrence were observed. The first occurrence included four cables, of which three were of the same construction (PE/PVC) and the other was PVC/PVC. All were of the thermoplastic polymer variety. The second instance of concurrence included two cables; one was EPR/CPE, and the other was PVC/PVC. Figure 2-35 and Figure 2-36 present plots of the hot short durations, and Table 2-32 provides a listing of the circuits involved in spurious operation concurrences and associated durations. The durations of these concurrences are longer than those in location A, likely due to the difference in thermal exposure conditions.

Figure 2-35. Concurrent hot shorts - upper hot gas layer - 4 cables

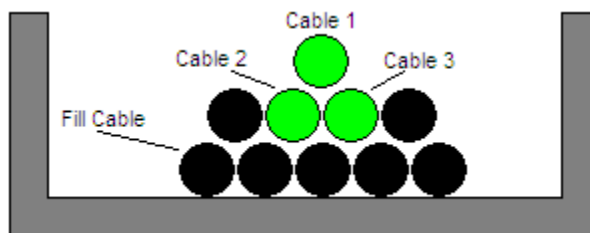
Figure 3-1 provides an illustration of how the cables were oriented within a cable tray for the inter-cable tests during the EPRI/NEI program. Cables 1-3 were monitored for electrical response, with cables 1 and 3 containing both energized source conductors and target conductors, while cable 2 only contained target conductors. The target conductors were connected to burden resistors to simulate a load. The black cables in Figure 3-1 represent fill cables that were not monitored for electrical response, but were used as a buffer between the electrically monitored cables and the metallic cable tray. These fill cables likely reduced the likelihood of an energized source coming in contact with the ground plane and causing a fuse clear failure.

Figure 3-1. EPRI/NEI inter-cable test tray fill

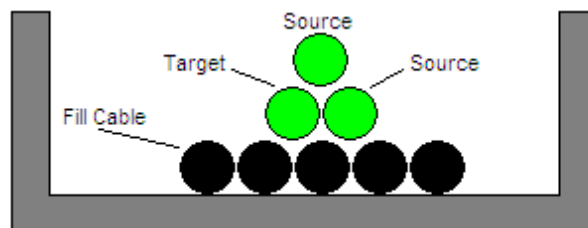
The CAROLFIRE inter-cable test set-up was slightly different in that all of the conductors in two multi-conductor cables were energized as sources and a third multi-conductor cable had all of its conductors connected to a motor starter contactor, a target. Thus, the CAROLFIRE circuit could detect inter-cable interactions, but was unable to recognize when conductors internal to the multi-conductor cables had failed. The CAROLFIRE inter-cable test set-up is shown in Figure 3-2.

Figure 3-2. CAROLFIRE inter-cable test tray fill

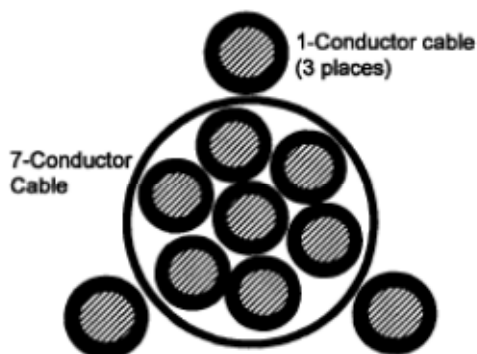
increase the likelihood of inter-cable interactions because of the lack of jacket and the use of cable ties to keep the single conductors in close proximity to the 7/C cable.

Figure 3-3. EPRI/NEI cable configuration

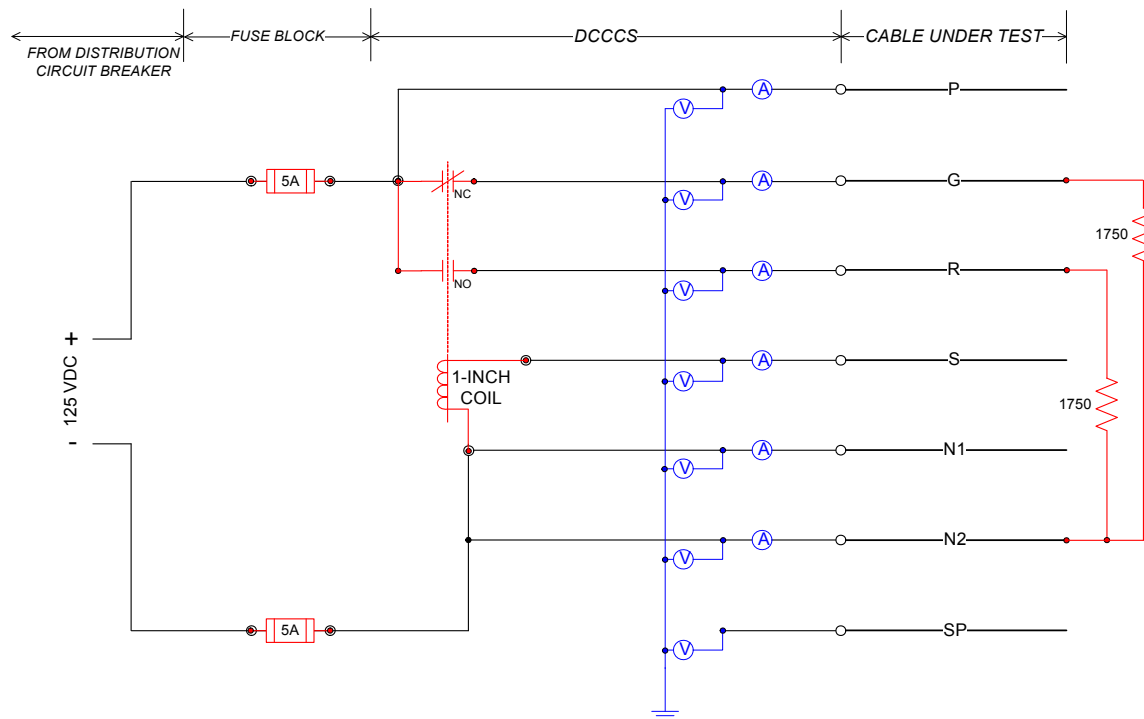
For the 1-inch valve circuit, conductor S was the hot short (HS)/spurious operation (SA) target, and conductors G and R were the HS targets for the penlight tests. For intermediate-scale tests, conductor S was the HS/SA target, and conductors G and R were not used for fuse status. The SP conductor was a non-energized target that could either short to the positive or negative sides of the circuit for all tests. The other conductors were used to determine whether a fuse had blown. Once the positive or negative fuse had blown, the durations for the HS and/or HS/SA were assumed to be complete.

Figure 4-1. Line drawing of the dc-SIM panel layout for a 1-inch coil circuit

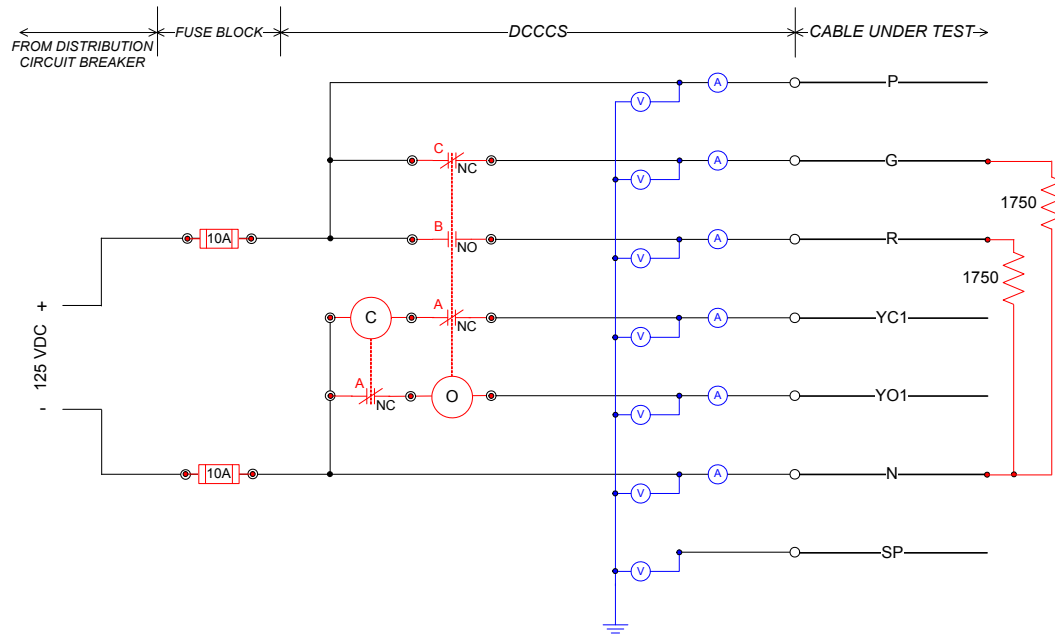
The MOV circuit that was tested is shown below in Figure 4-3. As seen in the figure, there are seven conductors that were monitored during the test. Those seven conductors' electrical measurement data was analyzed based on the information displayed in Table 4-4 for all tests. Each test had two MOV circuits designated as MOV1 and MOV2. Conductors YO1 and YC1 for MOV1 were HS/SA and HS targets. With MOV1, there were mechanical interlocks that caused YC1 to lock out if YO1 was engaged; thus, if YO1 had an HS/SA while YC1 got an HS, YC1 would not engage. Conductors G and R were HS targets. The SP conductor was a non-energized target that could short to either the positive or the negative side of the circuit for all tests. The other conductors were used to determine whether a fuse had blown. Once the positive or negative fuse had blown, the durations for the HS and/or HS/SA were assumed to be complete.

Figure 4-3. Line drawing for dc MOV circuit

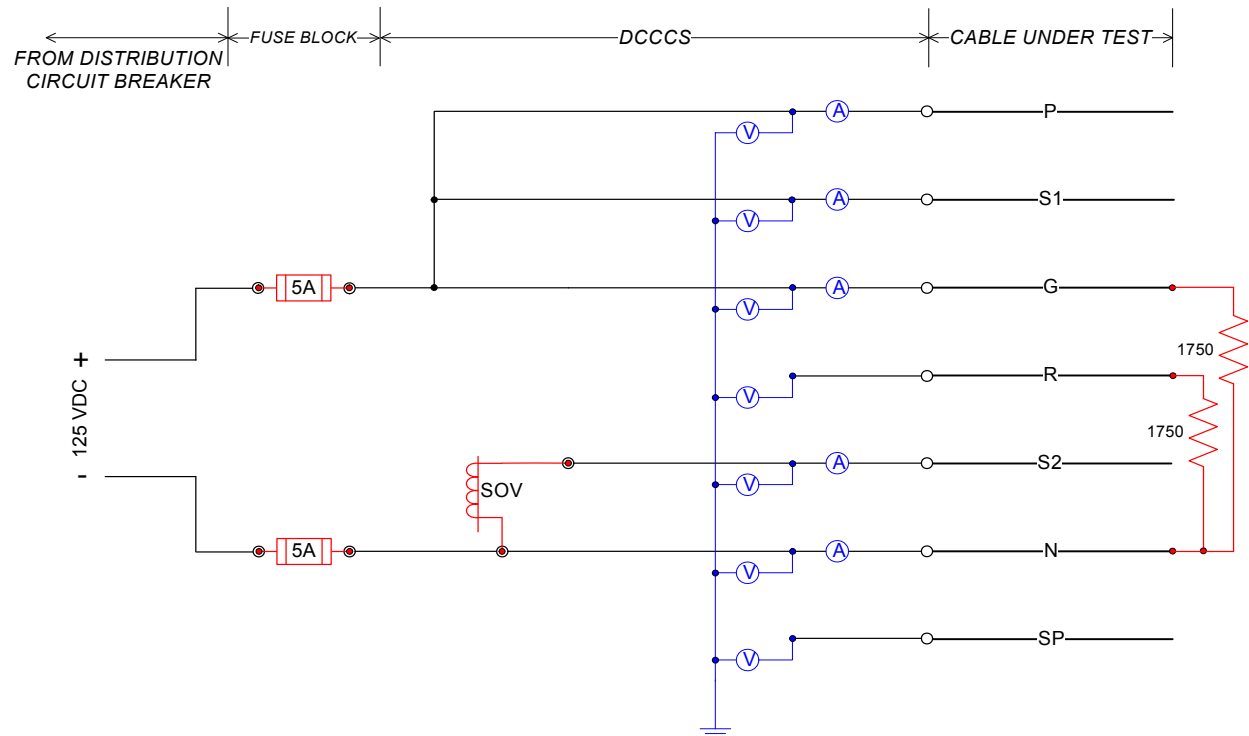
The SOV circuit that was tested is shown below in Figure 4-4. As seen in the figure, there are seven conductors that were monitored during the test. Those seven conductors' electrical measurement data was analyzed based on the information displayed in Table 4-5 for all tests. For this circuit conductor, S2 was the HS/SA target, and conductor R was an HS target for all tests. The SP conductor was a non-energized target that could short to either the positive or the negative side of the circuit for all tests. The other conductors were used to determine whether a fuse had blown. Once the positive or negative fuse had blown, the durations for the HS and/or HS/SA were assumed to be complete.

Figure 4-4. Line drawing for dc SOV circuit

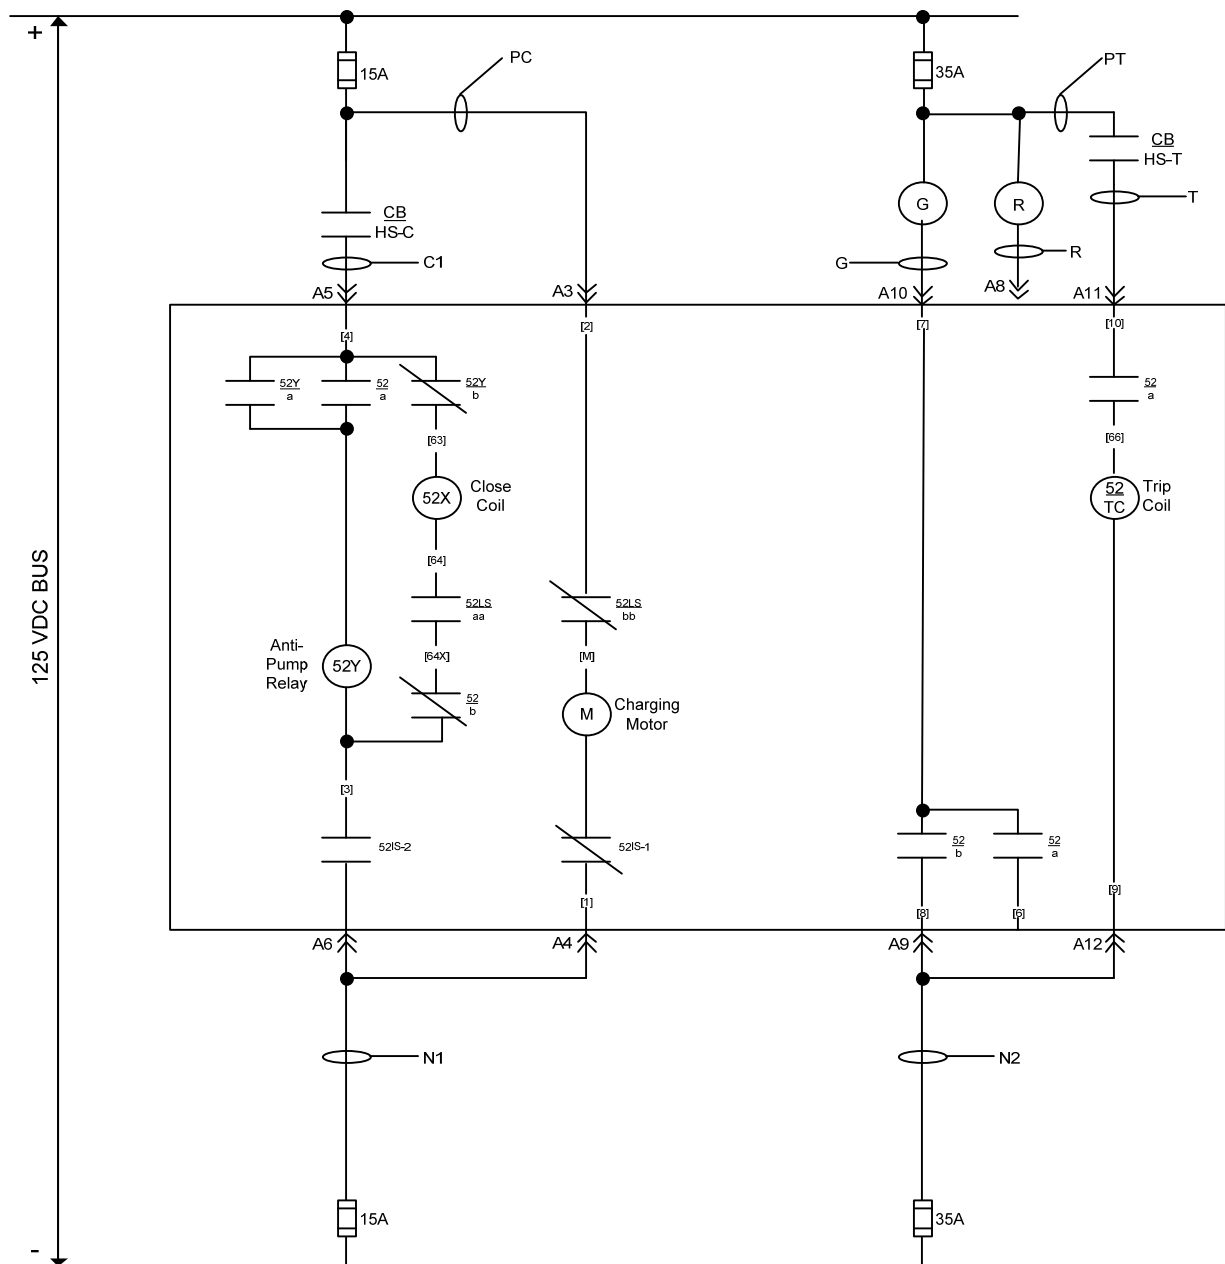
There were two different medium-voltage circuit breakers (SWGR) circuits used during DESIREE testing. As mentioned in the report, there was a problem with the first breaker during intermediate-scale Test #8. The first SWGR circuit is displayed in Figure 4-5, with the instrumentation's data analysis displayed in Table 4-6. The internal manufacturer wired this SWGR in reverse, which is depicted in Figure 4-5. The wiring did not affect the functionality of the SWGR, the only difference being that the red light was not energized. Table 4-6 has a different set-up than the tables for the previous circuits analyzed. The SWGR circuits were more complex to analyze, resulting in the different format. Conductors G, T, and C1 were hot short targets, while T and C1 were used to determine whether the breaker had tripped or closed (HS/SA target). The duration for the HS/SA was never more than one time step. Conductor R was treated as a energized spare. The two SP conductors were non-energized targets that could short to either the positive or the negative side of the circuit for all tests. The other conductors were used to determine whether a fuse had blown. Once the positive or negative fuse had blown, the durations for the HS and/or HS/SA were assumed to be complete. The second SWGR circuit is displayed in Figure 4-6, with the instrumentation's data analysis displayed in Table 4-7. The only difference with this SWGR in terms of the data analysis logic was that R was an HS target and not an energized spare. It is also noted in Table 4-6 and Table 4-7 that there were two cables tested for each SWGR test. One cable was connected to the close circuit, and the other was connected to the trip circuit. The conductors associated with each are identified in the tables.

Figure 4-5. Line drawing for dc SWGR 1 circuit

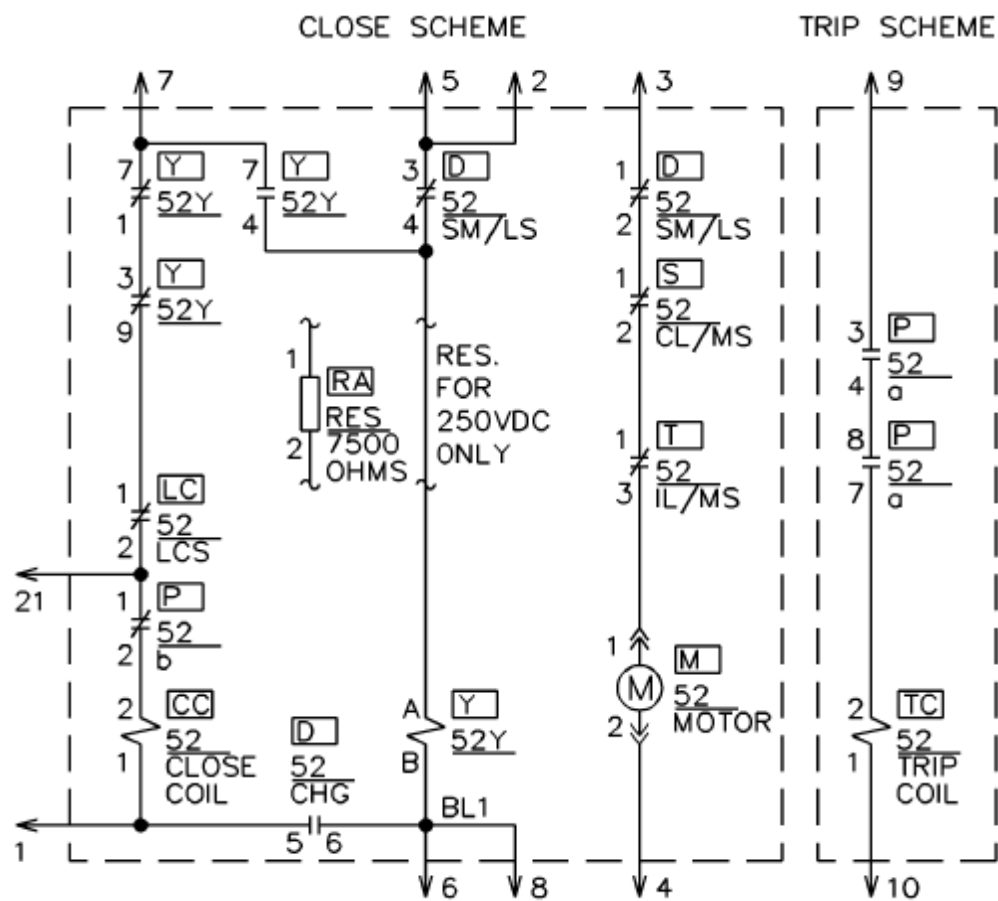
Figure 4-6. Line drawing for dc SWGR 2 circuit

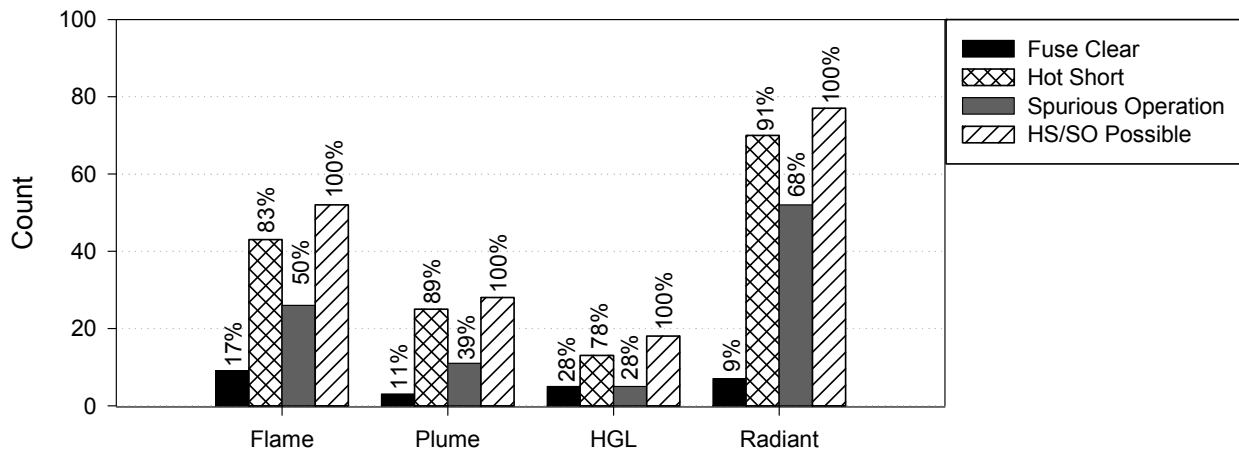
**Figure 4-9. Thermal exposure conditions column plot, global approach, dc tests**

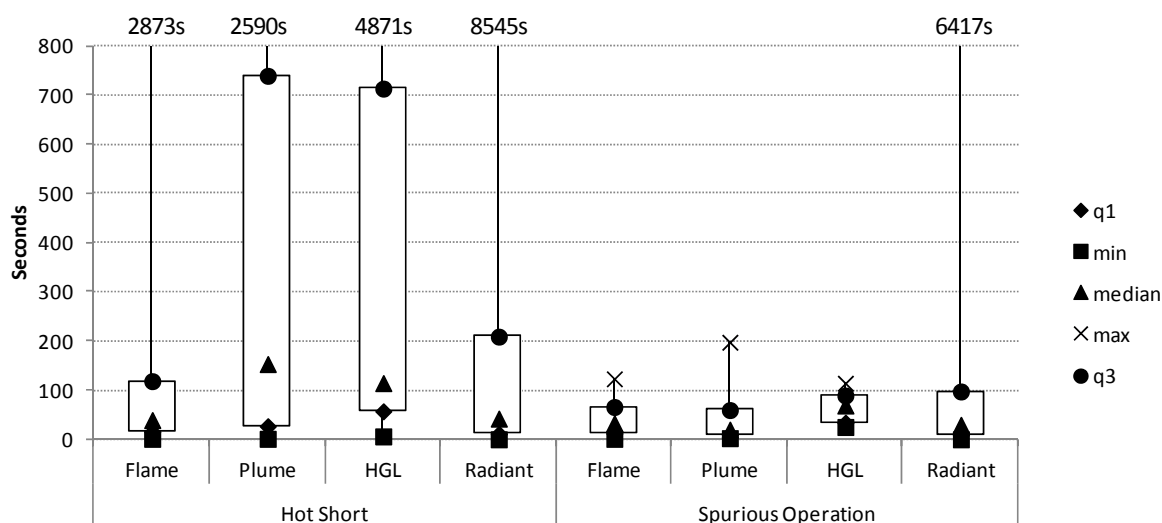
**Figure 4-10. Thermal exposure conditions box plot, duration, dc tests**

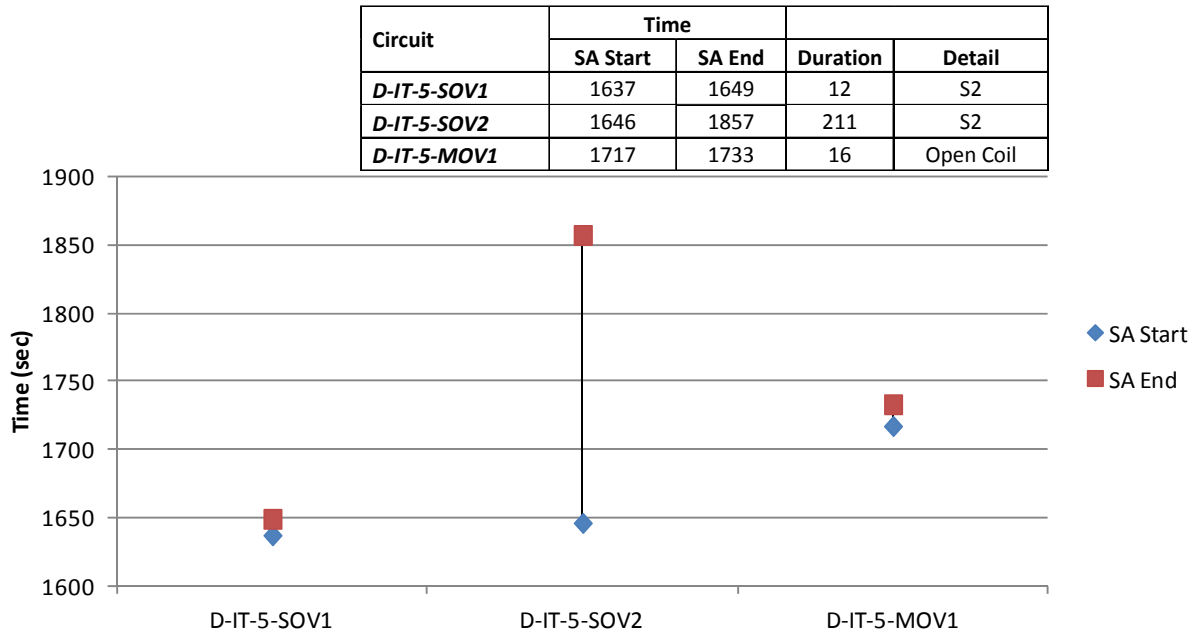
Figure 4-35. Time plot of concurrent hot shorts for DESIREE-FIRE intermediate-scale test 5

Figure 4-35 depicts the dc hot short concurrence between SOV-2, SOV-1, and MOV-1 for intermediate-scale test #5. It is important to note the physical location of the cables because thermal exposure conditions can influence the timing of cable failure. The SOV-2 cable is located in position D (upper plume), while the SOV-1 and MOV-1 cables are both located in a conduit in position B (lower plume). As referenced in Table 4-36, SOV-2 and SOV-1 have a concurrent spurious operation duration of three seconds, while SOV-2 and MOV-1 have a concurrent spurious operation duration of 16 seconds. Figure 4-36 provides the temperature profile for the two cable locations that experienced concurrent hot shorts.

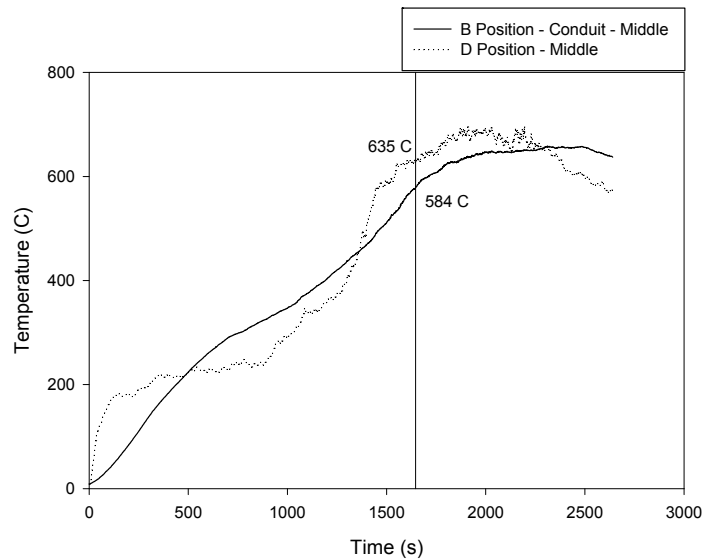
Figure 4-36. Plot of intermediate-scale test 5 for MOV and SOV cable locations

To summarize the data presented in Figure 4-36 and Table 4-35, intermediate-scale test #5 experienced two concurrent hot shorts among three circuits; the cables are physically located in Location D and Location B (inside the conduit). All of the cable insulation is thermoplastic. Figure 4-36 plots temperature versus time for MOV and SOV cable locations in intermediate-scale test #5. According to Figure 4-36, the cables located in the B Position fail at approximately 600 °C, whereas the cable located in the D Position fails at approximately 630 °C. This indicates the importance of understanding thermal exposure conditions and the effect that they have on concurrent failure timing. Although the cables are in different locations, each has a similar temperature profile, which is why they failed at approximately the same time.

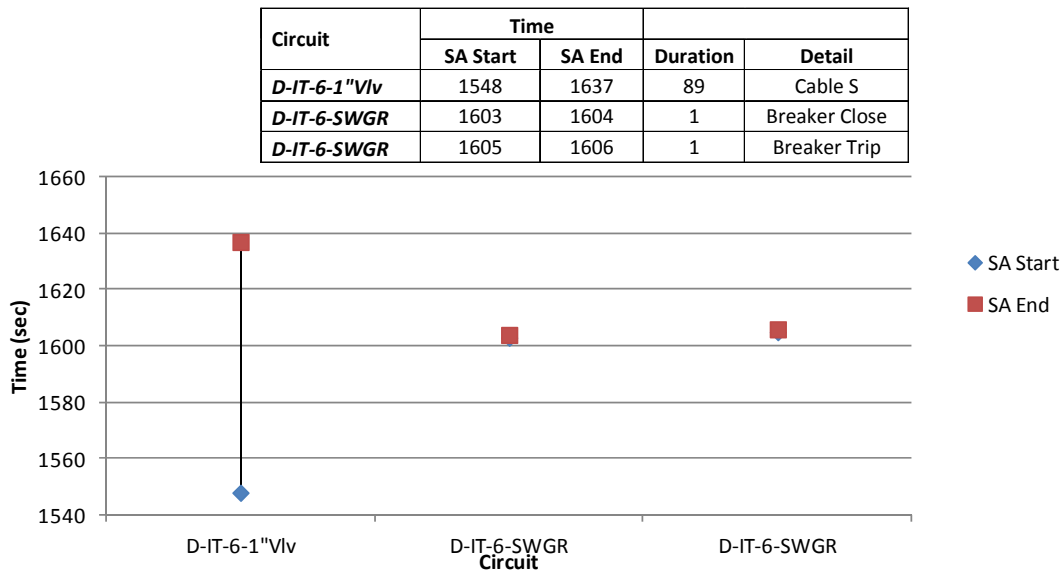
Figure 4-37. Concurrent hot shorts - test 6

Figure 4-37 depicts the dc hot short concurrence between the 1-inch valve circuit and switchgear circuits for intermediate-scale test #6. There are two data points for the SWGR circuits since one is for the close function and the other for the trip function. The 1-inch valve cable is located in position C (hot gas layer), while the switchgear close and trip cables are both located inside a conduit at position B (lower plume). As referenced in Table 4-35, the 1-inch valve and switchgear (close) circuits have a concurrent spurious operation duration of one second, as do the 1-inch valve and switchgear (trip) circuits.

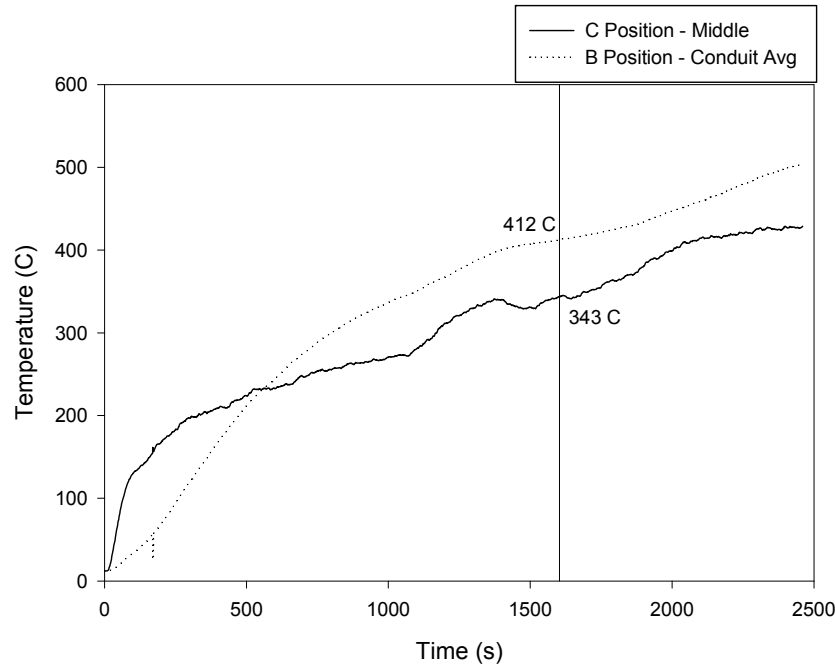
Figure 4-38. Plot of intermediate-scale test 6 for 1-inch valve and switchgear cable locations

To summarize the data presented in Figure 4-37 and Table 4-35 intermediate-scale test #6 experienced two concurrent hot shorts among three circuits; the cables are physically located in Locations C and B inside the conduit. All of the cable insulation is thermoplastic. Figure 4-38 plots temperature versus time for intermediate-scale test #6 for 1-inch valve and switchgear cable locations. According to the plot, cables located in B Position fail at approximately 460 °C, whereas the cable located in C Position fails at approximately 340 °C. Both of these temperatures fall within the typical range of cable failures for this cable type. This plot provides an analytical representation of the importance of cable location and the thermal exposure conditions due to the HGL effects.

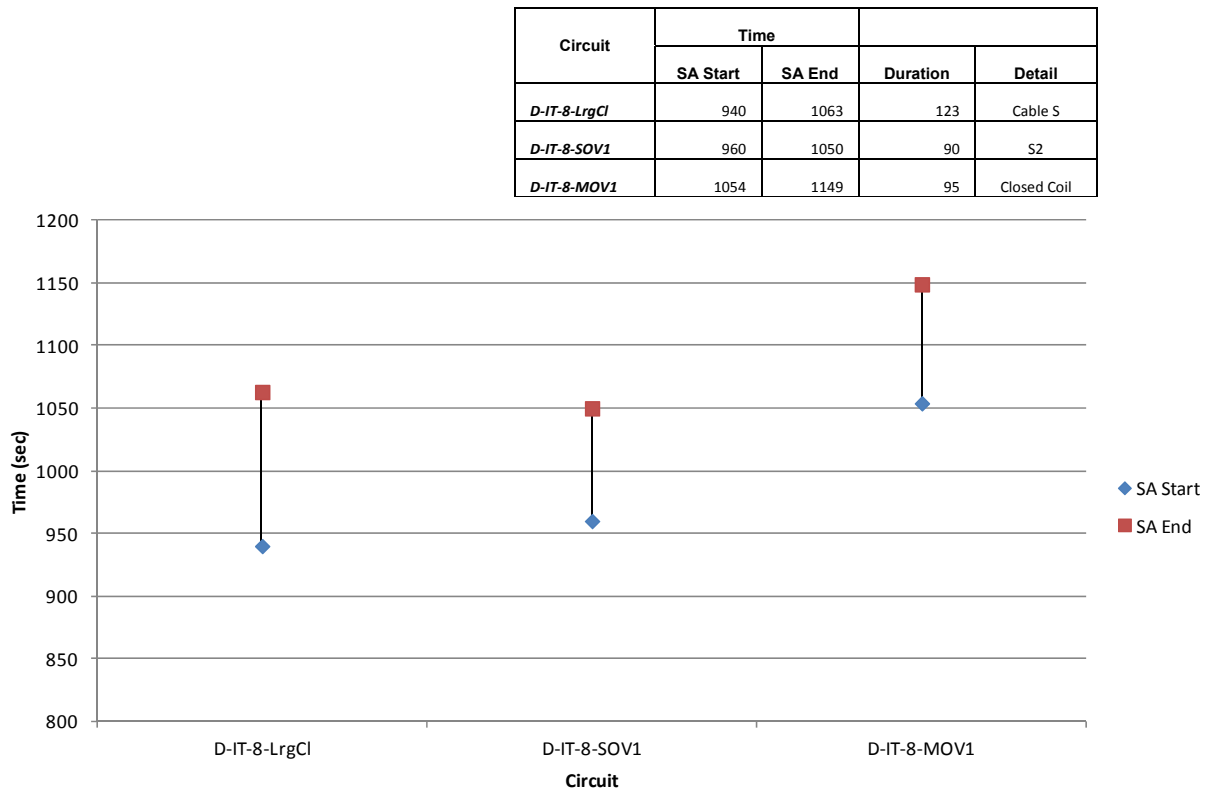
Figure 4-39. Concurrent hot shorts - test 8

Figure 4-39 depicts the dc circuit hot short concurrence between Large Coil, SOV-1, and MOV-1 for intermediate-scale test #8. In the case of the two concurrent hot shorts observed in this test, all circuit cables were located in Position A (flame exposure). As referenced in Table 4-35, large coil and SOV-1 have concurrent spurious operation durations of 90 seconds, while the large coil and MOV-1 have concurrent spurious operation durations of nine seconds. All of the cable insulation is thermoplastic. Given that all of the cables are located in A, in the flame, this is consistent with the concurrent failure timing because all cables are experiencing similar thermal insult.
