Electrical Cable Test Results and Analysis During Fire Exposure (ELECTRA-FIRE)

**A Consolidation of Three Major
Fire-Induced Circuit and Cable
Failure Experiments Performed
Between 2001 and 2011**

Draft Report for Comment

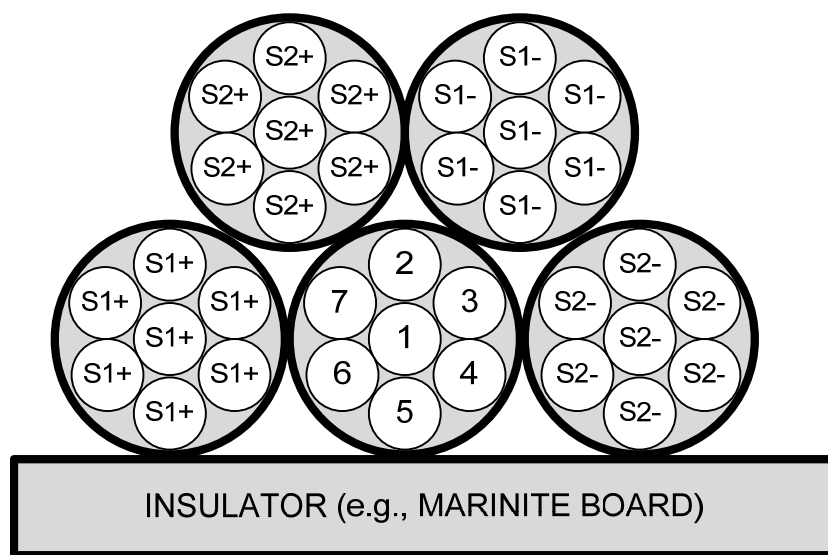
Figure 5-1. DESIREE-FIRE inter-cable configuration

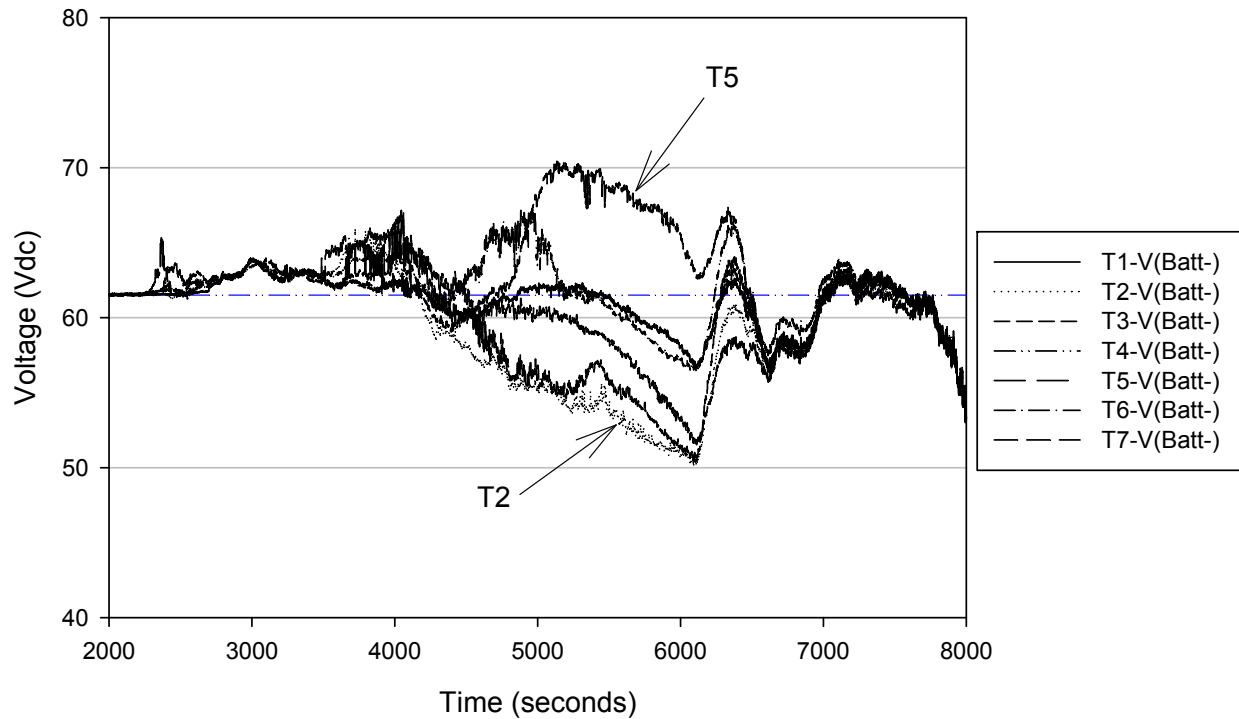
Figure 5-2. DESIREE-FIRE inter-cable test results penlight #47

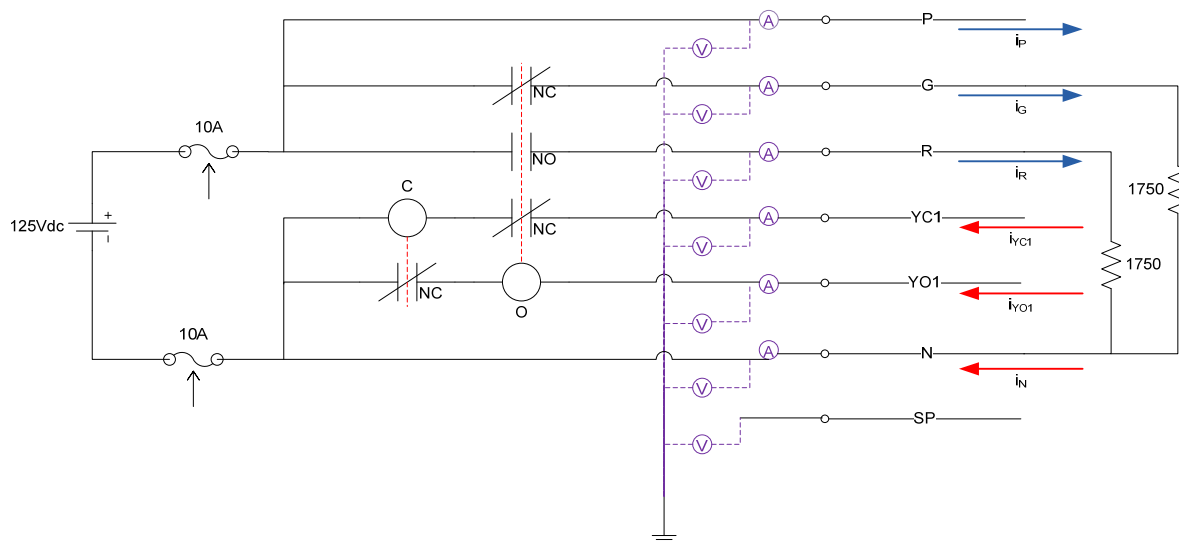
Figure 5-3. dcMOV schematic showing current summation used in identifying inter-cable shorting behavior

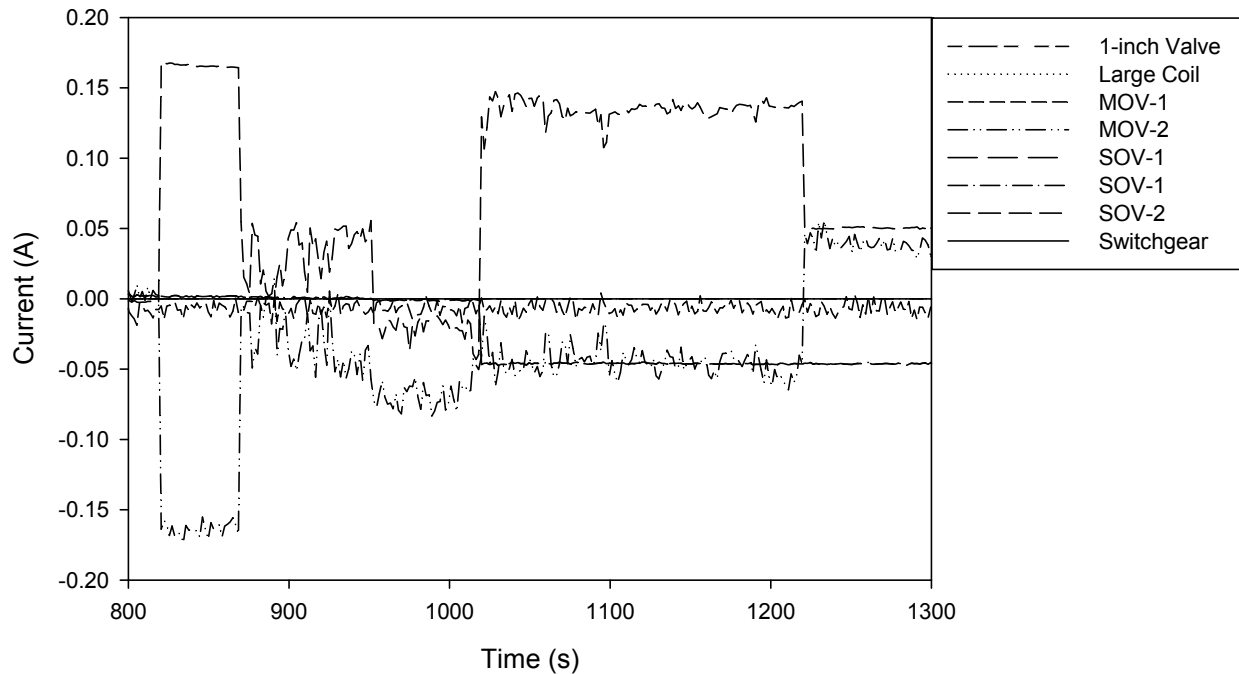
Figure 5-7. Intermediate-Scale Test Preliminary 2 – Inter-cable shorting between SOV-2 and MOV-2

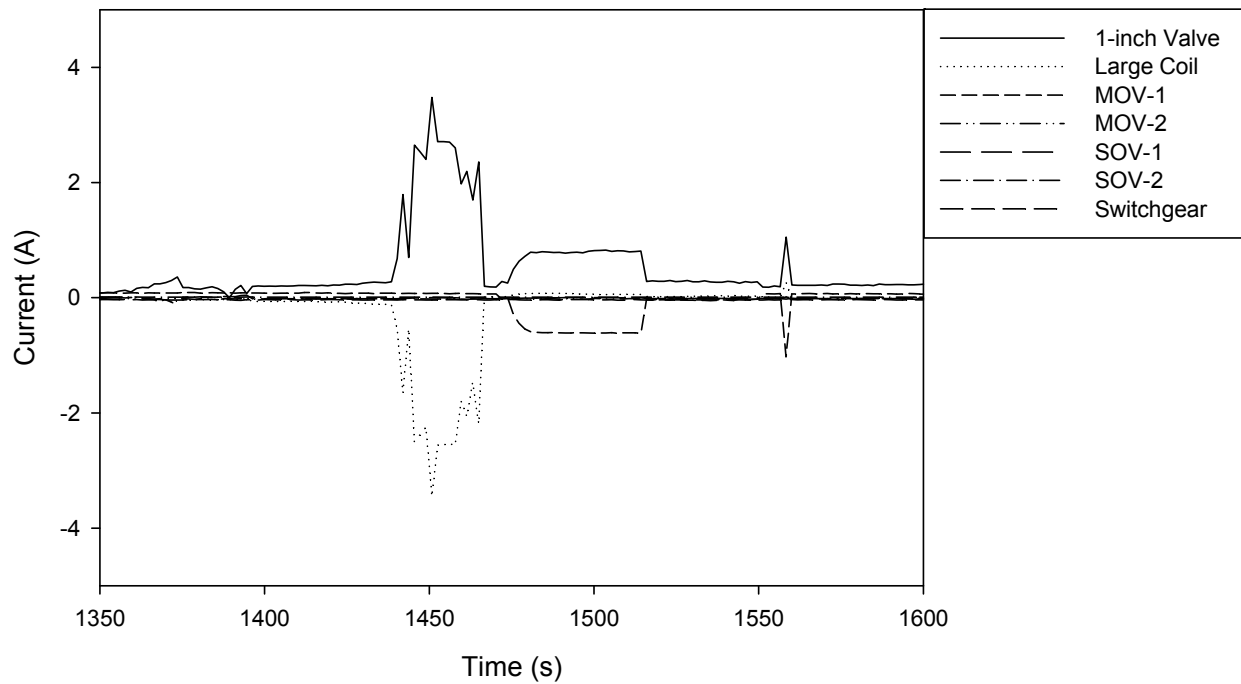
Figure 5-9. Outstanding current hot shorting for Intermediate-Scale Test #1 between 1-inch valve, large coil, and MOV-1 circuits

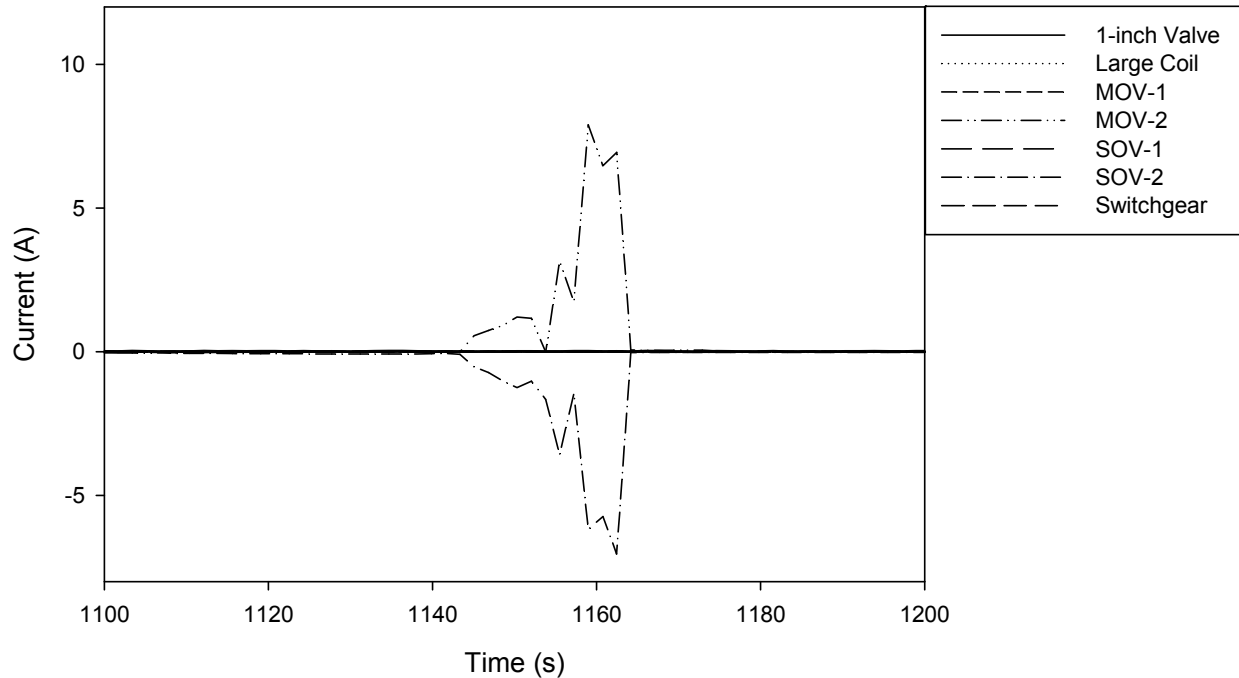
Figure 5-11. Outstanding current shorting in Intermediate-Scale Test #2, between SOV-2 and MOV-2

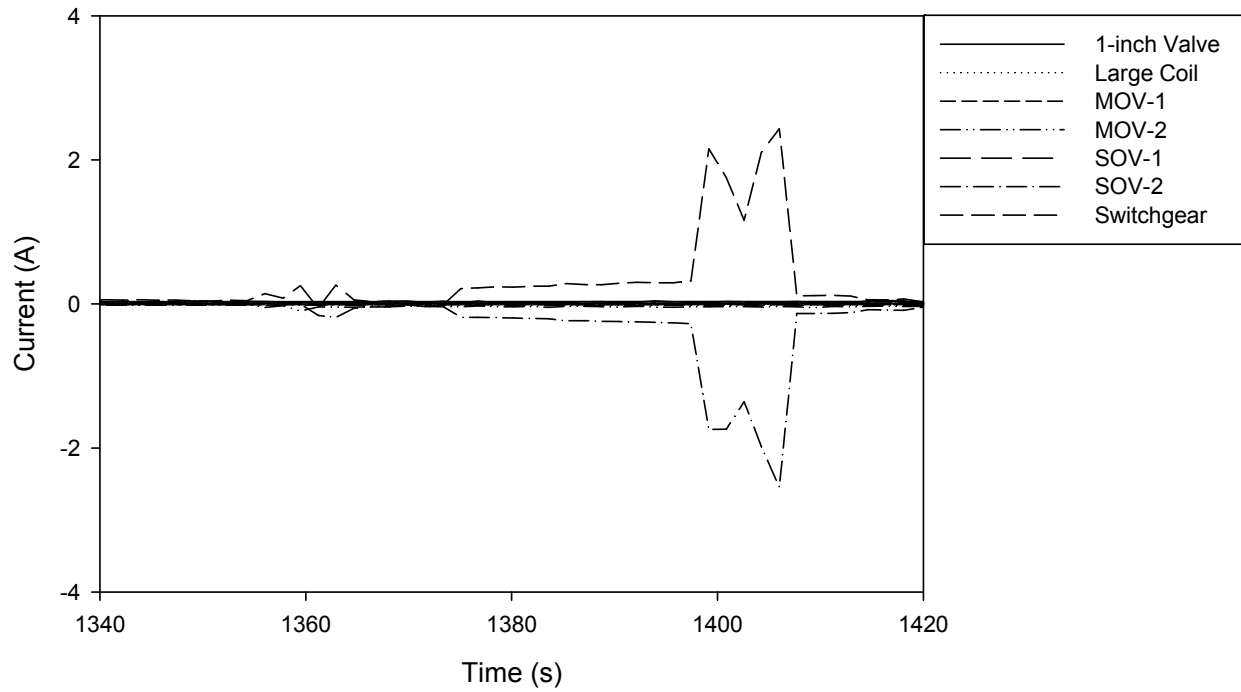
Figure 5-13. Outstanding current shorting in Intermediate-Scale Test #3, between SOV-2 and SWGR-T

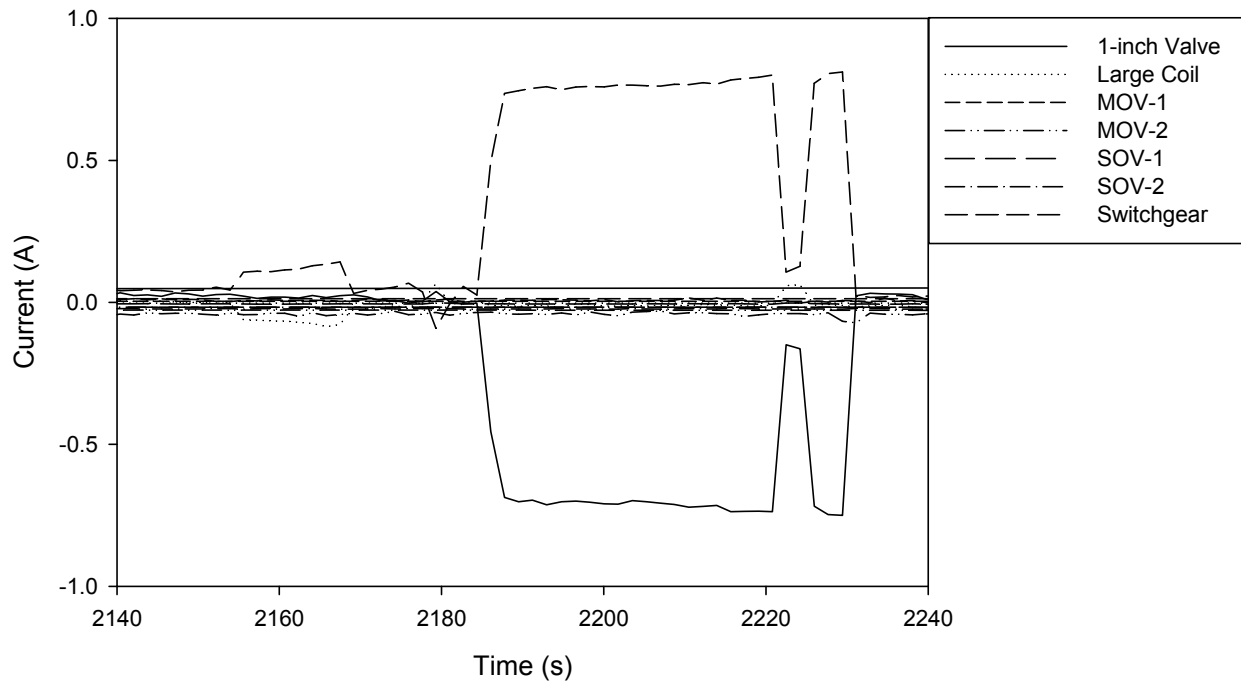
Figure 5-14. Outstanding current shorting in Intermediate-Scale Test #3, between 1 inch valve and SWGR-T

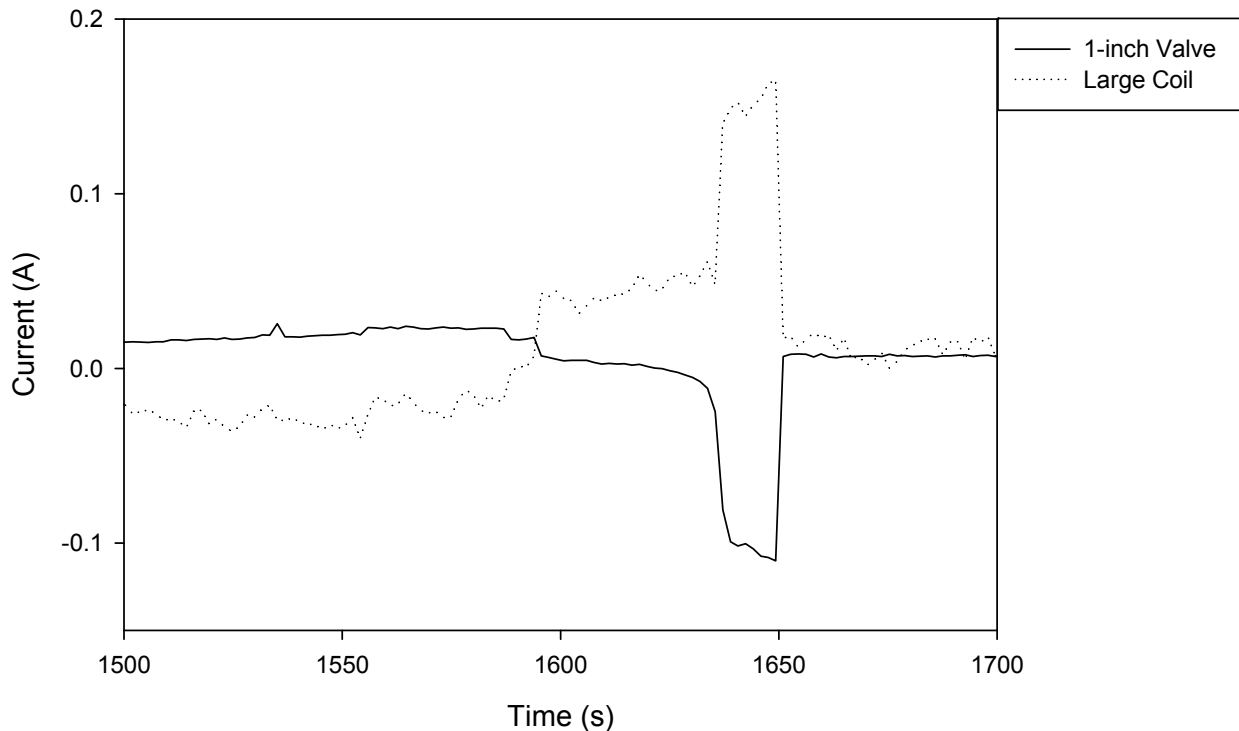
Figure 5-17. Outstanding current shorting in Intermediate-Scale Test #5, between SOV-1 and SWGR-T

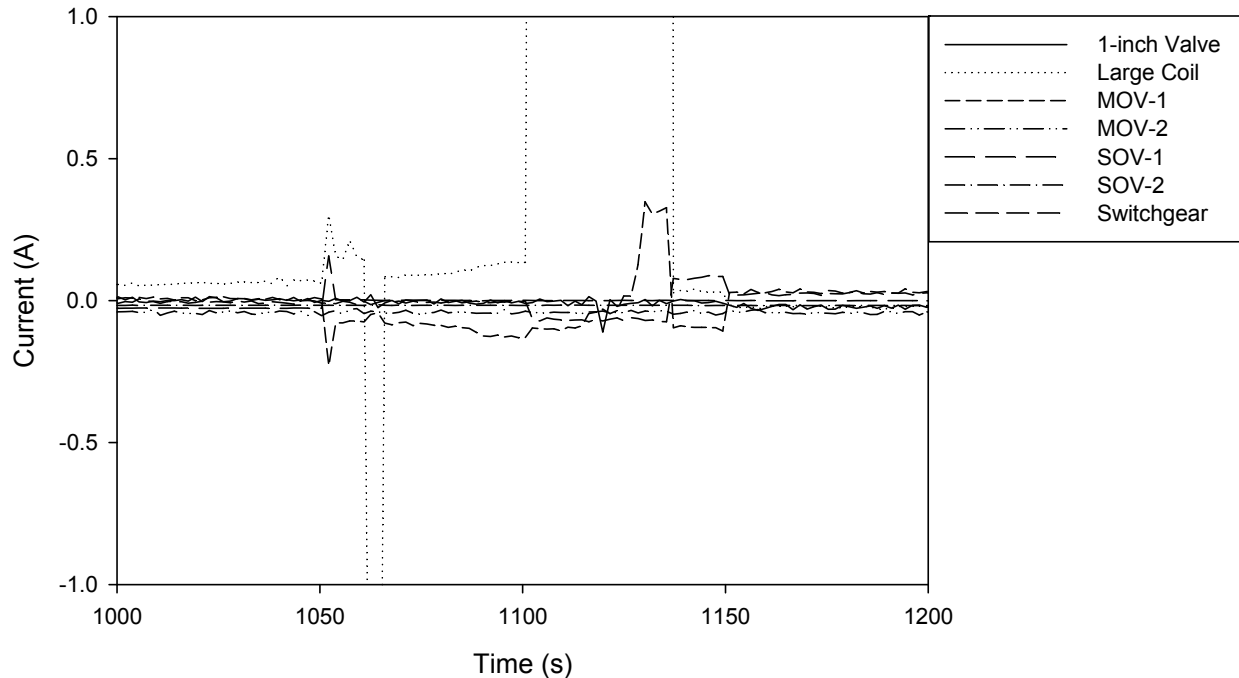
Figure 5-21. Outstanding current shorting in Intermediate-Scale Test #8, between MOV-1 and Lg Coil

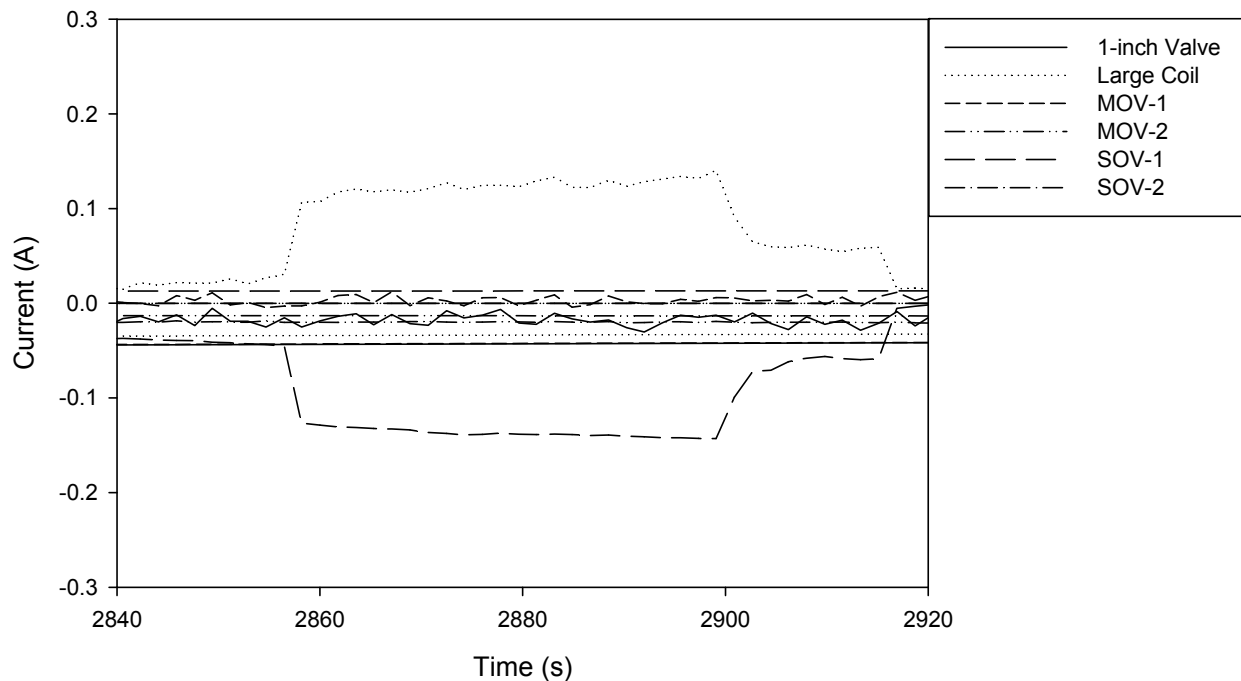
Figure 5-25. Intermediate-Scale Test #11 Current Summation

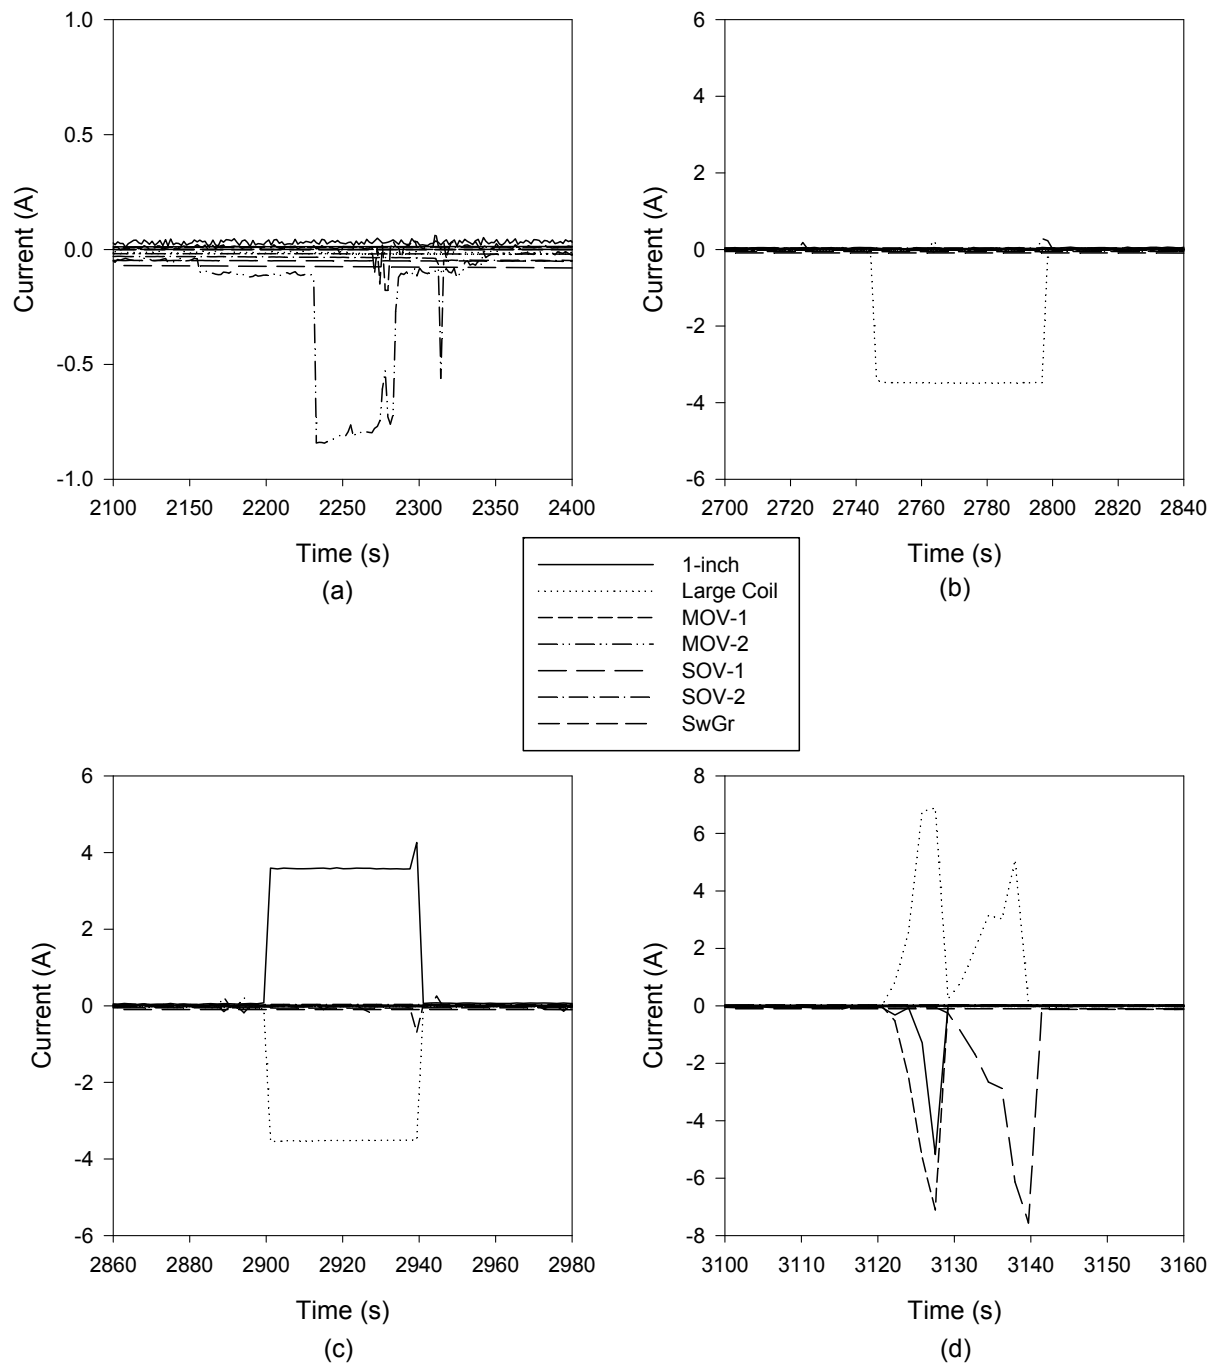
Figure 5-27. Intermediate-Scale Test 12 Current Summation Plot

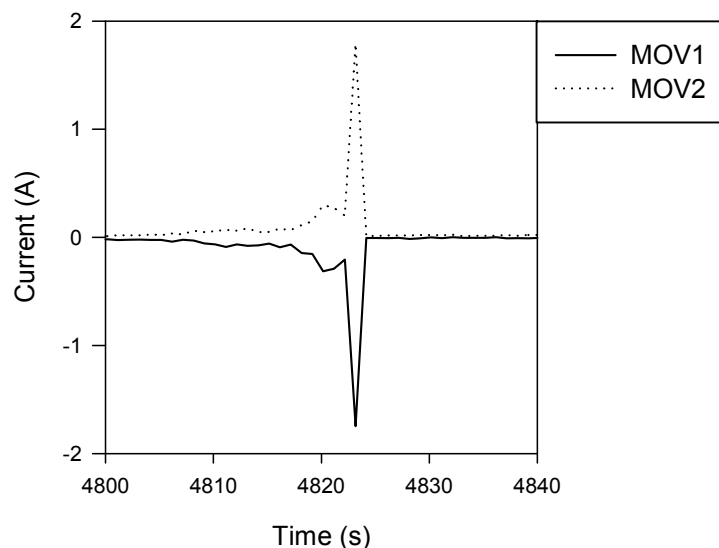
Figure A-19. Outstanding current shorting in Penlight MOV Test #49
