PSEG Power, LLC  
PSEG Site ESPA  
Part 2, Site Safety Analysis Report

FIGURE 2.4.6-20

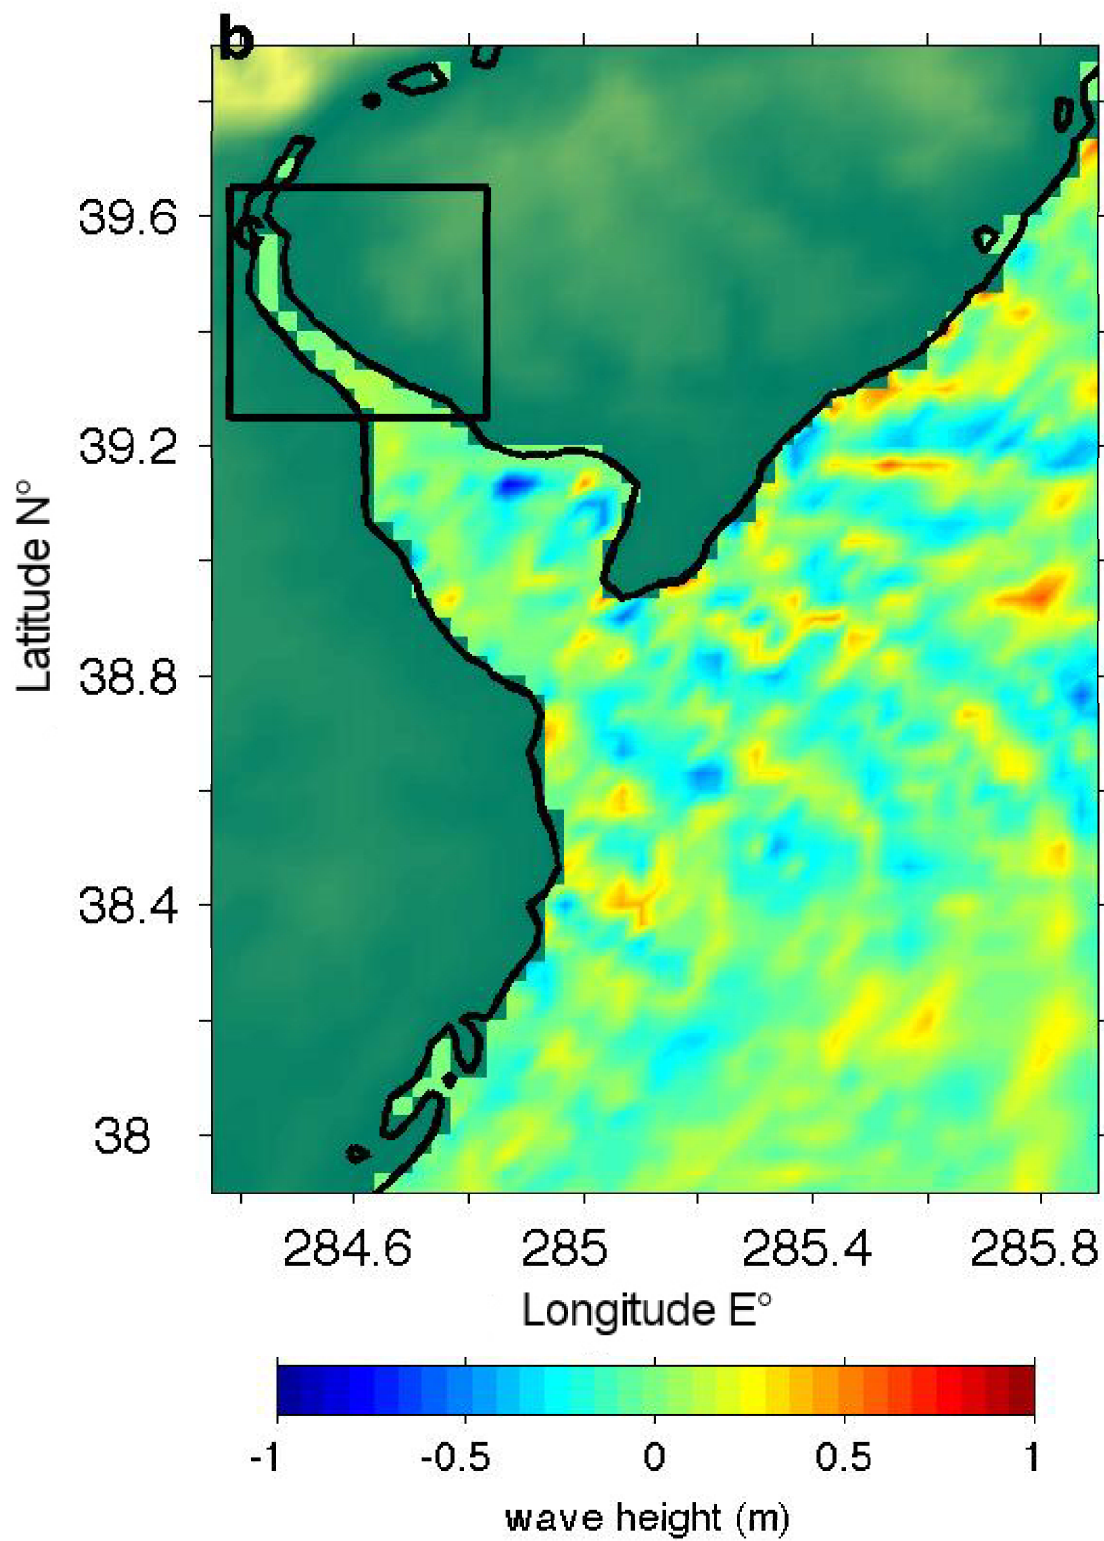
2-D Image for La Palma Slide  
at 11 hours
