NEI Steam Generator Task Force

NRC/Industry Update

February 18, 2011

EdF Divider Plate Cracking Update

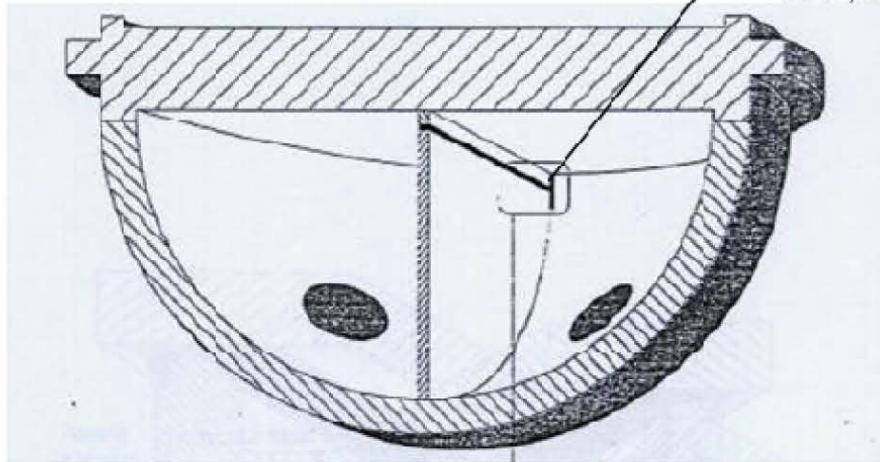
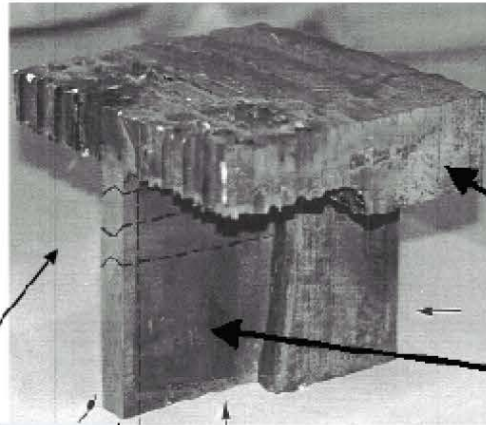
Triple Point

- DE on 3 SG divider plates
- Fabrication defects
- No SCC

Tubesheet

Divider Plate

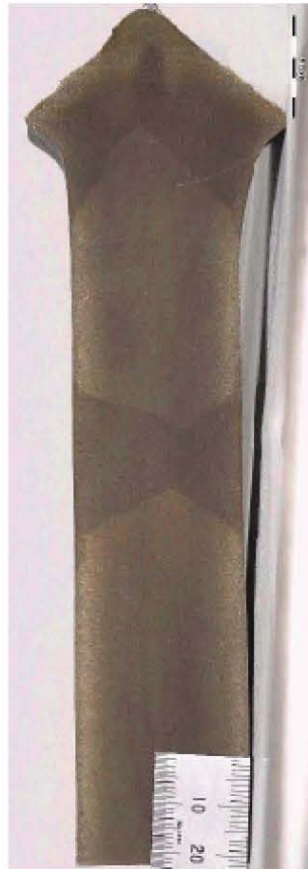
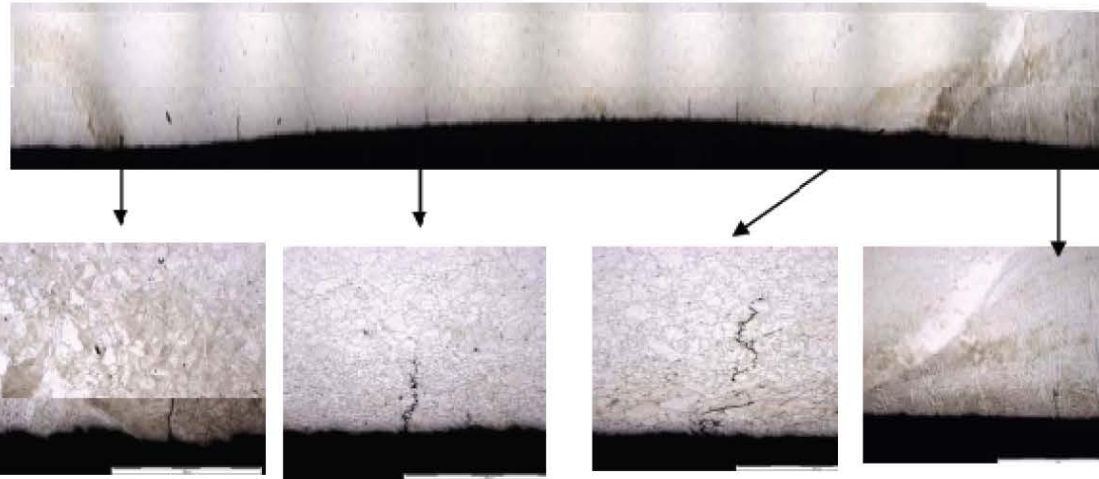
- Deeper cracks are on the top and bottom of the stub runner
- Cracks are intergranular
- Propagation is parallel to the weld
- No cracks on the divider plate and no cracks on the weld
- No cracks at the triple point or near the tubesheet

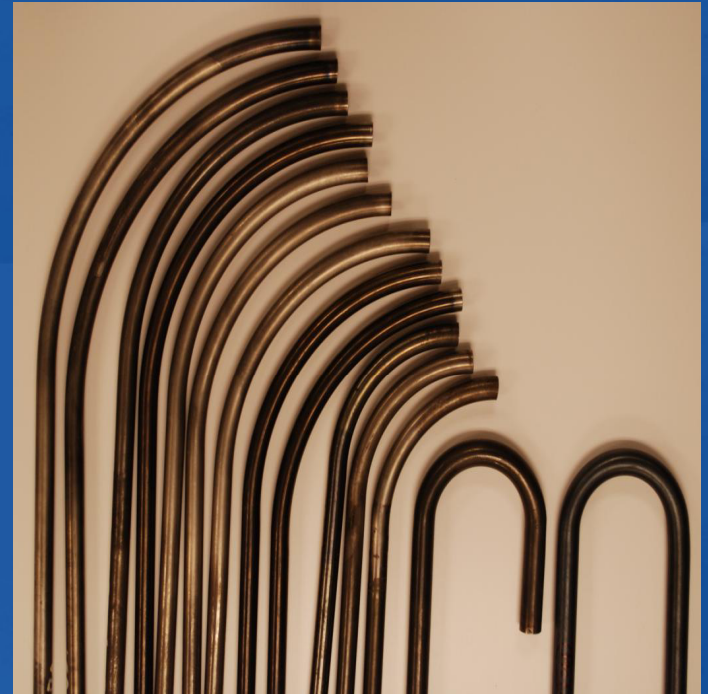
- ETSS's Peer Reviewed August 2010
 - “Detection of Axial ODSCC in Low Row U-Bends”
 - ETSS 10411, Plus Point Coil
 - Includes Phase and Amplitude Sizing
 - ETSS 10413, X-Probe
 - Detection Only
 - ETSS 10414, I-Probe
 - MIDAS analysis software
 - ETSS 10415, I-Probe
 - EddyNetSuite analysis software

Techniques Available for Industry Use
