NUREG/CR-5363

A Study of the Use of Crosslinked High-Density Polyethylene for Low-Level Radioactive Waste Containers

Prepared by P. Soo, C. I. Anderson, J. H. Clinton

Brookhaven National Laboratory

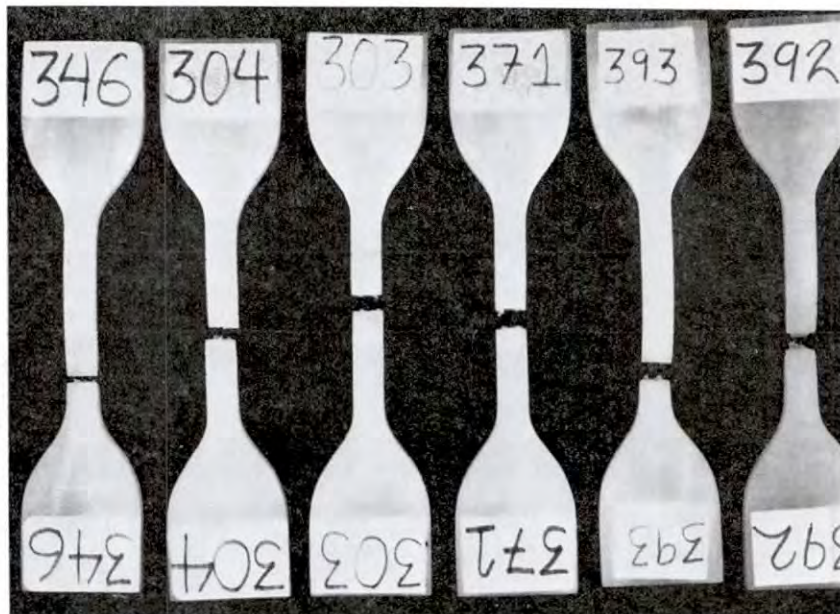
Figure 4.12 Fracture characteristics of Marlex CL-100 HDPE in Igepal CO-630. Applied stresses from left to right were 8.96, 9.65, 10.34, 11.03, 11.72, and 12.41 MPa. Magnification 0.72 X.

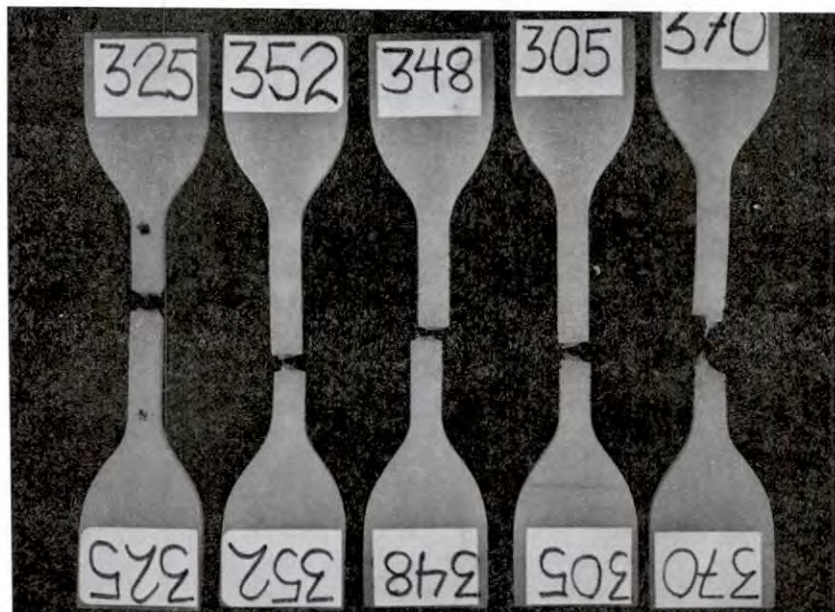
Figure 4.13 Fracture characteristics of Marlex CL-100 HDPE in turbine oil. Applied stresses from left to right were 8.27, 8.62, 8.96, 10.34, and 11.03 MPa. Magnification 0.72 X.
