Assessment of the Hydraulic Connection Between Ground Water and the Peace River, West-Central Florida

Water-Resources Investigations Report 97-4211

Prepared in cooperation with the
SOUTHWEST FLORIDA WATER MANAGEMENT DISTRICT

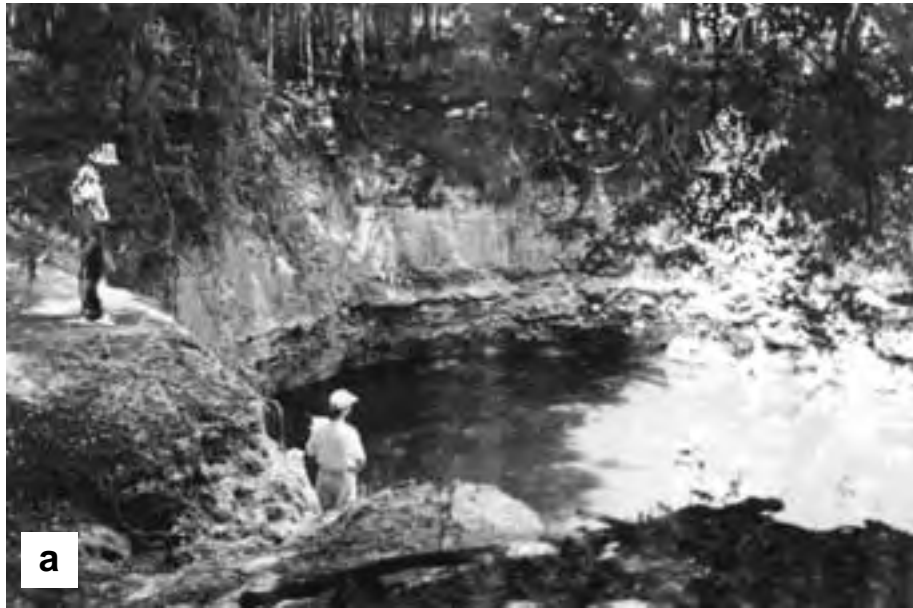
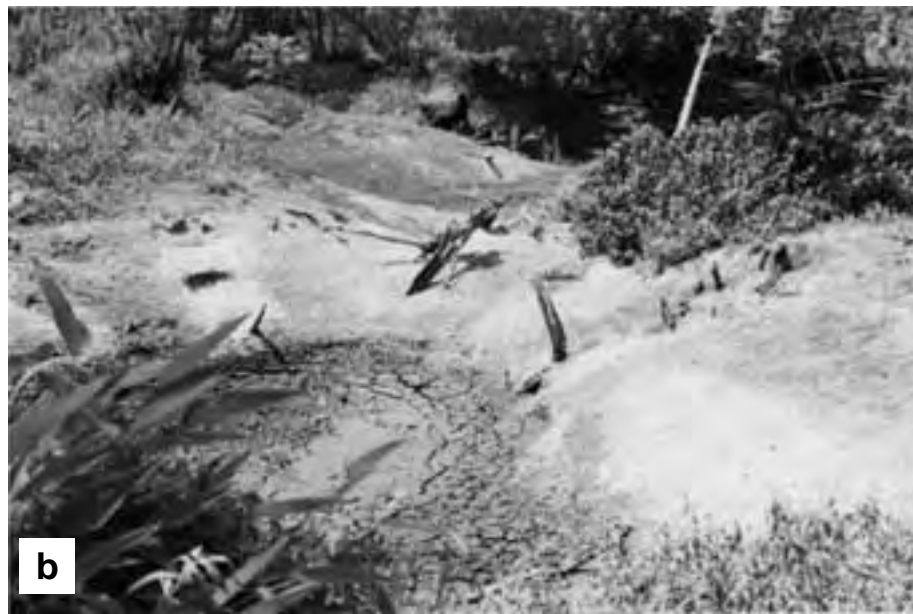
Figure 22. Examples of subsidence features observed in the upper Peace River floodplain: (a) large collapse feature with steep walls and (b) small sand-filled depressions. (Location of subsidence features are shown in figure 18.)

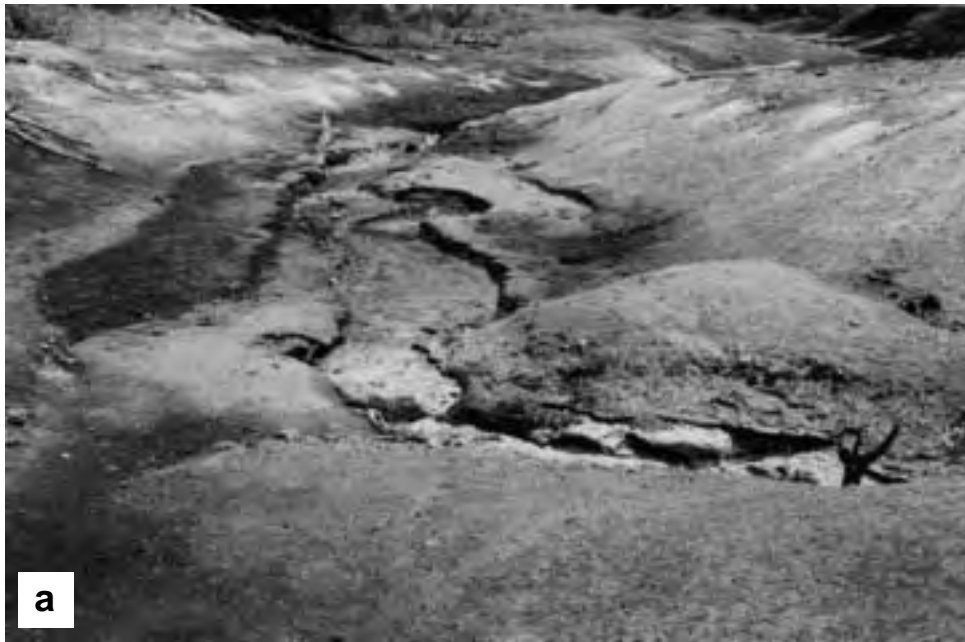
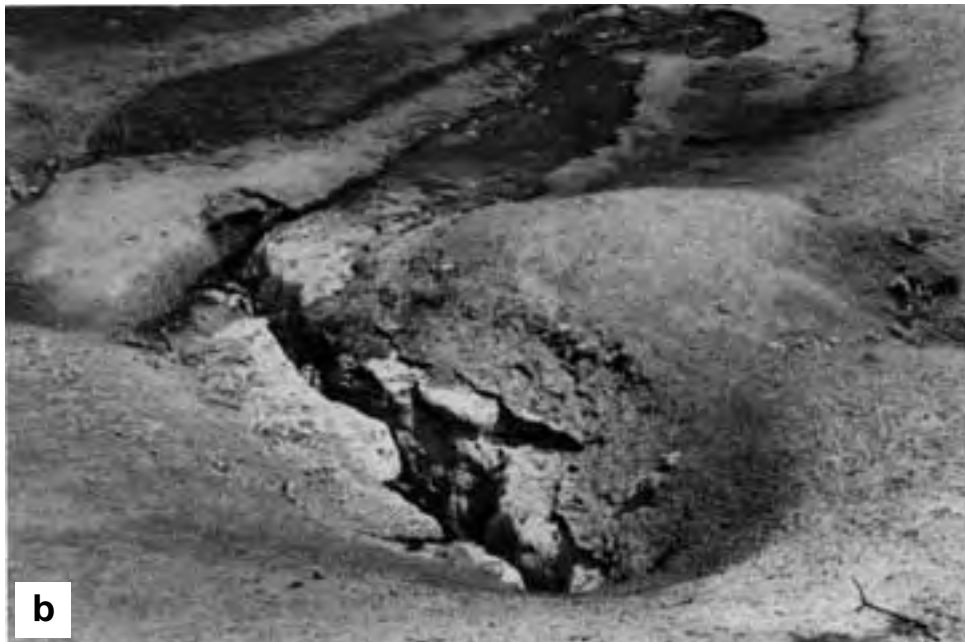
Figure 23. Example (a and b) of an enlarged linear solution feature capturing Peace River flow during low base-flow conditions, May 1995. (Location of solution feature is shown in figure 18.)

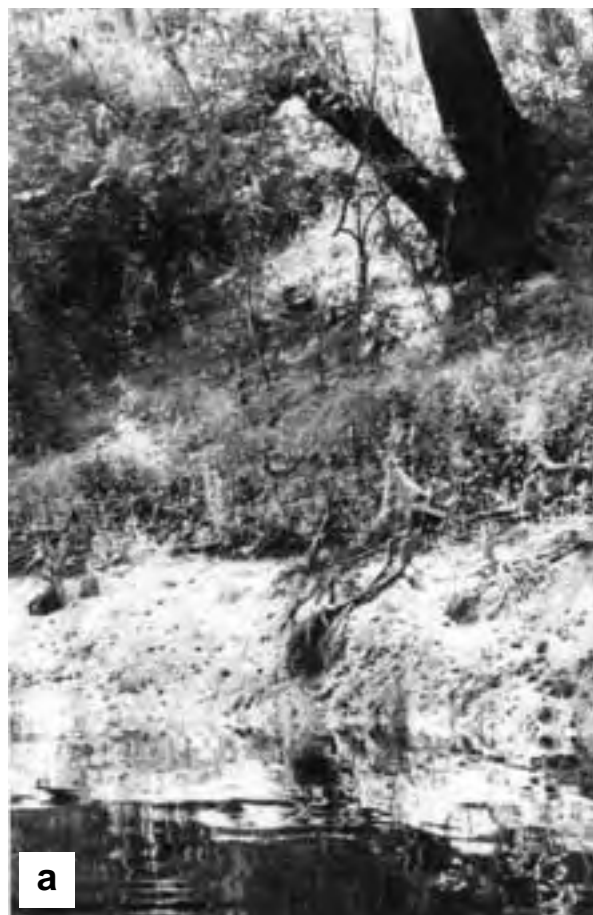
Figure 28a. Example of exposed geologic units along the banks of the lower Peace River.

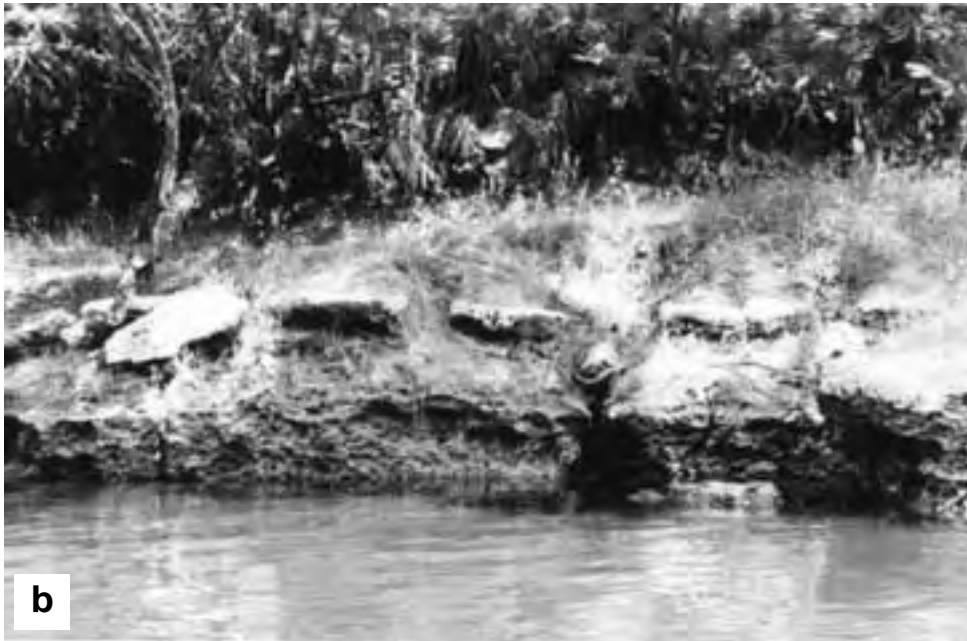
Figure 28b. Example of exposed geologic units along the banks of the lower Peace River.

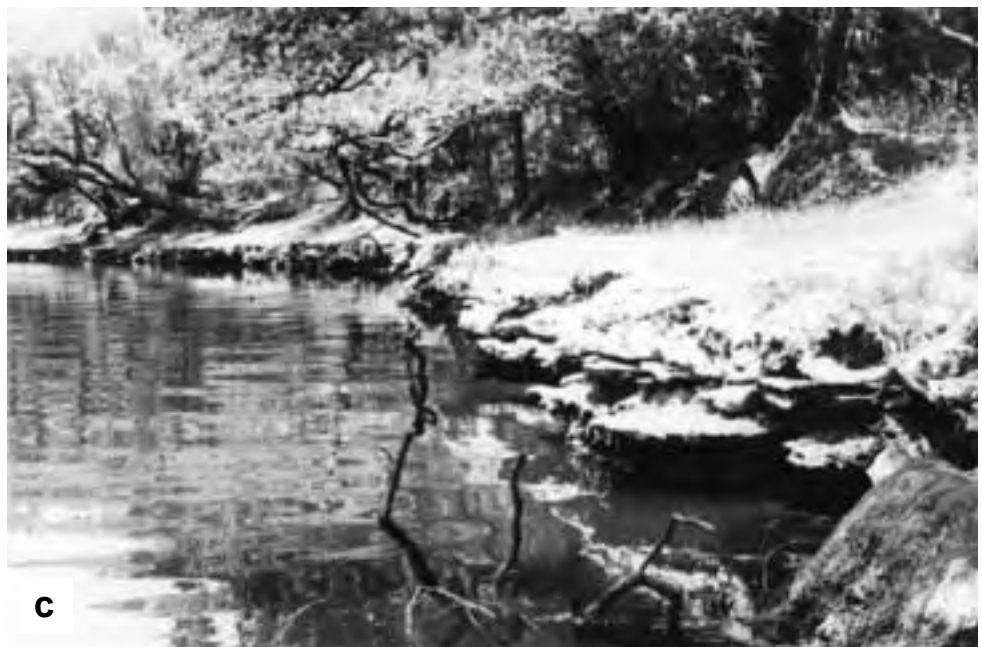
Figure 28c. Example of exposed geologic units along the banks of the lower Peace River.

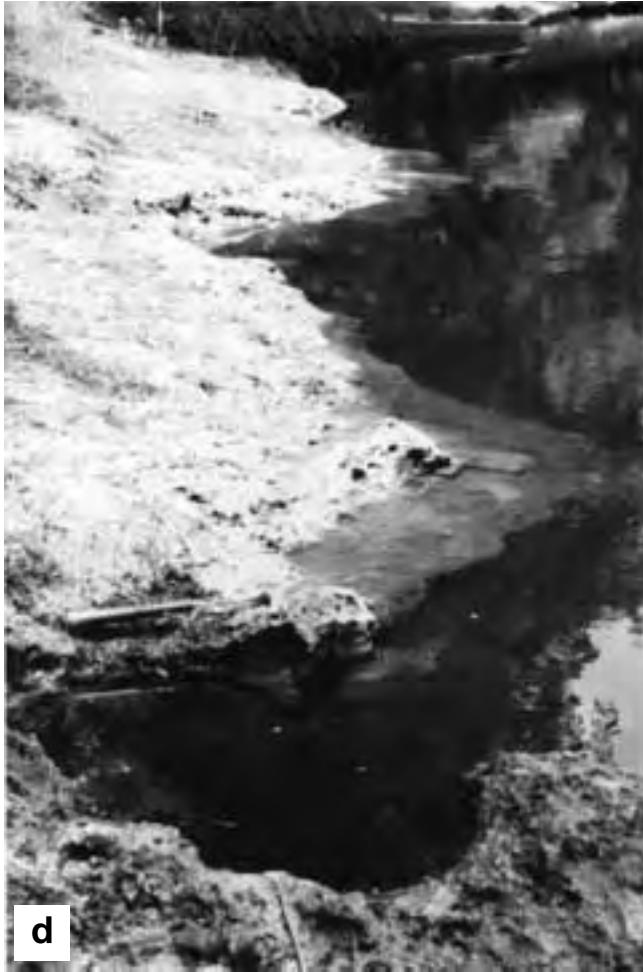
Figure 28d. Example of exposed geologic units along the banks of the lower Peace River.
