**Inspection report  
30B cylinder containing Uranium Hexafluoride  
MFR SERIAL NR 20 920-043, STOOMWEZEN REC. NR 4010381,  
URECO NR 1629/000515**

**Issued by  
Carolina Materials Testing Company, Inc.  
Irmo S.C.**

MFR SERIAL NR 20 920-043

MODEL 30 B, YEAR BUILT 2000 (No month stamp on plate as required by ANSI 14.1)

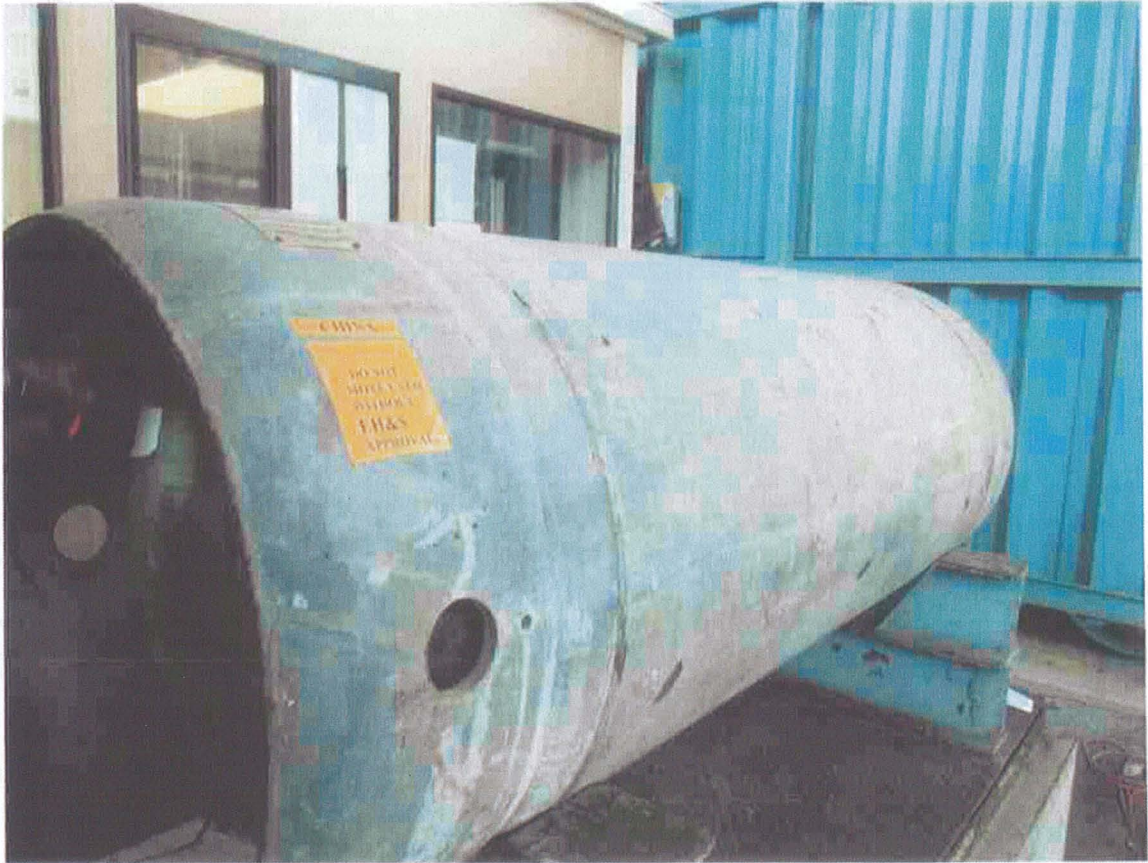
Side view from valve end showing typical construction and no defects.

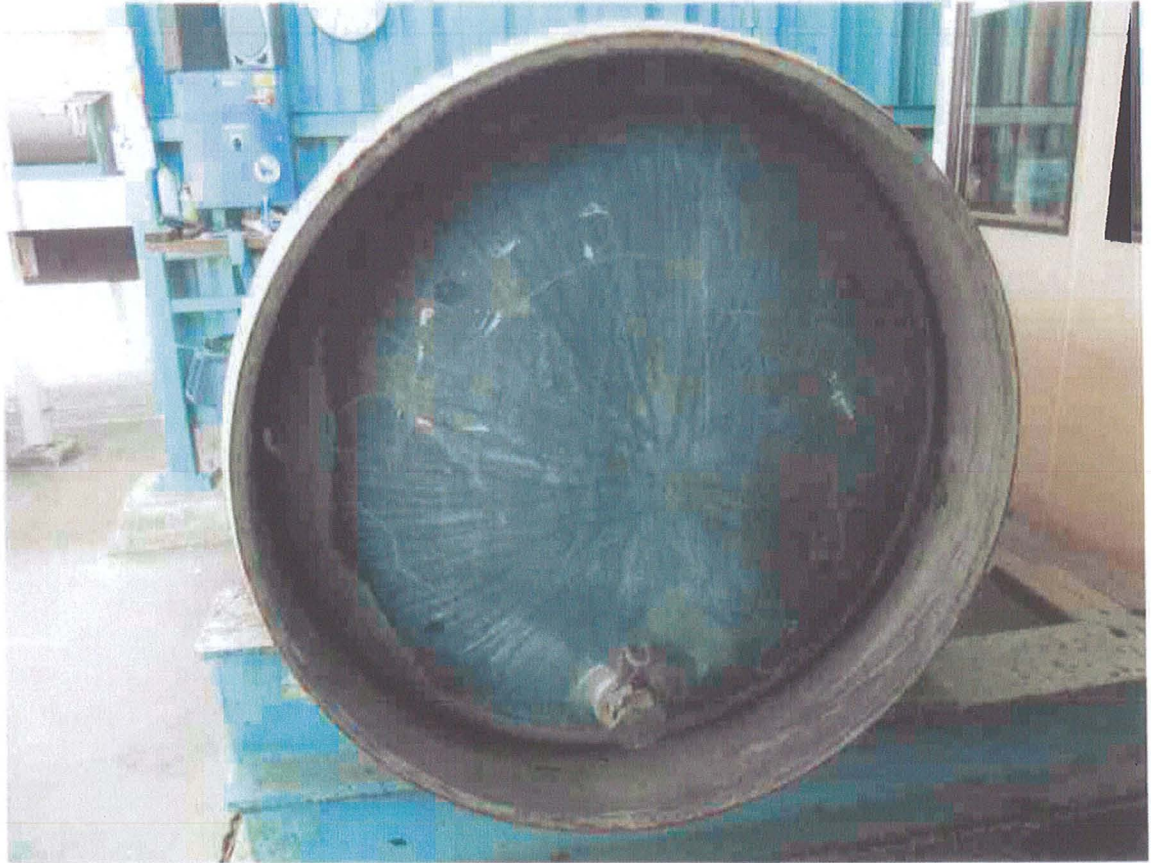
**Plug end view showing typical construction and no defects.**

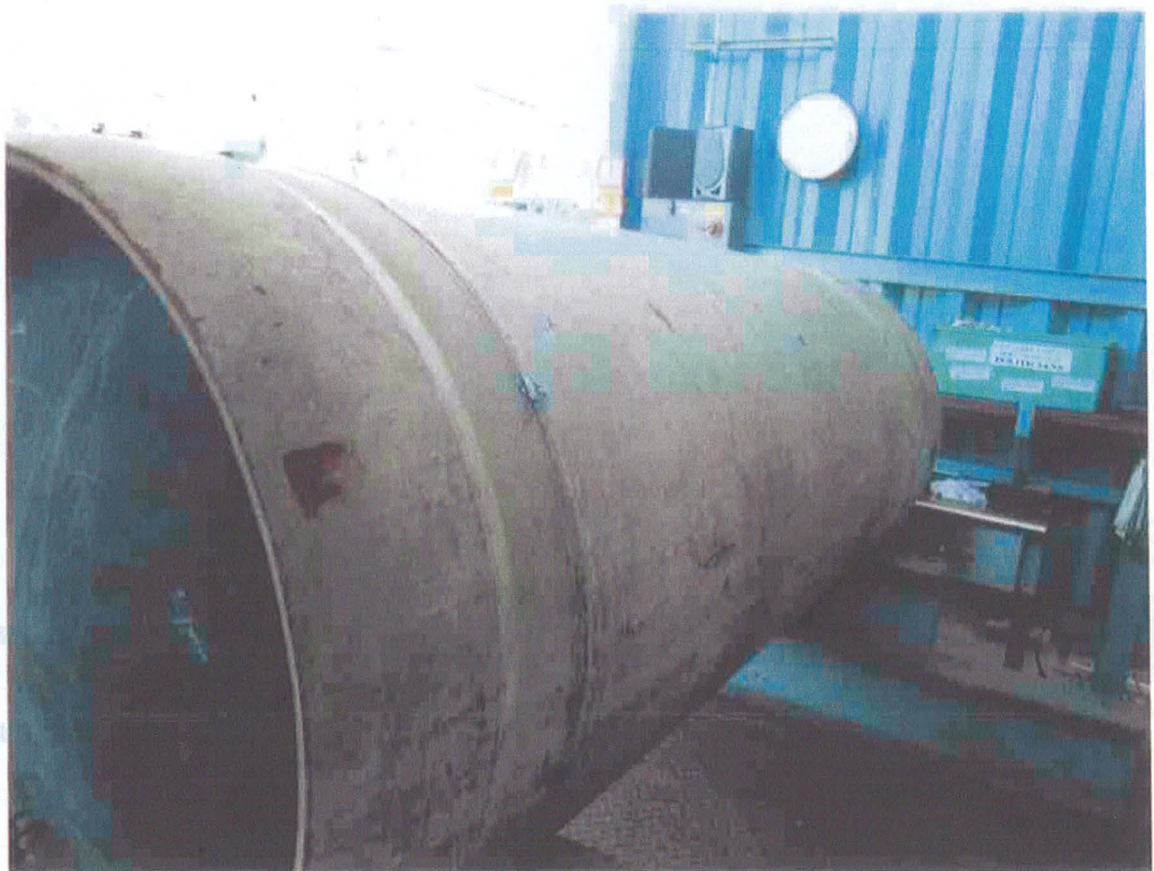
**Side view of plug end showing typical construction and no defects**

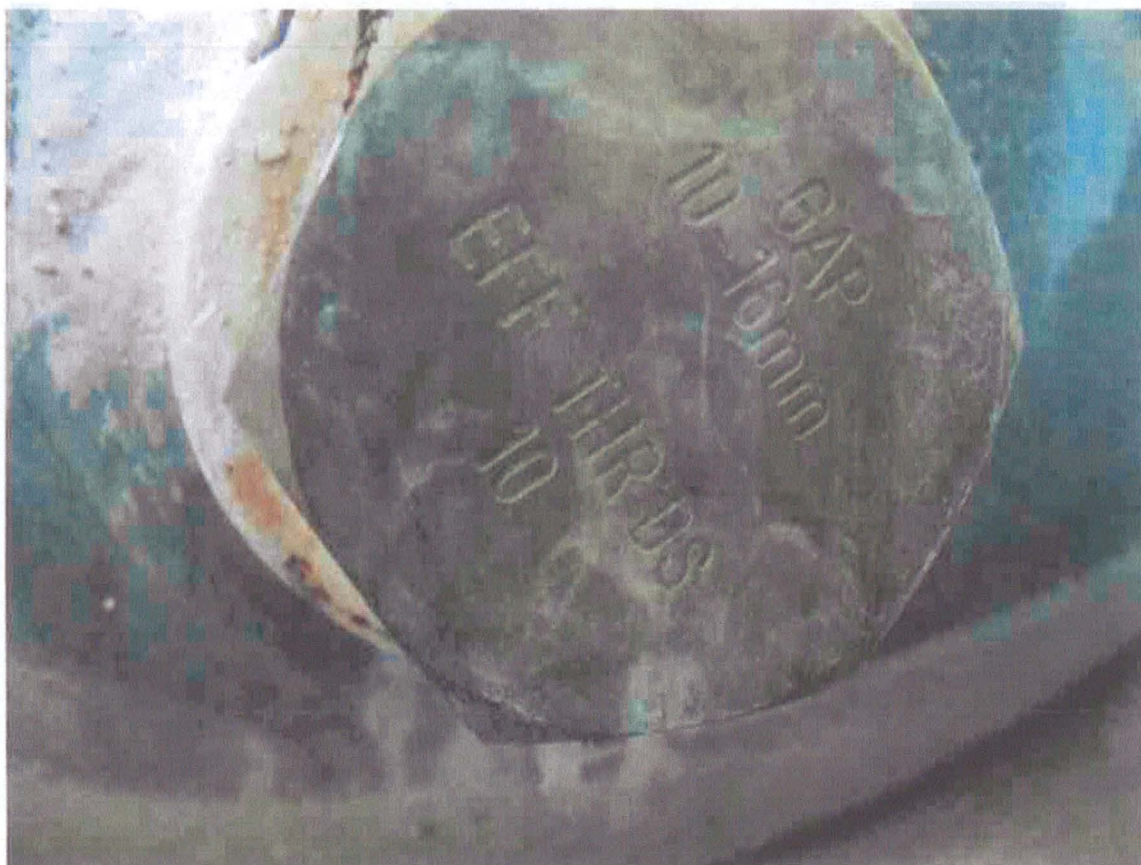
The back plug is stamped "10." Five threads are exposed, indicating five threads are engaged.

**View of plug showing typical construction and no defects**
