This Supplemental Technical Evaluation summarizes the information contained in the report "Tube wear of Unit 3 RSG – Technical Evaluation Report" (L5-04GA564 latest revision, Ref. 1) ("TER") and supplements it with information taken from other MHI documents and the AREVA Operational Assessment and with further analysis. It is intended as a guide and introduction to the main findings of the TER as well as an explanation of key information from related documents.

1. Introduction

On January 31, 2012, during the first cycle after steam generator replacement, San Onofre Nuclear Generating Station (SONGS) Unit 3 was shut down to investigate a steam generator tube leak. Steam generator tube inspections confirmed a small leak in one tube in one of the two steam generators. Further inspections of 100% of the steam generator tubes in both Unit 3 steam generators discovered unexpected wear, including tube-to-tube as well as tube-to-tube-support wear. At the time of the Unit 3 leak, SONGS Unit 2 had already completed one cycle of power operation (~22 months) and was in a refueling outage. Inspections of tubes in the Unit 2 steam generators revealed similar wear to that found in Unit 3.

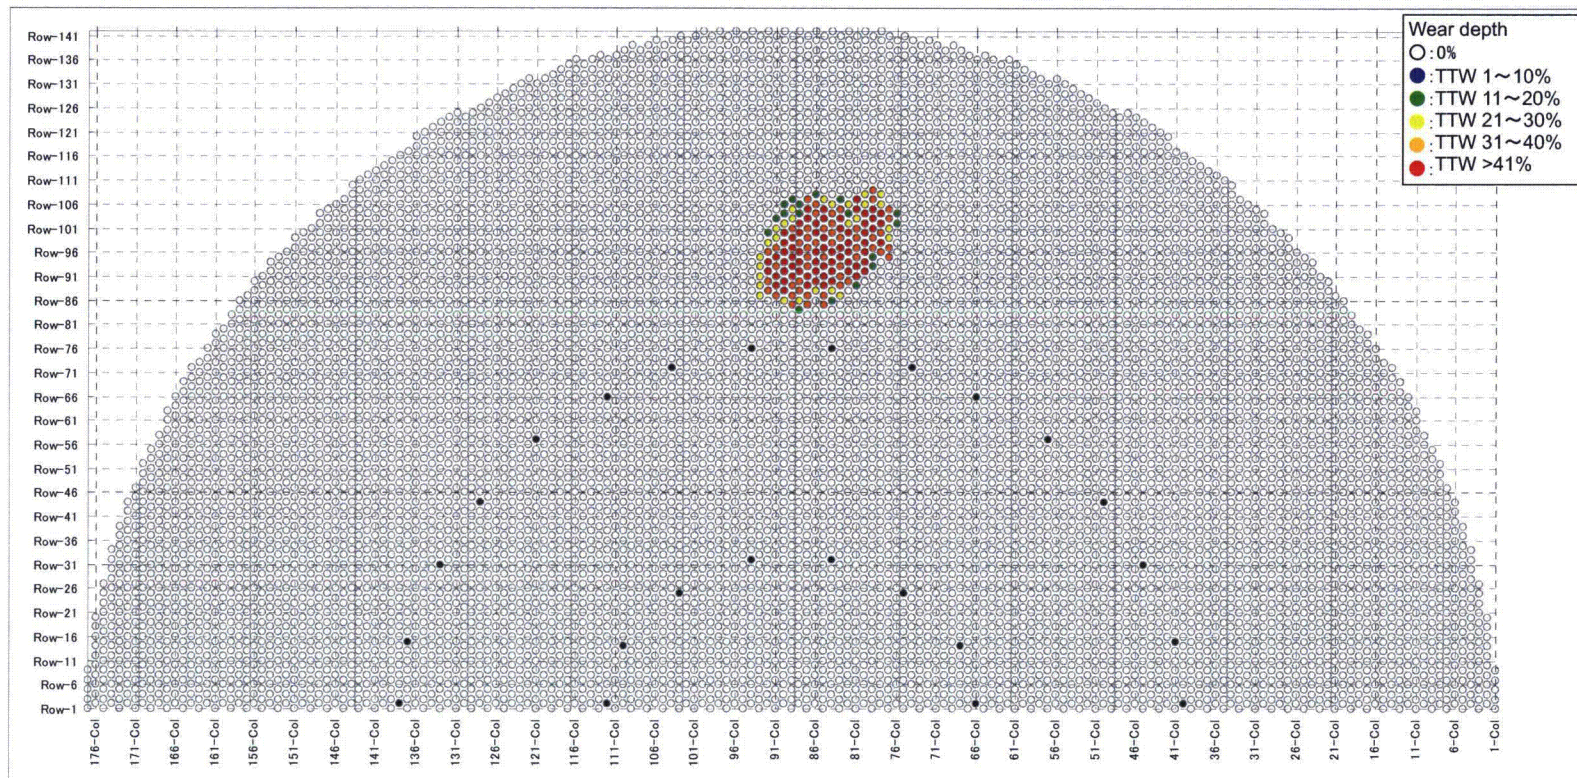
Both steam generators in Unit 3 had more than 160 tubes with TTW indications in U-bends. The three most degraded tubes exhibited wear scars that were more than 28 inches long . . . TTW scars are located on the extrados and intrados locations of U-bends. Wear scars on extrados locations of a given U-bend have matching wear scars on intrados locations of the neighboring row tube in the same column.

Fig 2.1-2 (1/2) Unit 3 Tubes with TTW indications

Fig 2.1-2 (2/2) Unit 3 Tubes with TTW indications

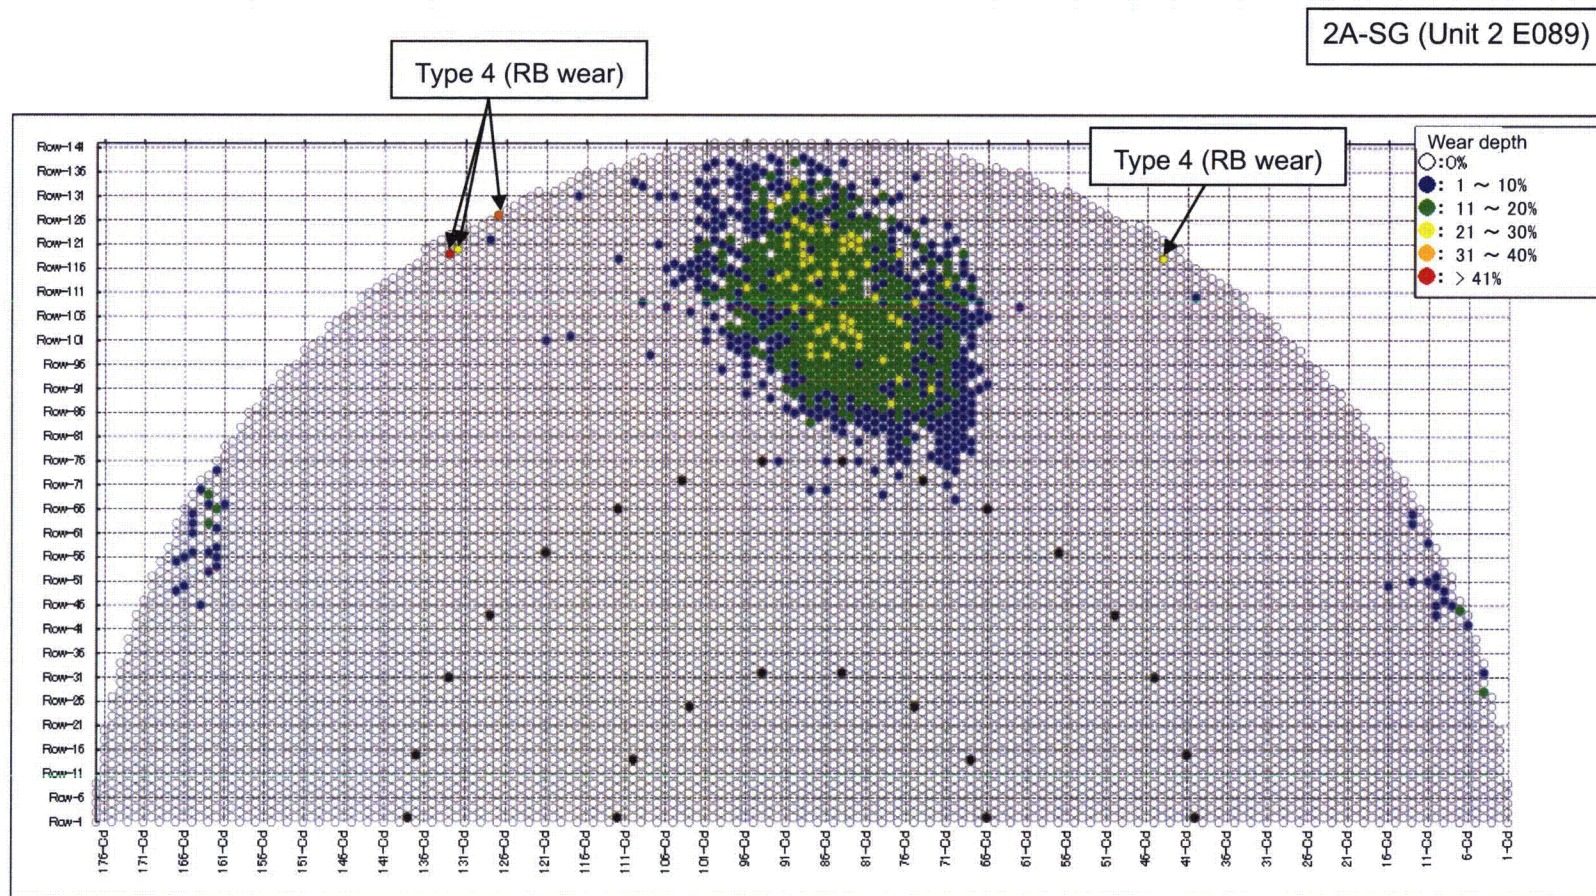
Tubes with Type 2 (AVB wear) indications are characterized by wear at the tube-to-AVB intersections with no free-span wear indications. They are produced primarily by U-bend tube vibration without any contribution from straight leg vibration although there are a few TSP wear indications on some of them. The locations of the tubes with wear indications at the tube-to-AVB intersections, including Type 2 wear, are shown in Fig. 3.1-1 (Unit 2) and Fig. 3.1-2 (Unit 3). The same data is shown on Fig 4.1.1-2 of the TER (Ref.1).

Fig 3.1-1 (1/2) All Unit 2 U-bend tube indications
(Type 1 TTW, Type 2 Tube-to-AVB and Type 4 Retainer Bar to Tube)

Fig 3.1-1 (2/2) All Unit 2 U-bend tube indications
(Type 1 TTW, Type 2 Tube-to-AVB and Type 4 Retainer Bar to Tube)

The Type-2 wear indications are in the region of high void fraction and dynamic pressure. Referring to Fig. 2.3.4-3 of the previous section, it can be seen that the area of the U-bend occupied by the high average void fraction (values above $\frac{1}{2}$ where the max value is $\frac{1}{2}$) is very similar to the Type-2 wear map in Figs. 3.1-1 and 3.1-2.

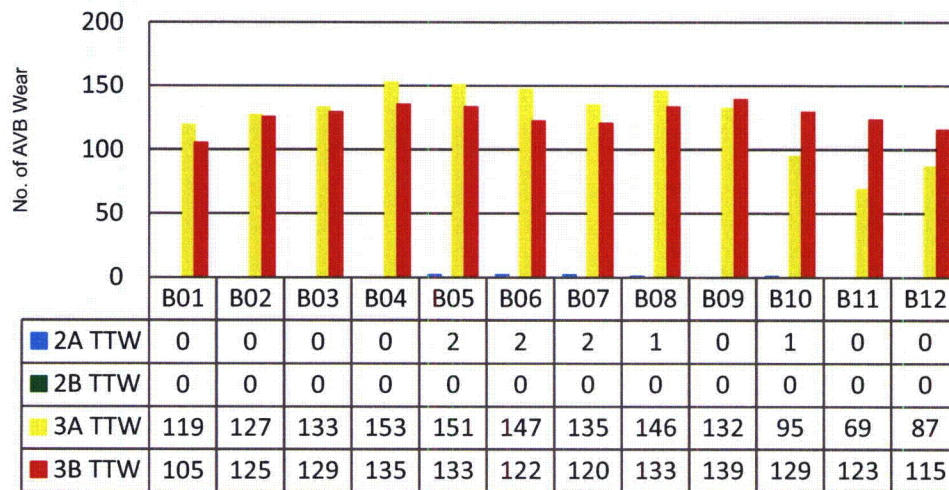
- 1) While the number of tubes with tube-to-AVB wear without in-plane TTW is greatest at the top of the tube bundle, the number of TTW tubes with tube-to-AVB wear is almost uniformly distributed along the different AVB intersections. (See Fig. 3.5-1.) If random vibration wear were a precursor for in-plane FEI TTW, then the pattern of AVB wear for TTW tubes should resemble the tube-to-AVB wear pattern (i.e. be concentrated at the top of the tube bundle). However, this is not observed for tubes with TTW.

Figure 3.5-1 AVB Tube Wear Number Comparison
