Combined Events A Systems Perspective

Patrick Regan

Federal Energy Regulatory Commission
Division of Dam Safety and Inspections

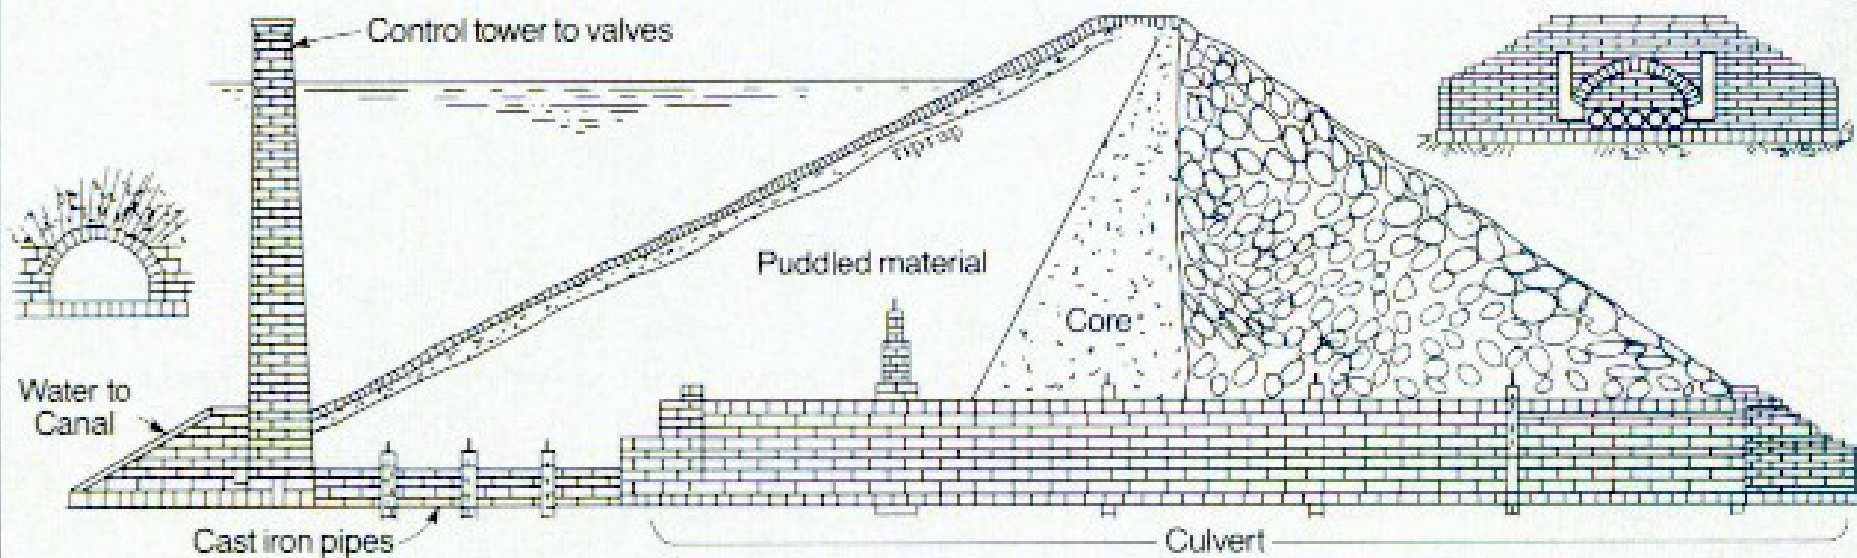
A schematic of the design for the Johnstown, Pa. South Fork Dam, circa 1840.

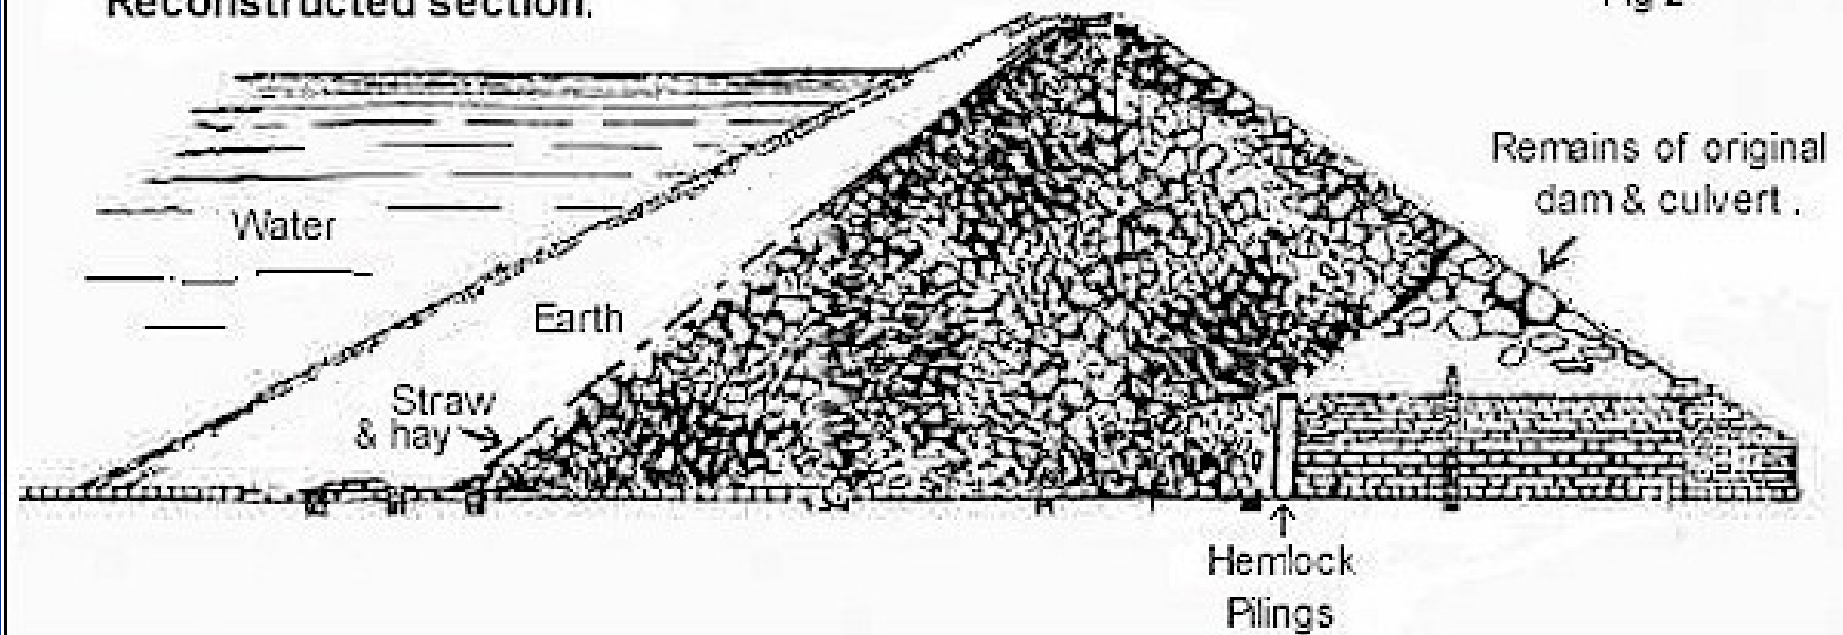
Fig 2

Reconstructed section.

Causes of Failure

Overtopped and Failed

- 2' crest lowering to allow carriages to pass
(spillway capacity reduced to ~72% of design)
- 3.5' settlement due to poor re-build
(spillway capacity reduced to ~35% of design)
- Fish screen constructed in front of spillway
(spillway capacity reduced to ~21% of design)

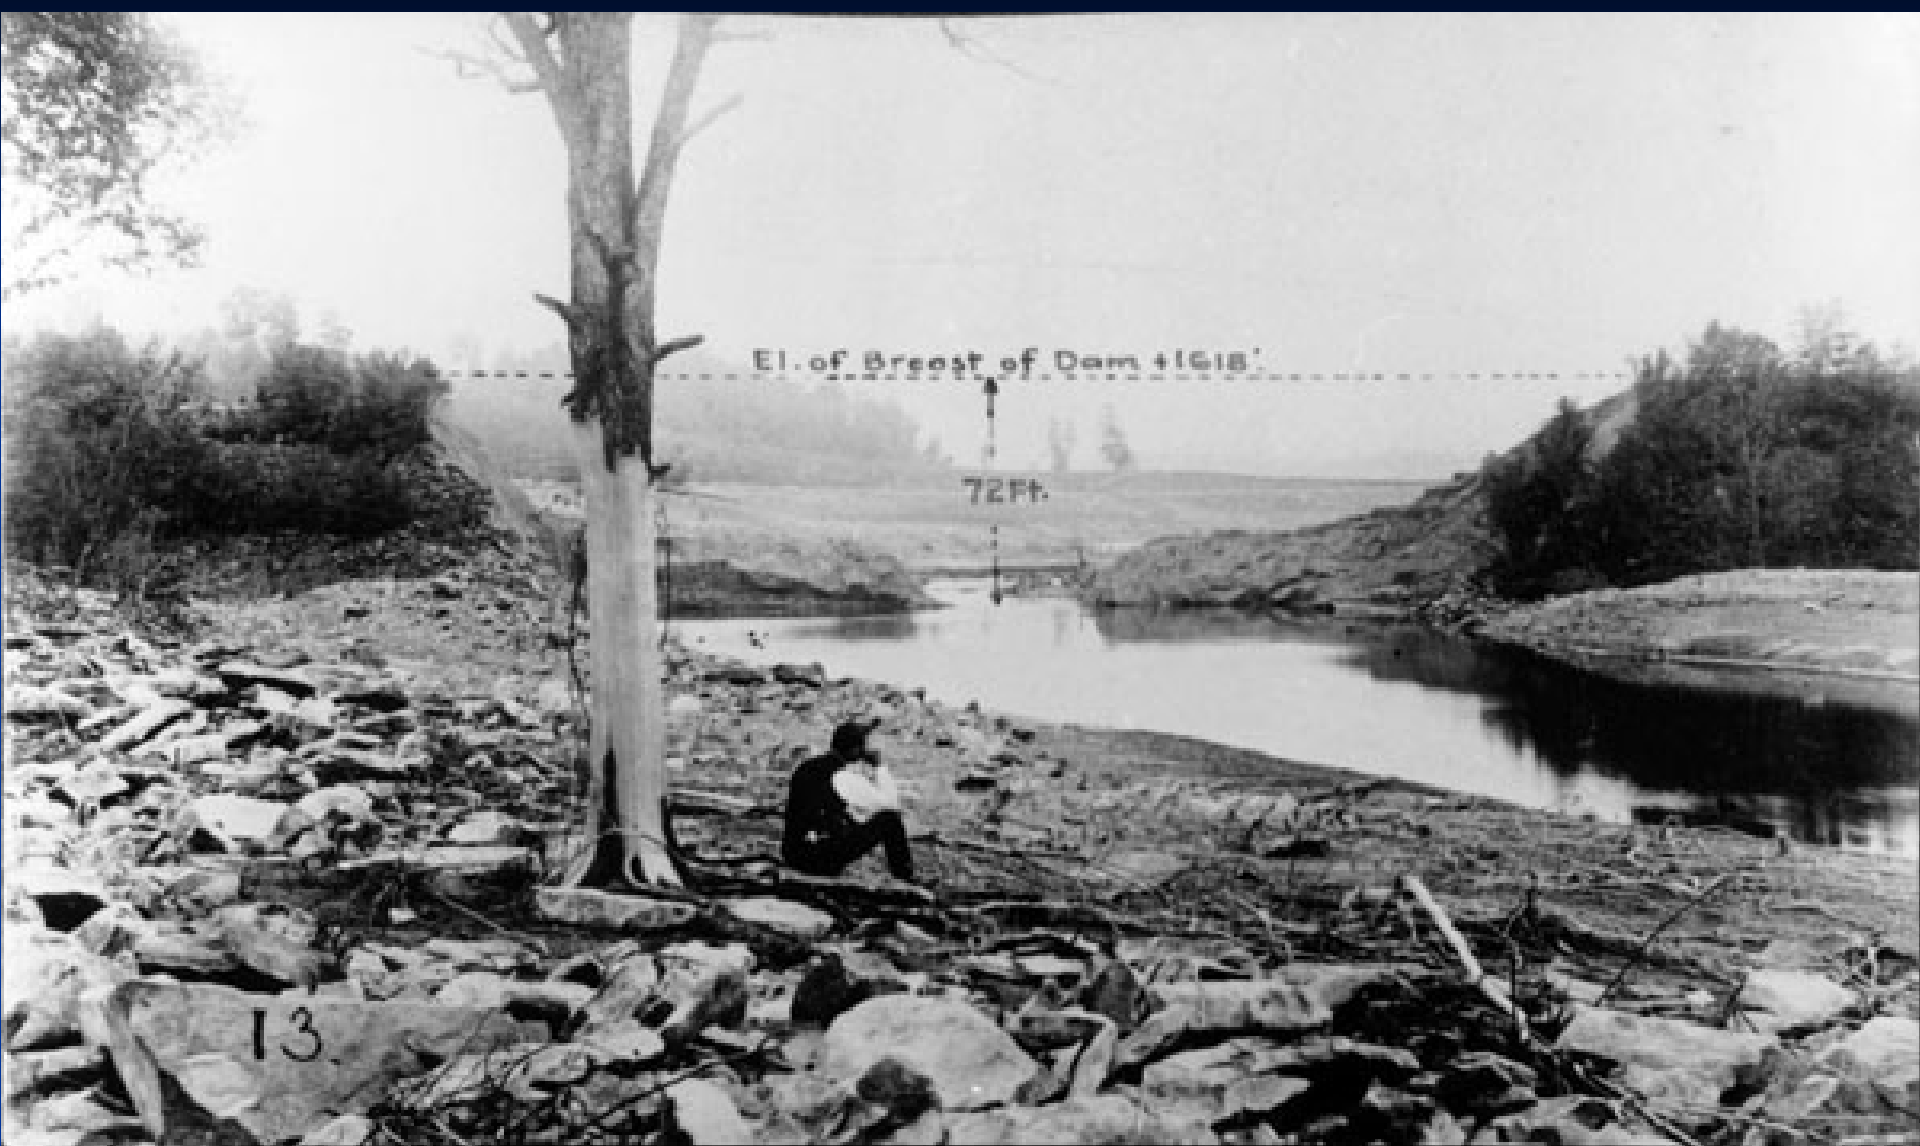
LOOKING EAST THROUGH BREAK IN DAM
