Progress Energy Carolinas
**Shearon Harris Nuclear Power Plant
Units 2 and 3**
Part 2, Final Safety Analysis Report
New Hill, North Carolina

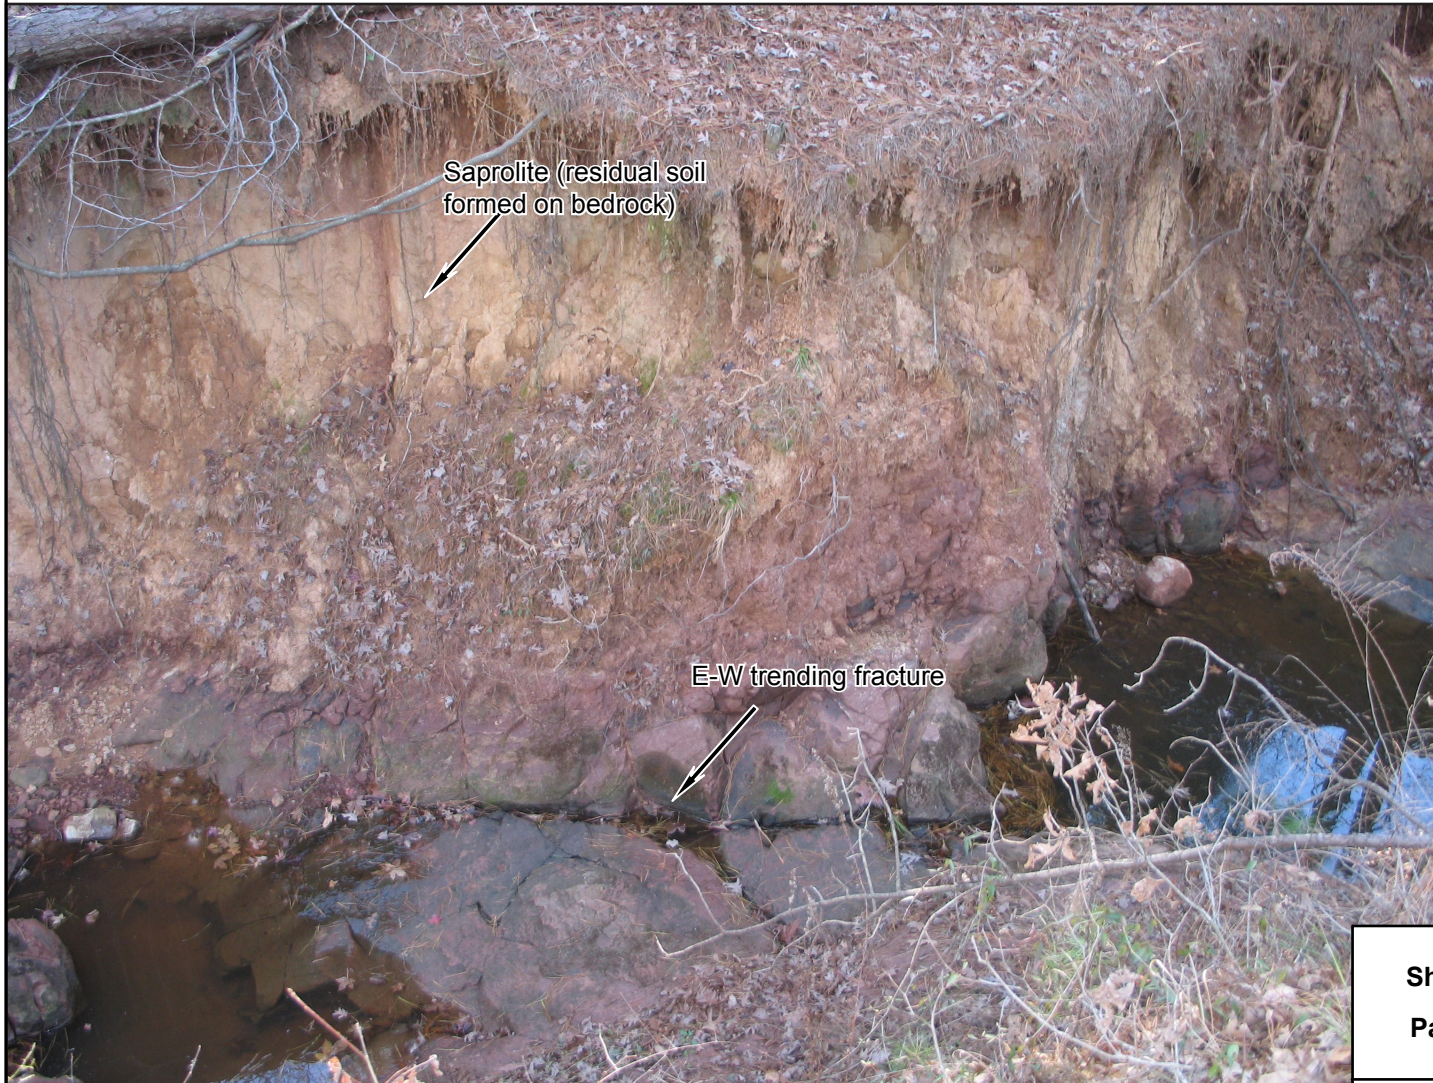
Photograph of E-W Trending Fracture
Exposed North of HAR 3
FIGURE 2.5.3-209
