REPORT ON LIMITED APPEARANCE OF MR. D. W. PHIFER  
AND ALLEGED GEOLOGIC FEATURES,  
CAMP PENDLETON, CALIFORNIA  
JULY 29, 1981

SOUTHERN CALIFORNIA EDISON COMPANY AND  
SAN DIEGO GAS AND ELECTRIC COMPANY

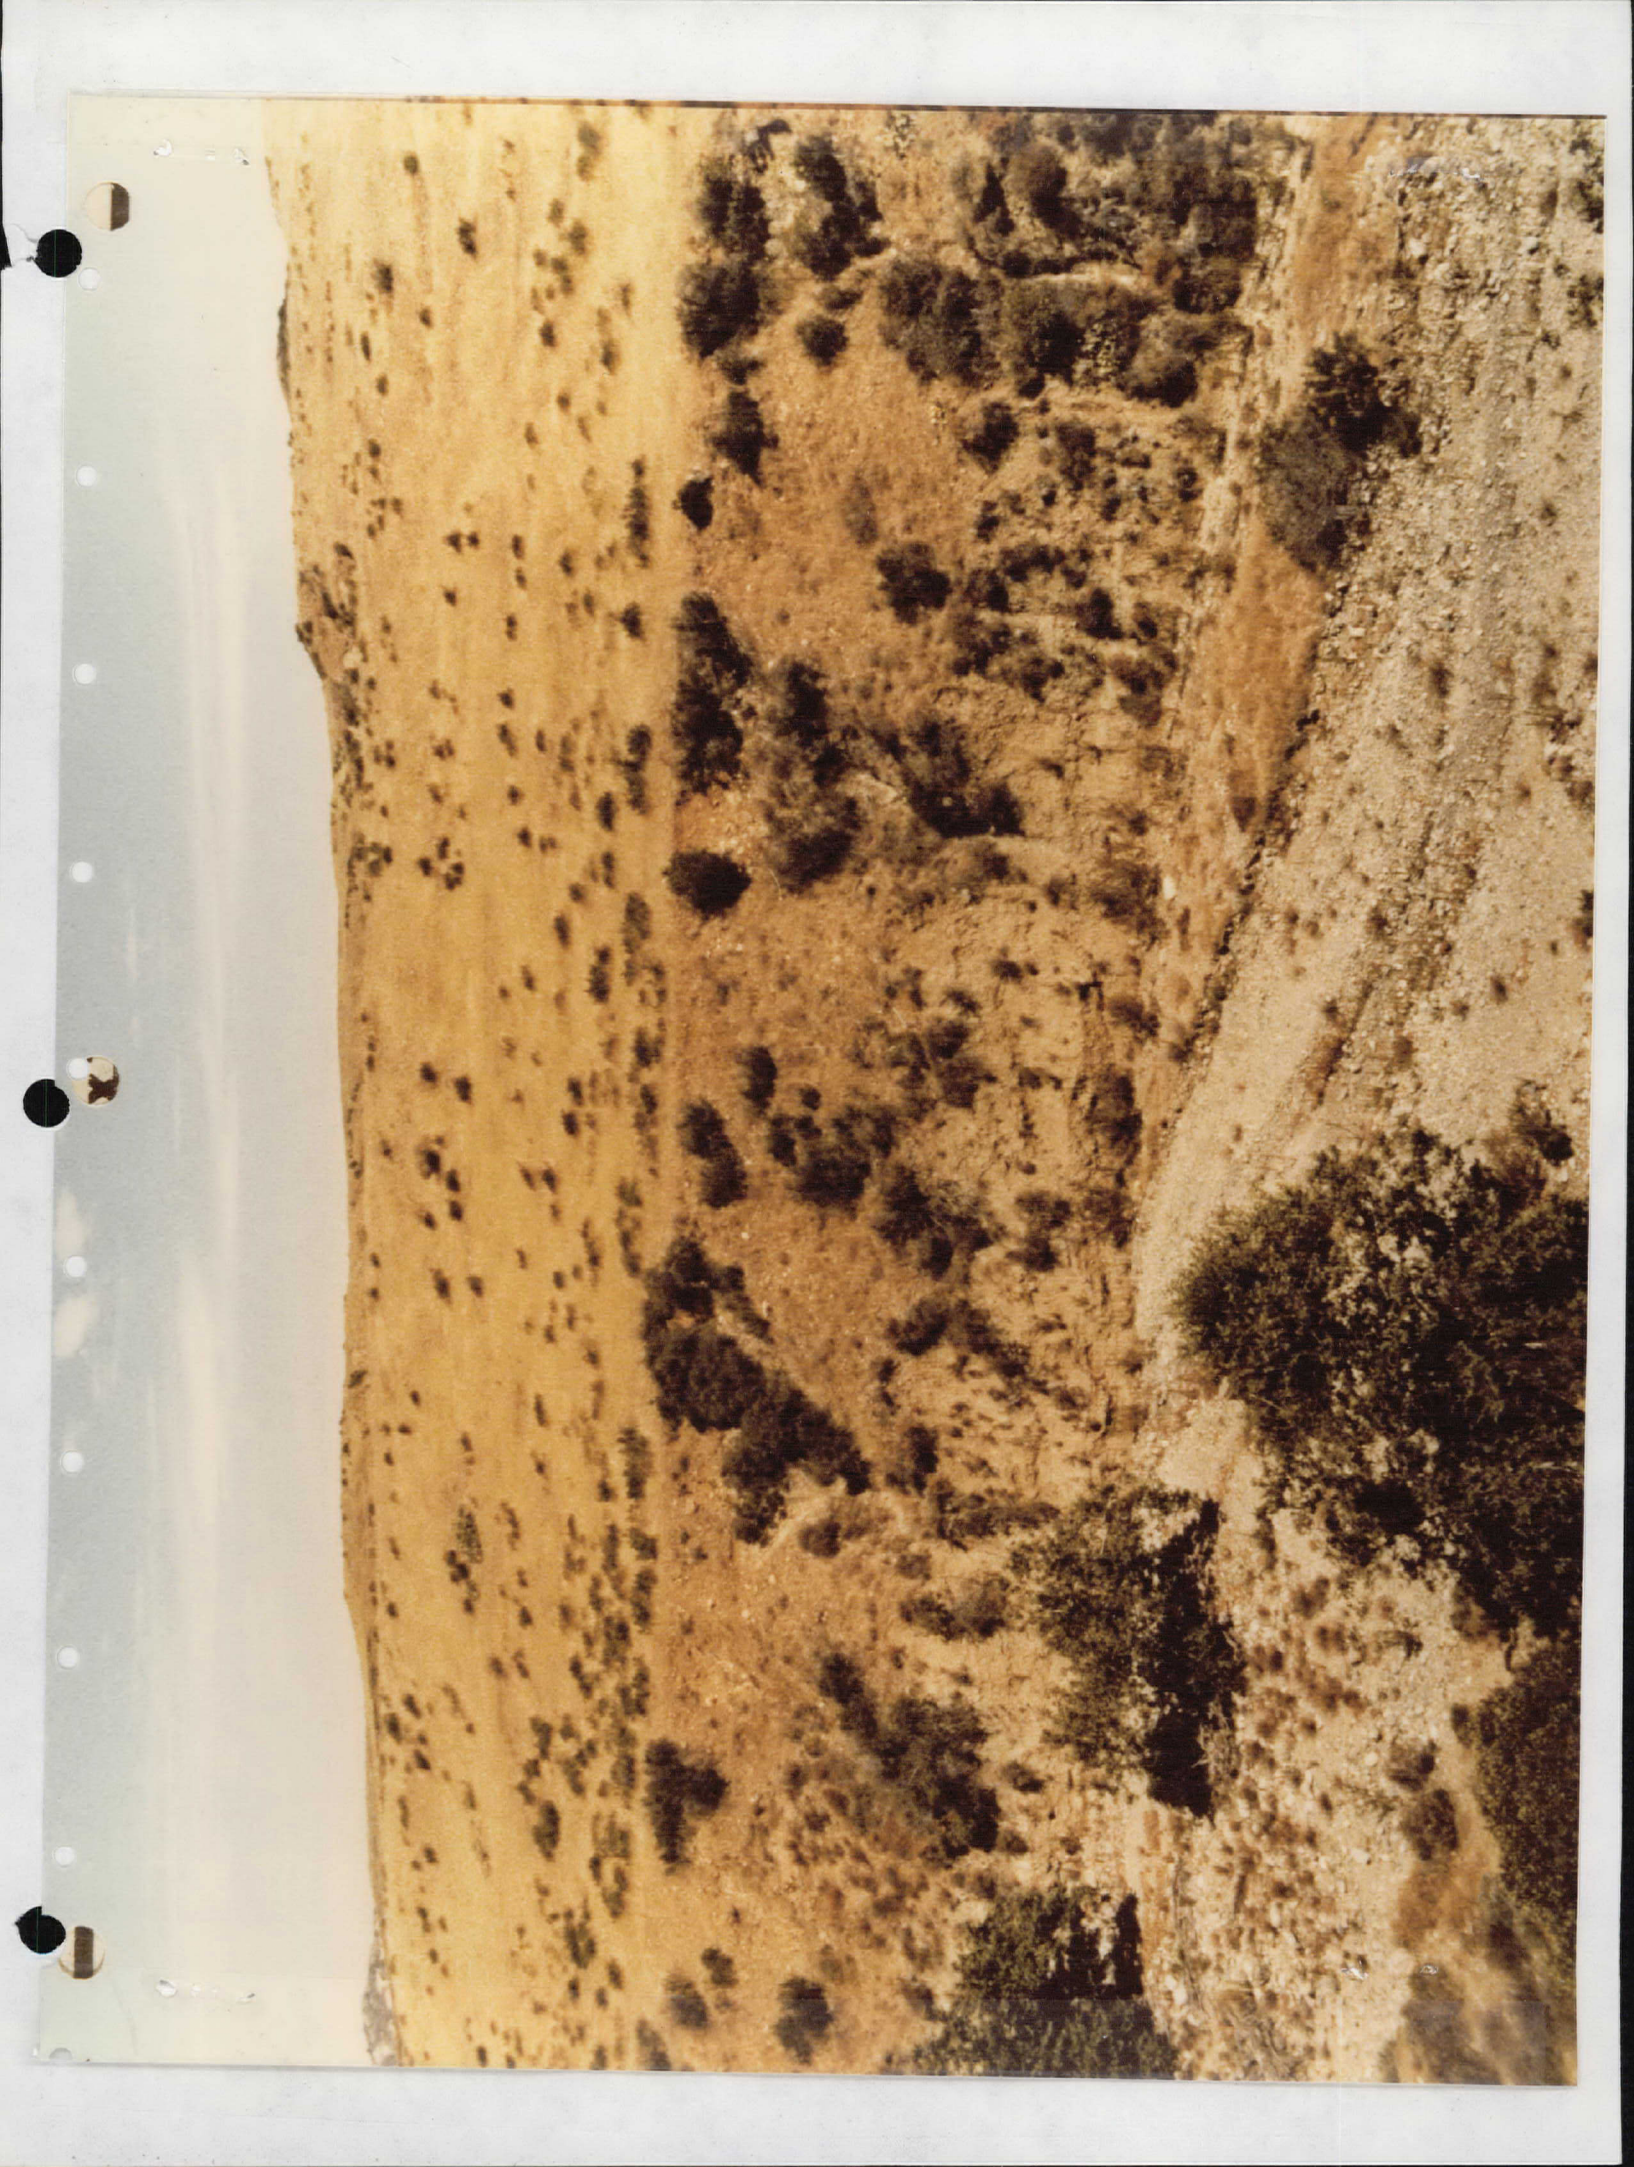
Terrace Deposits, San Onofre Canyon

Terrace deposits, approximately 20-25 feet thick on north bank of San Onofre Canyon (NW 1/4, sec. 13, T. 9 S., R. 6 W.). Lowest terrace, approximately 60 feet above floodplain, bears an old, strongly developed soil (red area). This and higher (older) terraces cross unbroken over Mr. Phifer's inferred "Horno Summit fault" approximately 0.6 miles downstream (left).

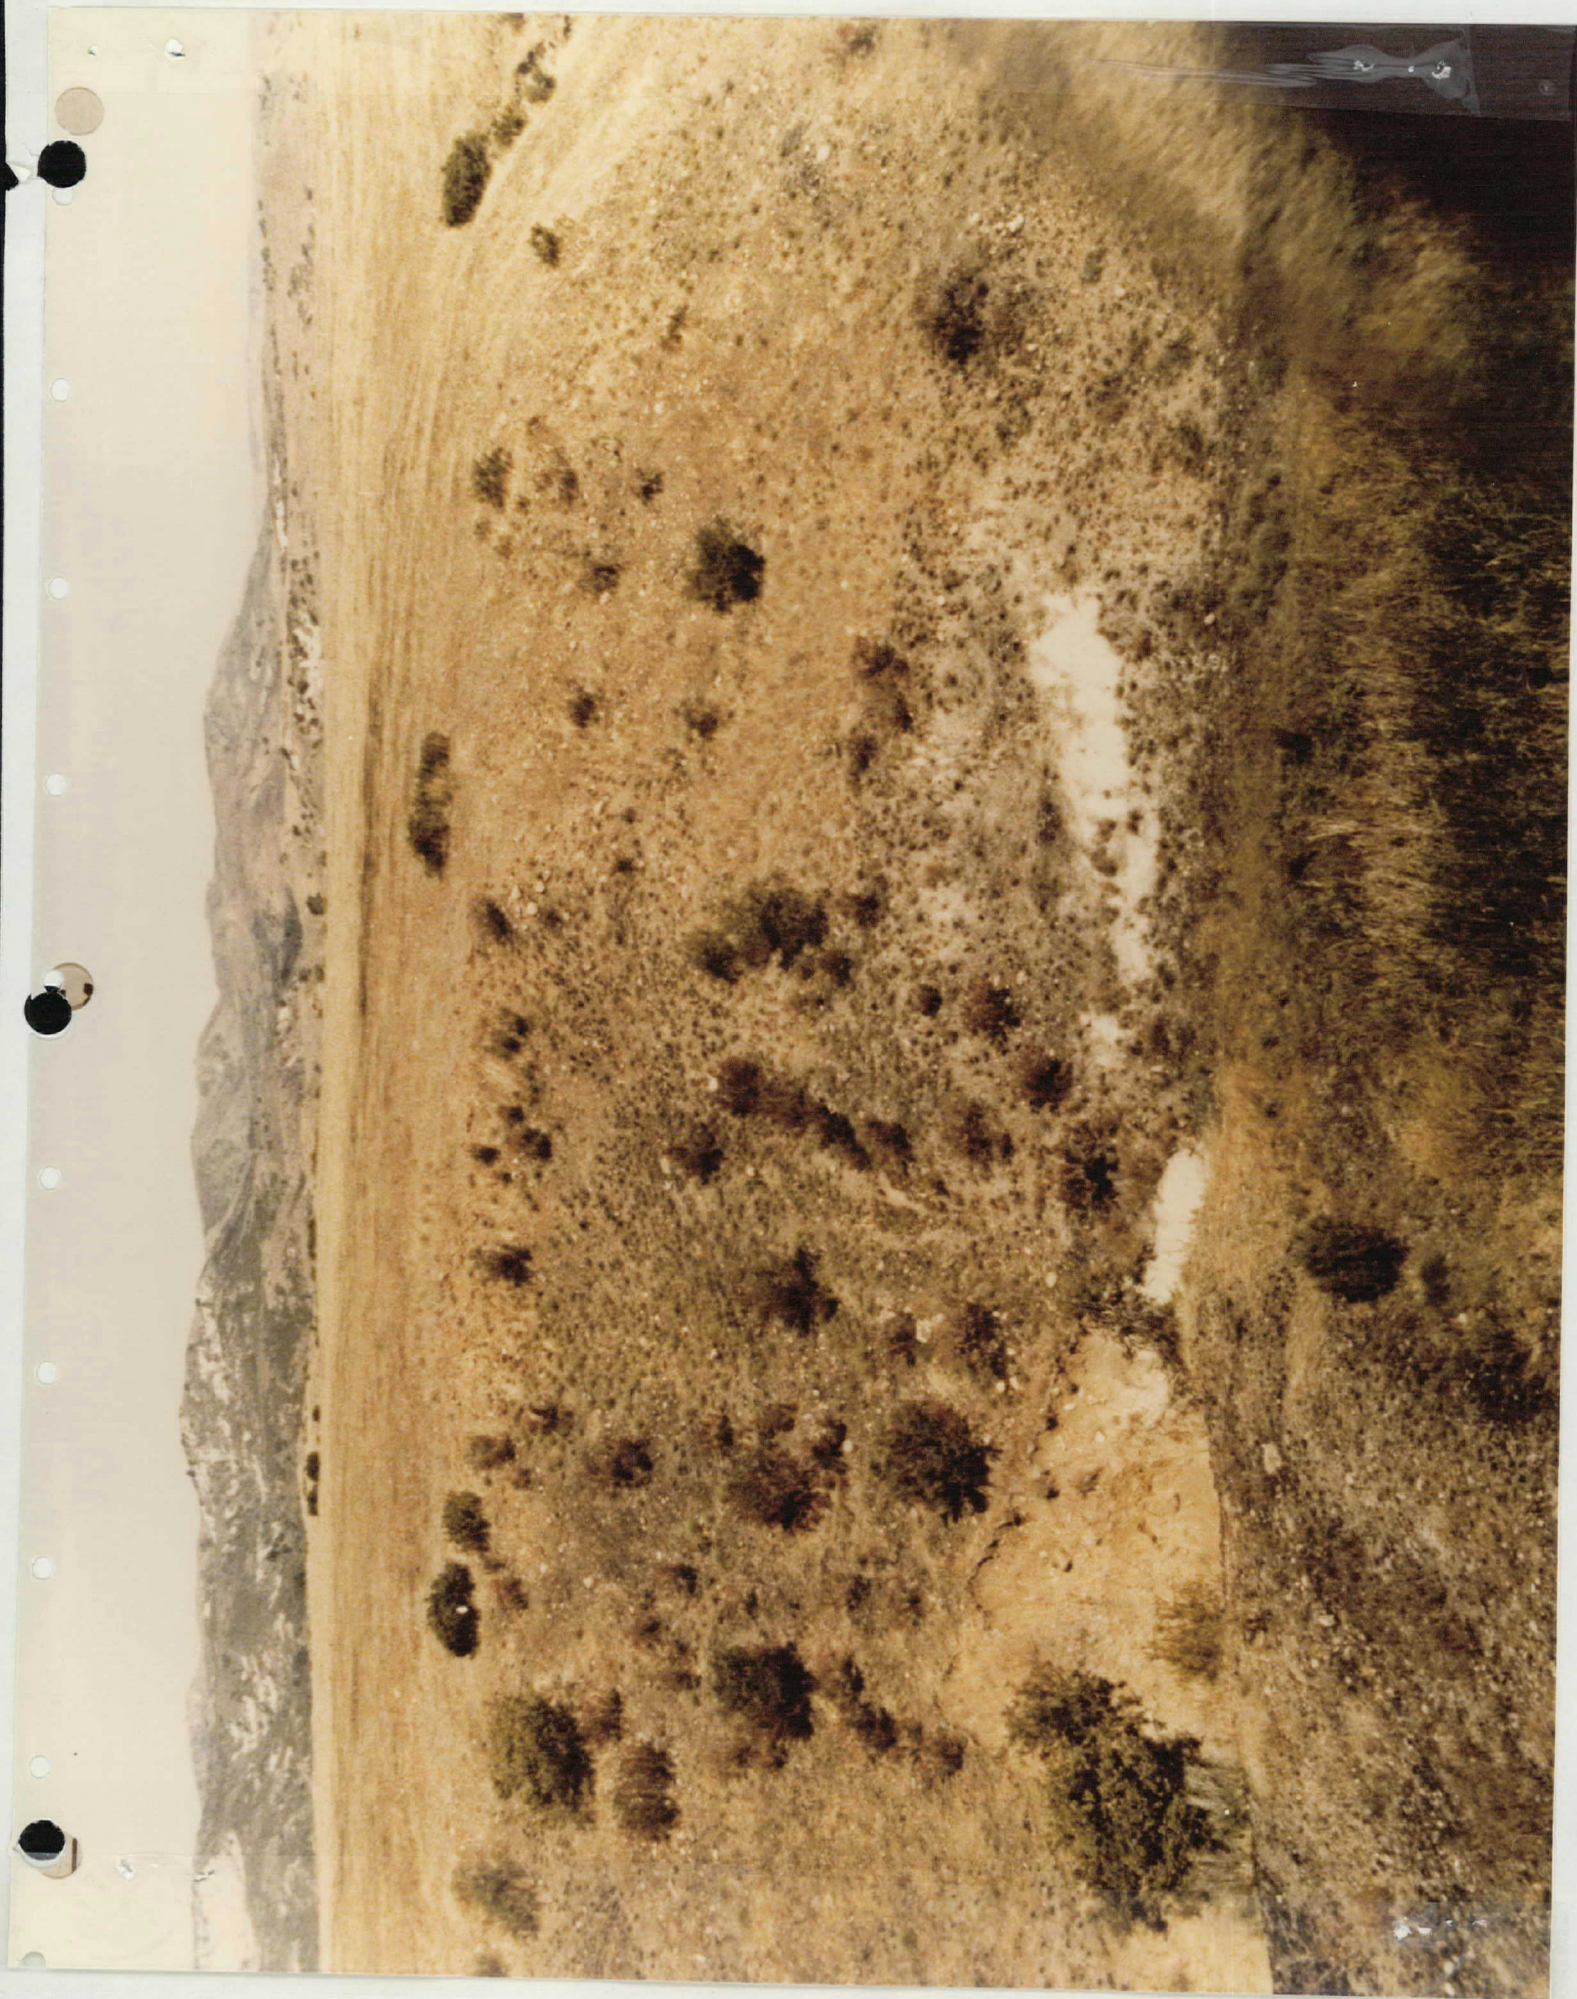
FIGURE 4

Fault in San Onofre Creek Terrace Area

Faulting northward from Rifle Range 214 exposed in gully cut through overlying river terrace sediments. Note continuous terrace surface across fault trace.

About 3 miles southeast of San Mateo Canyon the inferred fault would project through a flight of five distinct river terraces on the north side of San Onofre Canyon ("middle fork") (Fig. 2, secs. 14 and 15, T. 9 S., R. 6 W.; Moyle, 1973). The three higher terraces are locally eroded and do not extend sufficiently "downstream" for correlation across the inferred fault. However, the lower two terraces are continuous and unbroken where crossing its inferred trend and a small fault exposed in the bottom of a deep gully (Figs. 2 and 4).

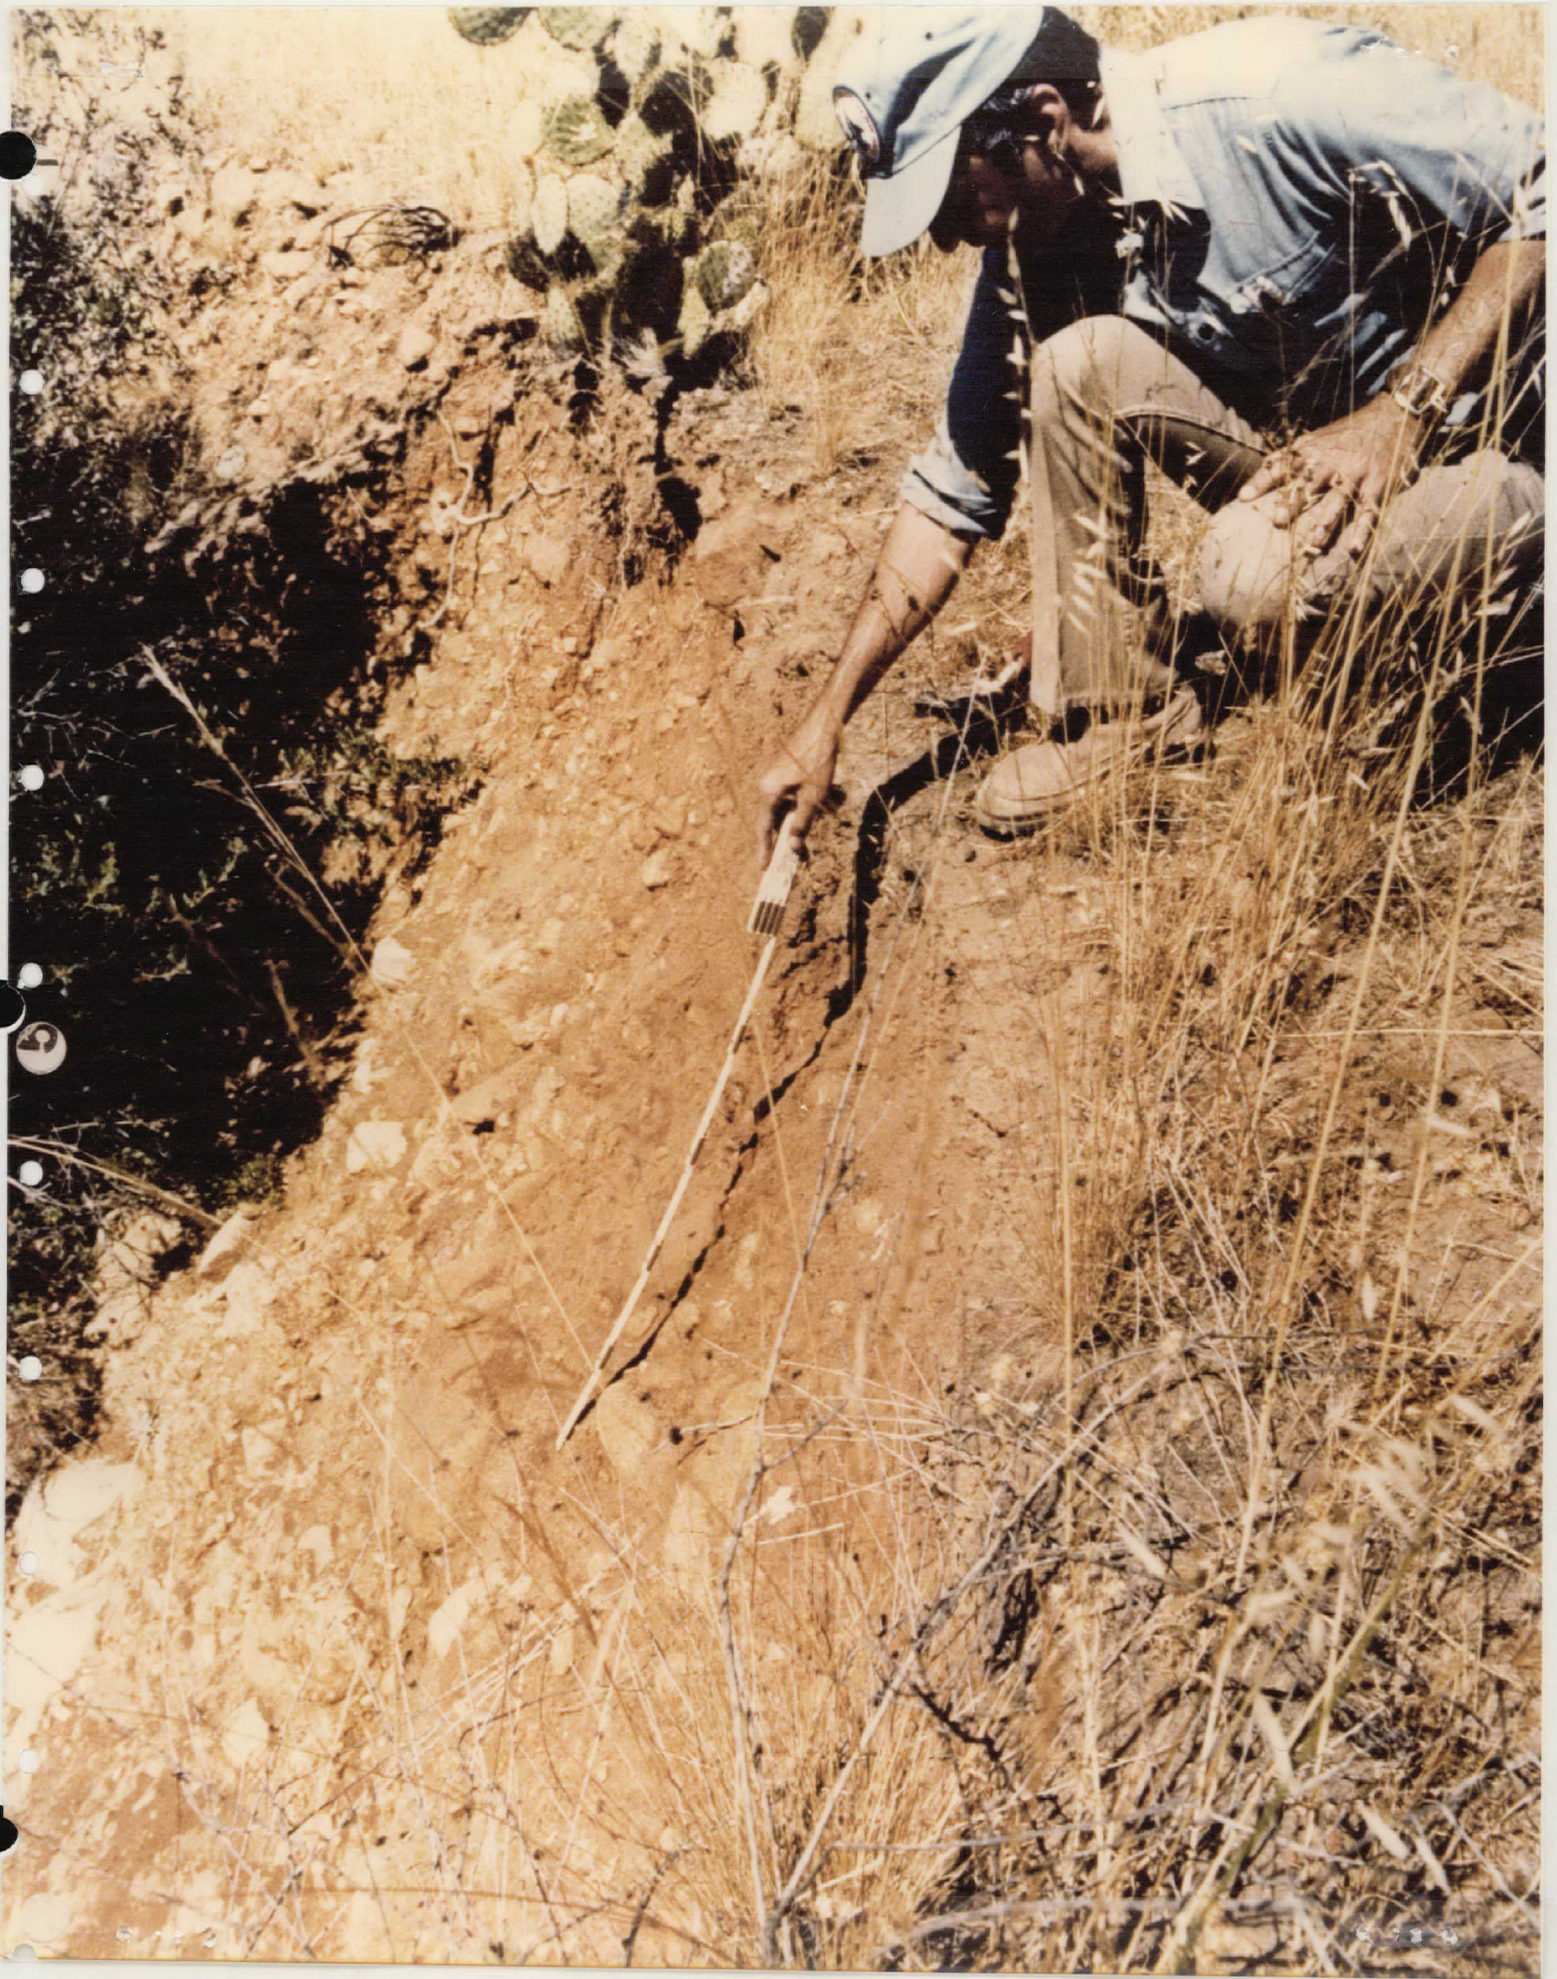
FIGURE 5

Terrace Fill, North Bank San Onofre Canyon

Strongly developed, dark red (2.5YR 4/6-3/4) soil approximately five feet thick forming on lowest terrace fill, north bank San Onofre Canyon. Soil is at least 35,000 to 40,000 years old; underlying terrace fill is older (NE 1/4, sec. 13, T. 9 S., R. 6 W.).

A more accurate age estimate for the lowest terrace is afforded by the relative development of soil profiles. As shown in Fig. 5, the lowest terrace bears a strongly-developed soil about 5 feet thick. Particularly diagnostic of age are the dark red color (2.5YR 4/6-3/4), coarse angular blocky structure, and moderately-thick, continuous illuvial clay films on ped faces (Fig. 7). Compared with soils dated near San Onofre and elsewhere in mediterranean climatic regimes of California (Shlemon, 1978) this lowest terrace profile is judged to be at least 35,000 to 40,000 years old (stage 3).

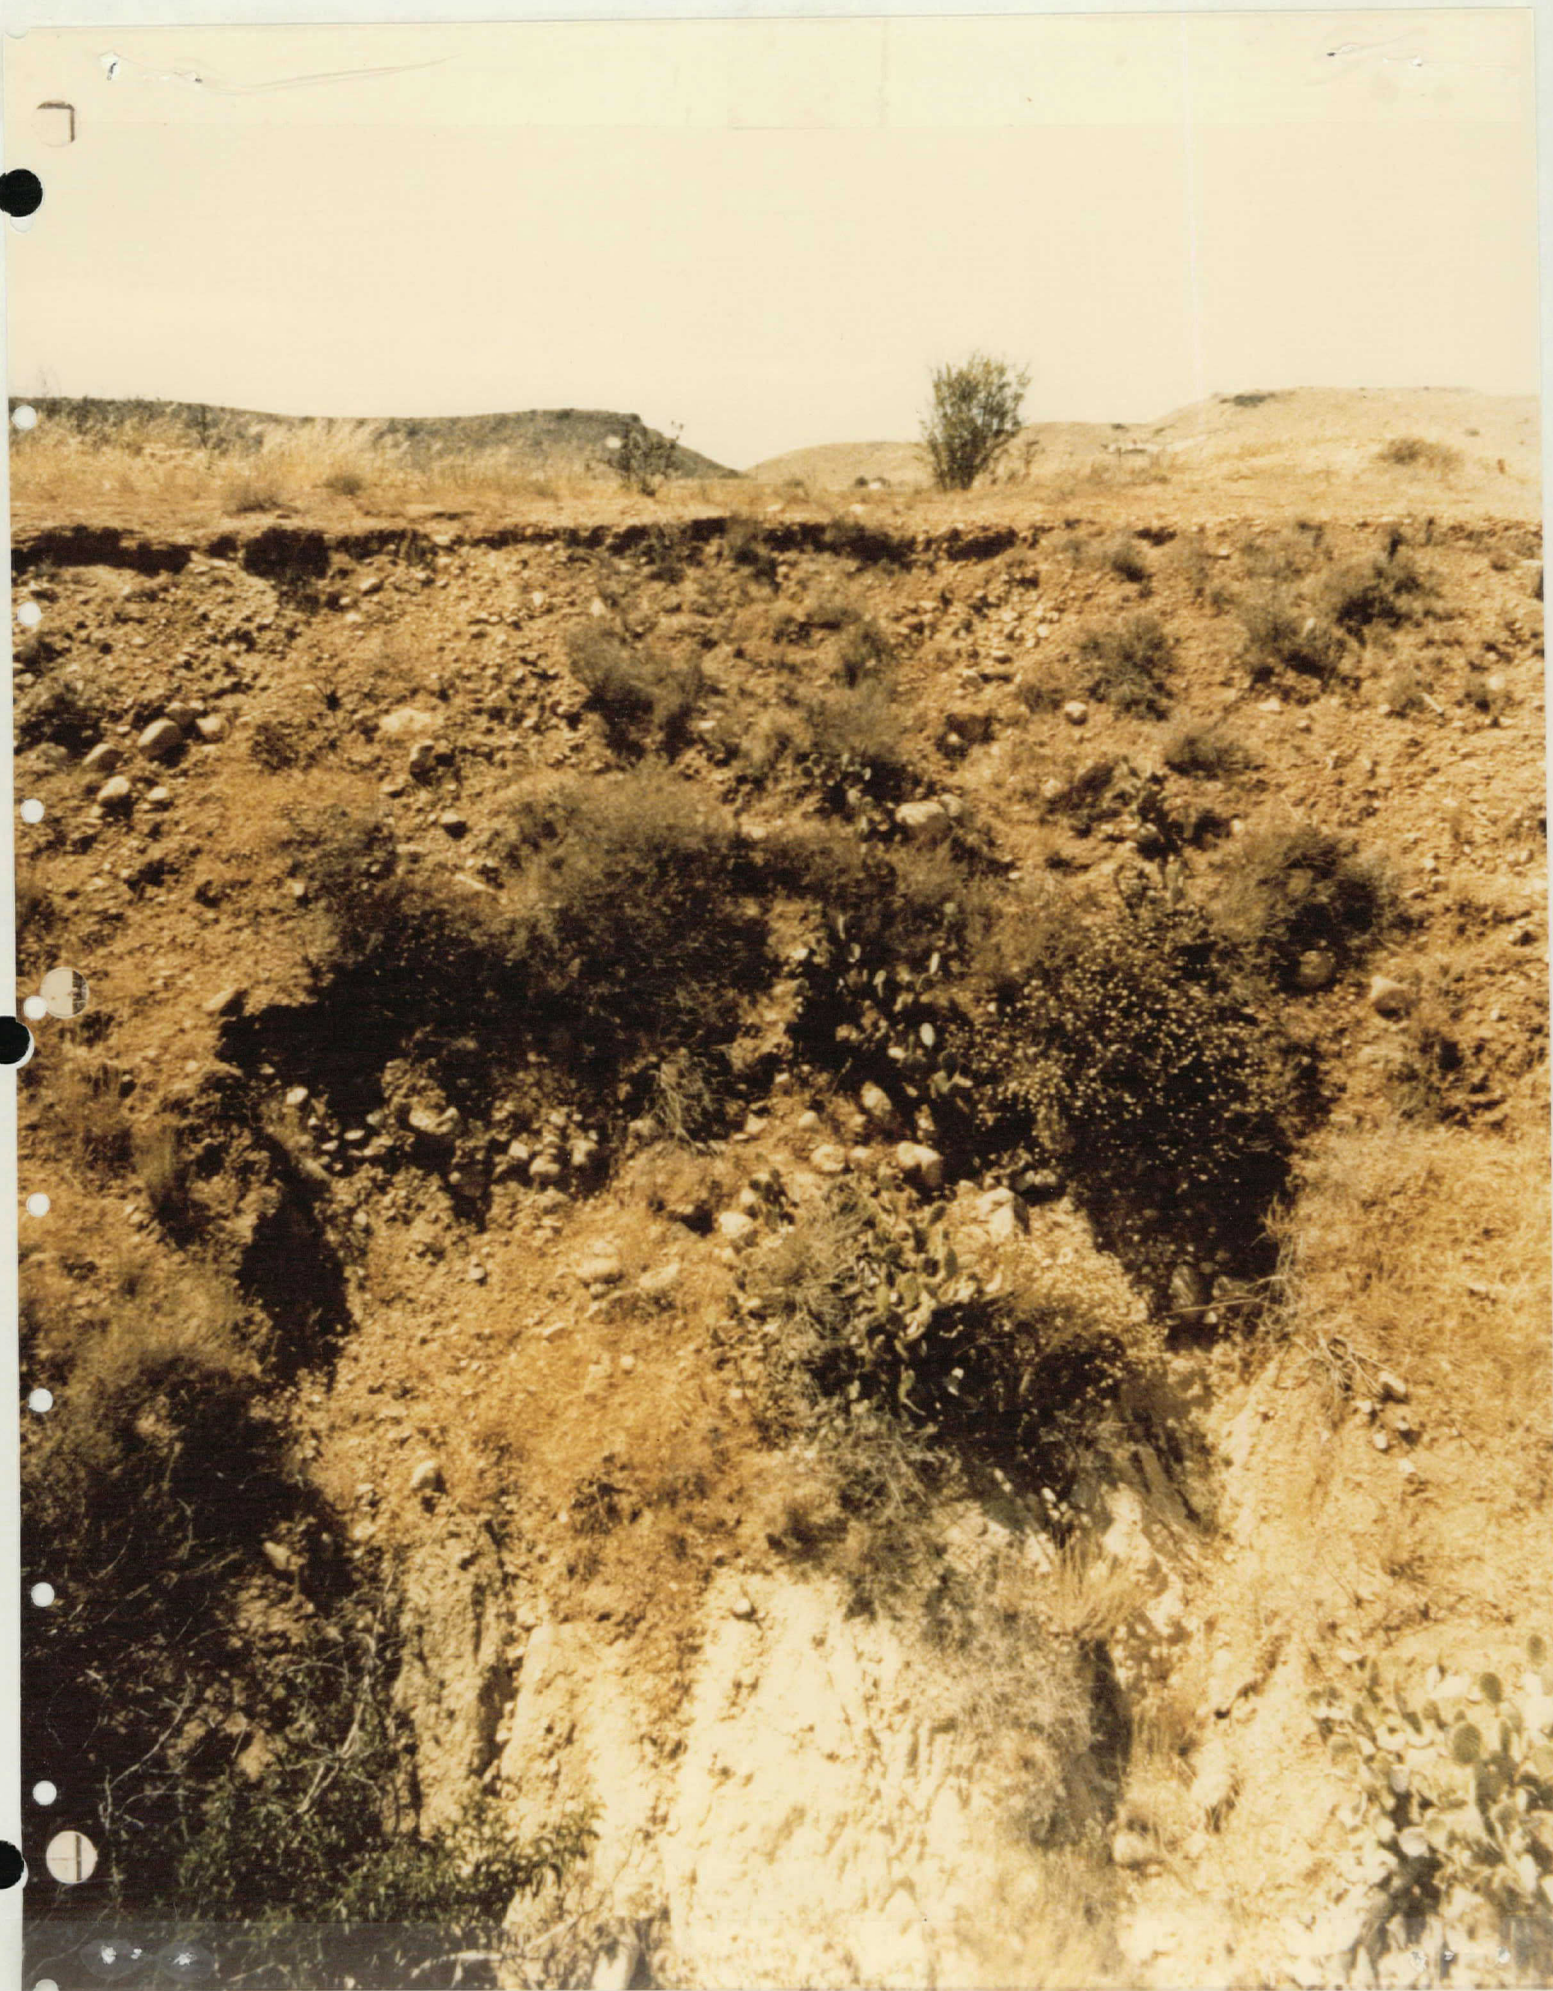
FIGURE 6

Strongly Developed Soil, San Mateo Canyon

Strongly developed soil on 15-20 ft-thick fluvial terrace fill near Range 313, northwest side of San Mateo Canyon. This terrace, at least 100,000 years old, is unbroken where projected across the trace of Mr. Phifer's inferred "Horno Summit fault." Projections of elevations across remnants of three older (higher) terraces also indicates no measurable tectonic displacement.

The third highest San Mateo Creek terrace, approximately 100 feet above the floodplain, bears a very strongly-developed relict paleosol (Fig. 6). Some five feet of the B<sub>2</sub>t (argillic) and B<sub>3</sub> horizons are still preserved in a roadcut near

Firing Range 313 (NE 1/4, sec. 5, T. 9 S., R. 6 W.). The antiquity of the soil is indicated by its dark red (2.5YR 3/4) subsoil (B<sub>3</sub>) and the moderately-thick, continuous illuvial clay films on ped faces. From comparison with soils of similar development dated elsewhere in California, this terrace profile is judged to be at least 100,000 years old (isotope stage 5). The underlying terrace fill is therefore deemed to be in the order of about 125,000 to 180,000 years old (stage 6).

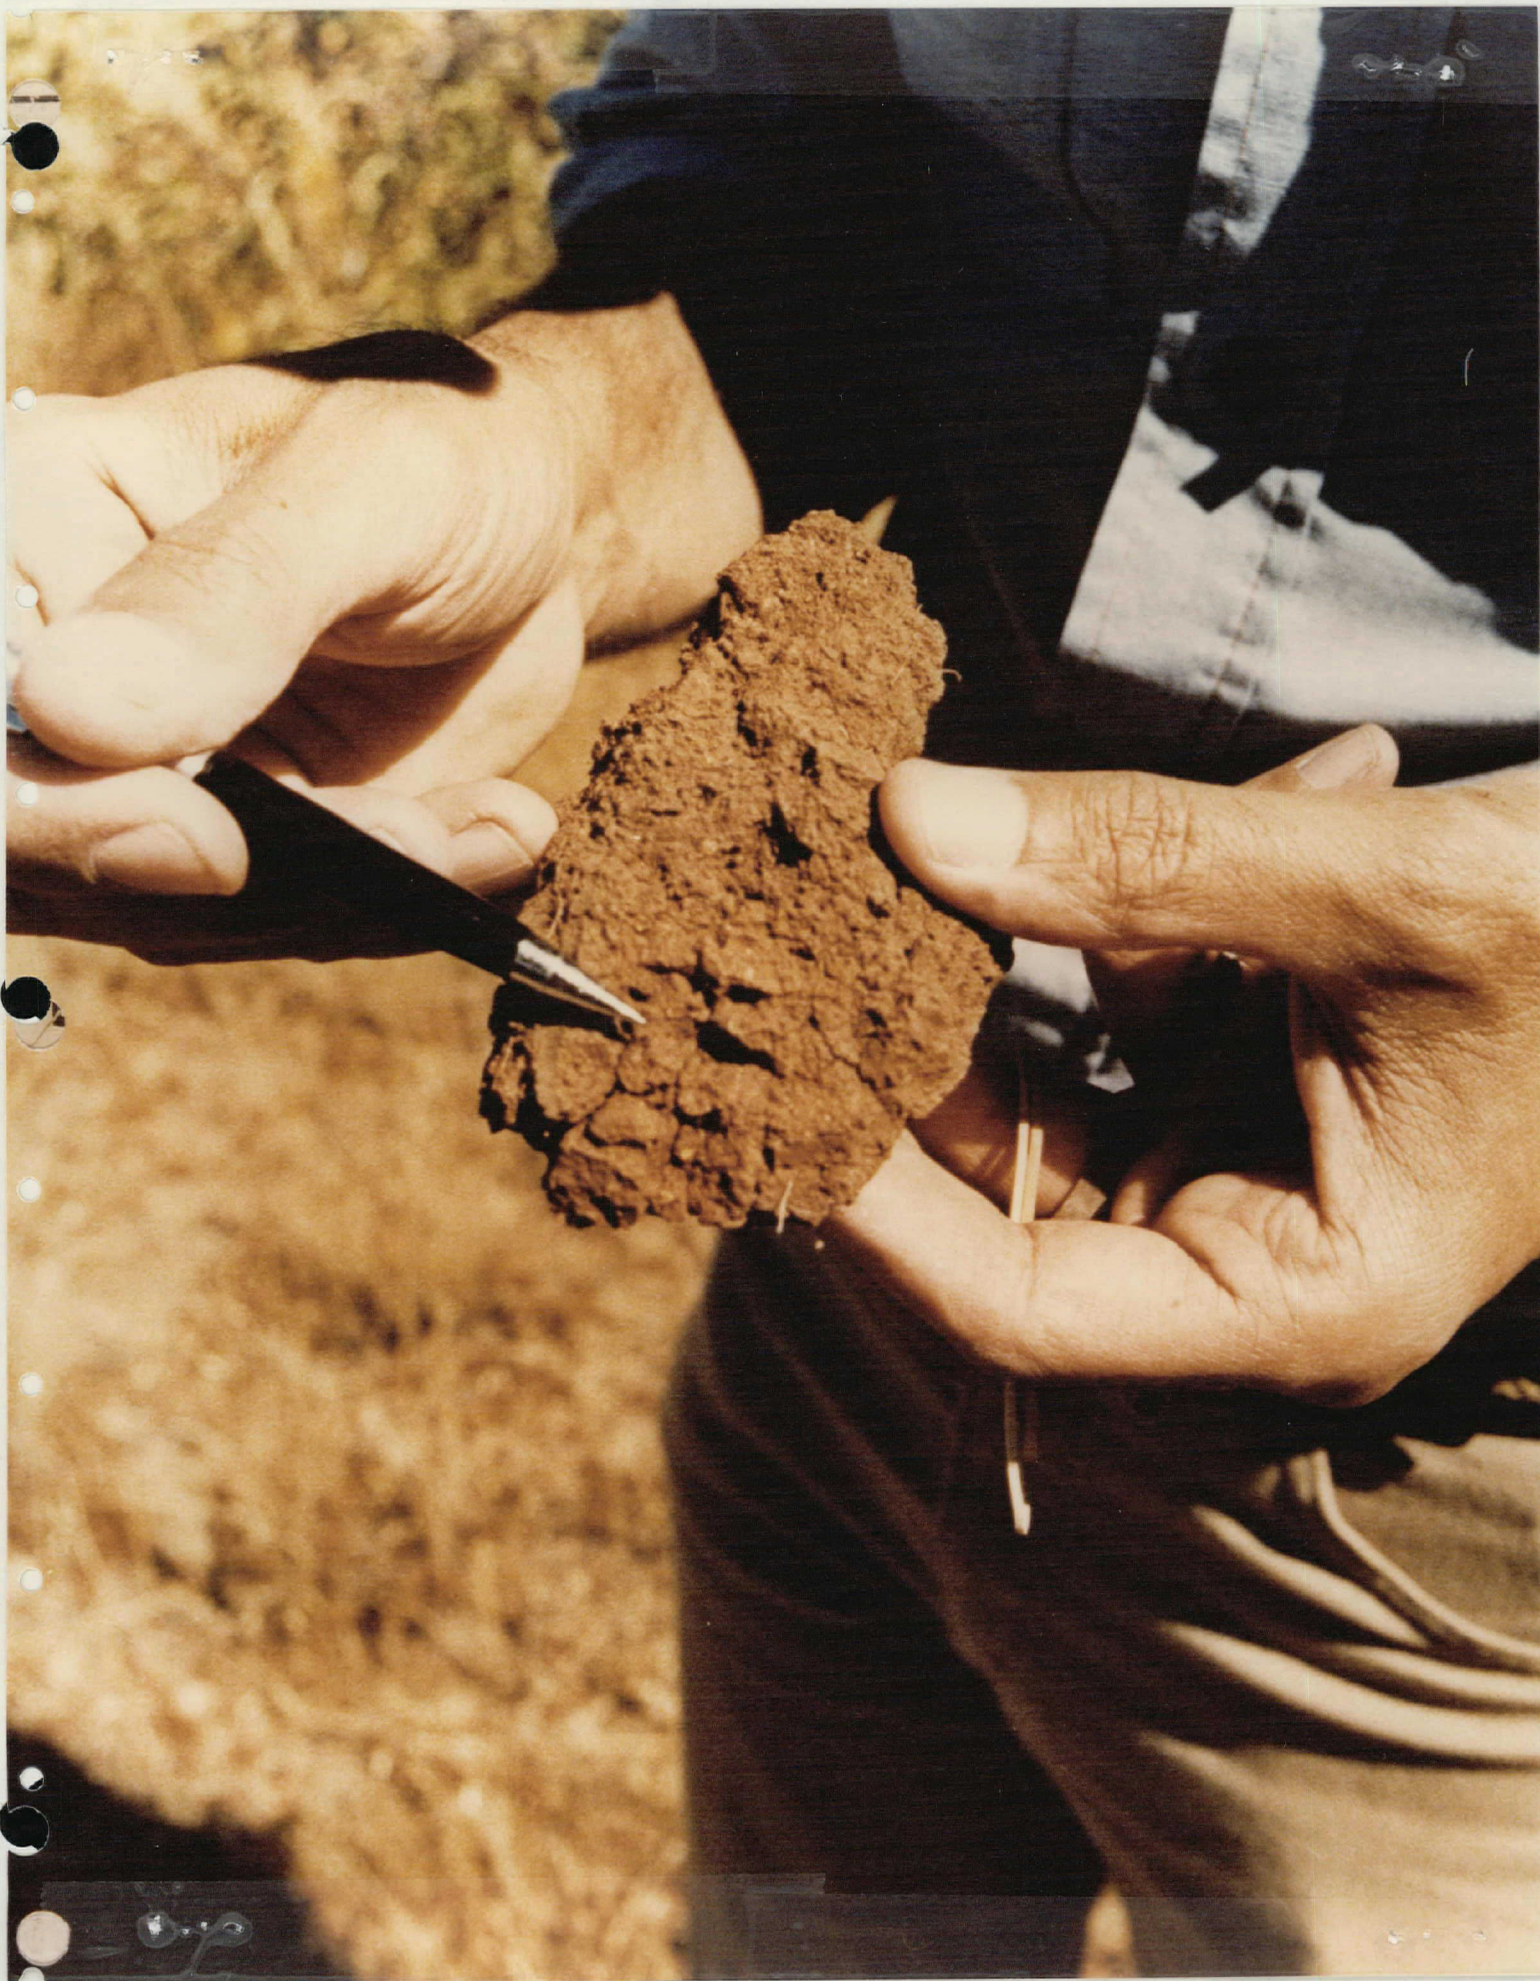
FIGURE 7

Angular-Blocky Ped

Strong, coarse angular-blocky ped from argillic (B2t) horizon of soil on lowest terrace crossing Mr. Phifer's inferred "Horno Summit fault," north bank San Onofre Canyon. Approximately 70 percent of ped faces are coated by moderately thick and continuous illuvial clay (cutans) attesting to antiquity of the weathering profile.

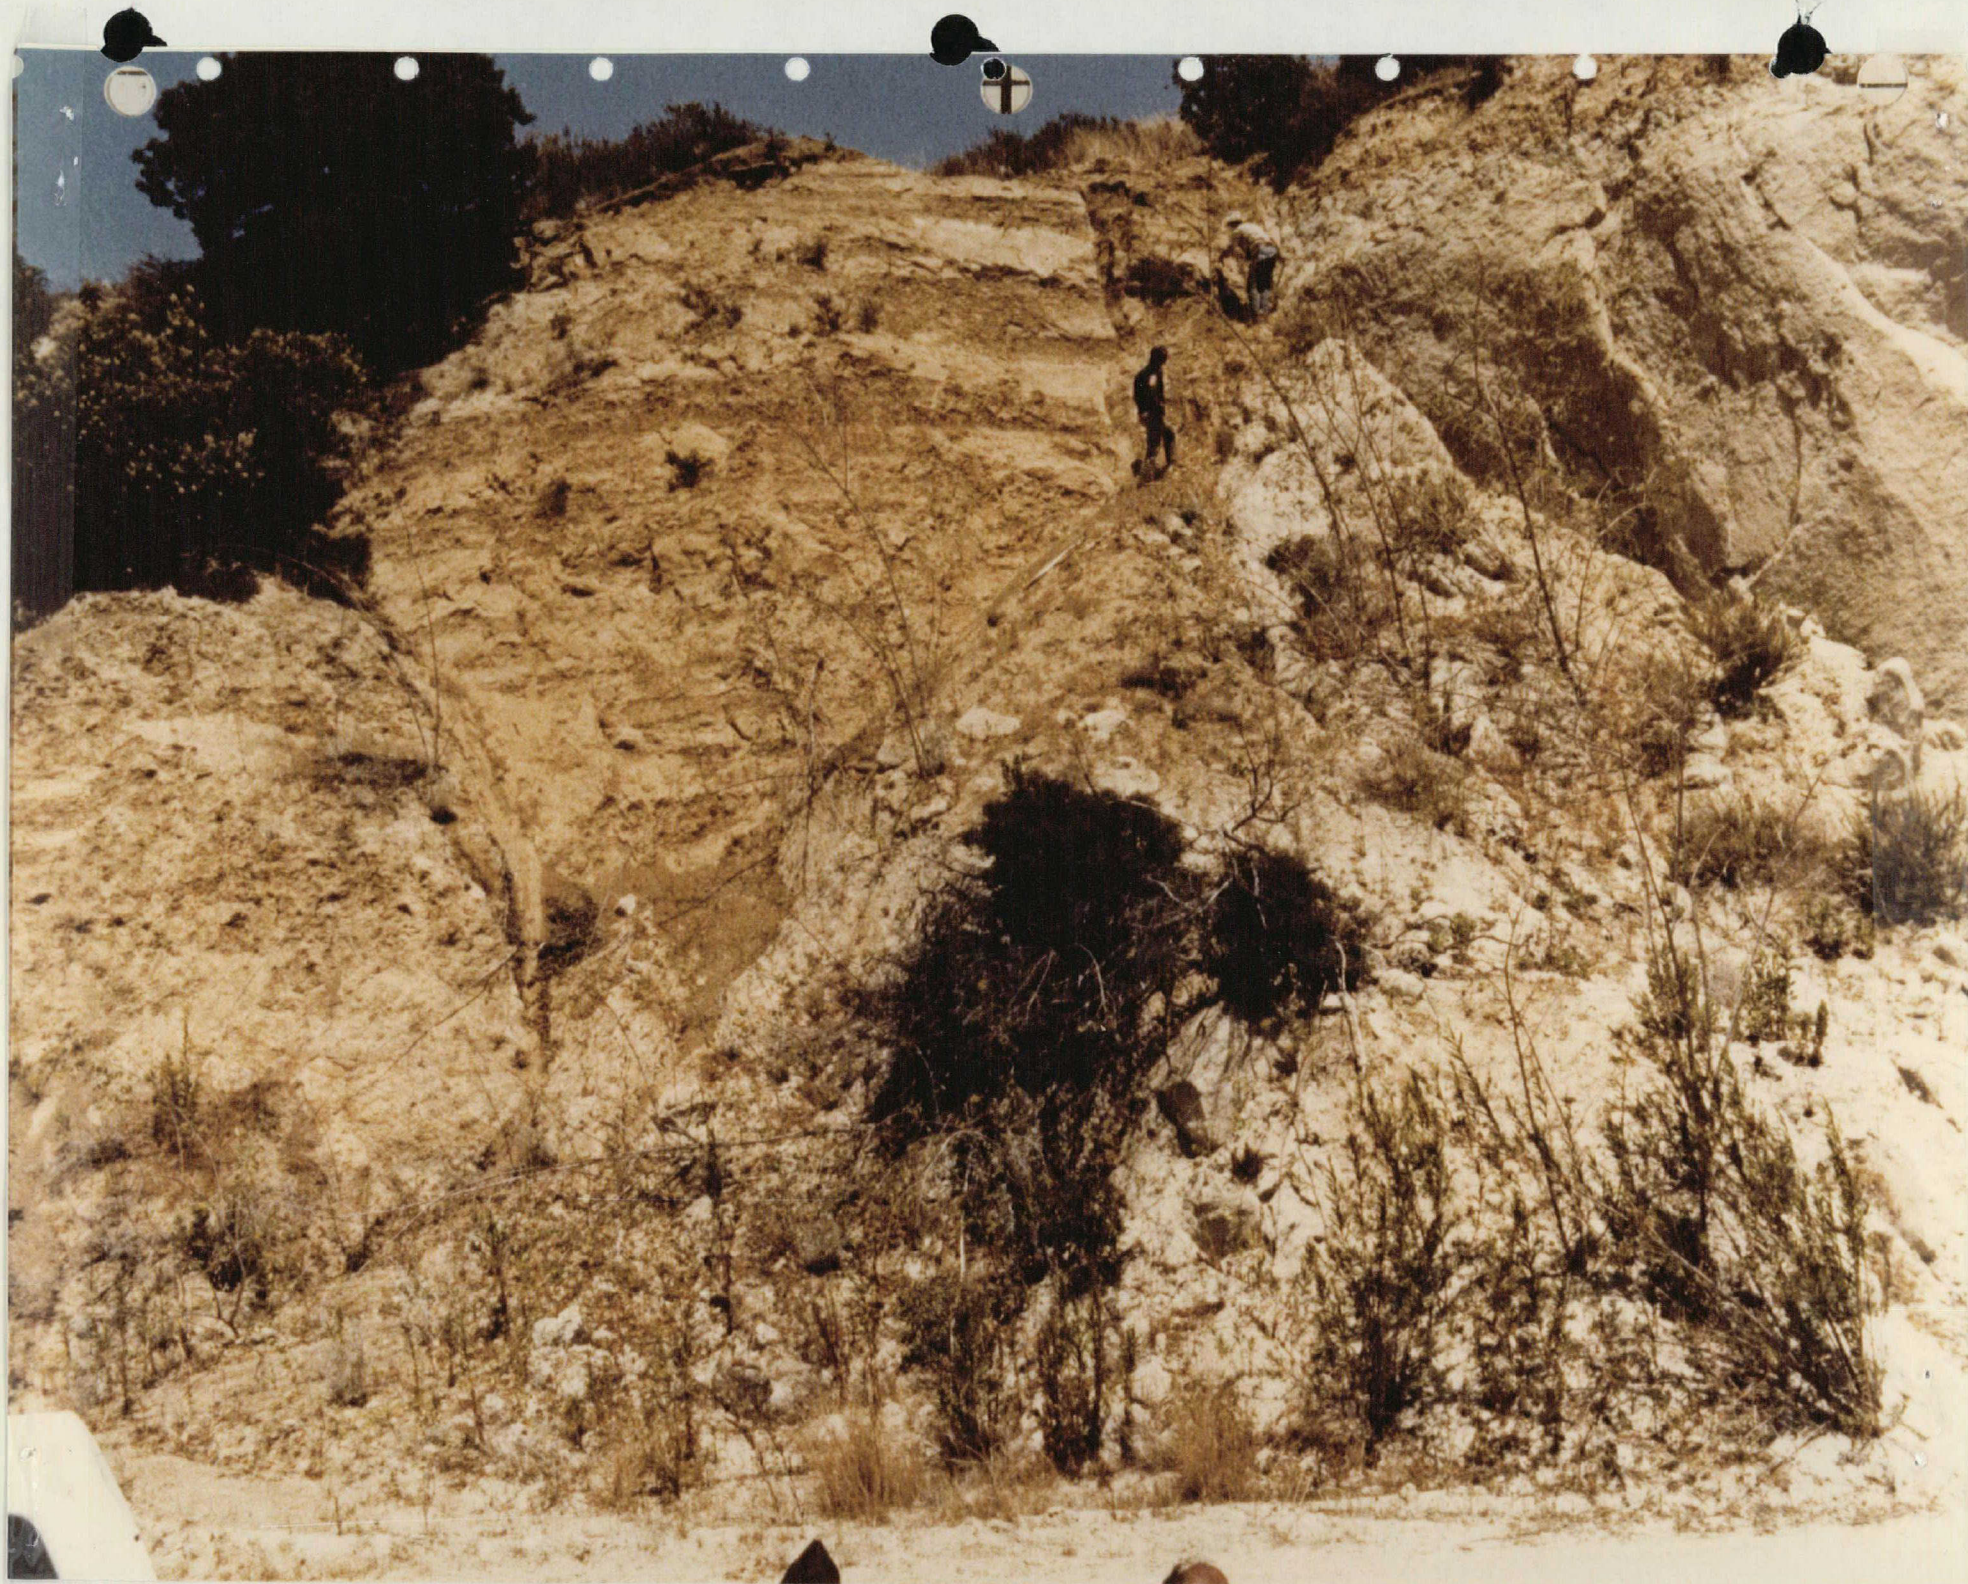
FIGURE 9

Faulting in Rifle Range 214.

At Rifle Range 214 the fault exposed in the cut at the northeast corner of the range strikes between N45W and N50W and dips 65 to 70 degrees to the southwest (Fig. 8). The fault is marked by about an inch of gouge. Slickensides are oriented in various directions but the most prominent ones trend down dip. Strata on the northeast side of the fault consist of interbedded sandstone and mudstone with most beds 1 to 3 feet thick. The sandstone beds are normally graded with coarse sand at the base and finer sand at the top. Exposures on the southwest side of the fault consist of coarse-grained cross-bedded sandstone mainly composed of quartz with some feldspar grains and granitic granules and pebbles. The exposed stratigraphic separation across the fault is about 30 feet (Fig. 9).
