REPORT ON LIMITED APPEARANCE OF MR. D. W. PHIFER  
AND ALLEGED GEOLOGIC FEATURES,  
CAMP PENDLETON, CALIFORNIA  
JULY 29, 1981

SOUTHERN CALIFORNIA EDISON COMPANY AND  
SAN DIEGO GAS AND ELECTRIC COMPANY

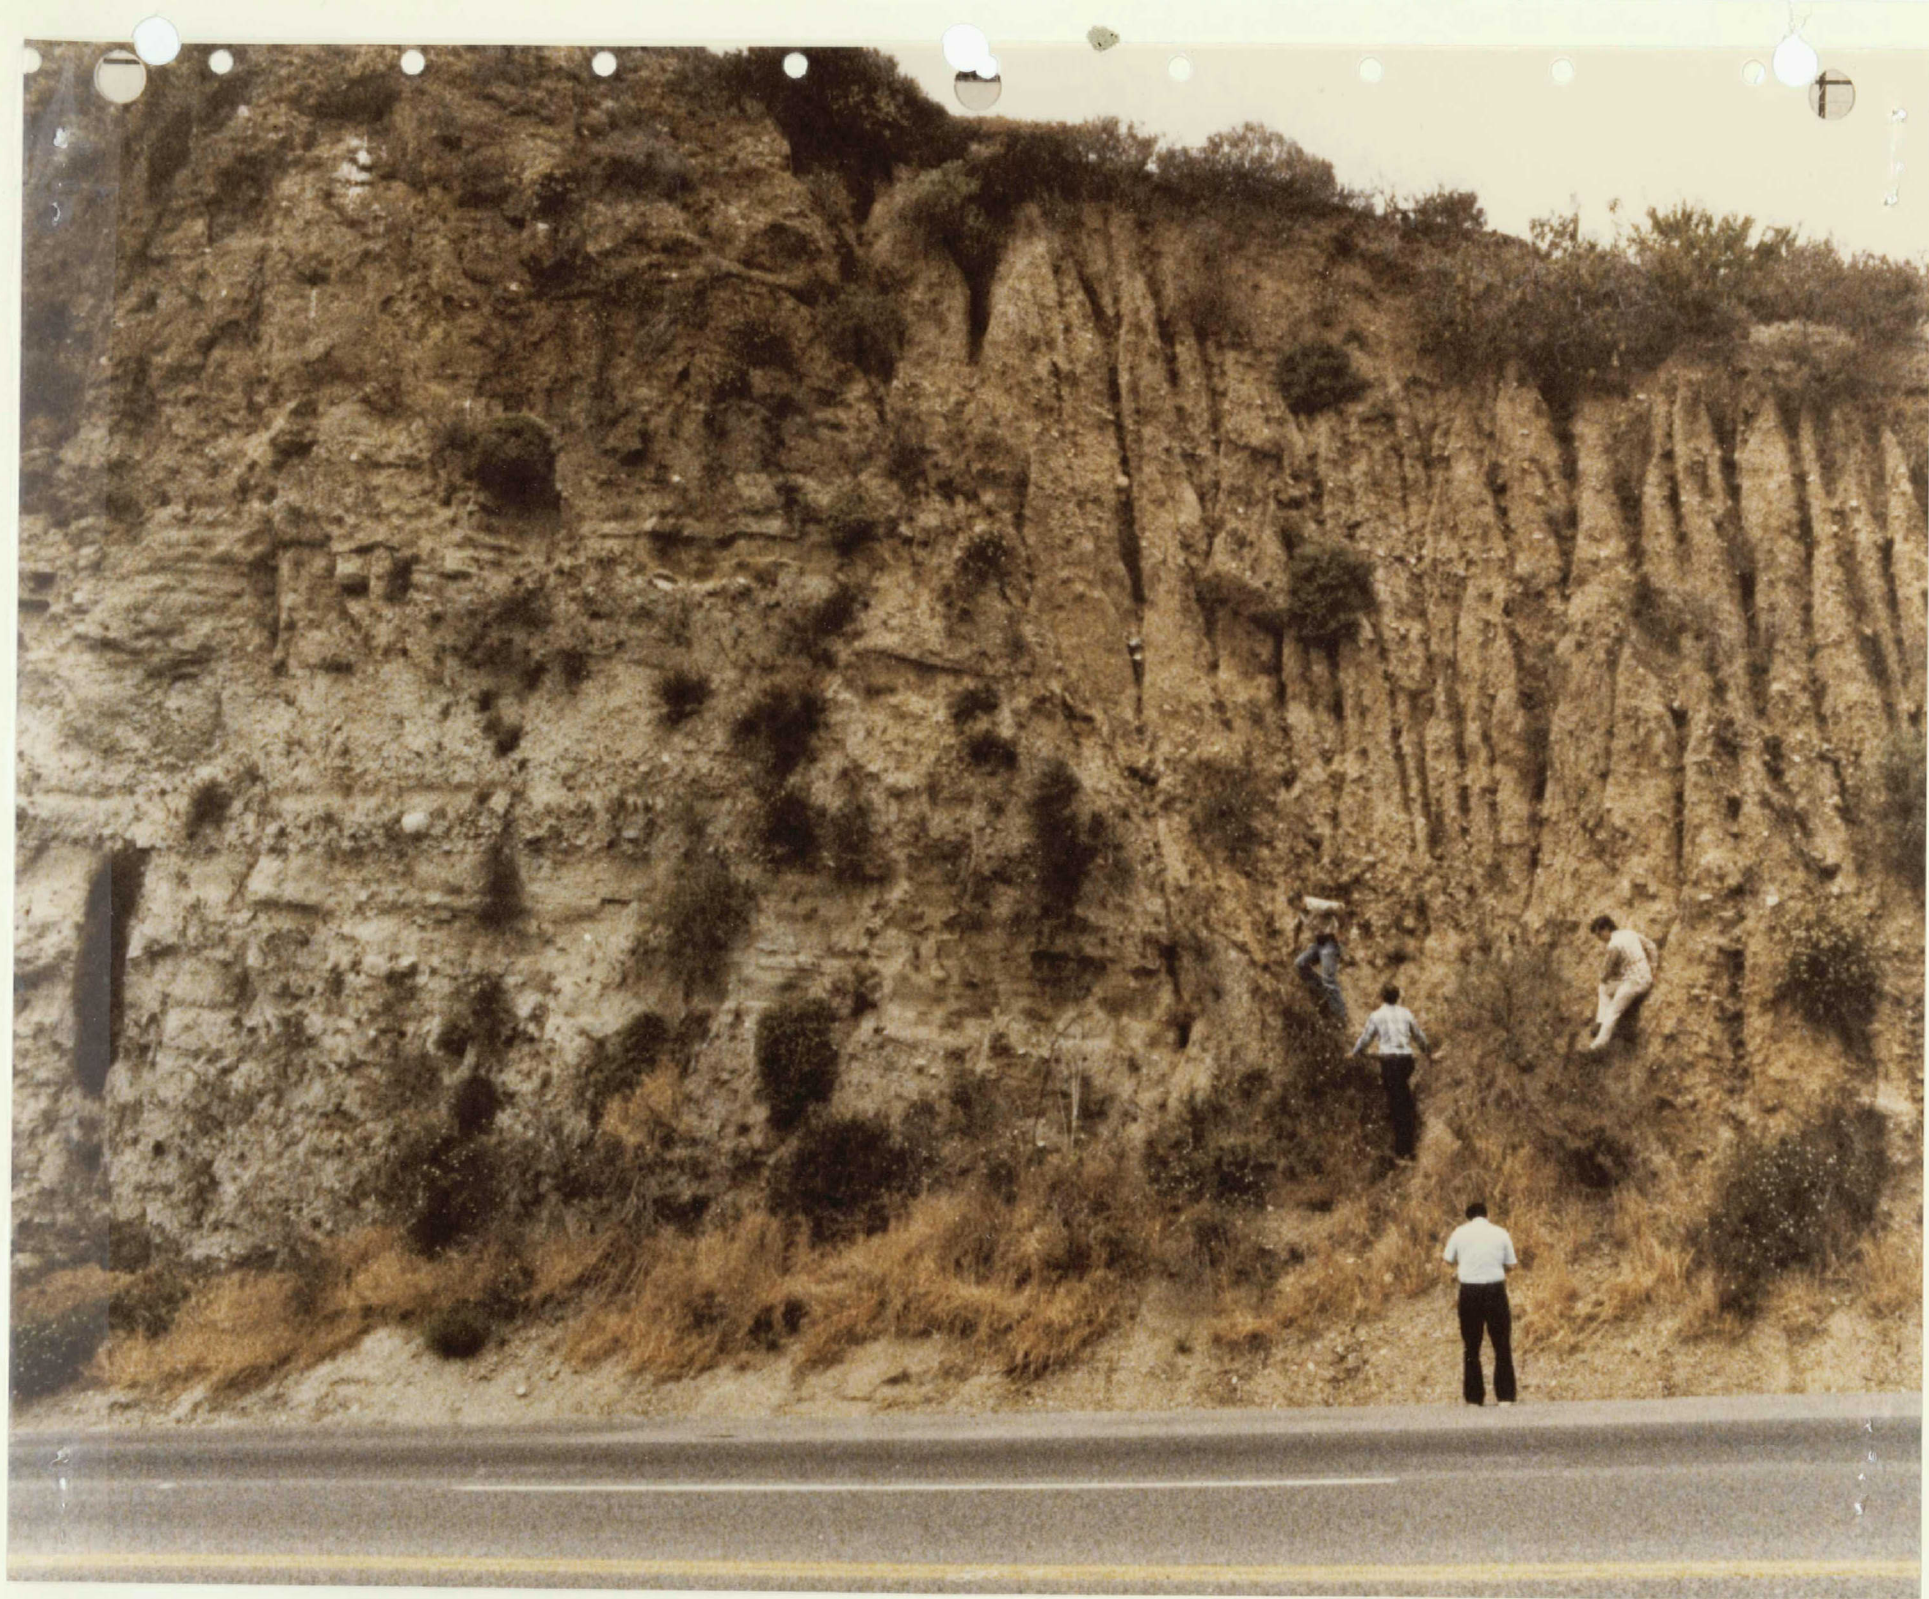
FIGURE 10

Vandegrift Boulevard Structure  
Quaternary sands and gravels in landslide contact  
with San Onofre Breccia at Vandegrift Boulevard,  
Camp Pendleton.

continuation of his "Horno Summit fault" (Figs. 10, 11). However, the Applicants conclude it was most likely formed by landsliding in the San Onofre Breccia followed by backfilling of talus and slope wash against the steeply inclined head scarp of the landslide. The bluffs on either side of this feature consist of San Onofre Breccia which is composed of material derived from Catalina Schist and has well defined bedding inclined toward the south-southwest at an average dip of about 5 degrees. At the top of the bluffs the breccia is overlain by marine and stream terrace deposits consisting of dominantly granitic sand and gravel derived from the interior of the Peninsular Ranges via the Santa Margarita River. The terrace deposits are the source of the talus and slope wash observed within the feature. The Applicants conclude that this feature was most likely formed by the following sequence of events.

2. As seen in the bluff along Vandegrift Boulevard (Figs. 10 and 11), the contact between the San Onofre Breccia and the sand and gravel deposits dips nearly vertically at the top of the bluff but curves toward the south as it comes down the face of the bluff and would appear to approach the horizontal if projected southward to a depth of several feet below the road elevation. This apparent flattening at shallow depth is characteristic of landslides but not faults of tectonic origin.

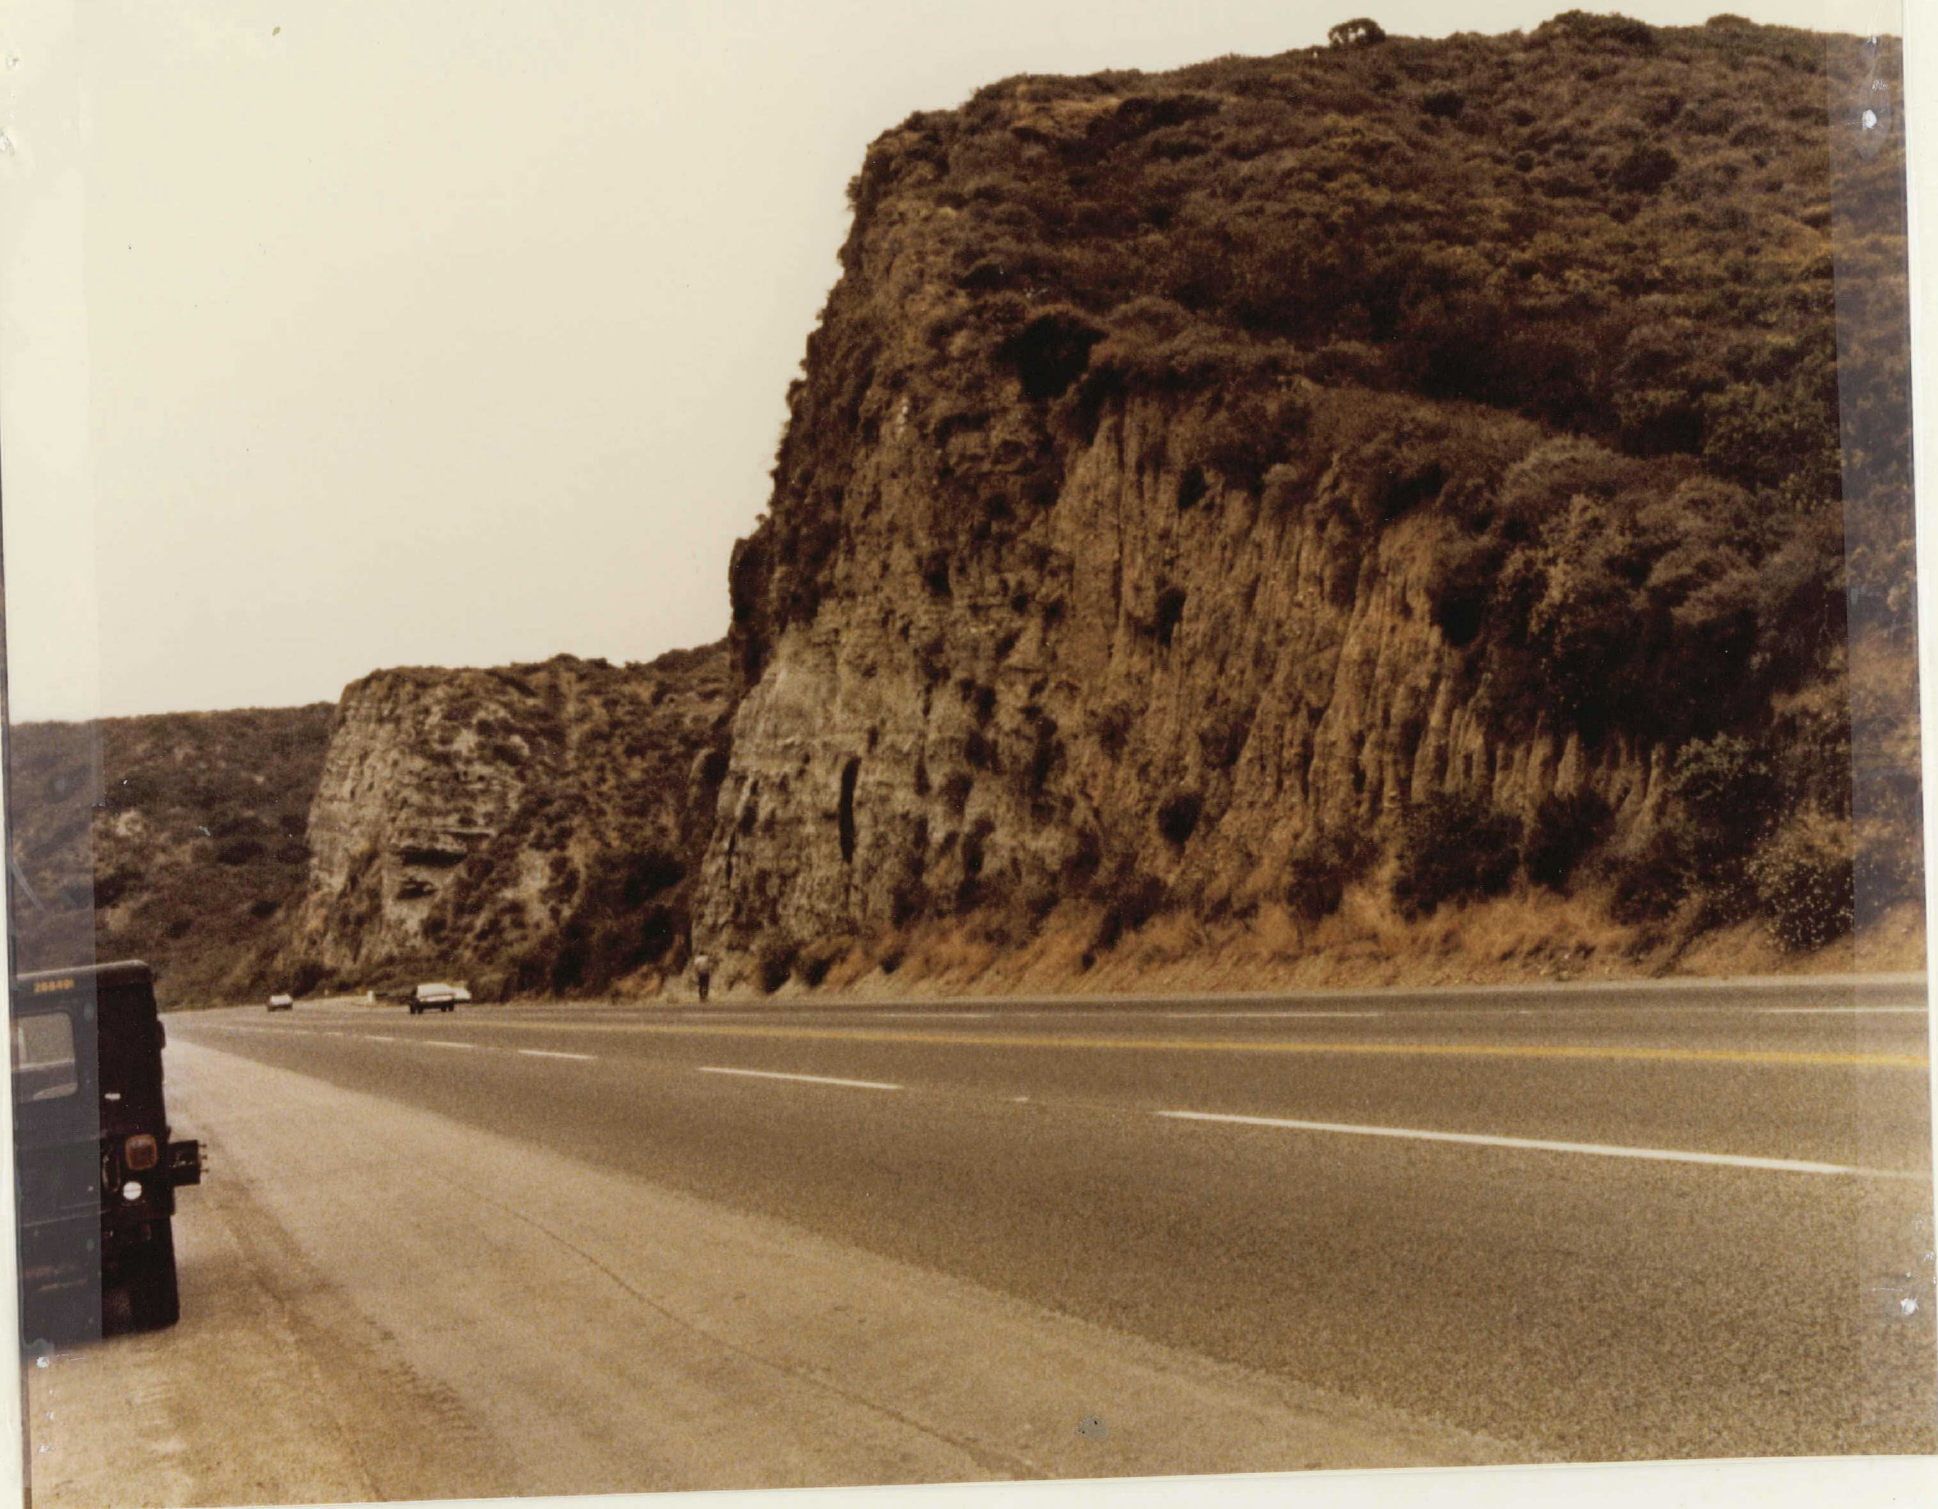
FIGURE 11

Vandegrift Boulevard Structure

View looking northeast along Vandegrift Boulevard. Steeply dipping Quaternary sand and gravel with curved initial dip resting on landslide contact with San Onofre Breccia.

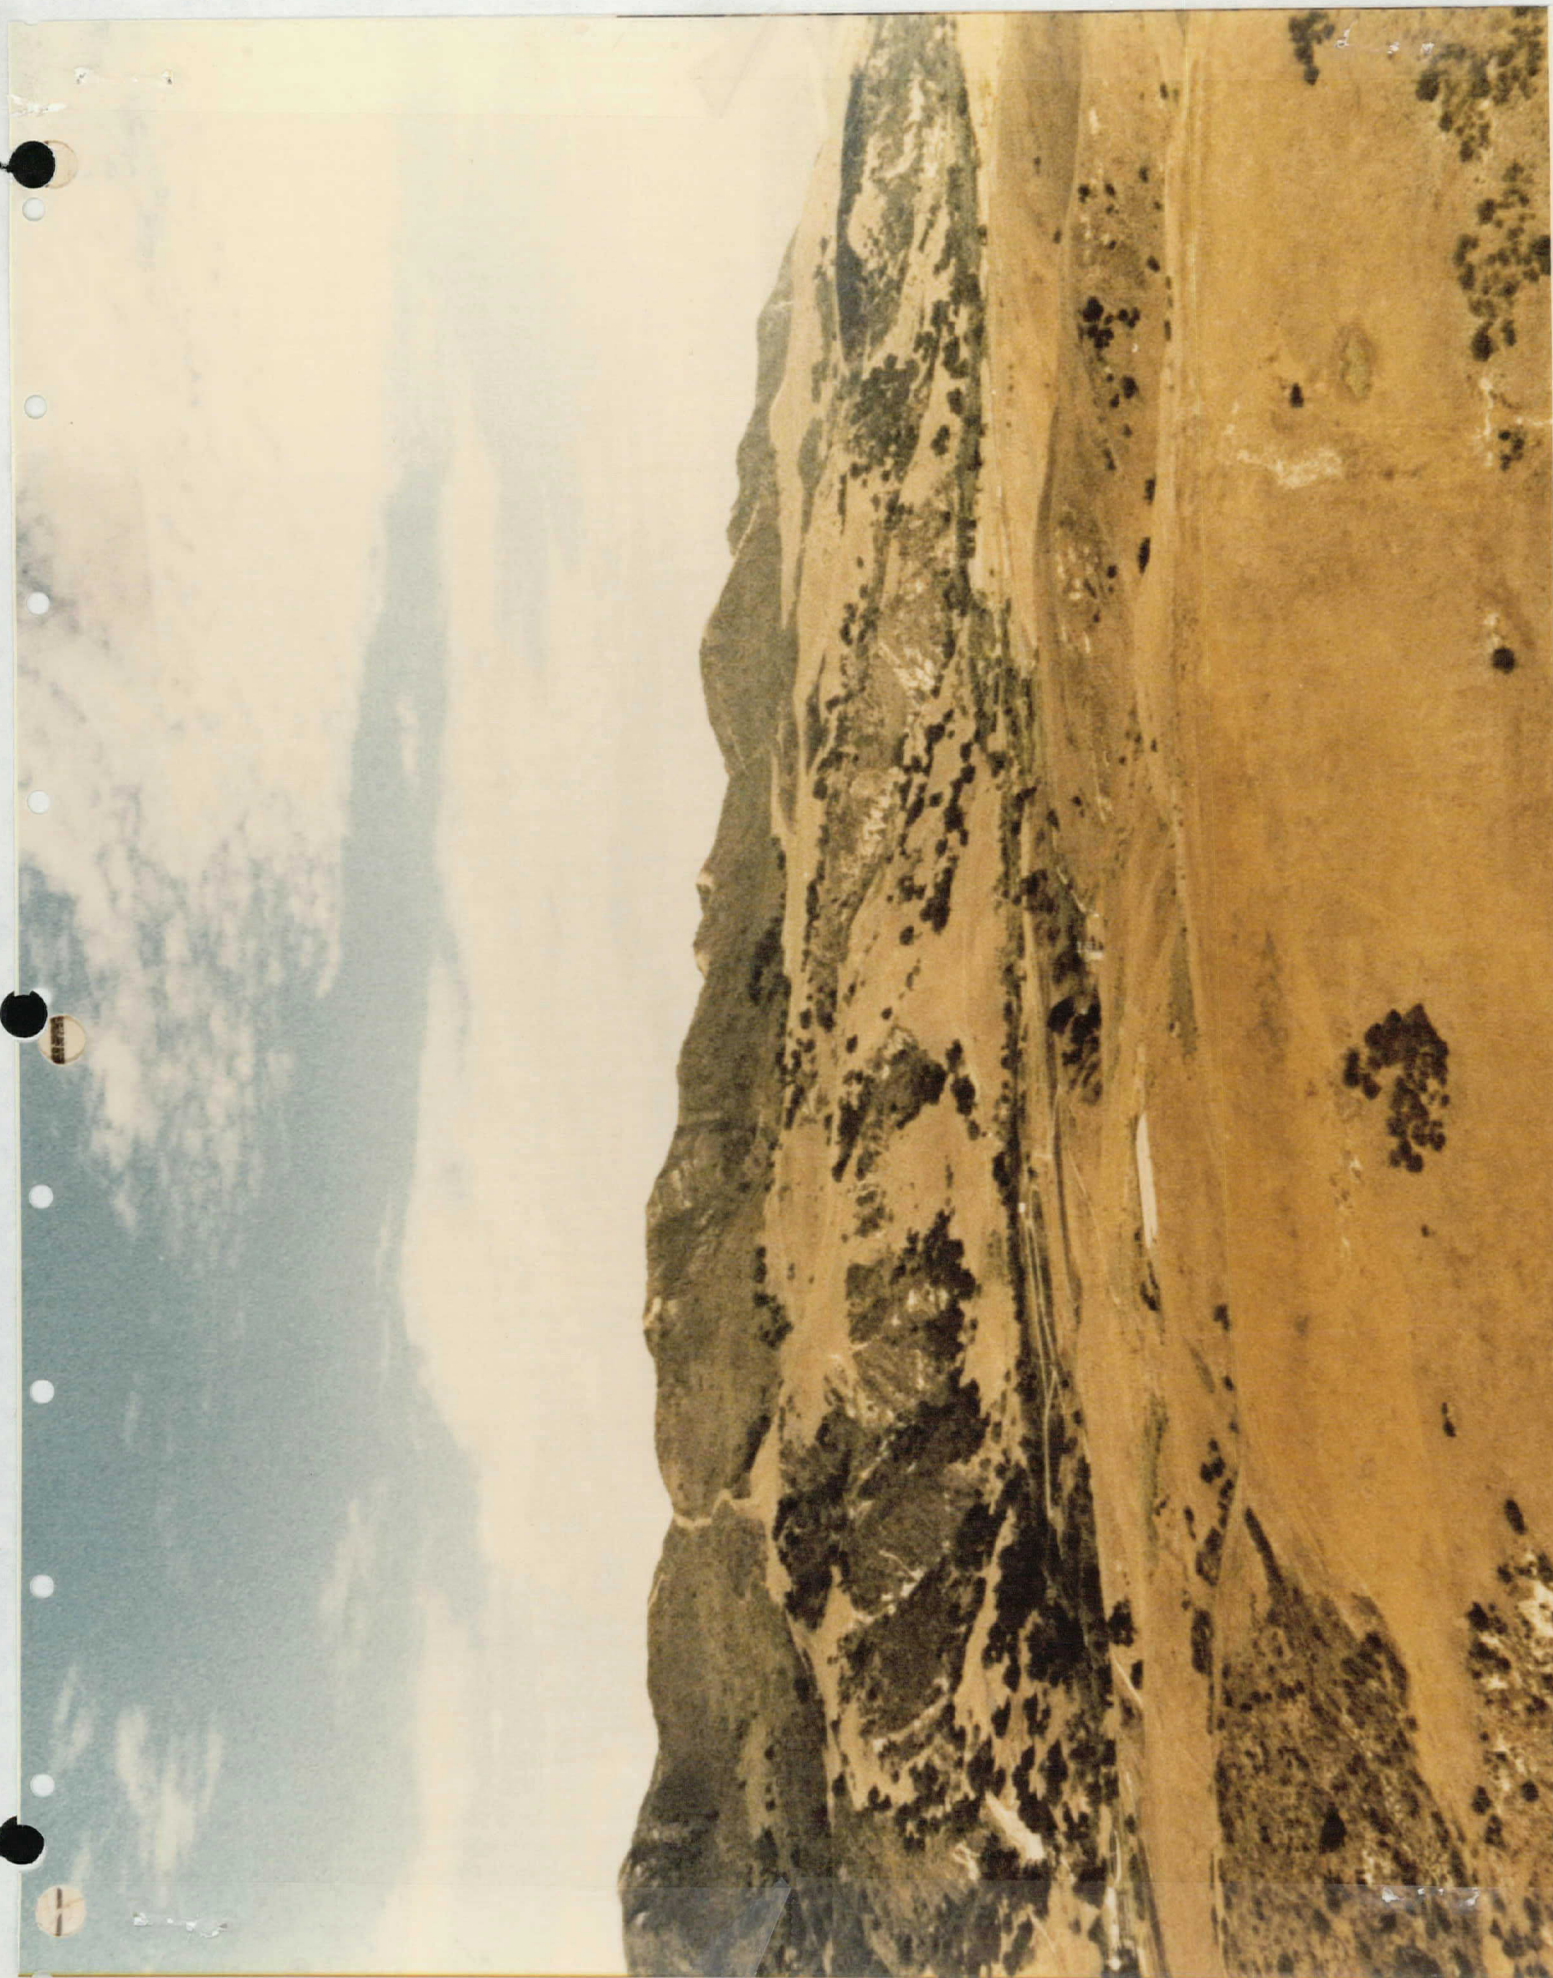
FIGURE 14

Landsliding creating scarp on horizon along  
Mr. Phifer's alleged "San Onofre Mountain Fault."

Detailed mapping, however, by Dr. P. L. Ehlig in 1977 and subsequent field checks indicate the east-facing scarp is the result of major landsliding occurring in the Eocene strata. The San Onofre Breccia is very hard and resistant, resulting in a pronounced ridge line and landslide scarps (Fig. 14). The unconformity between the San Onofre Breccia and underlying Eocene sandstone is observed on a firebreak at San Onofre Mountain and trends southeast to a ridgeline northwest of

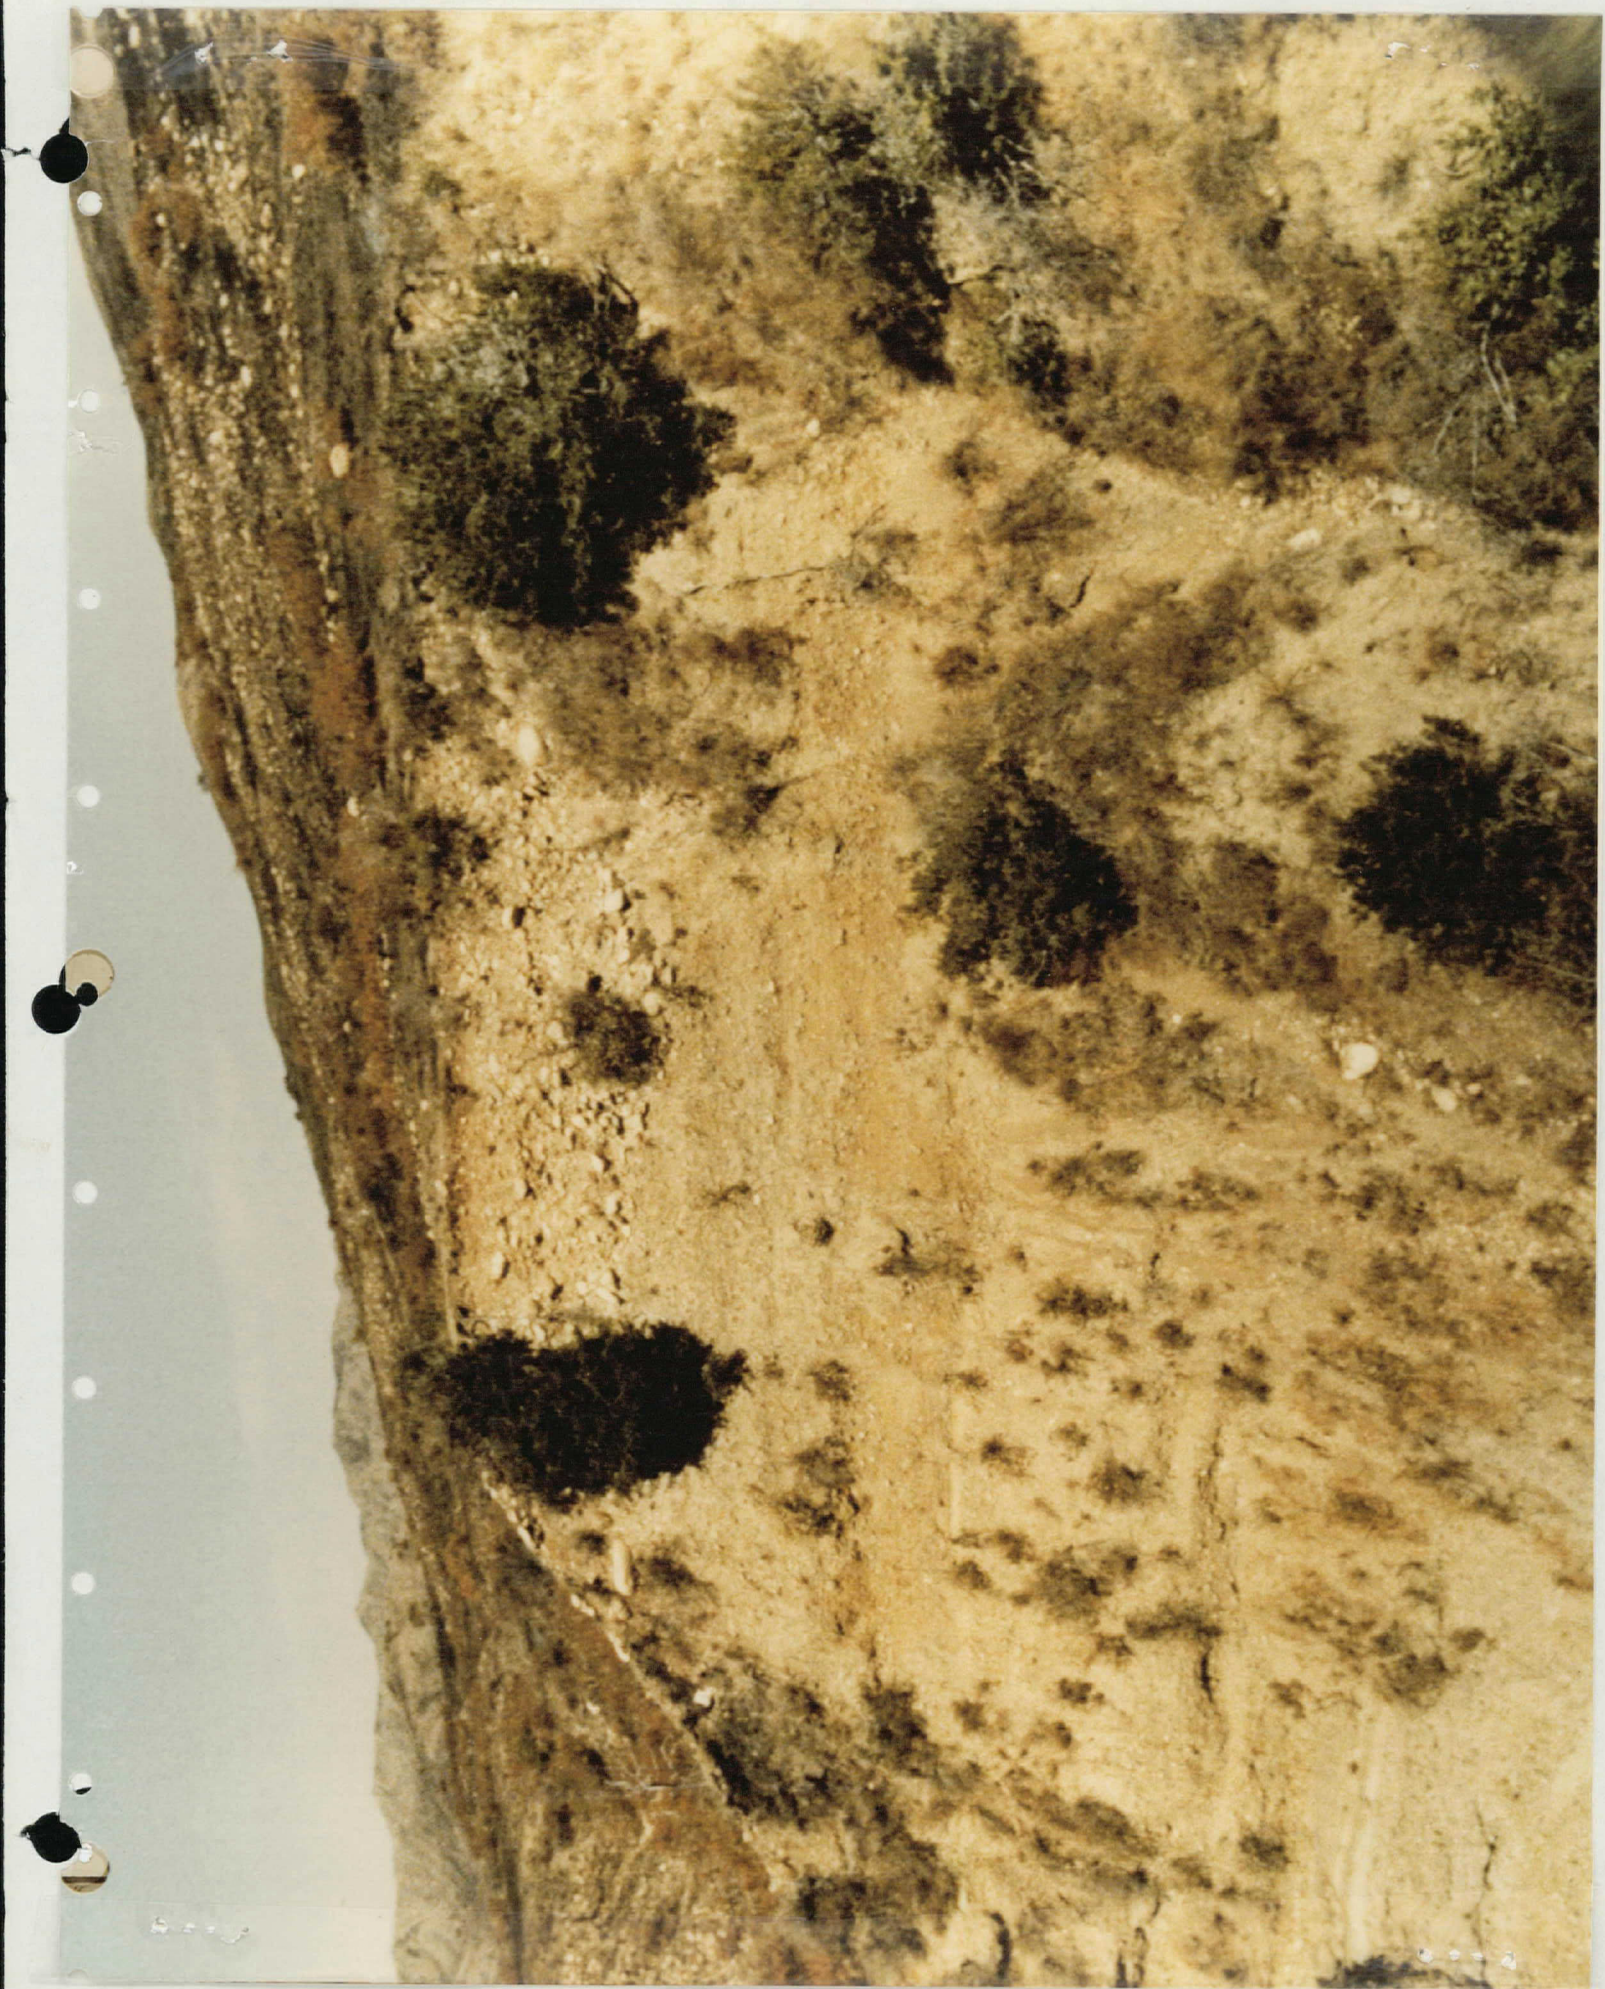
FIGURE 15

High Level Terrace Fill, San Mateo Canyon

High level terrace fill, approximately 15-20 feet thick, southeast side of San Mateo Canyon (NE 1/4, sec. 33, T. 8N., R. 6 W.). Surface is about 80 feet above floodplain and occurs at same elevation as more continuous paved terrace on north bank of canyon creek. Geomorphic position, terrace elevation and continuity, and relative soil profile development attest to a minimum age of about 100,000 years for paired terraces either side of San Mateo Creek.

3. To the northeast of the bend in San Mateo Canyon, about 1/2 mile northeast of Firing Range 313, paired terraces occur on opposite sides of the canyon about 100 feet above the present stream grade (Fig. 15). Instrumental hand-leveling across San Mateo Canyon at this locality reveals no measurable difference in elevation. These observations are also corroborated by identical helicopter altimeter settings for terrace remnants on either side of the creek. The unbroken San Mateo Creek terrace is the third regional fill above the floodplain (see discussion in "Horno Summit fault"); and, based on downstream continuity and soil development is judged to be on the order of at least 100,000 years old. This precludes the existence of significant faulting along the bottom of San Mateo Canyon in this area during the last 100,000 years and is supportive of the evidence presented in (1) above which indicates the bedrock is unfaulted in this area.
