SEABROOK UPDATED FSAR

APPENDIX 2J

SAMPLE DESCRIPTIONS FOR BORINGS MADE IN NOVEMBER-DECEMBER 1972

SEABROOK STATION
PUBLIC SERVICE COMPANY OF NEW HAMPSHIRE

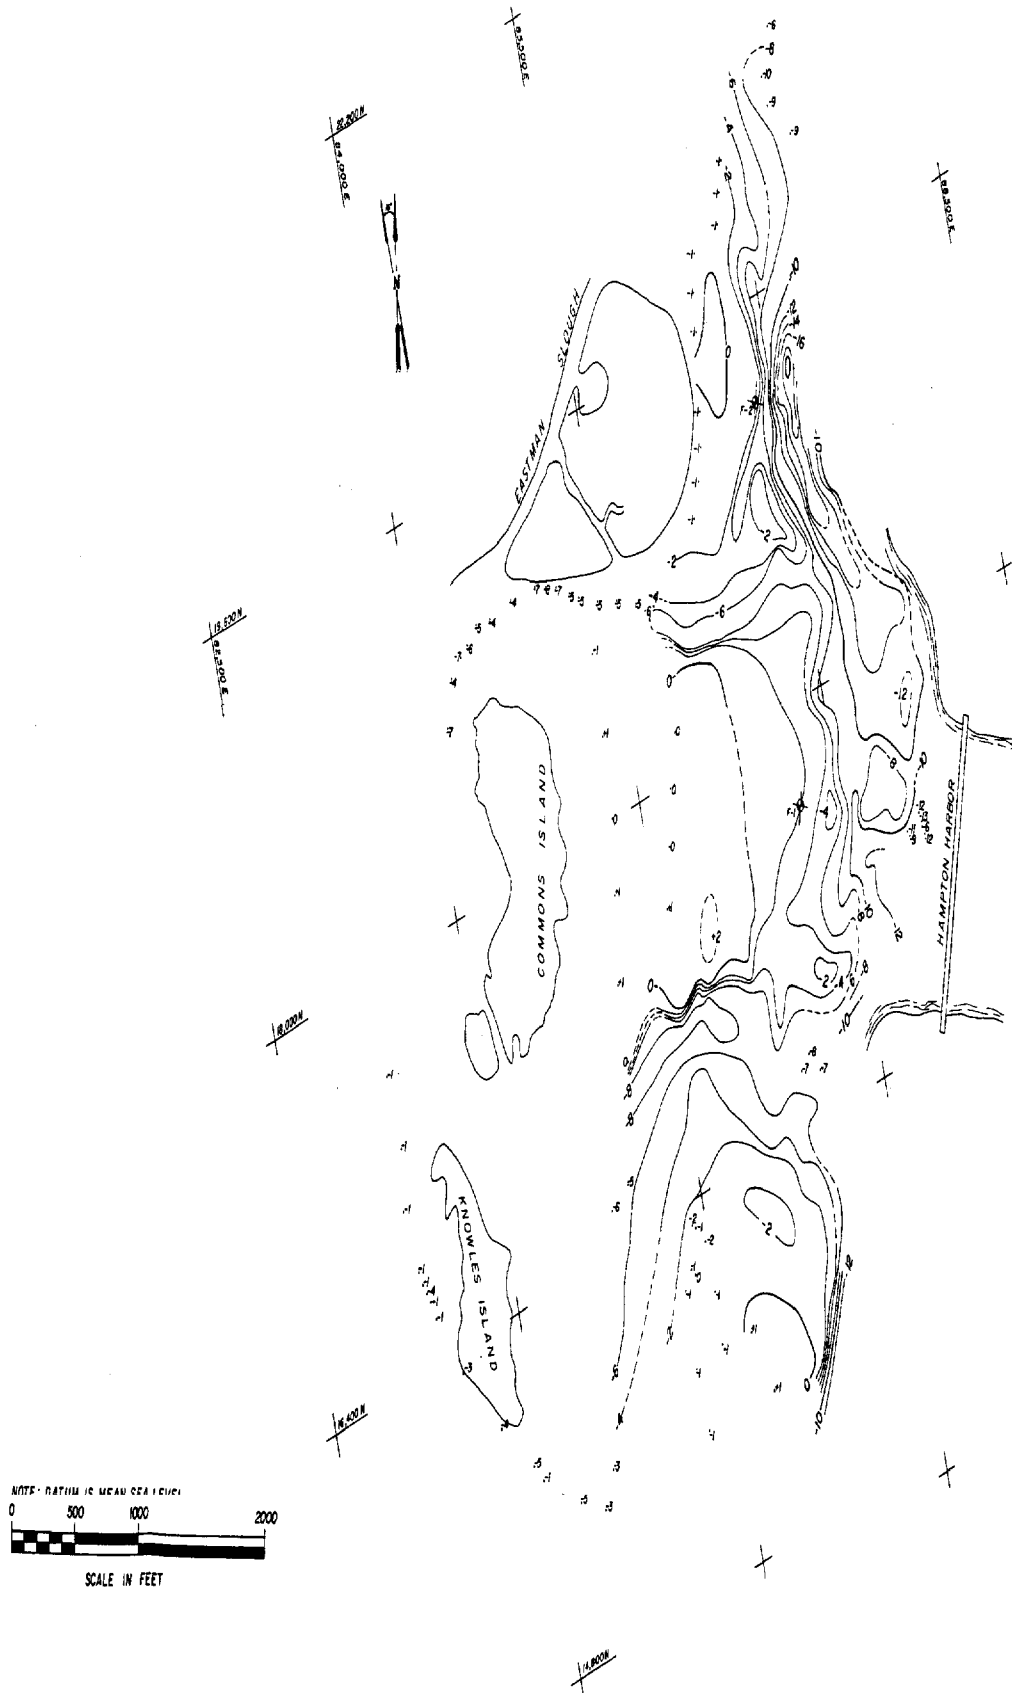
HAMPTON HARBOR AREA
BOTTOM CONTOUR MAP
SEISMIC SURVEY

The contour maps show that much of the ocean bottom **offshore** consists of highly irregular bedrock outcrops. A denser material, possibly glacial till as indicated by the seismic refraction velocities, was found along the northern and western sides of the ledge outcrops. Refraction velocities in the 5,500 to 5,700 **ft/sec** range were found in this area, while away from the area, velocities generally ranged between 5,100 and 5,400 **ft/sec**. The seismic reflection data showed both glacial till and bedrock, although in some areas, reflections were only obtained from the till. **In** these latter cases, the refraction data provided the basis for the bedrock contours. **Boring** ~~S~~**P-2** through P-10 conformed to the general picture shown by the seismic data.
