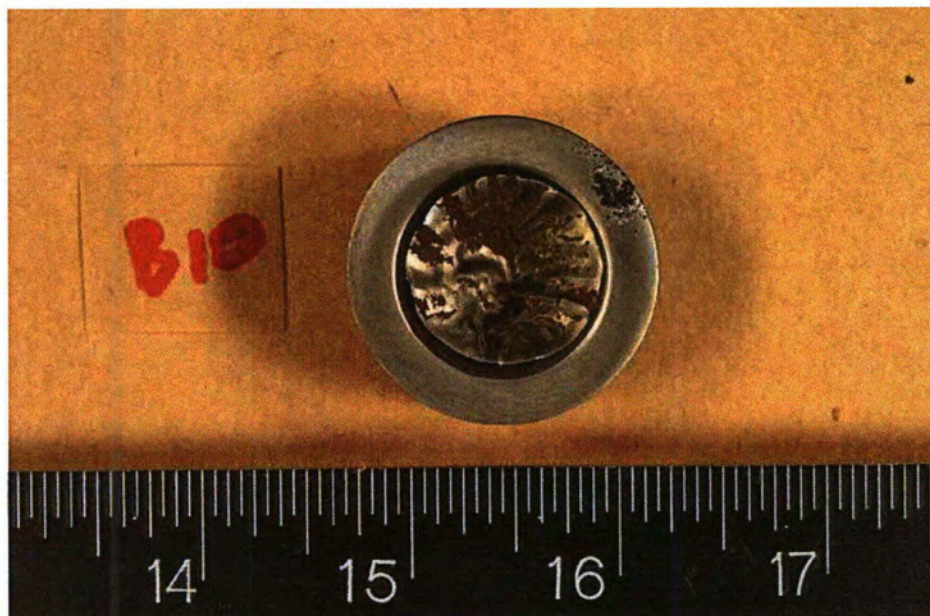
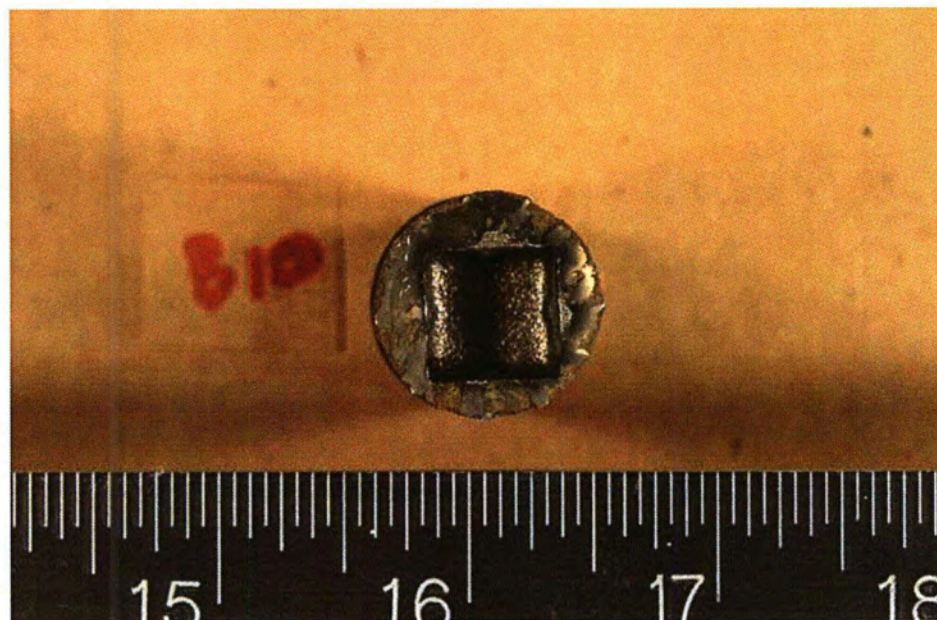
Bolt 300°-6 Head

Figure 34: Receipt macro photographs for bolt 300°-6.

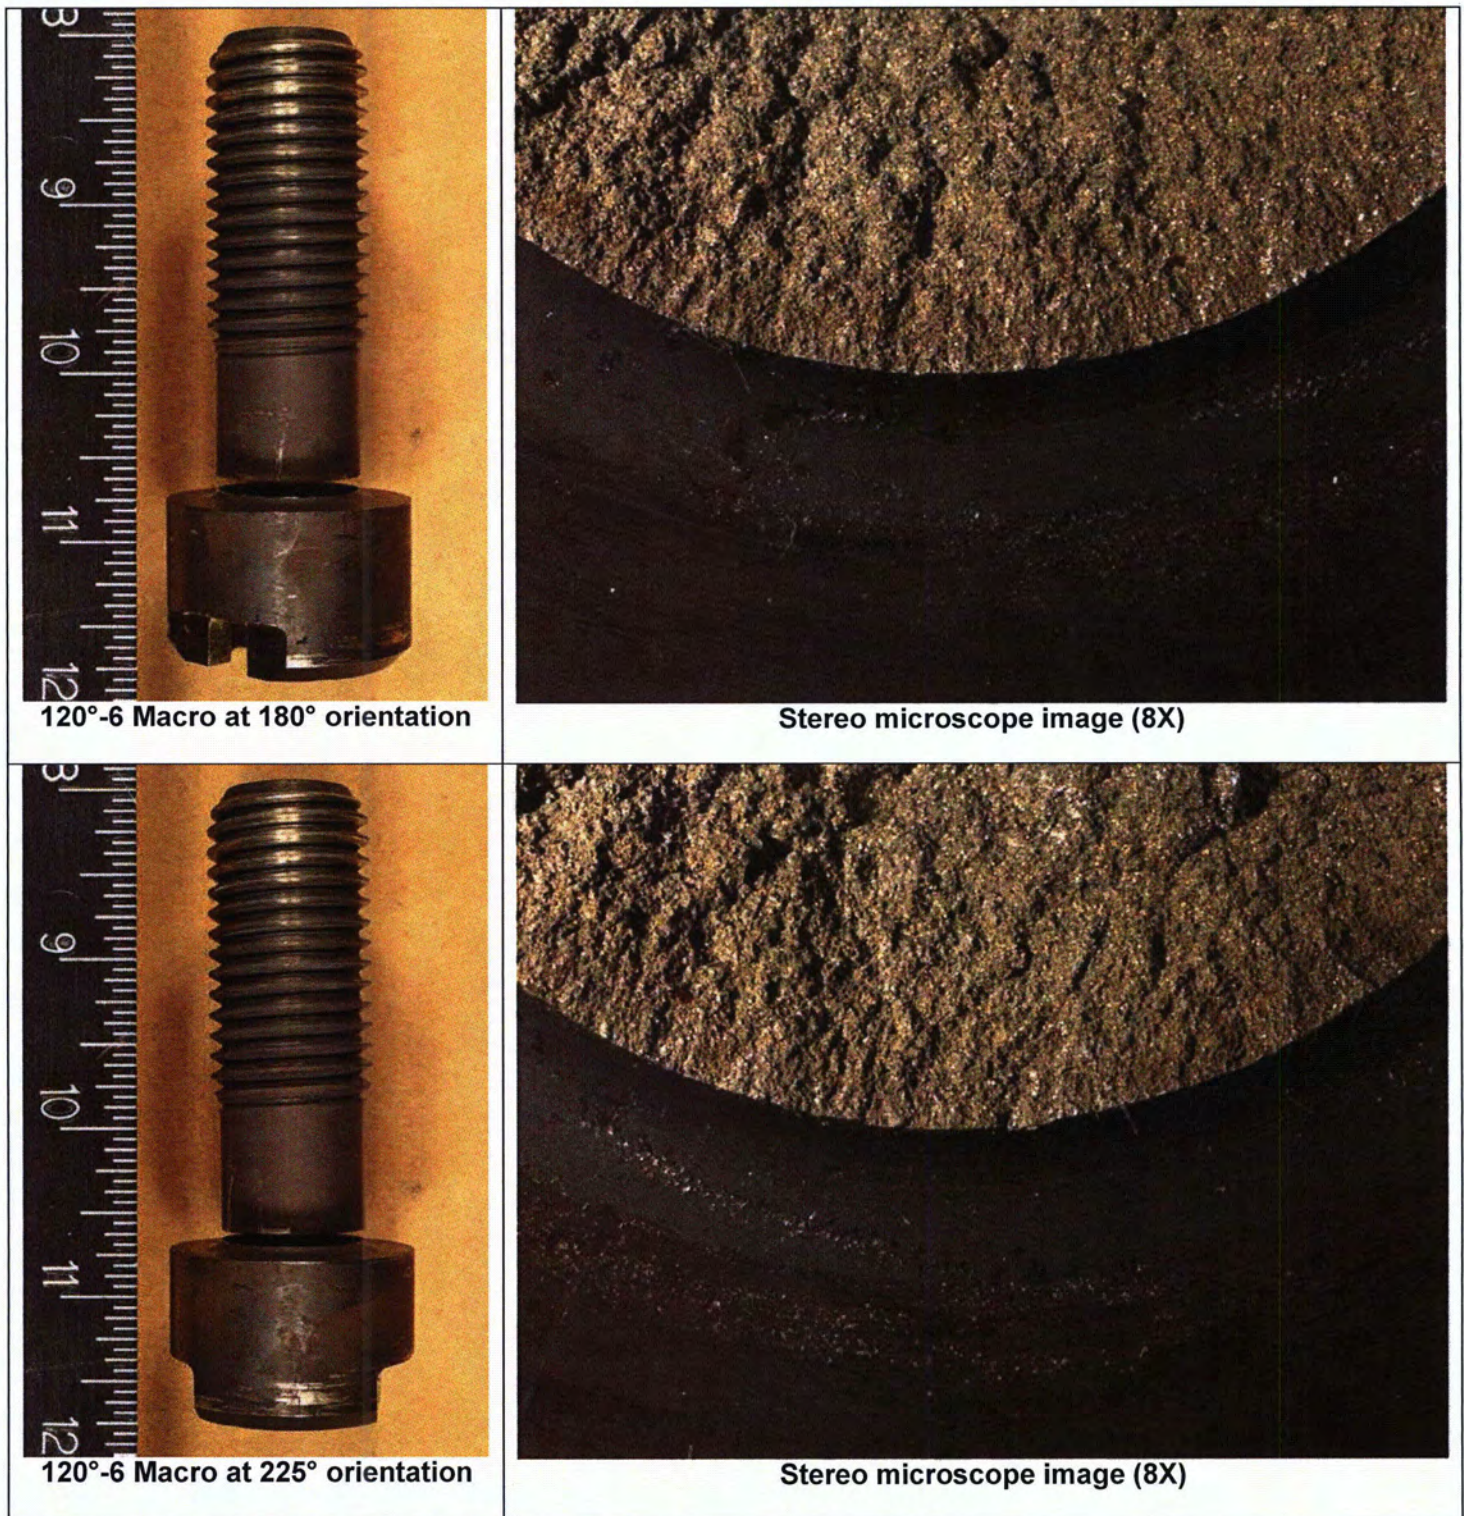
Figure 40: Macro and stereo photographs of bolt 120°-6 taken at 45° increments.

Figure 40 (continued): Macro and stereo photographs of bolt 120°-6 taken at 45° increments.
