**CAMECO RESOURCES
CROW BUTTE OPERATION**

On August 17, 2015, during routine 5-year Mechanical Integrity Testing (MIT), well number I-2430 in Mine Unit 7, Wellhouse 31 failed the MIT criteria at the Crow Butte Resources (CBR) mine site. Isolation procedures indicated that the failure was the casing joint at the 20-foot level. Shar Sapp, of the NDEQ Chadron field office, and Ron Burrows, NRC Project Manager, were notified concerning this well on August 17, 2015.

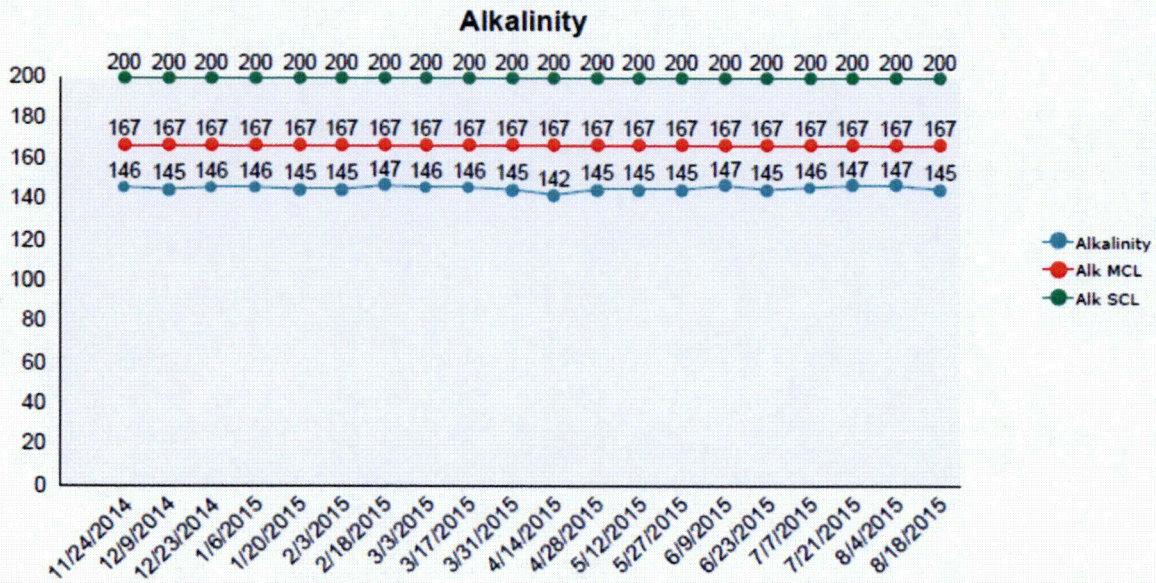
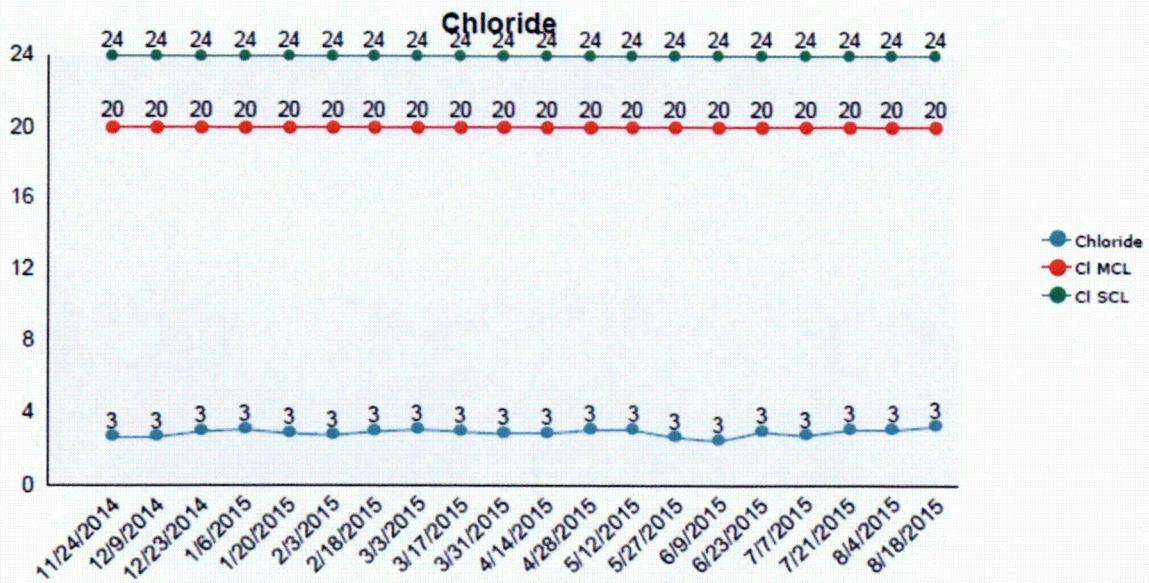
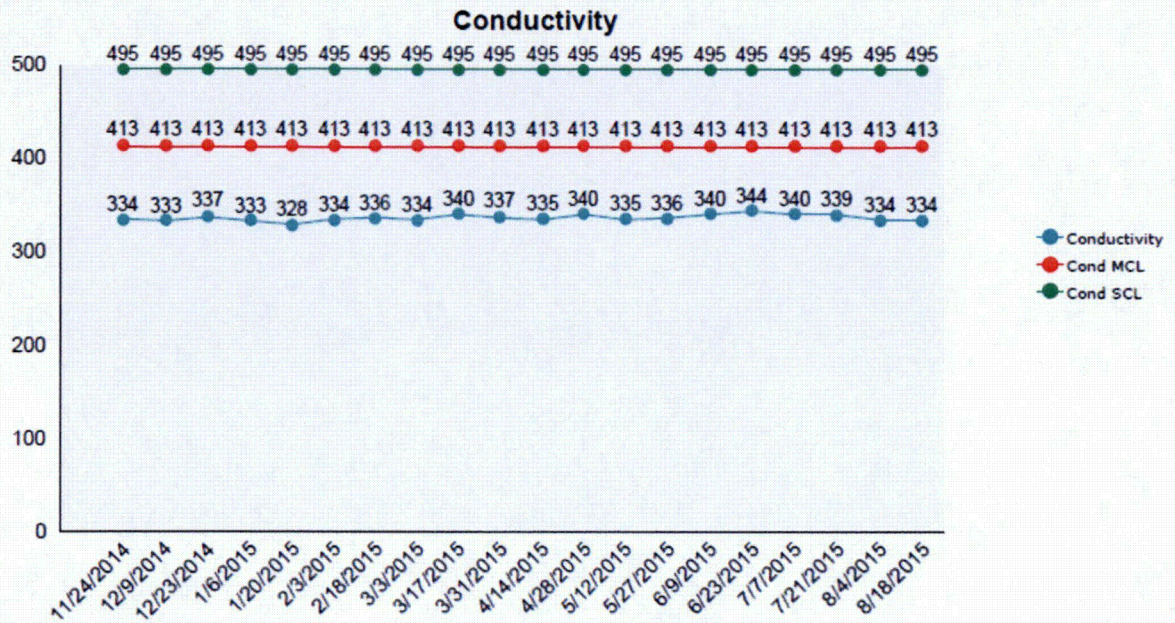
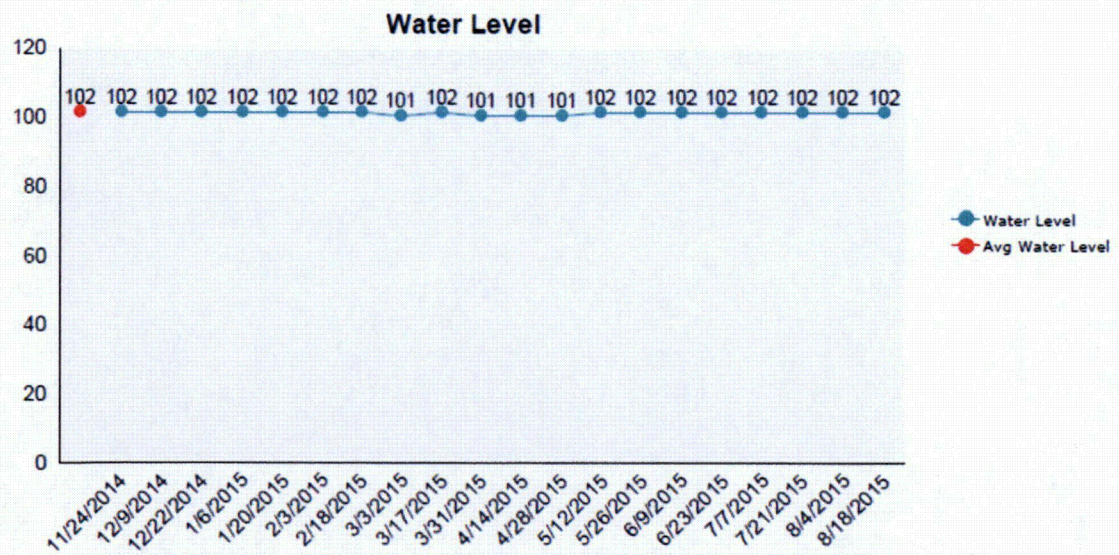
SM7-15
8-18-15

A graph of the sampling results for the nearest Shallow Monitor Well, SM 7-15, is included for your review. This well is located 285 feet northwest of I-2430.
