Heat Release Rates of Electrical Enclosure Fires (HELEN-FIRE)

Final Report

This report documents an experimental program to explore the heat release rate and burning behavior of electrical enclosures commonly found in nuclear power plants. Electrical enclosures are a potential source of fire in nuclear power plants because they contain both combustible materials and live electrical circuits. These fires have the potential to disrupt power, instrumentation, and control in the plant. Key parameters affecting fire in an enclosure include its size, openings, electrical voltage, and combustible load.

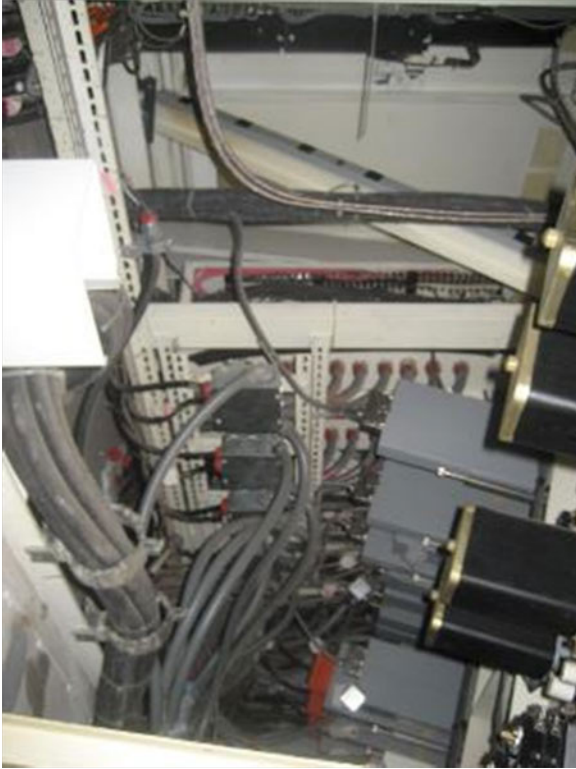
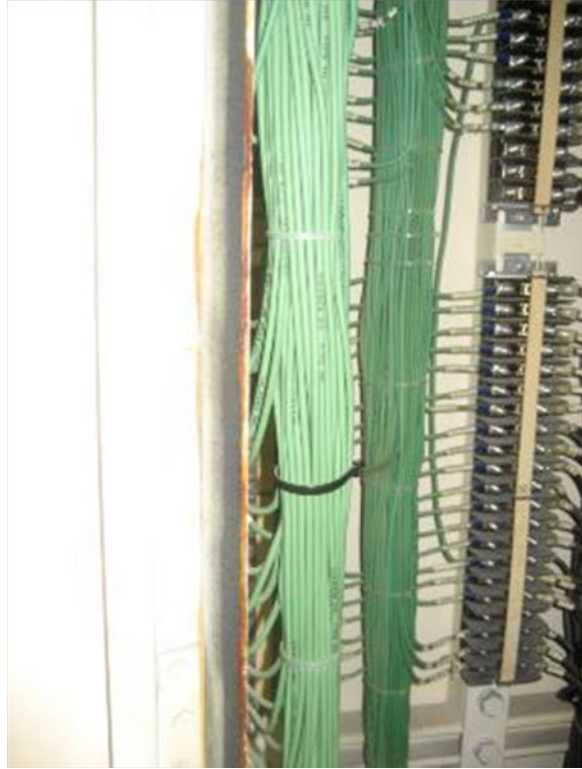
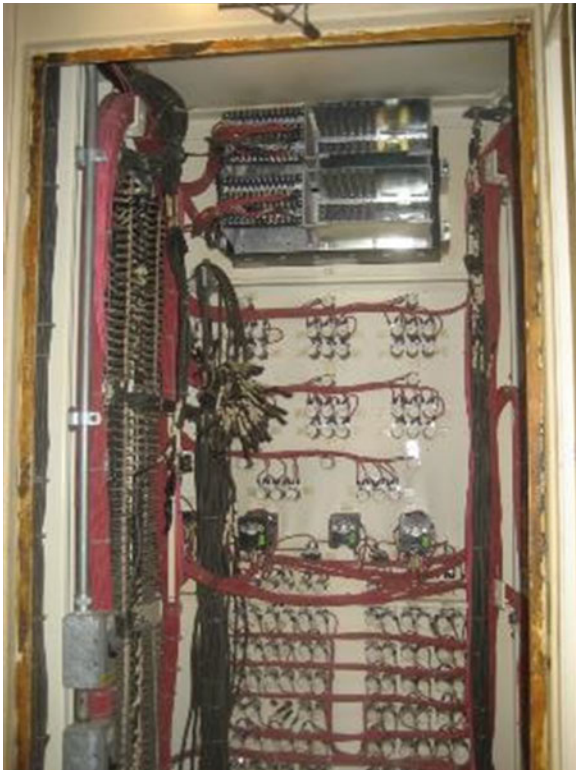
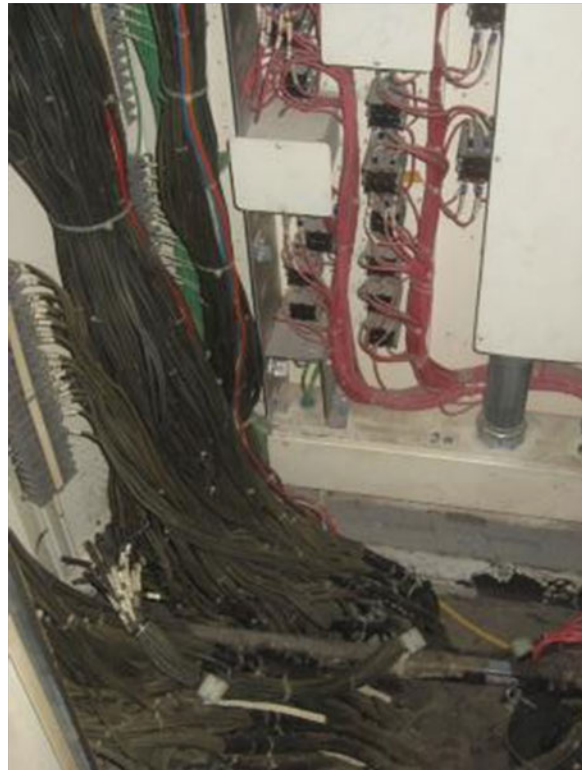
Figure 2-1. Photographs of enclosures typically found near the main control room.

Figure 2-1 and Figure 2-2 display photographs of enclosures in and around the main control room. These enclosures typically contain tight bundles of relatively small diameter insulated wiring and a large number of connection points. Racks of circuit boards are also common.

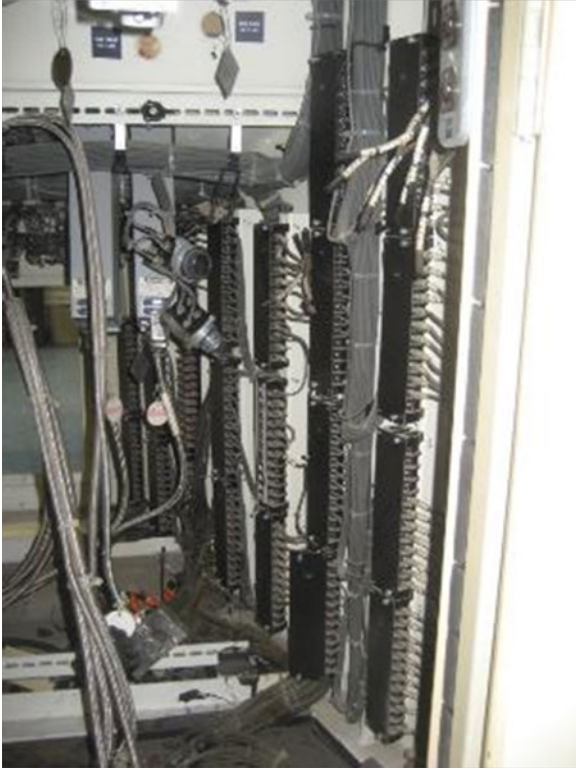
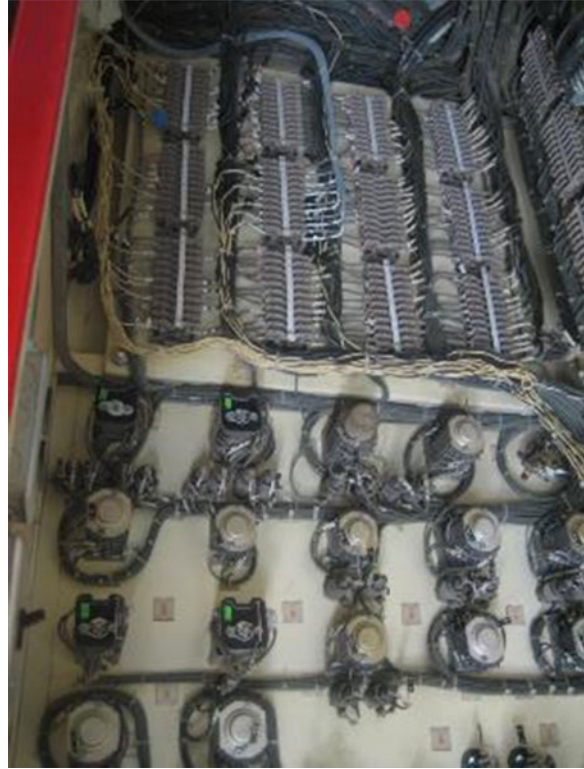
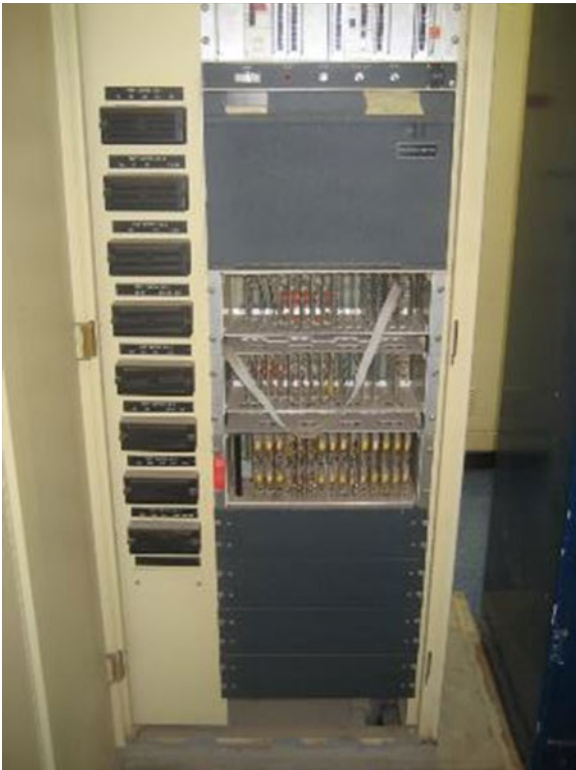
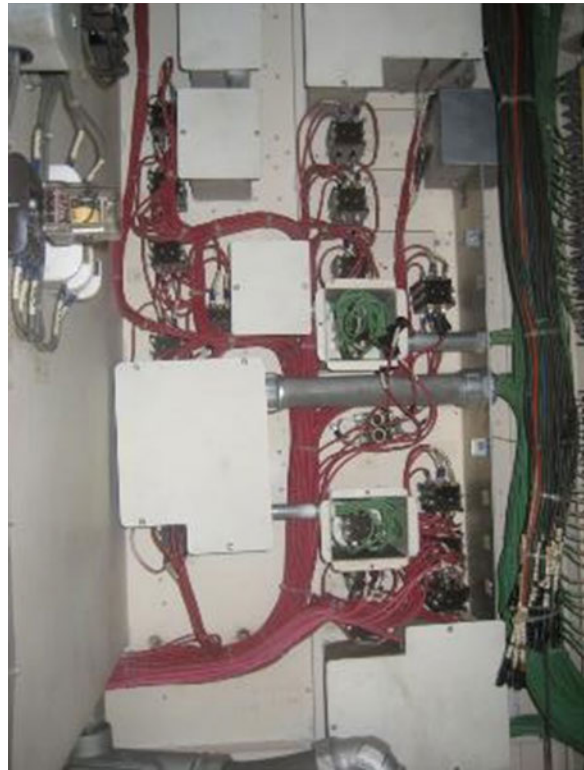
Figure 2-2. Photographs of enclosures typically found near the main control room.

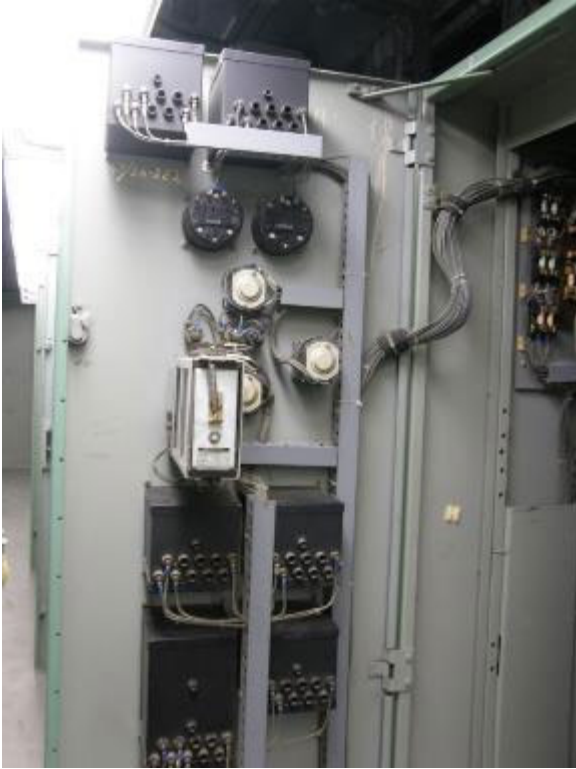
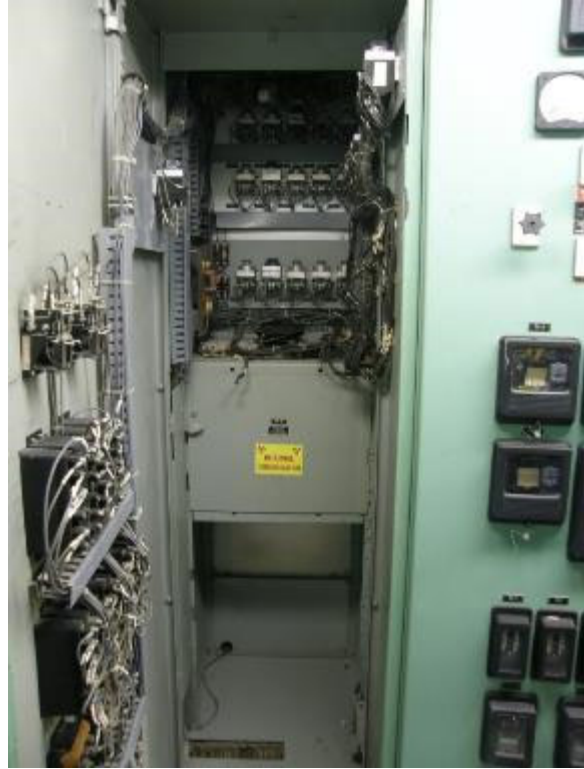
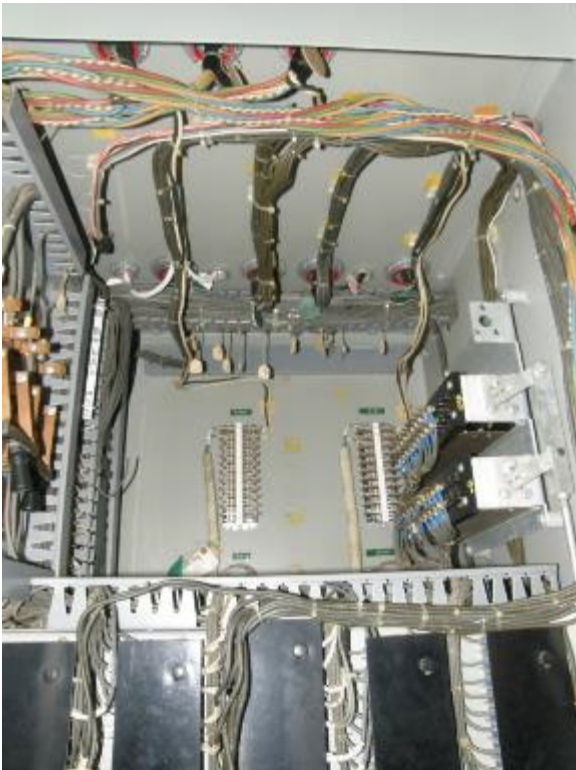
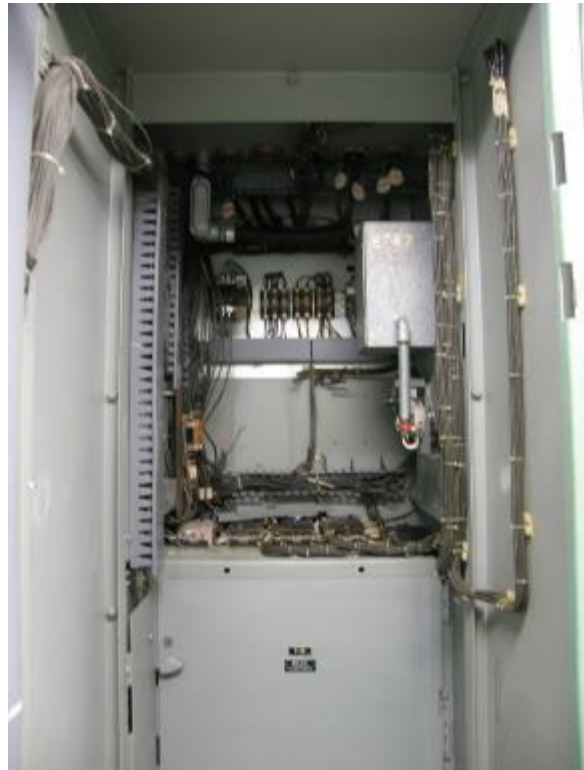
Figure 2-3. Photographs of the internal wiring of typical switchgear enclosures.

Figure 2-3 and Figure 2-4 displays photographs of switchgear enclosures. In general, these types of enclosures contain less wiring than the enclosures in the control room. These enclosures are also relatively large with large amounts of open volume inside.

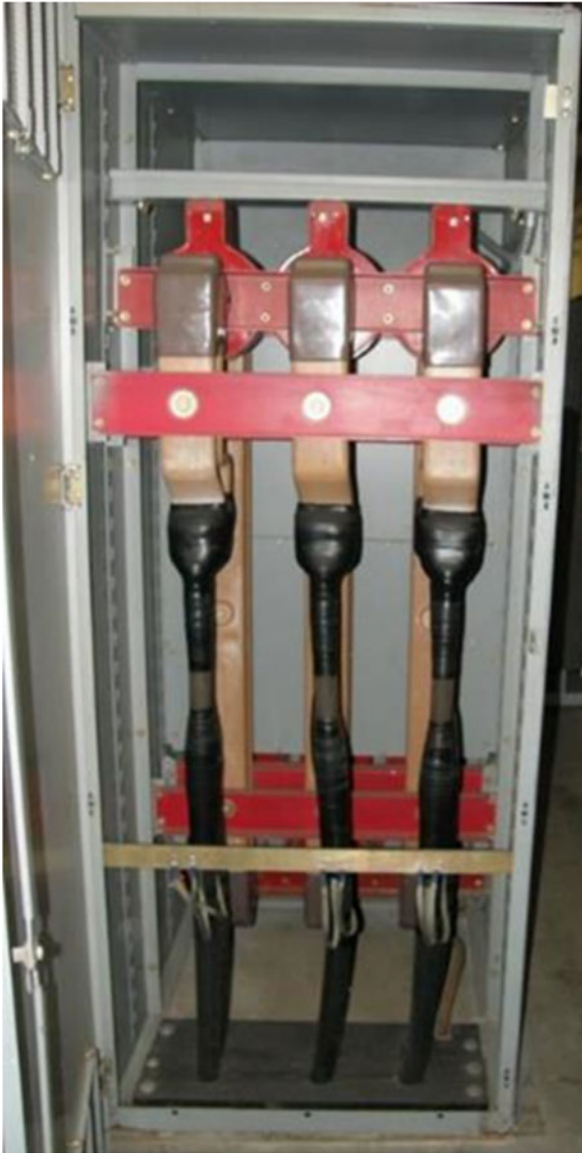
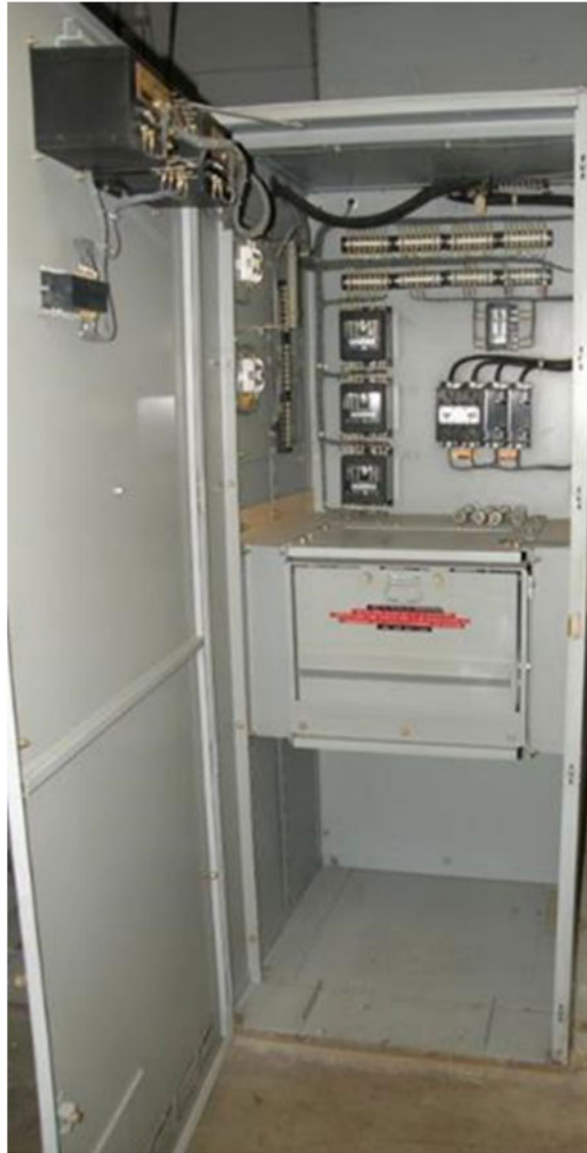
Figure 2-4. Photographs of the internal wiring of medium voltage switchgear.

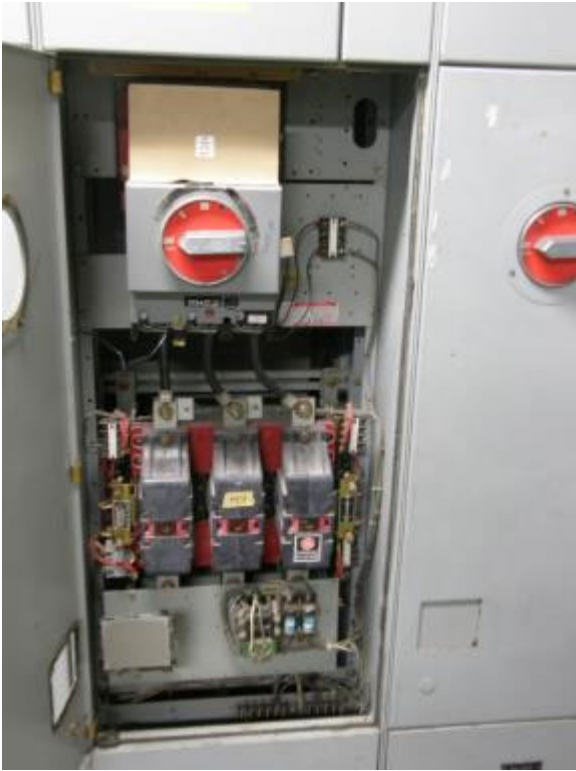
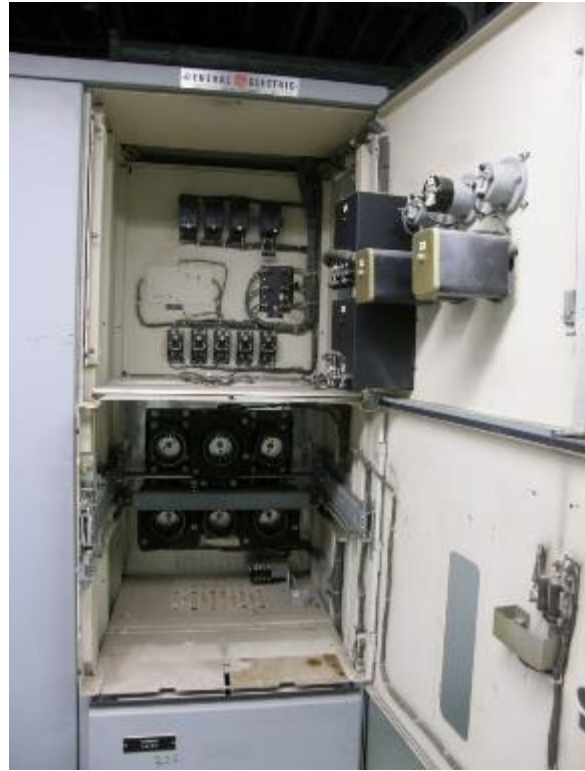
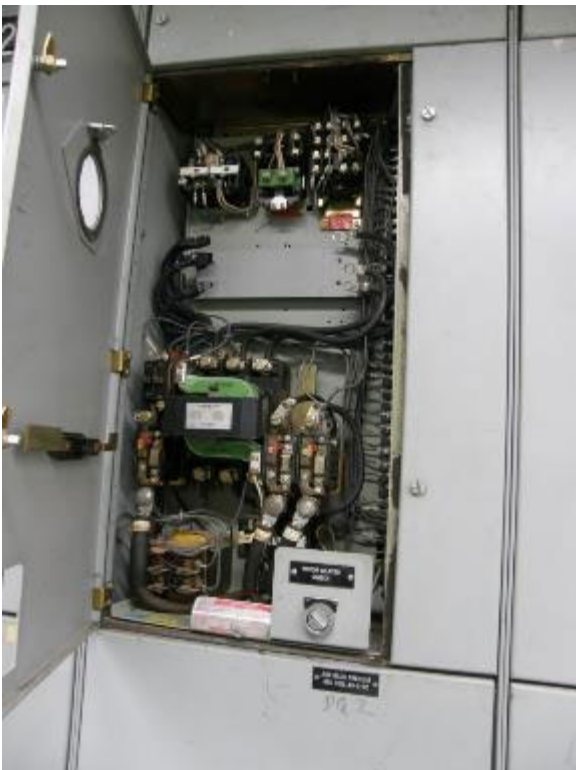
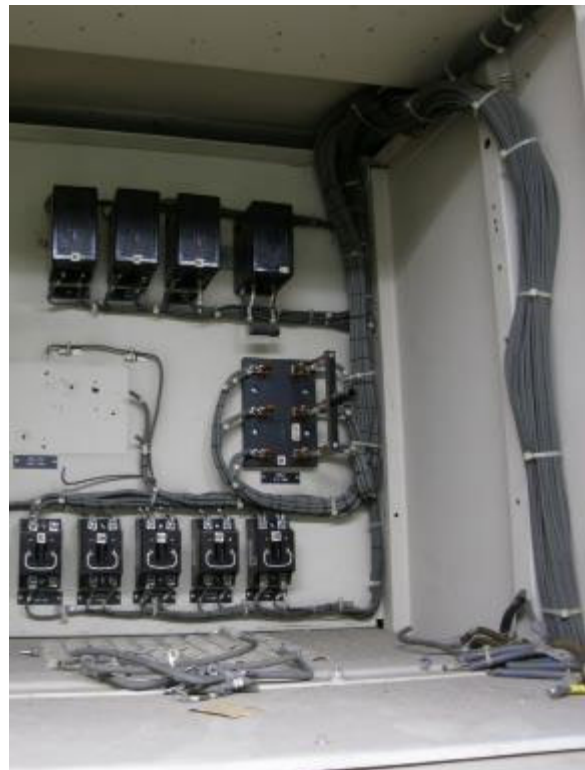
Figure 2-5. Photographs of the internal wiring from typical motor control centers.

Figure 2-5 displays photographs of motor control centers (MCCs). These enclosures contain relatively small compartments containing a variety of wiring and equipment. It is difficult to characterize these compartments in general terms other than to say that each “bucket” is relatively self-contained and isolated from its neighbors.

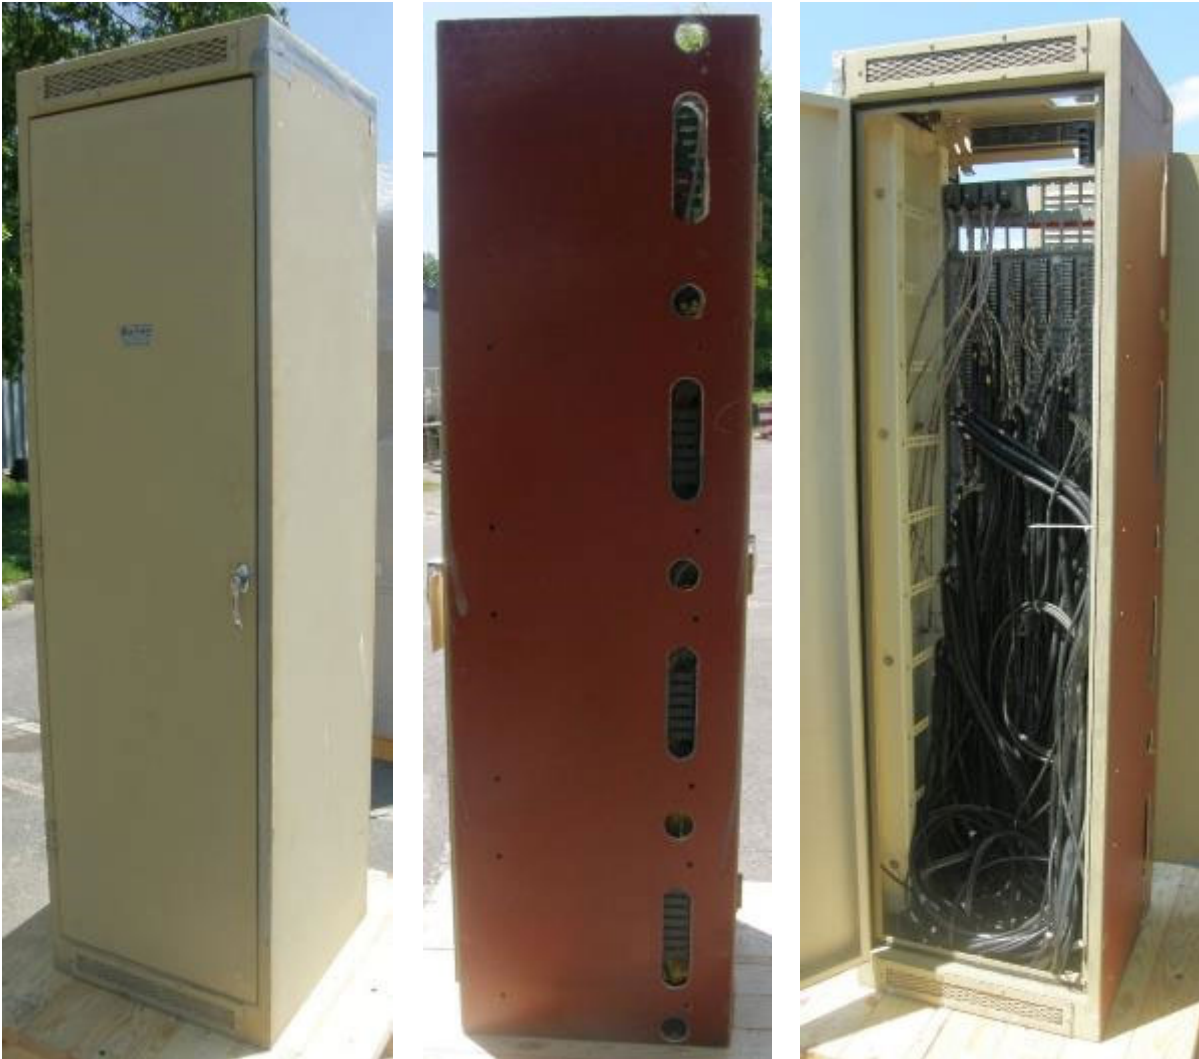
Enclosure 1 was classified as a “protection system auxiliary cabinet.” When removed from Bellefonte NPP, there were a relatively large number of multi-conductor cables connected to a panel dividing the front of the enclosure from the back. There were 432 connection points, divided among 6 levels. The floor opening was covered by a steel plate. As installed, the cables would be routed through the floor or access openings on one side.

Figure 2-6. Photographs of Enclosure 1.

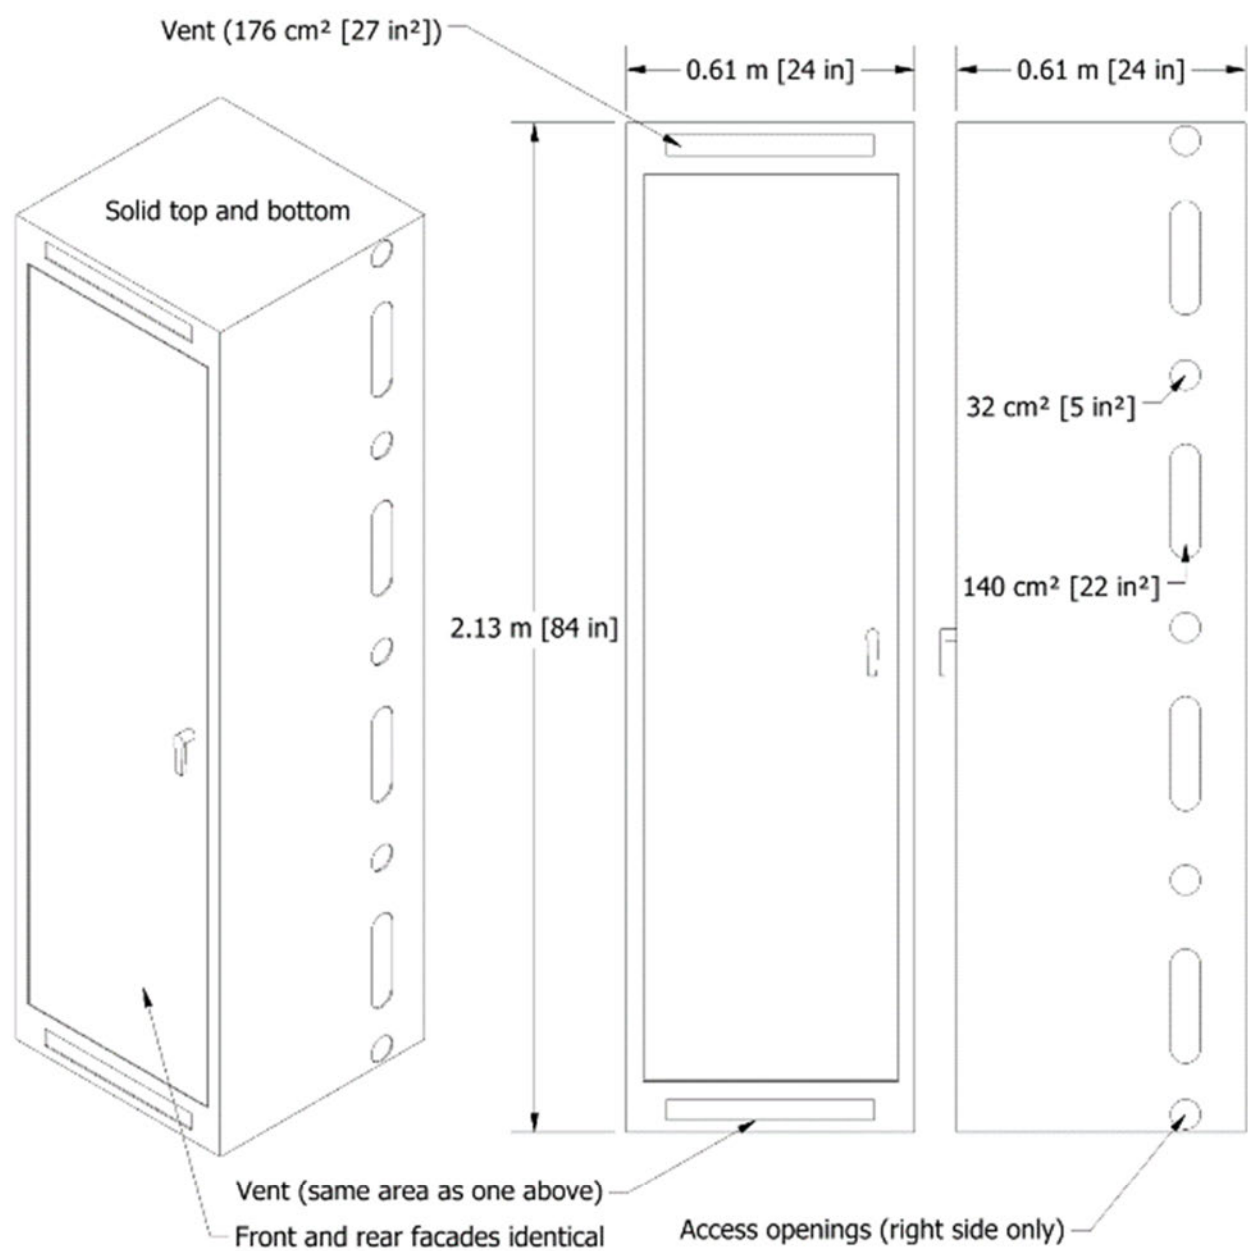
Enclosure 1

Figure 2-7. Sketch of Enclosure 1.

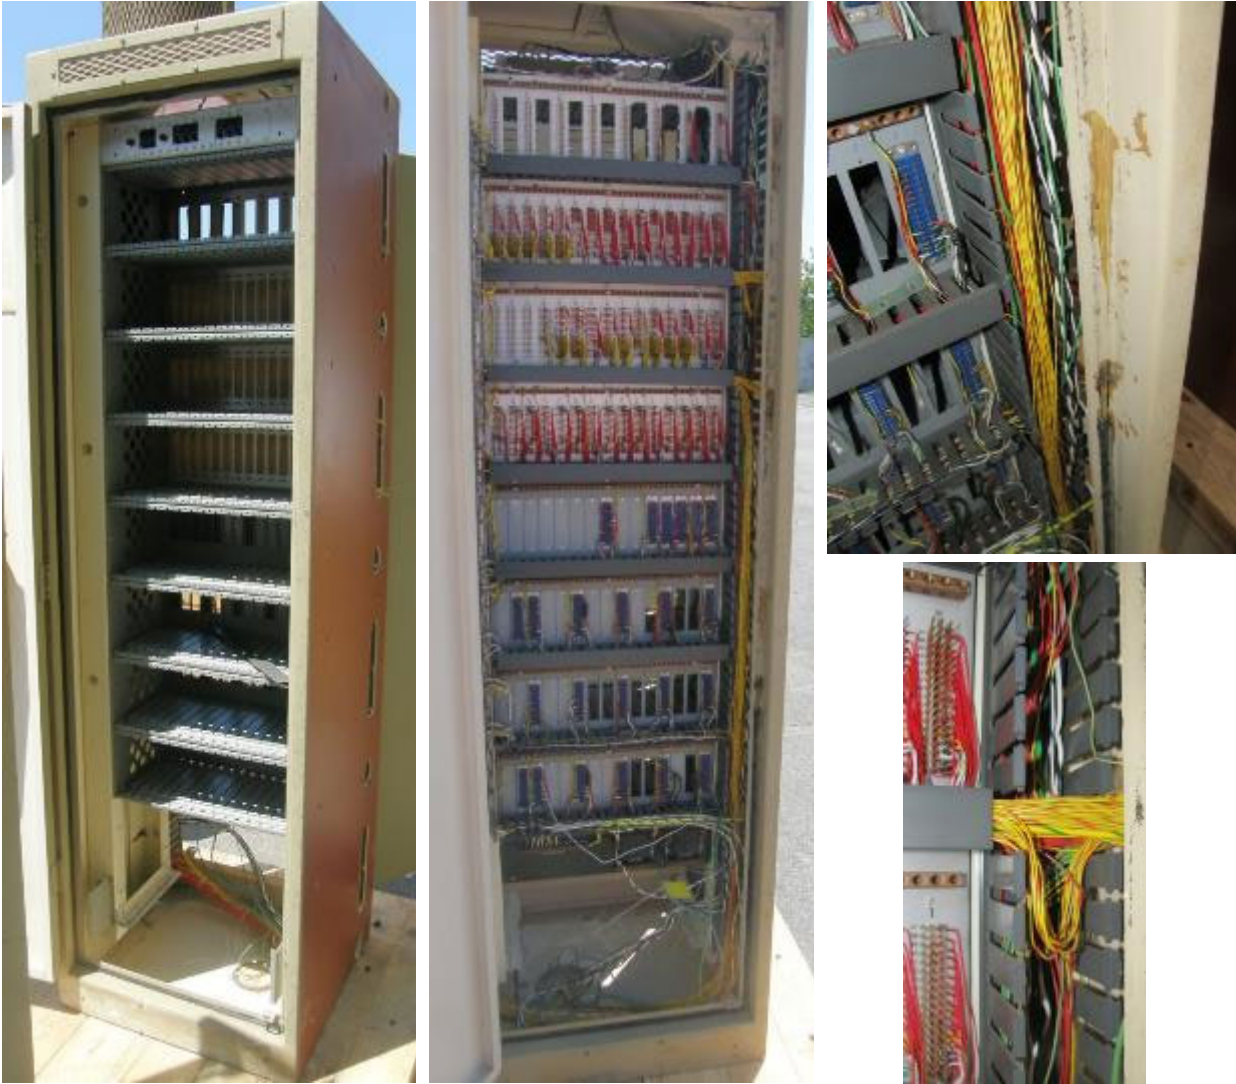
Enclosure 2 was very similar to Enclosure 1 on the exterior. The interior of Enclosure 2 was dedicated primarily to racks for circuit cards. There were a number of bundles containing relatively small wires running both vertically and horizontally. Plastic conduits (labelled "Panduit") was used to route the wire to the switches.

Figure 2-8. Photographs of Enclosure 2.

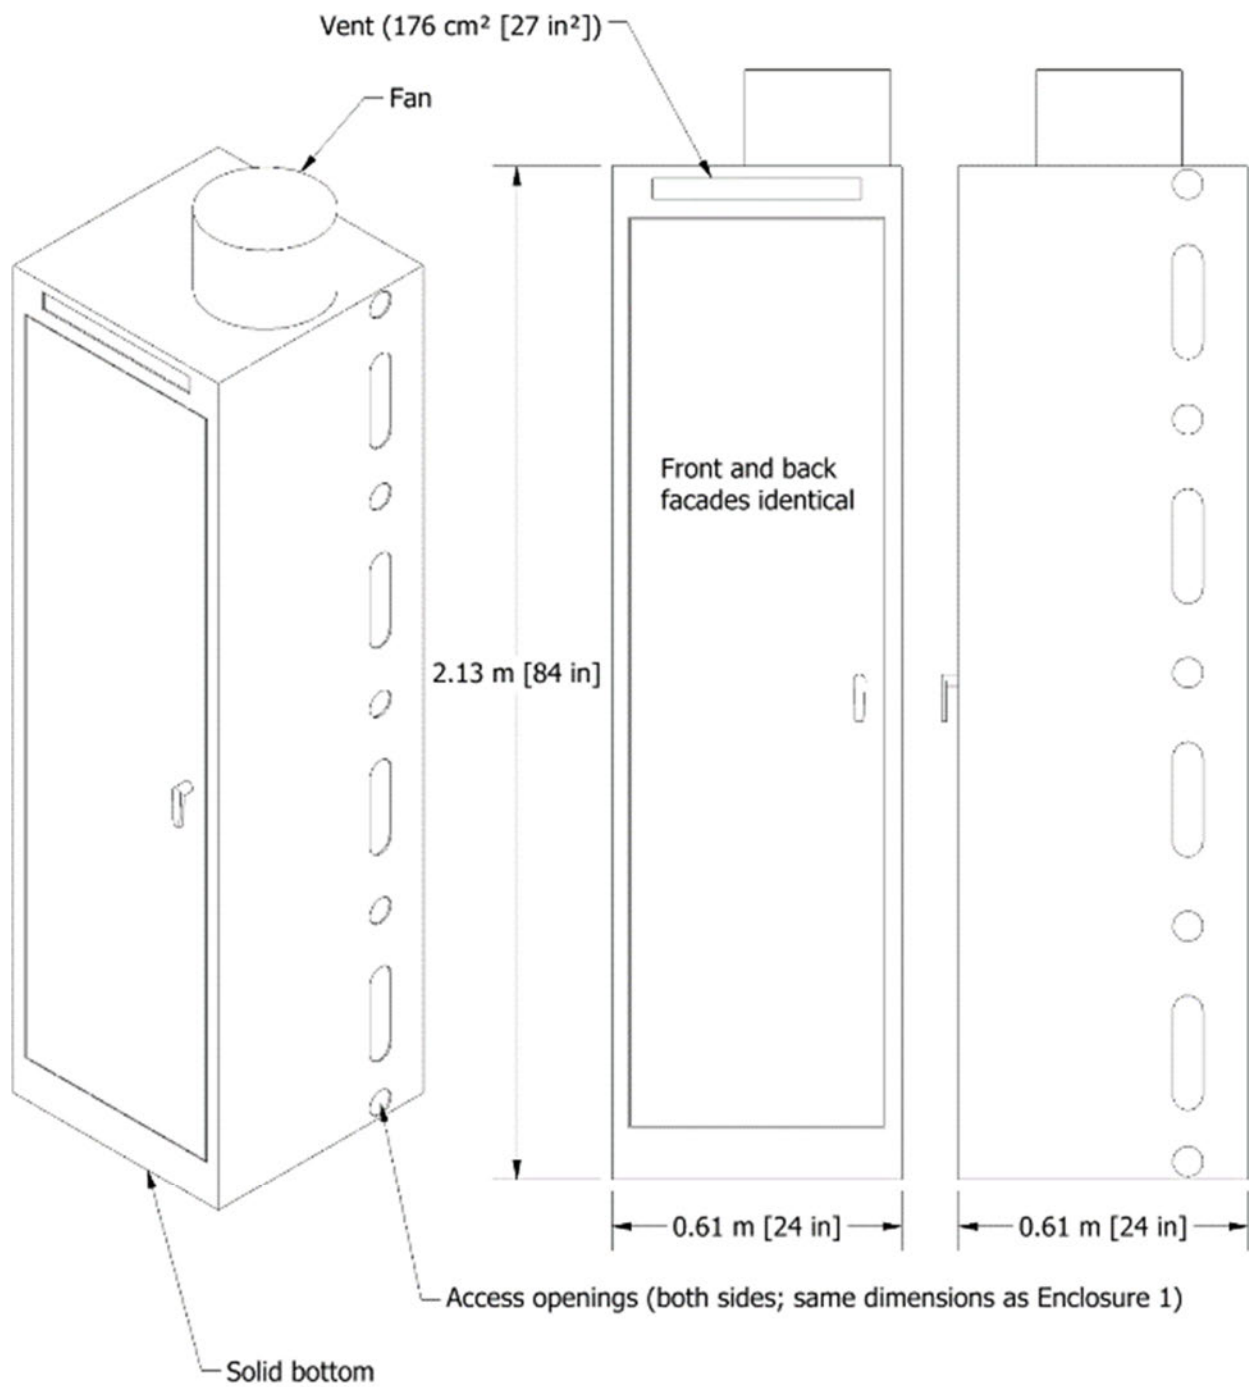
Enclosure 2

Figure 2-9. Sketch of Enclosure 2.

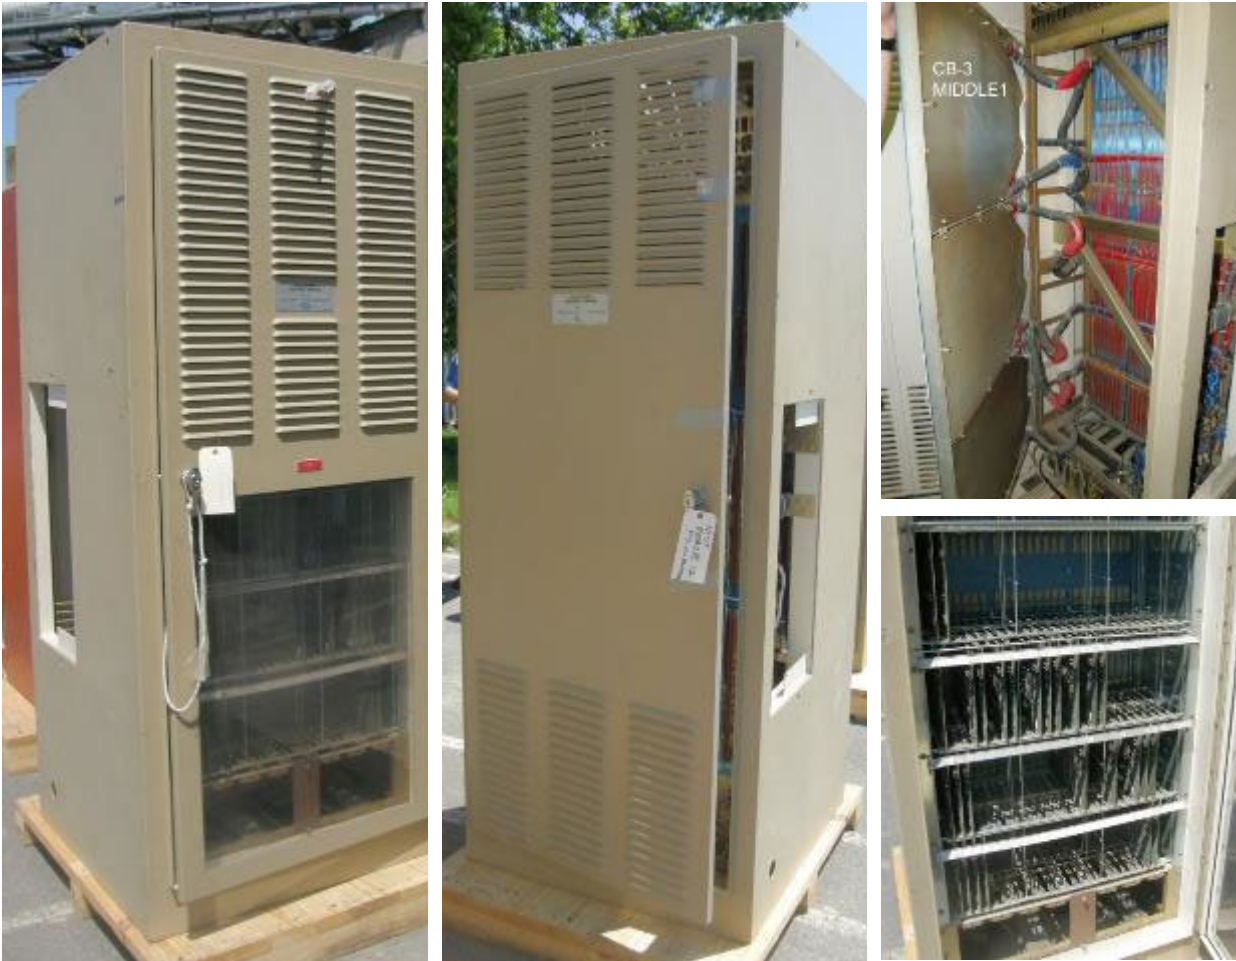
Enclosure 3 was labelled a “solid state control system.” It was divided into three sections. The front section contained a rack for holding circuit cards, as seen through the polymethyl methacrylate (PMMA) or Plexi-glass® window in Figure 2-10. The middle section (upper right photo) contained a large amount of relay wire. The rear section contained little combustible material. There was a relatively large access opening on the left side of the enclosure. There was also a relatively large opening in the floor.

Figure 2-10. Photographs of Enclosure 3.

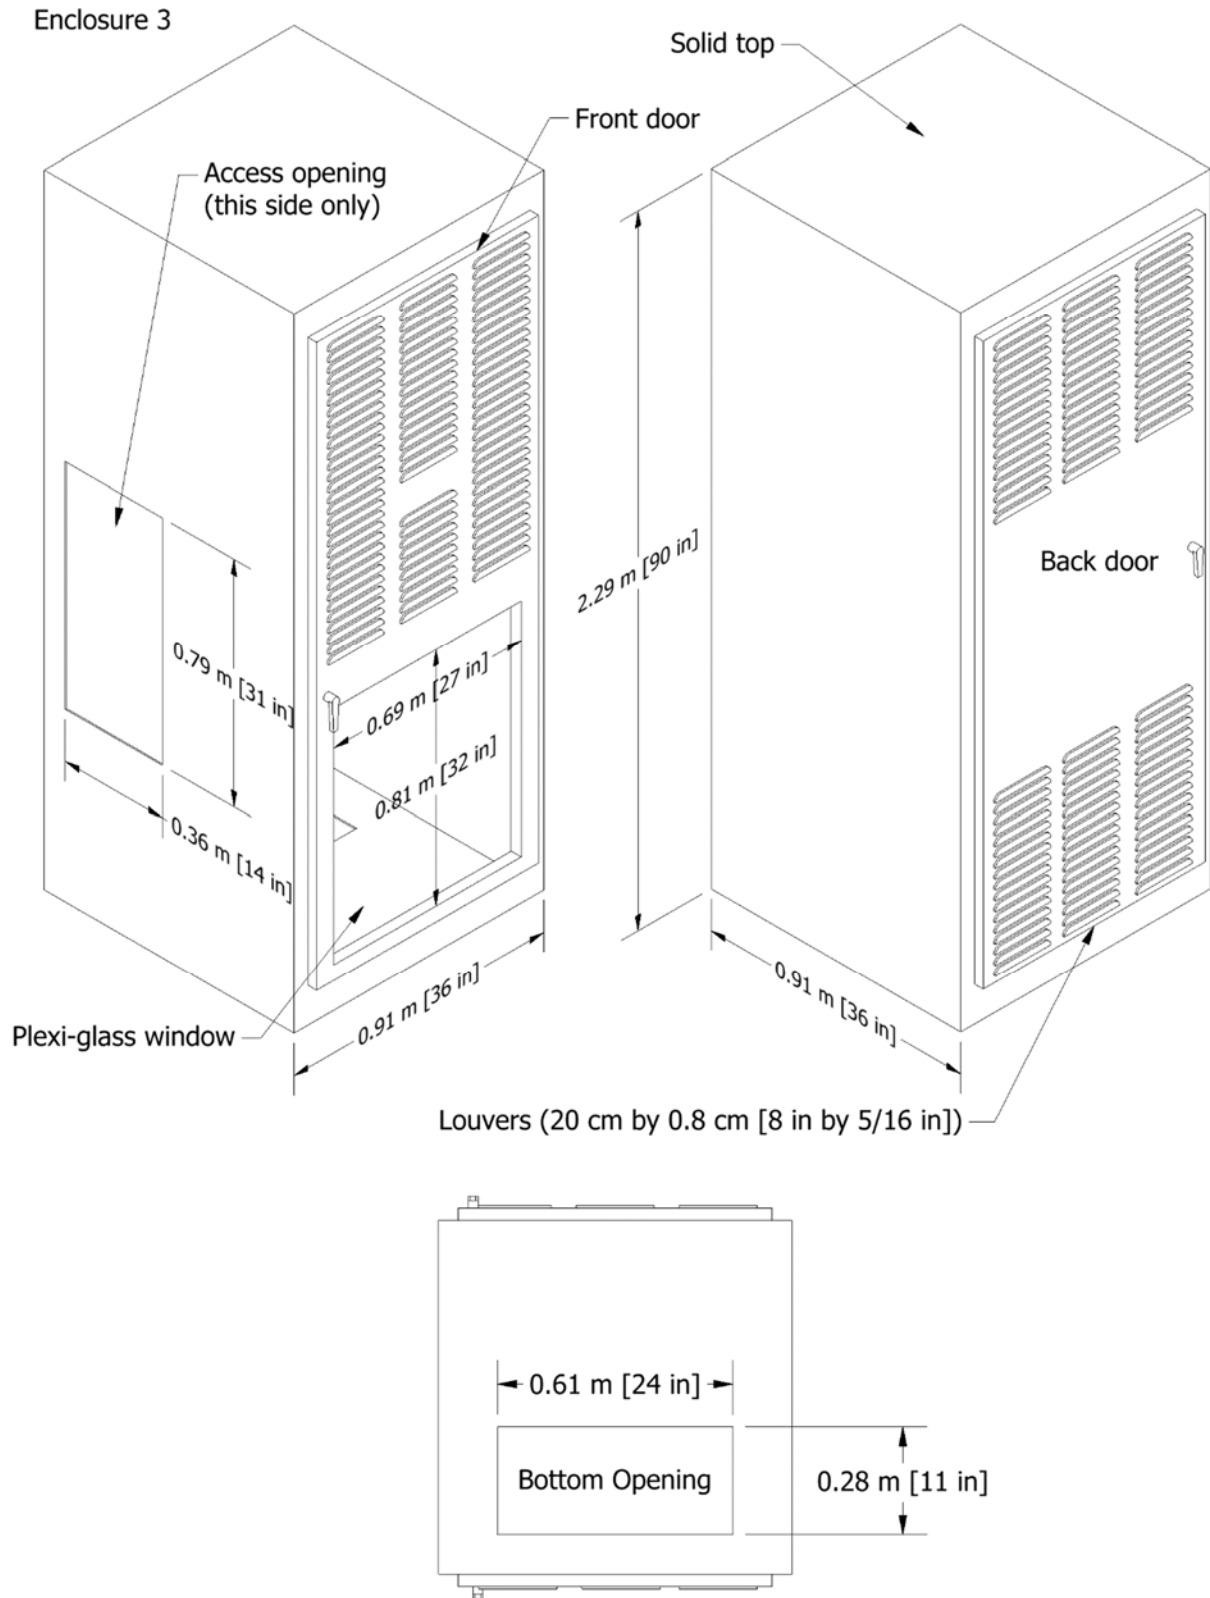
Figure 2-11. Sketch of Enclosure 3.

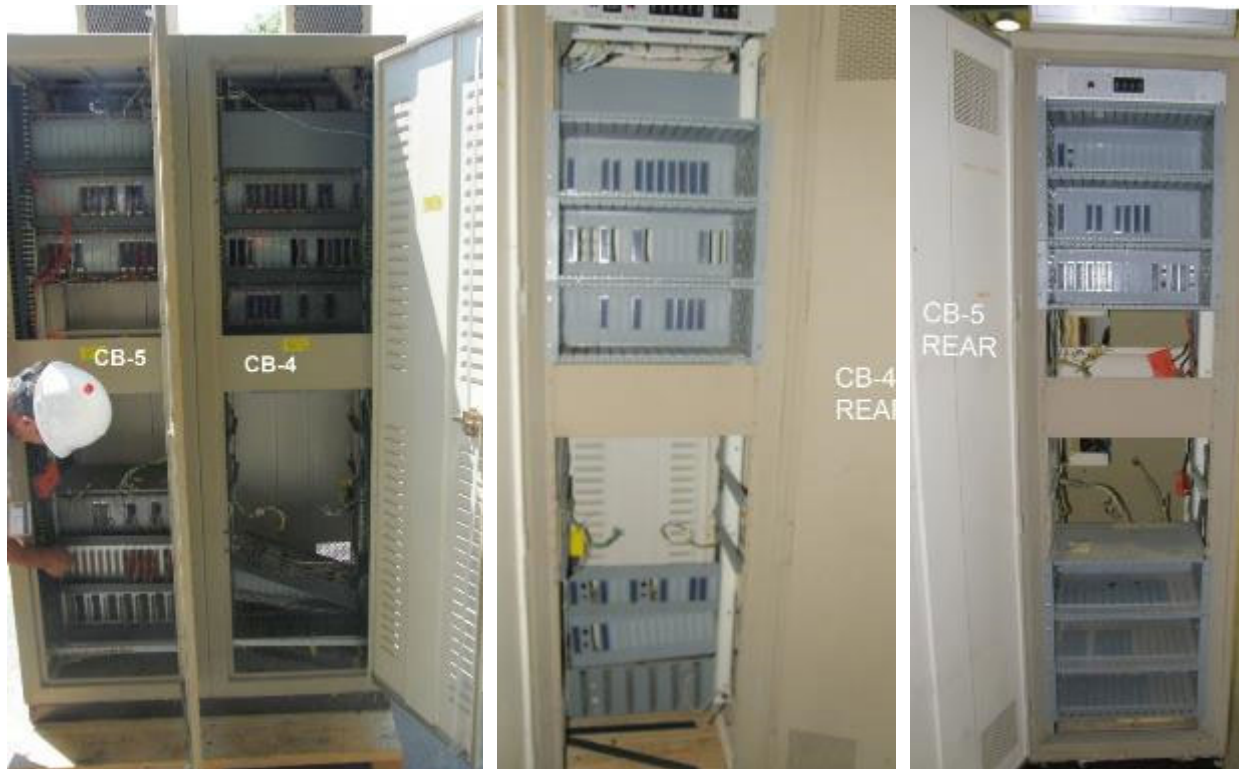
Enclosures 4 and 5 were bolted together and served as part of the “reactor protection system.” Both enclosures had similar exterior and interior features, including metal racks for circuit cards. Most of the circuit cards were removed prior to delivery, and the enclosure was reconfigured to mimic other types of enclosures. There was a small amount of miscellaneous wire left in the enclosure, but not enough to constitute a significant combustible load. The fans on the tops of the enclosures were functional, but it was decided not to operate them during testing because each would drive smoke downward and out the bottom, and this smoke would not be captured by the exhaust hood. An exploratory test was conducted to verify this effect, but it is not documented in this report.

Figure 2-12. Photographs of Enclosures 4 and 5.

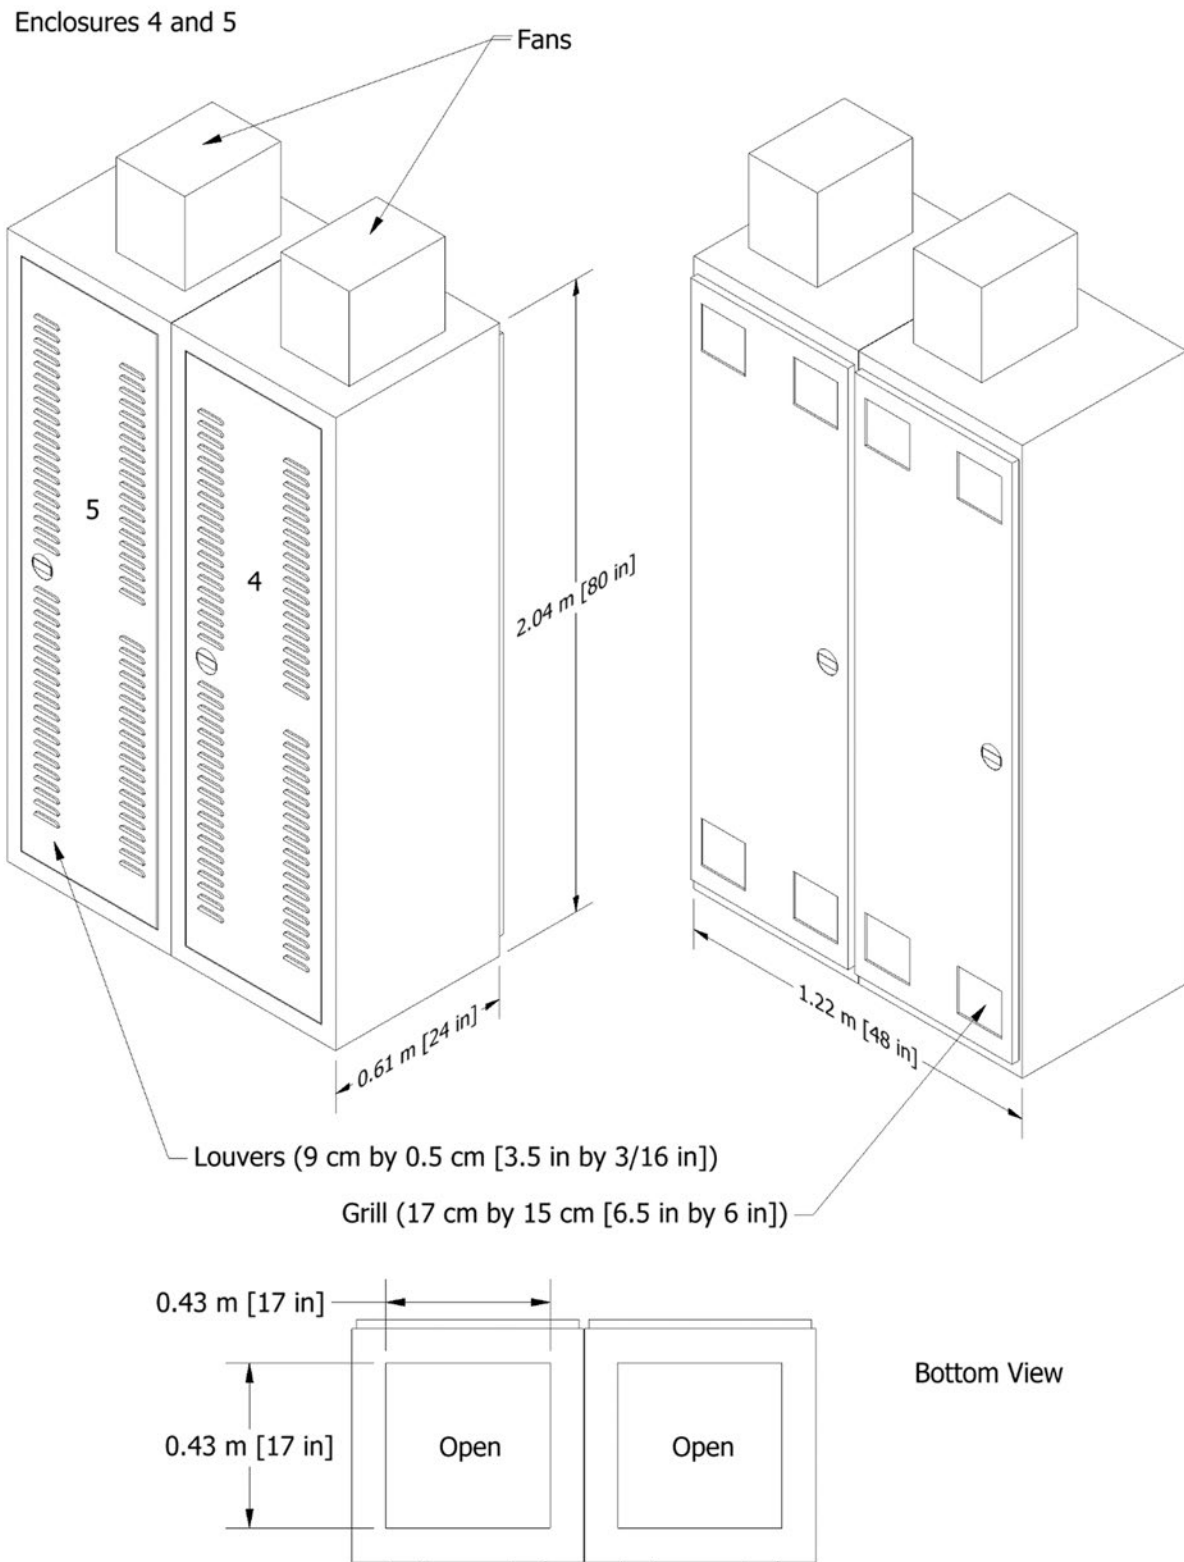
Figure 2-13. Sketch of Enclosures 4 and 5.

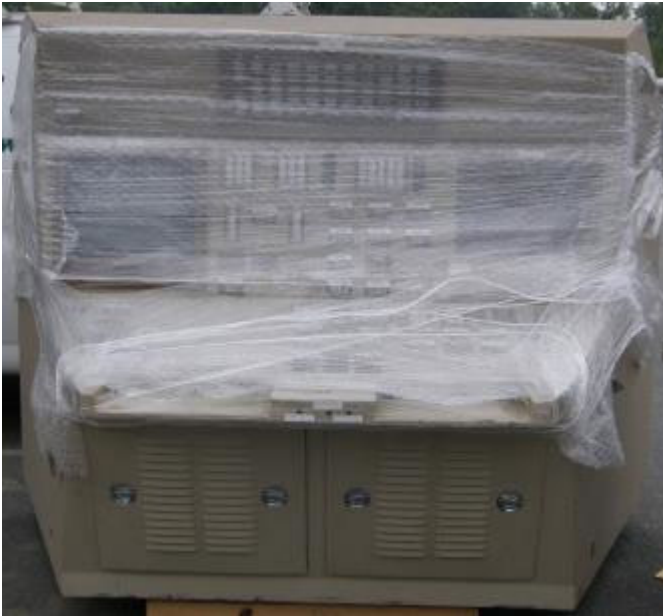
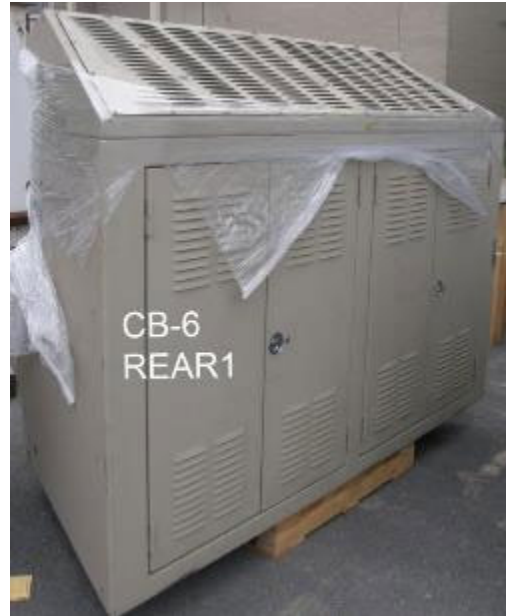
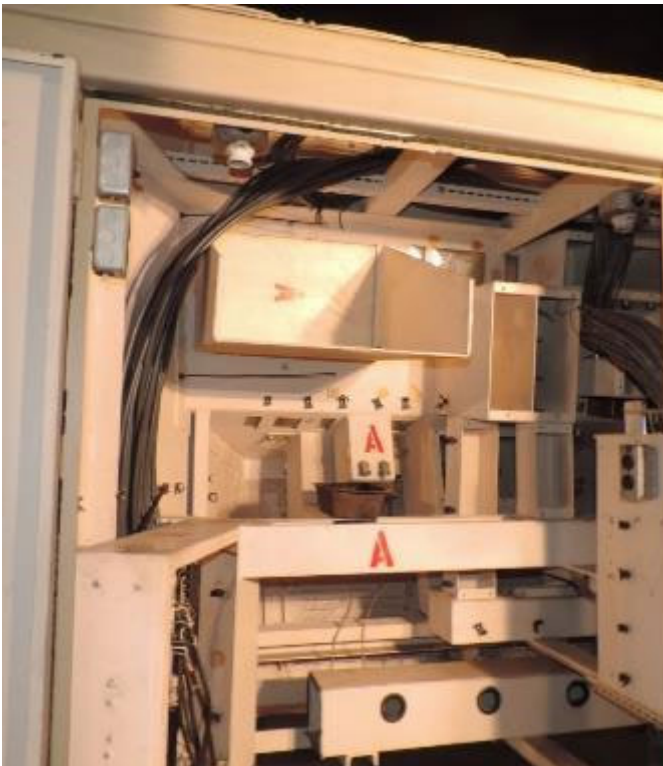
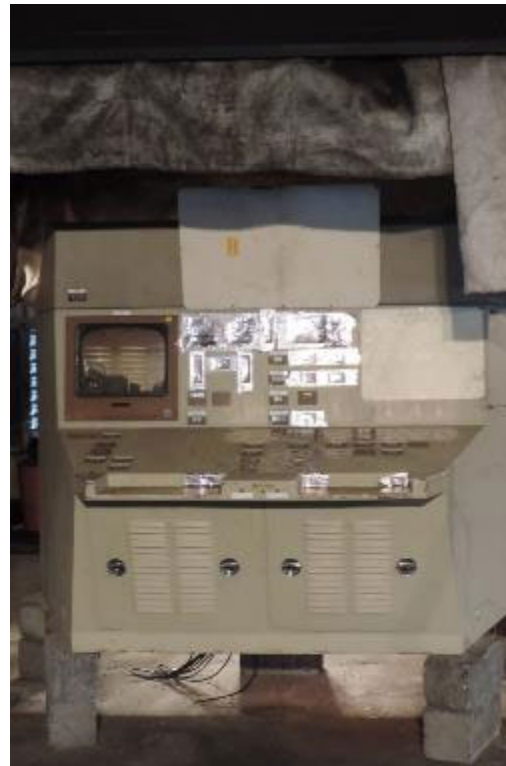
Enclosure 6 was a section of the main control room “horseshoe.” Its two side panels were beveled at angles of 22.5° to achieve a 45° turn near the apex of the horseshoe. The enclosure was well-ventilated via louvers on its front, rear, and top. Additionally, its floor was largely open.

Figure 2-14. Photographs of Enclosure 6.
