Heat Release Rates of Electrical Enclosure Fires (HELEN-FIRE)

Final Report

This report documents an experimental program to explore the heat release rate and burning behavior of electrical enclosures commonly found in nuclear power plants. Electrical enclosures are a potential source of fire in nuclear power plants because they contain both combustible materials and live electrical circuits. These fires have the potential to disrupt power, instrumentation, and control in the plant. Key parameters affecting fire in an enclosure include its size, openings, electrical voltage, and combustible load.

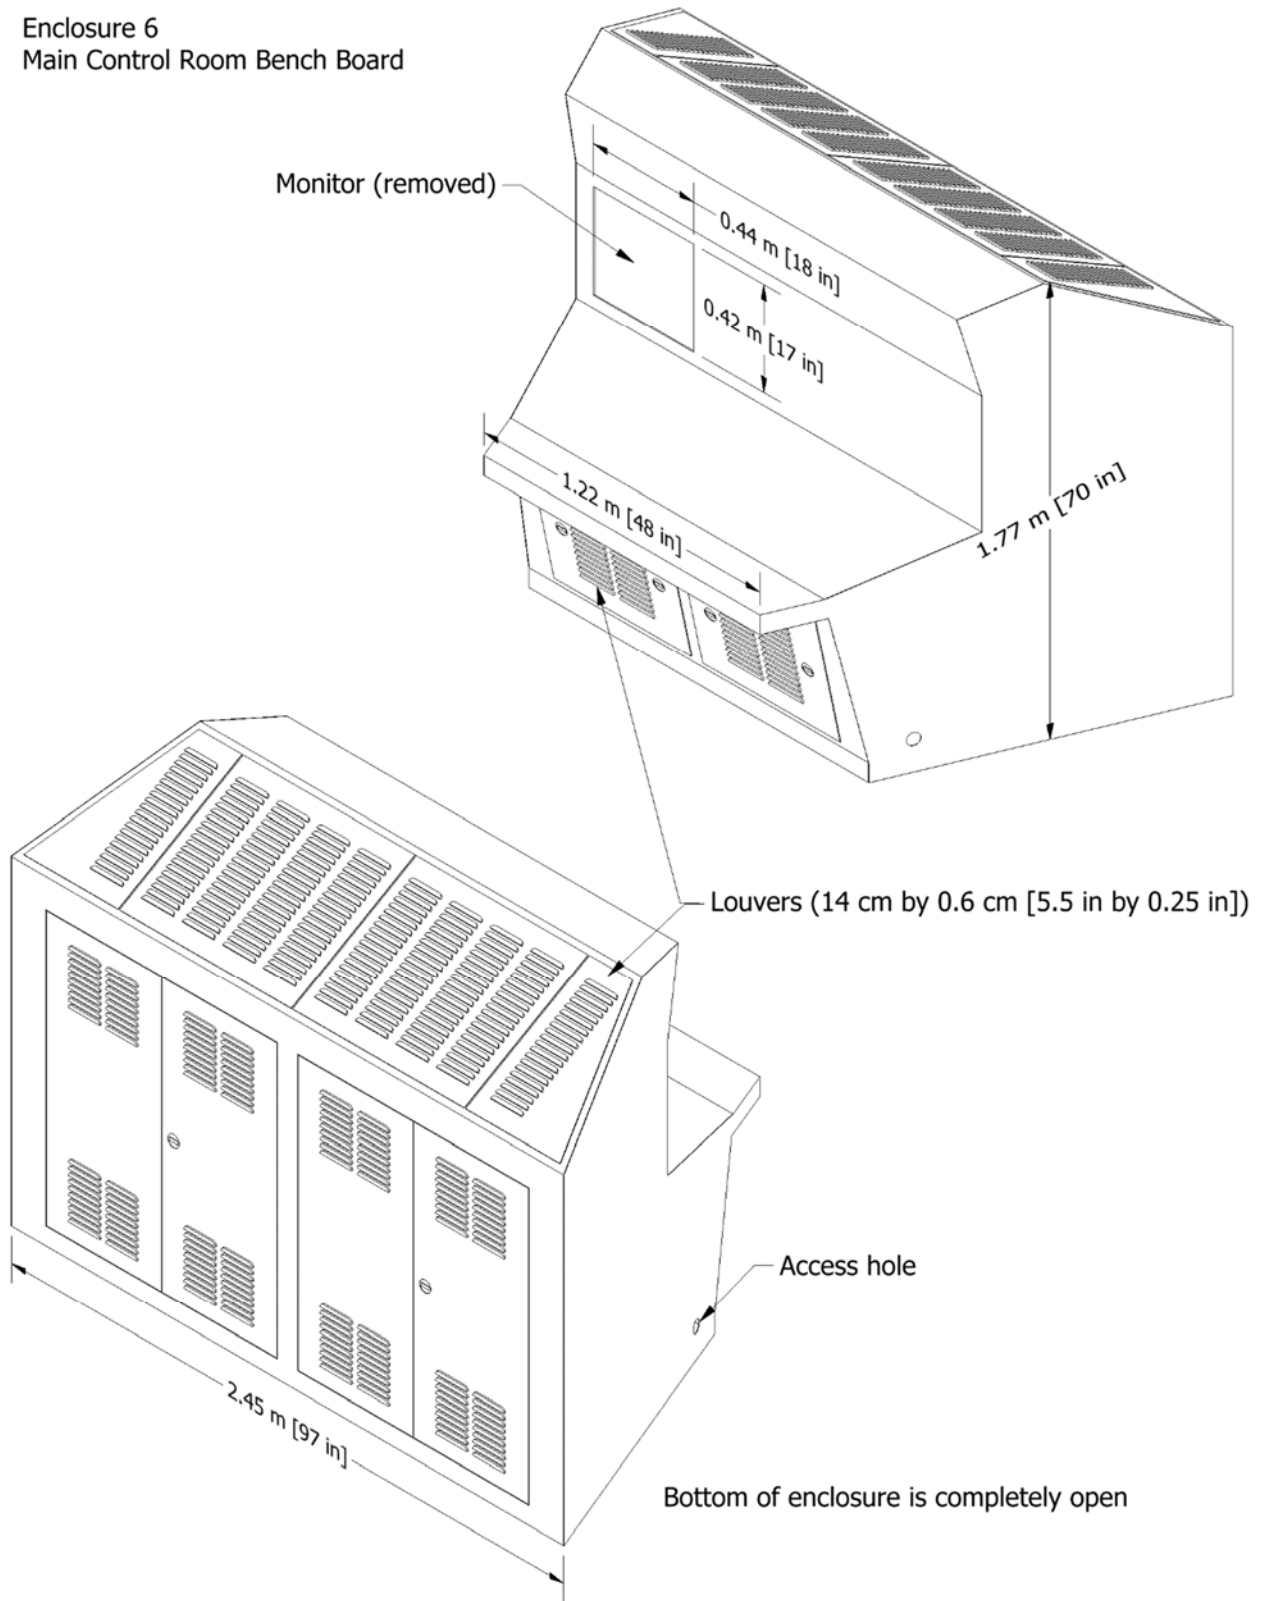
Enclosure 6
Main Control Room Bench Board

Figure 2-15. Sketch of Enclosure 6.

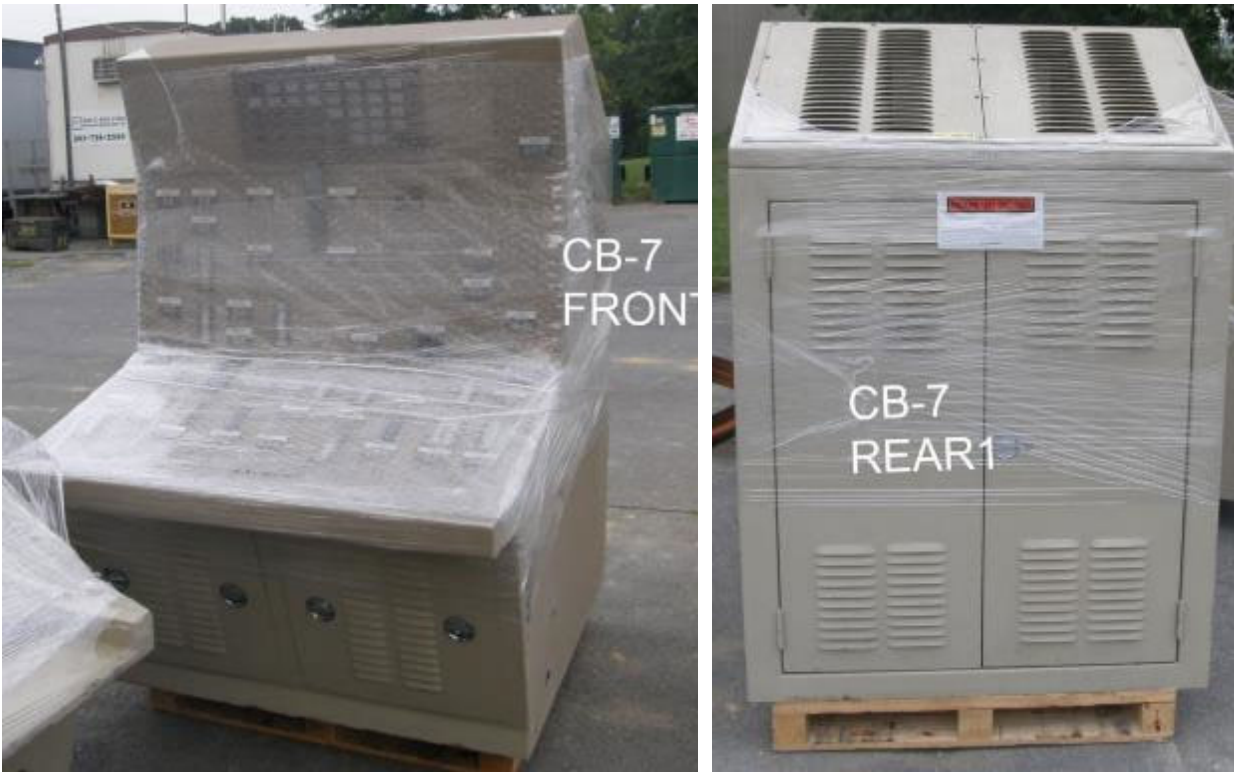
Enclosure 7 was a straight section of the main control room “horseshoe”. Its interior was similar to that of Enclosure 6. Much of it was compartmentalized, and, as delivered, there was not a significant amount of combustible materials.

Figure 2-16. Photographs of Enclosure 7.

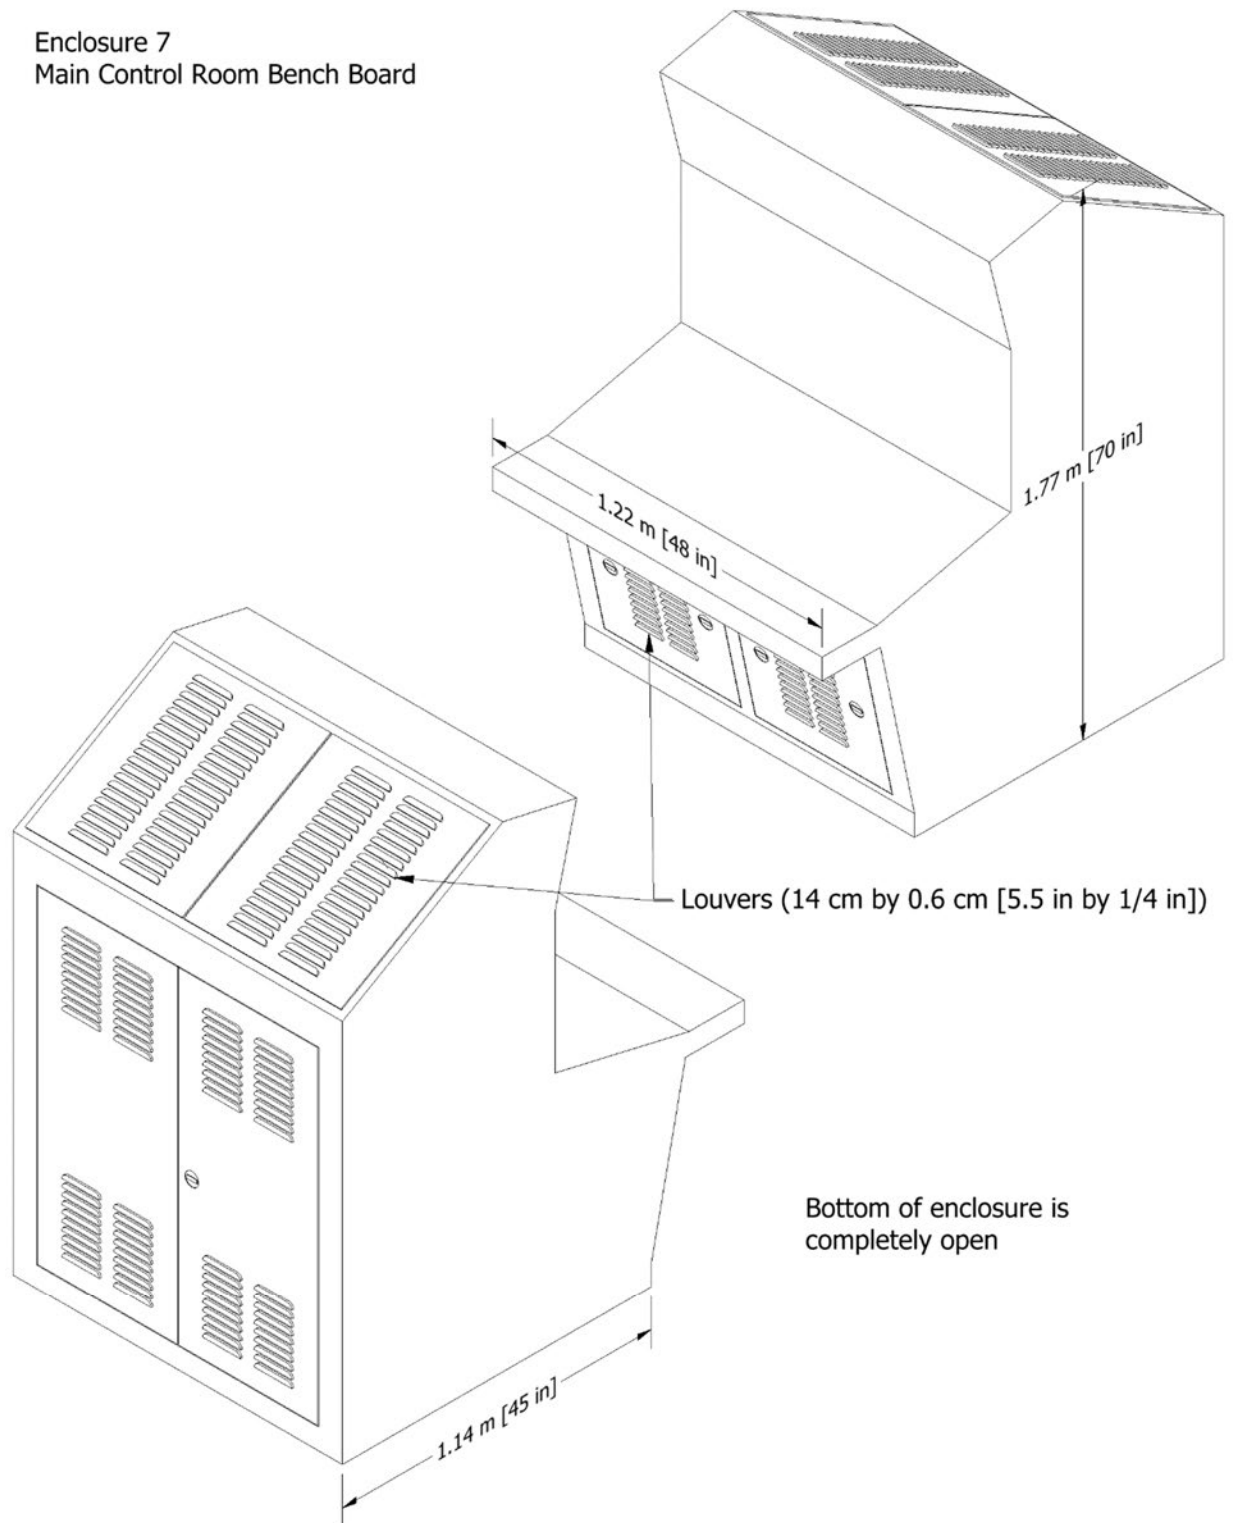
Enclosure 7
Main Control Room Bench Board

Figure 2-17. Sketch of Enclosure 7.

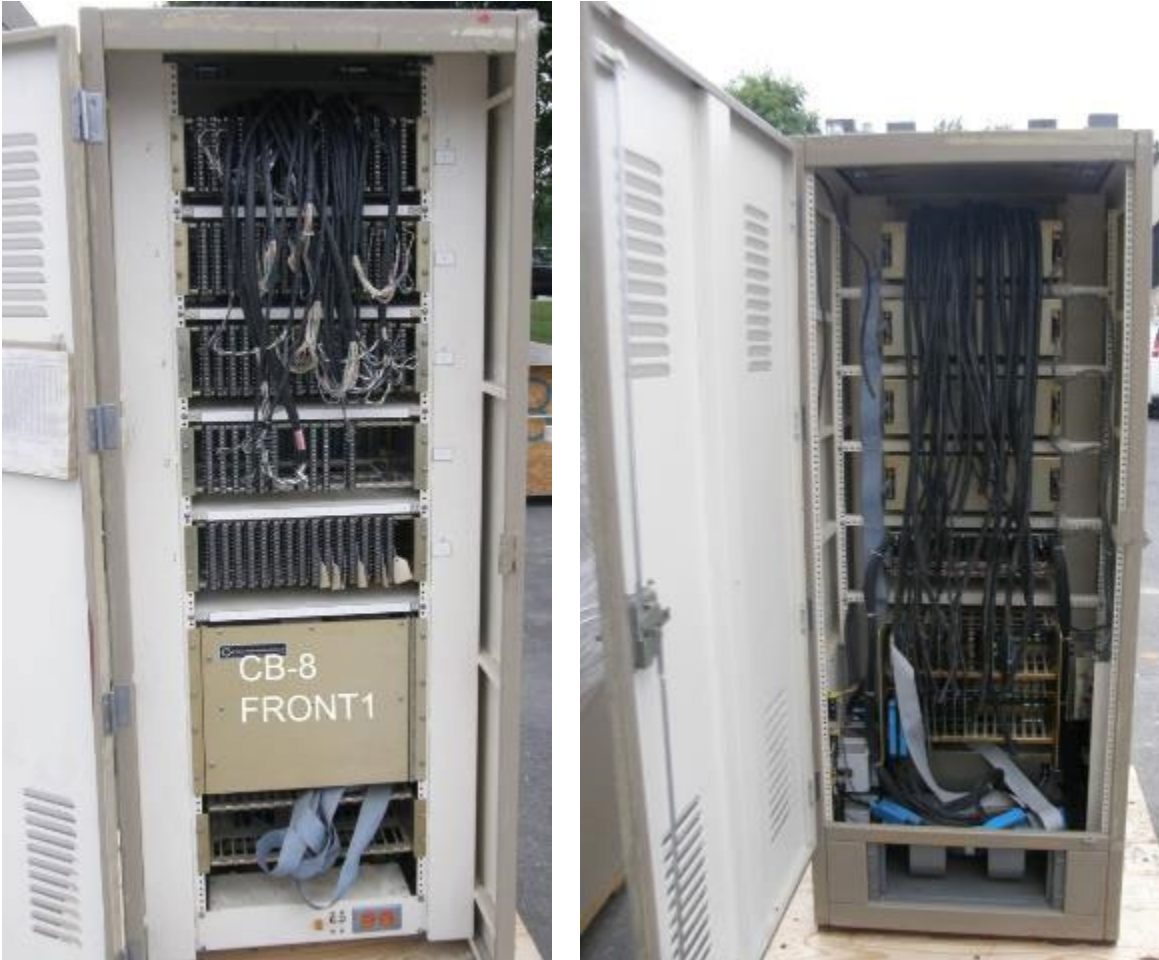
Enclosure 8 was labelled a “SEAMS Multiplexer”. SEAMS means “Support Equipment Acquisition Management System.” The notable feature of this enclosure were the conduits used for routing cable out the top and, presumably, into cable trays overhead. To mimic this configuration, a 1.2 m (4 ft) section of cable tray was mounted 45 cm (18 in) above the enclosure to collect the exiting cables.

Figure 2-18. Photographs of Enclosure 8.

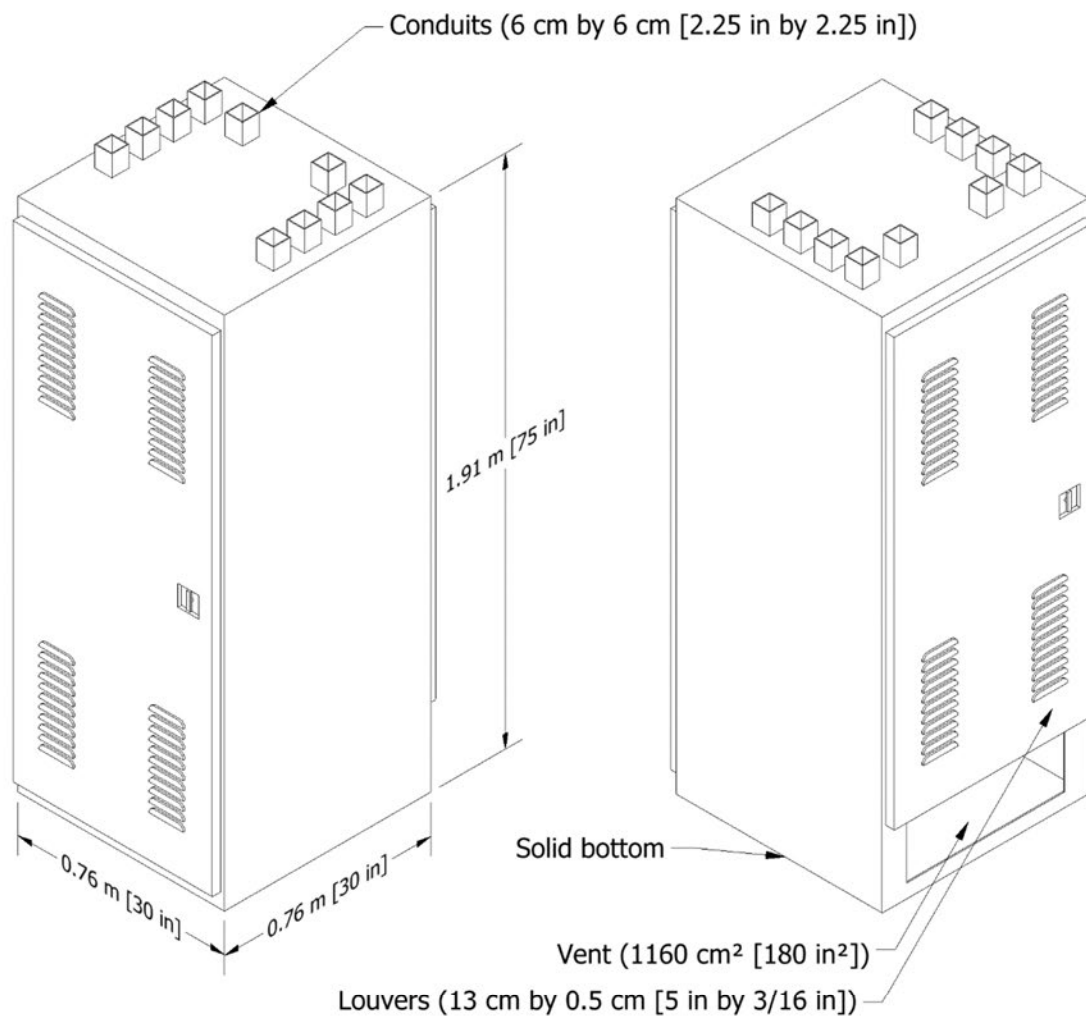
Enclosure 8

Figure 2-19. Sketch of Enclosure 8.

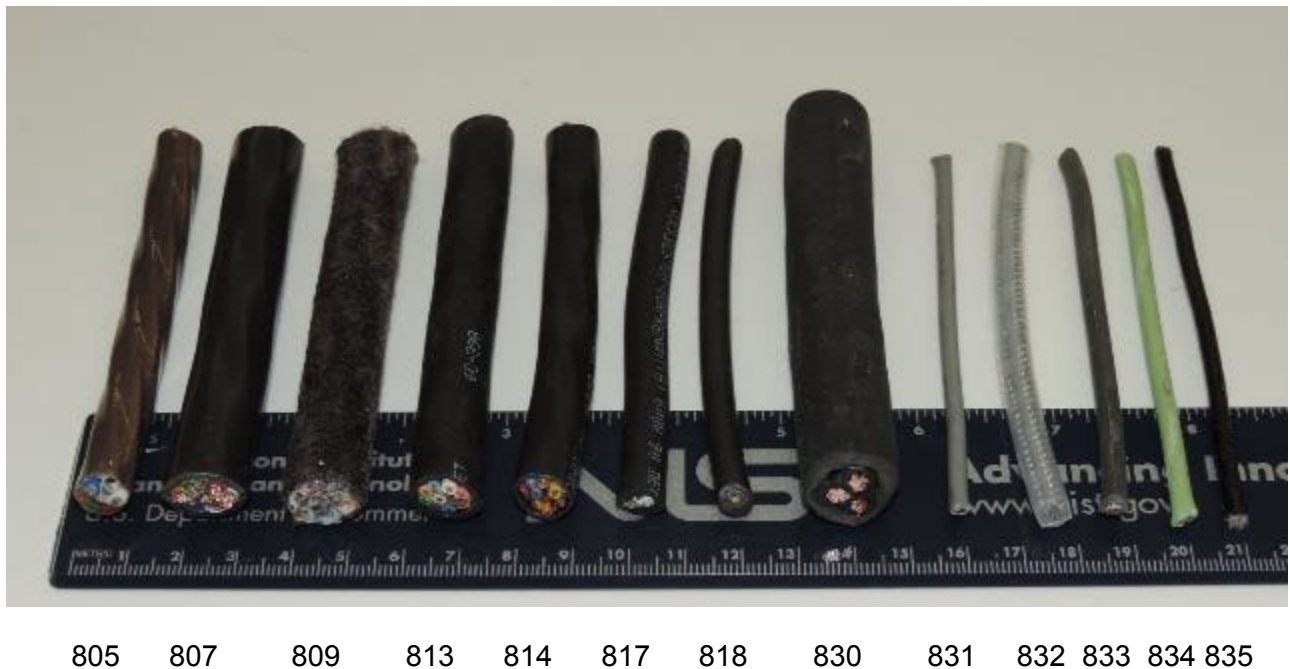
Figure 3-1. Photograph of Cables 805-835.

The tables on the following pages contain a general description of the cables that were used to mock up different enclosure configurations. Note that the “Cable No.” is merely an identifier and has no relevance beyond this project. Photographs of the cables are shown in Figure 3-1 through Figure 3-3. The cable markings are listed in Table 3-1. The cable properties are listed in Table 3-2. The property data was obtained by dissecting 20 cm (8 in) cable segments into their constituent parts – jacket, filler, insulators, and conductors. Note that the “Class” of cables, either TS for thermoset or TP for thermoplastic, refers to the broad classification of the two main types of cables used in plants.

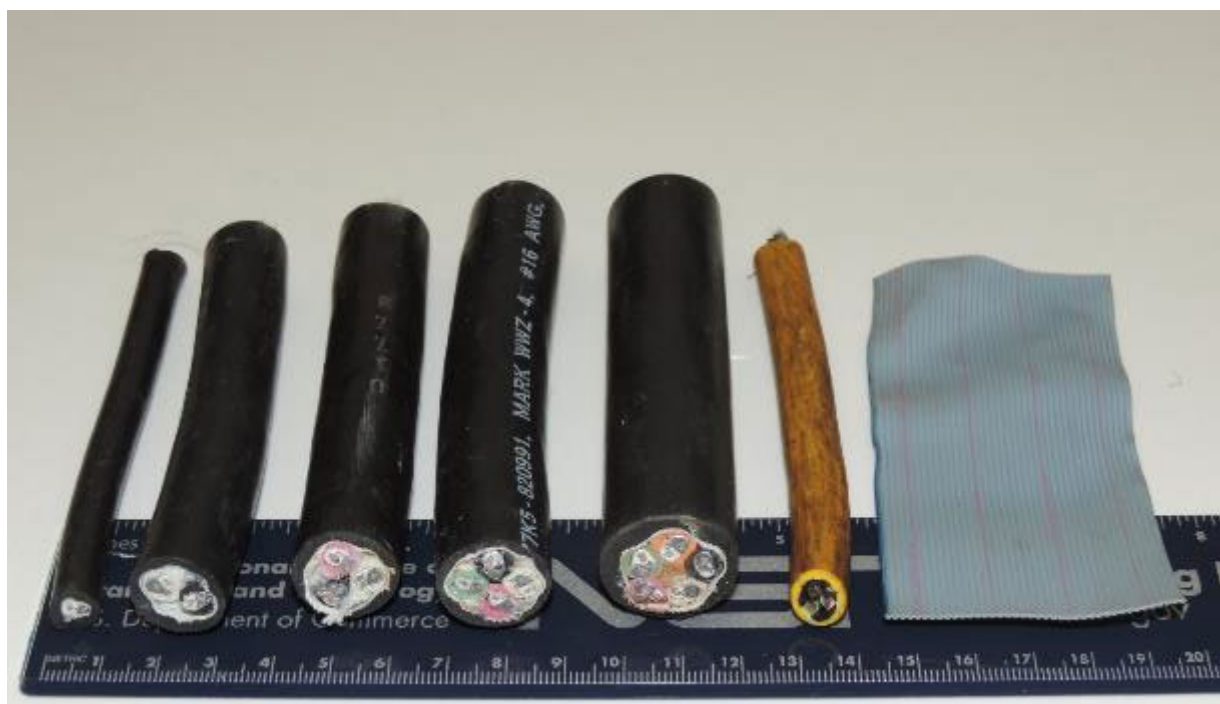
836 837 838 839 840 841 842

Figure 3-2. Photograph of Cables 836-842.

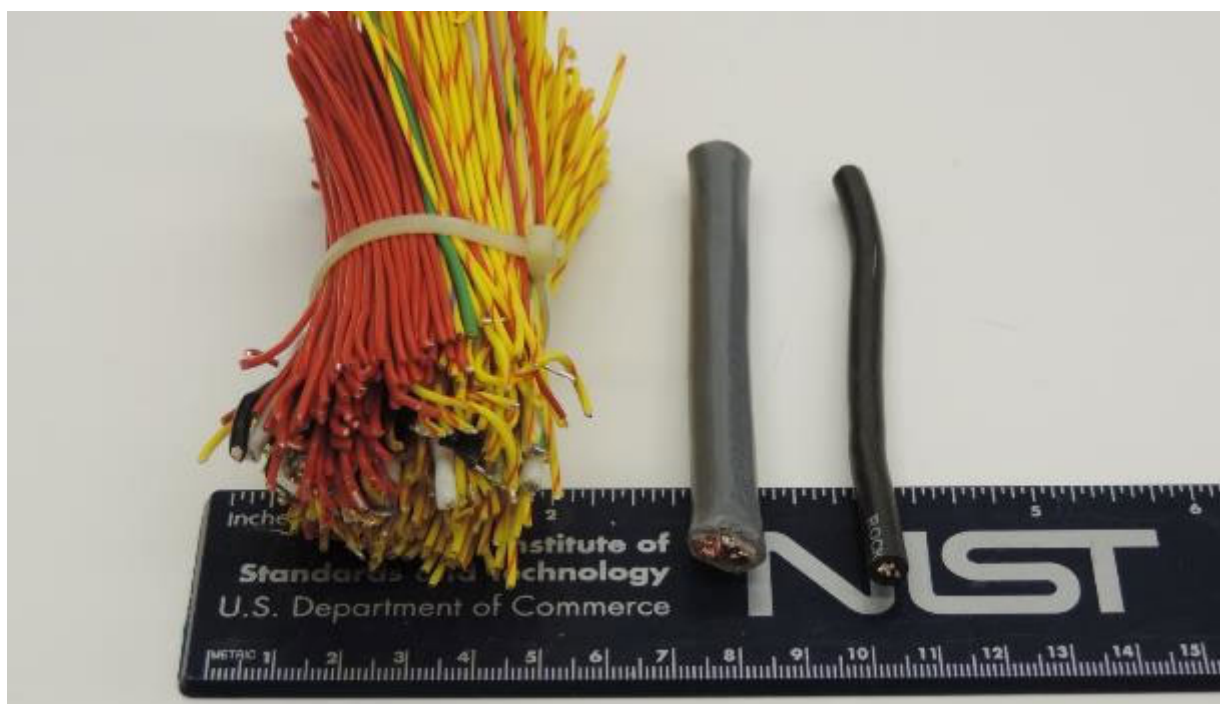
843 844 845

Figure 3-3. Photograph of Cables 843-845.

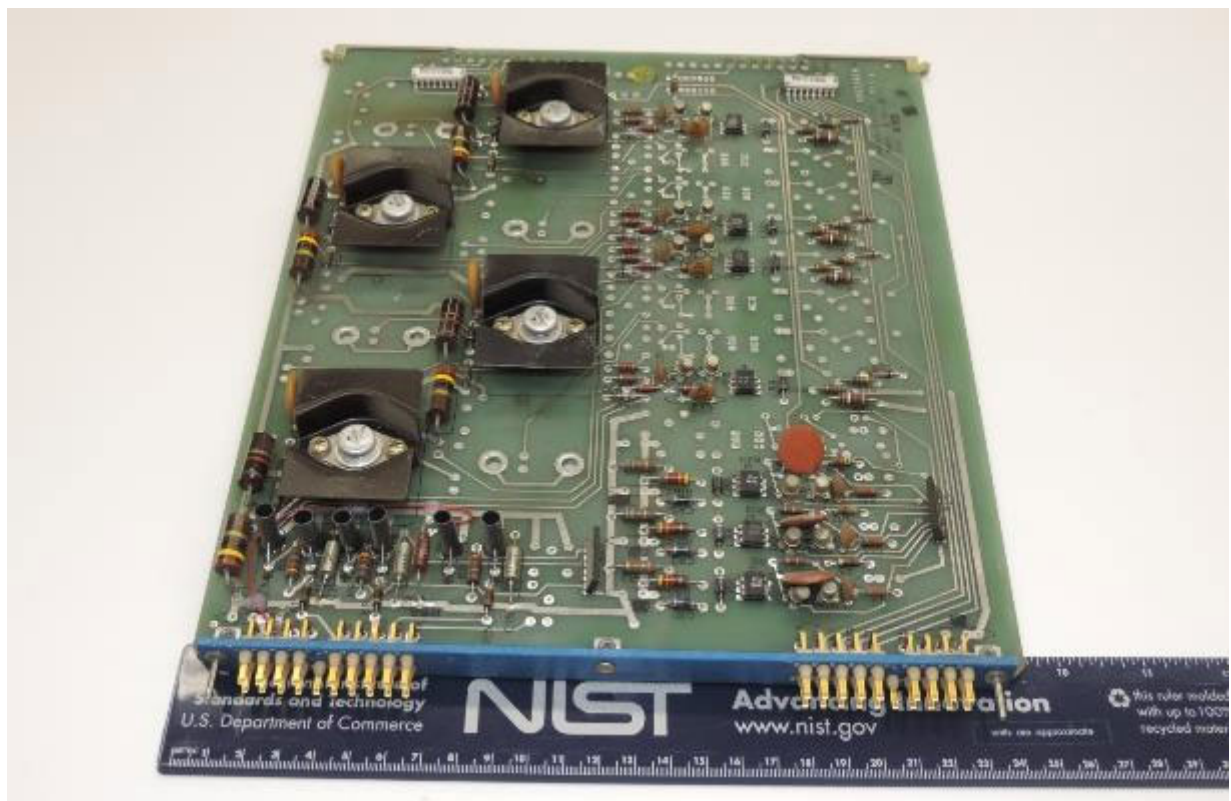
Figure 3-4. Photograph of a circuit card installed in Enclosure 3.

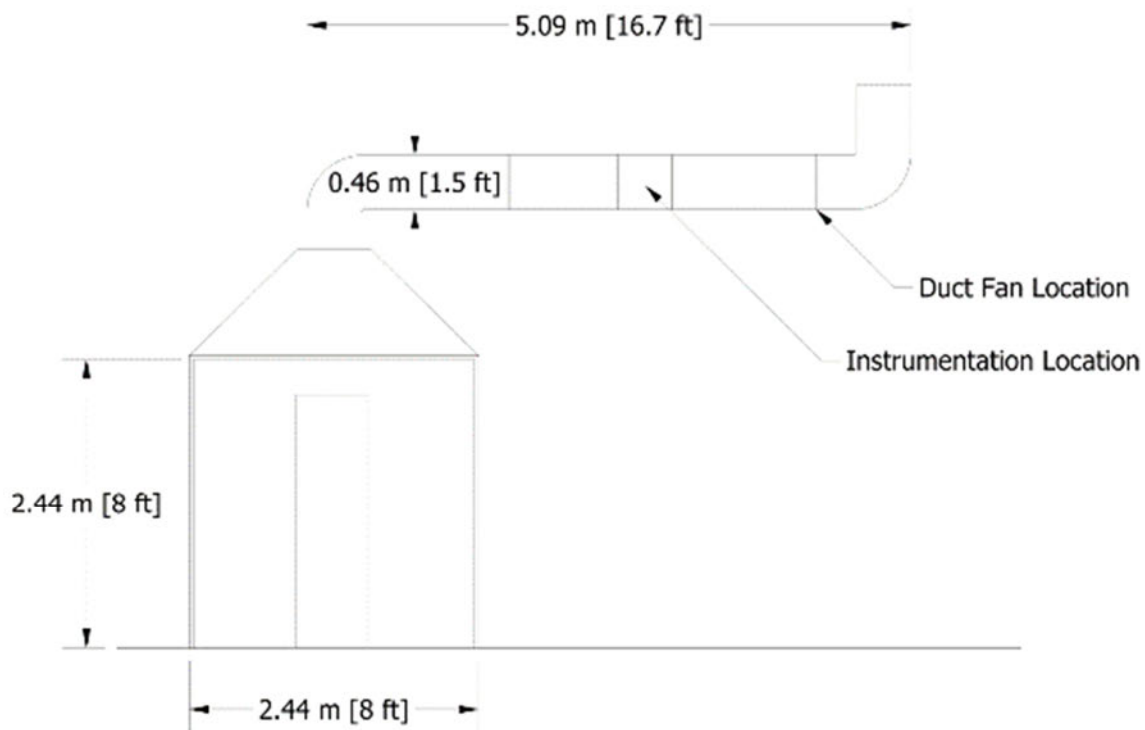
The measurements of the heat release rate (HRR) of the enclosure fires were performed at the Chesapeake Bay Detachment of the Naval Research Laboratory². This facility has a large-scale calorimeter that is nominally 6.1 m by 6.1 m (20 ft by 20 ft), designed to measure the HRR of fires ranging from approximately 100 kW to 10 MW. However, its instruments are not sensitive enough to measure accurately the HRR of the small fires that were expected in many of the enclosure experiments. For this reason, a smaller calorimeter (see Figure 4-1) was built to fit underneath the large hood (see Figure 4-2). The smaller hood was 2.4 m by 2.4 m (8 ft by 8 ft), and 2.4 m (8 ft) off the floor. Its 46 cm (18 in) duct was instrumented with a Rosemount Annubar® to measure the volume flow, four thermocouples to measure the gas temperature, and a gas extraction tube to measure the oxygen concentration of the exhaust gases. The instruments were located approximately 4 m (13 ft) from the vertical centerline of the hood.

Figure 4-1. Schematic diagram of the small calorimeter.

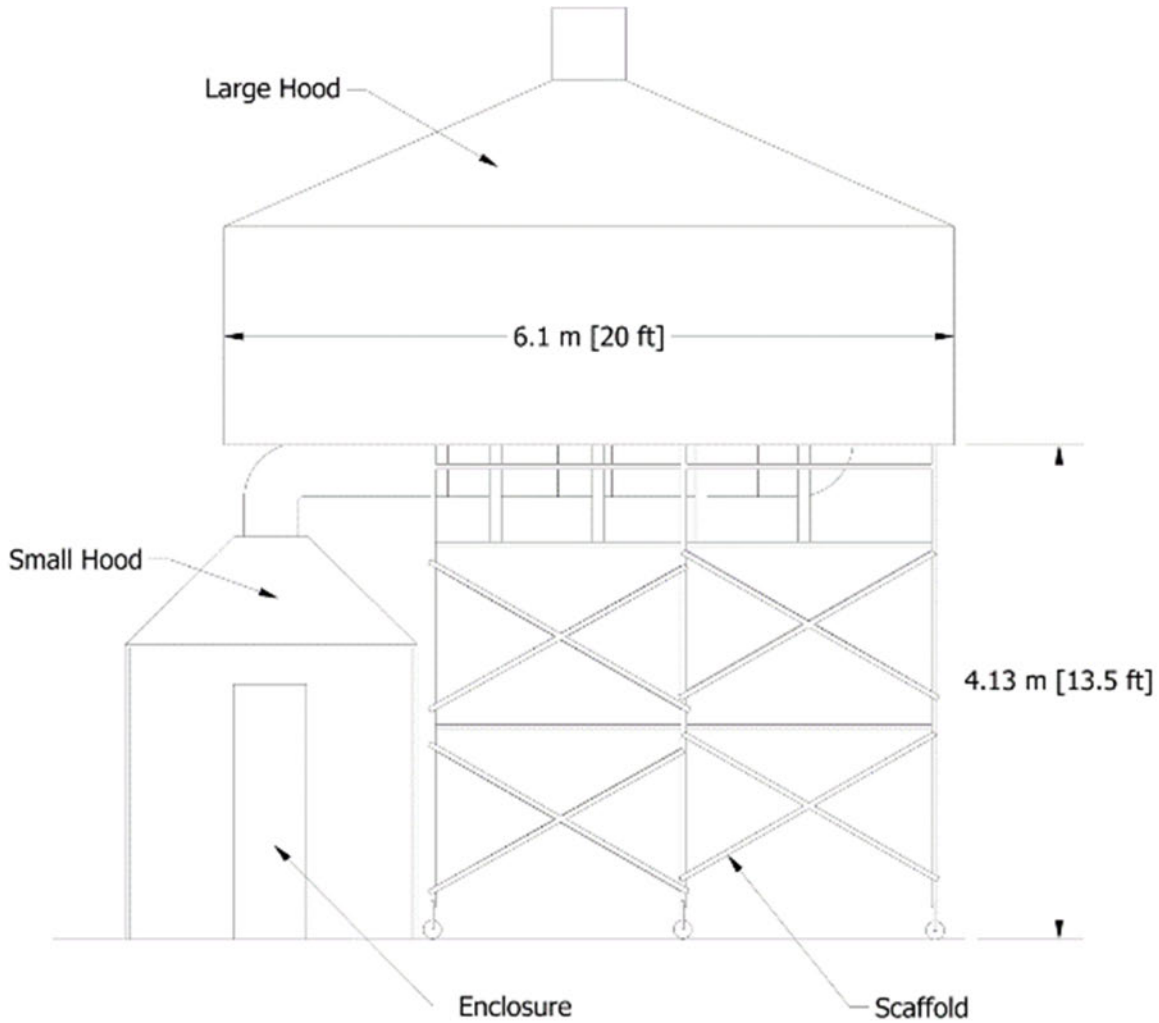
Figure 4-2. Schematic diagram of the small calorimeter underneath the large hood at the CBD test facility.

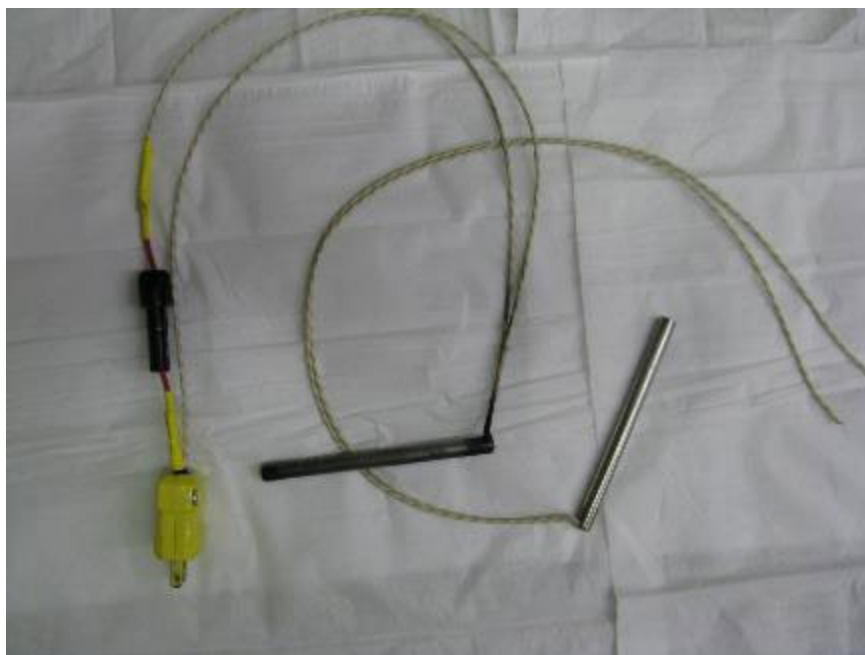
Figure 4-3. Two 300 W cartridge heaters. One has an in-line circuit breaker.

A cartridge heater is a cylindrical rod approximately 15 cm (6 in) in length and 1 cm (0.4 in) in diameter (Figure 4-3) that can be inserted lengthwise within a bundle of electrical wires or cables. Bench-scale experiments were conducted prior to the full-scale experiments to determine the exact dimensions and power requirements for reliable, reproducible ignition. A bundle of cables, each 15 mm in diameter, was ignited with a 300 W heater and spark igniter. However, the heaters were used only for a single full-scale experiment because they were prone to shorting following ignition and the spark igniter drew too much power from the existing electrical circuit in the laboratory. Consequently, the cartridge heaters were abandoned for the remainder of the program.

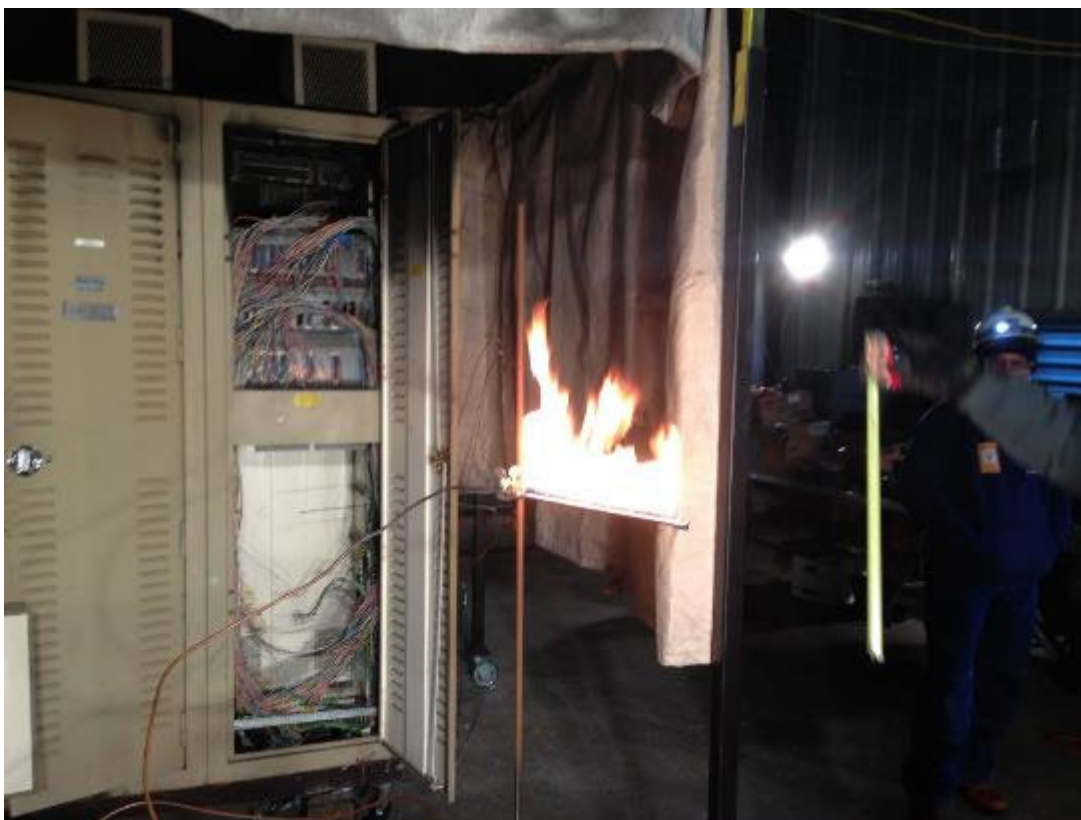
Figure 4-4. Photograph of 30 cm (12 in) propane line burner.

Two propane “line burners” were used as the principal ignition sources. The smaller of the two was constructed from 0.95 cm (3/8 in) copper tubing and was 5 cm (2 in) long. The larger was constructed of the same type of copper tubing and was 30 cm (12 in) long (see Figure 4-4). The smaller burner produced flames with HRRs in the range of 0.5 kW to 2 kW. The larger burner produced flames in the range of 4 kW to 10 kW. The propane flowing to the burners was

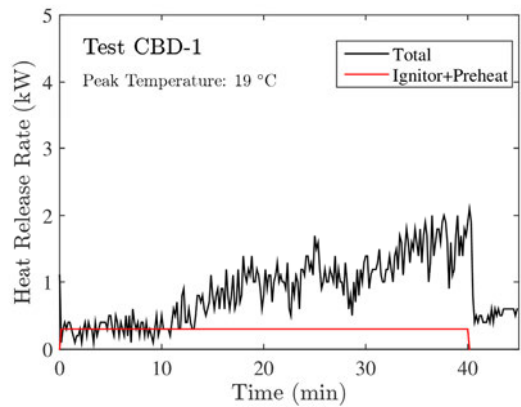
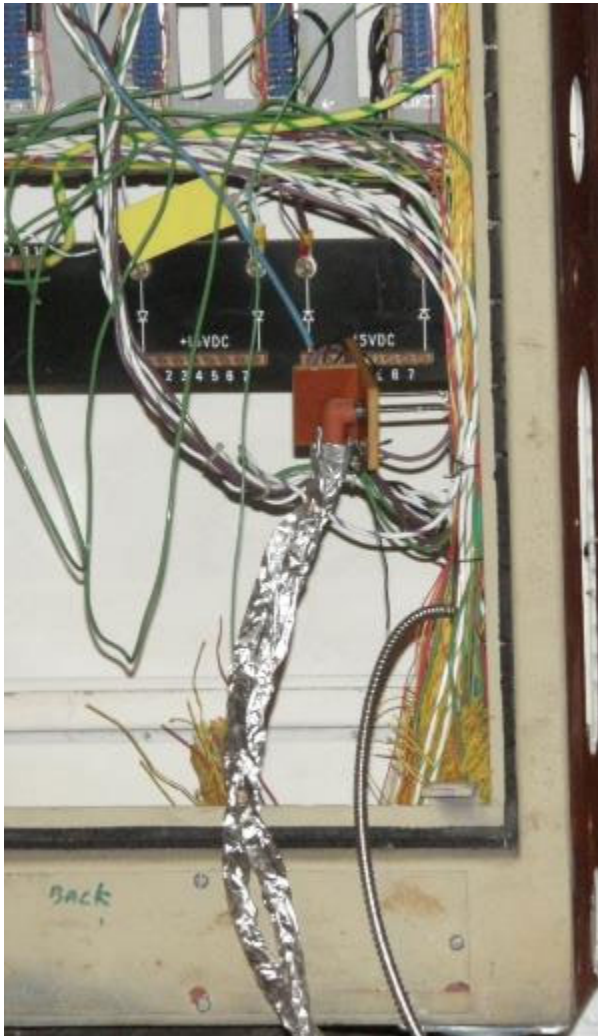
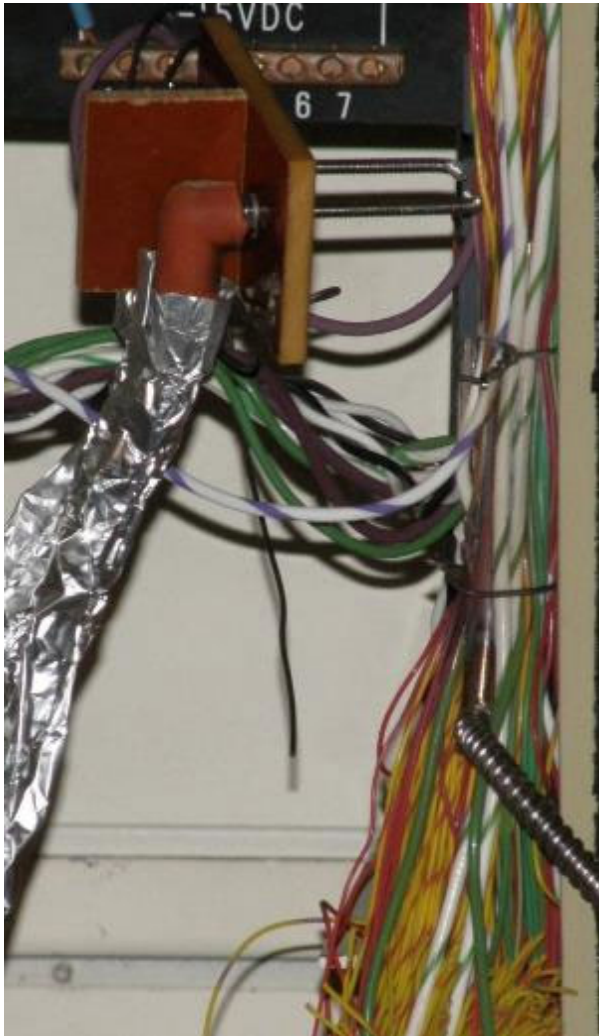
Table 5-3. Summary of Test 1

<p>Test: 1</p> <p>Enclosure: 1</p> <p>Fuel Load: 7/C control cables</p> <p>Ignition Source: 300 W cartridge heater</p> <p>Ventilation: Door open</p> <p>Notes: The fire did not spread beyond its point of origin (right side of photos below). The heater was turned off at 40 min.</p>

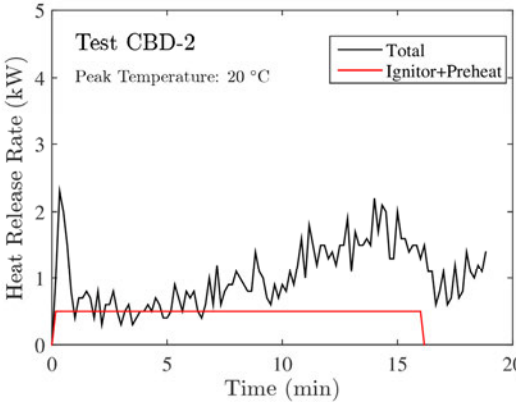
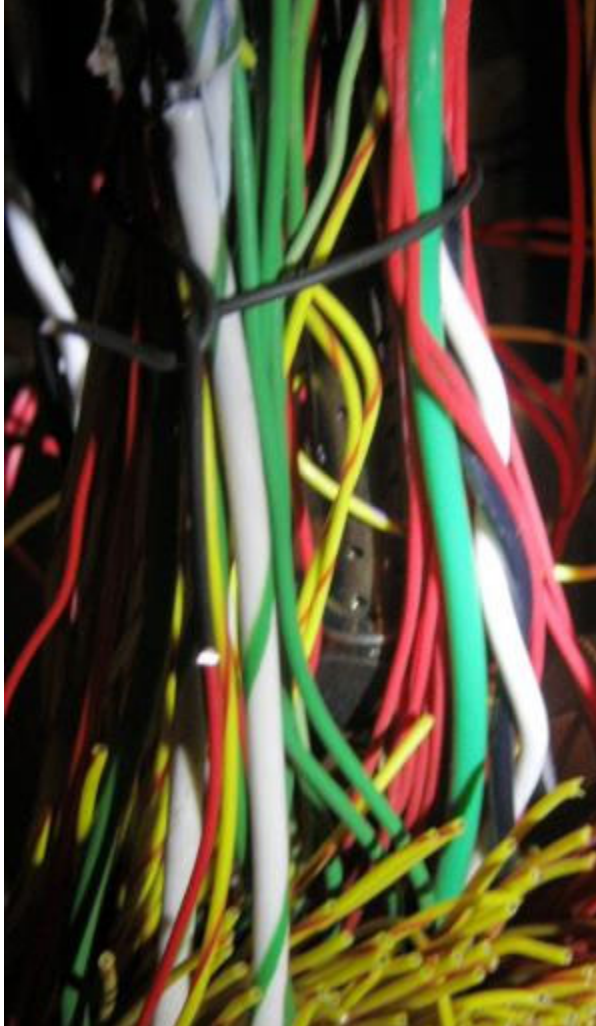
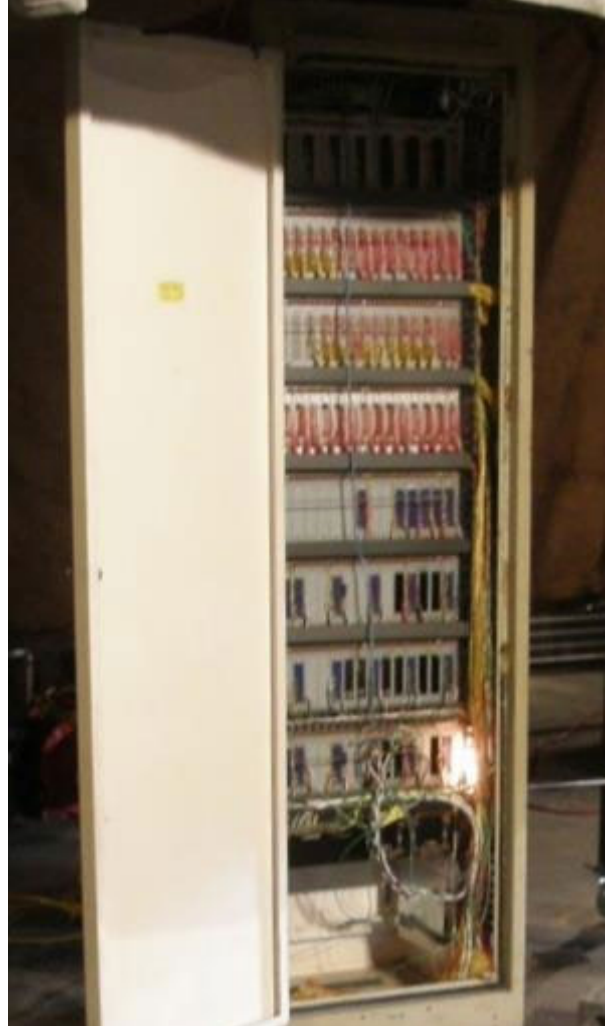
Table 5-4. Summary of Test 2

<p>Test: 2</p> <p>Enclosure: 2</p> <p>Fuel Load: Vertical bundle of SIS wire</p> <p>Ignition Source: 0.5 kW propane burner</p> <p>Ventilation: Door open</p> <p>Notes: The fire did not spread beyond its point of origin. The burner was turned off after approximately 16 min.</p>

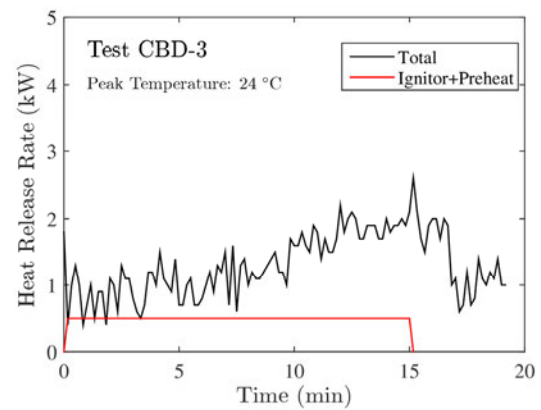
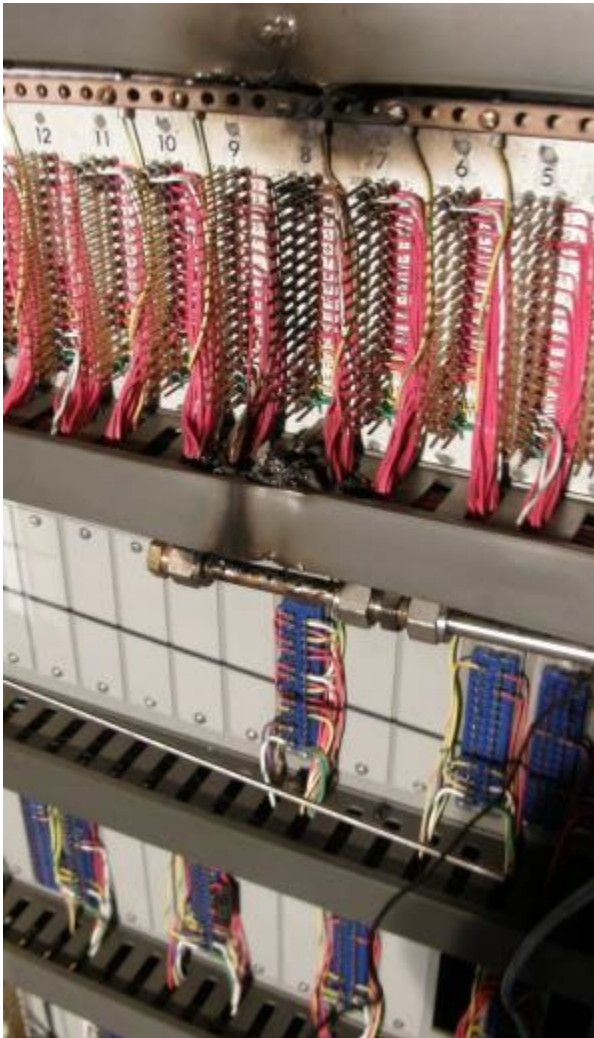
Table 5-5. Summary of Test 3

Ignition Source: 0.5 kW propane burner

Notes: The fire did not spread beyond its point of origin. The plastic harness charred and deformed, but did not appear to add to the heat release rate. The burner was turned off after approximately 15 min.

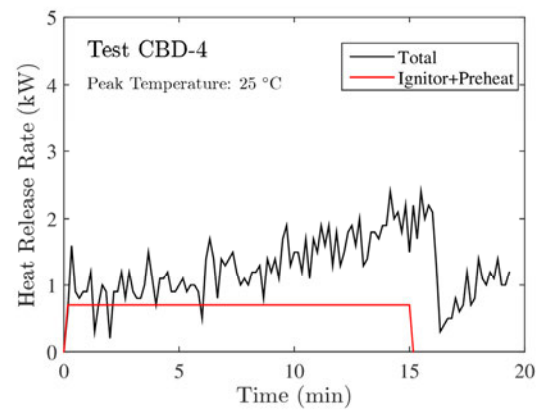
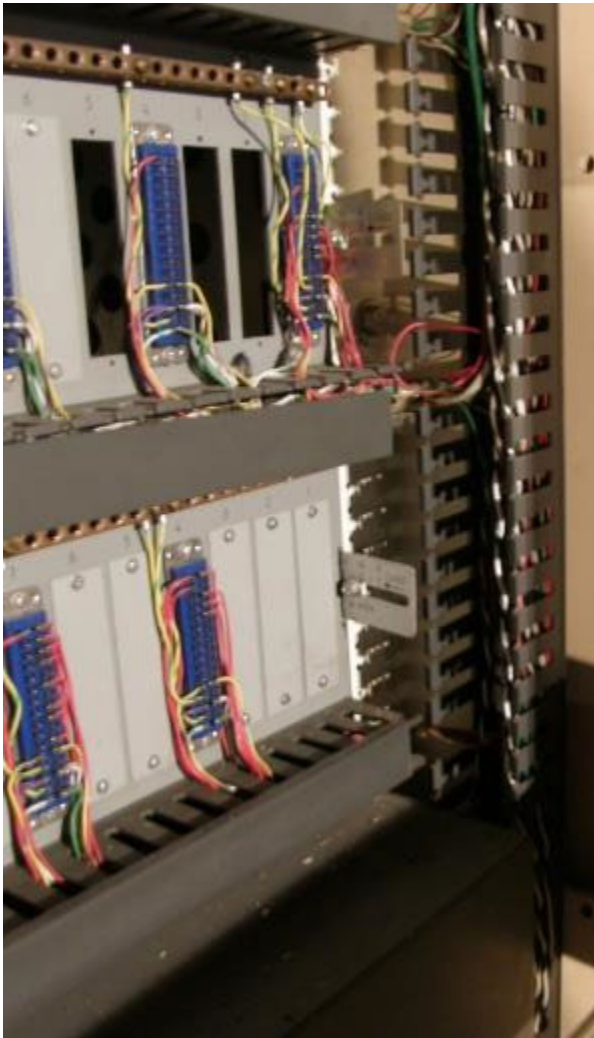
Table 5-6. Summary of Test 4

Ignition Source: 0.7 kW propane burner

Notes: The fire did not spread beyond point of origin. The burner was turned off at approximately 15 min.

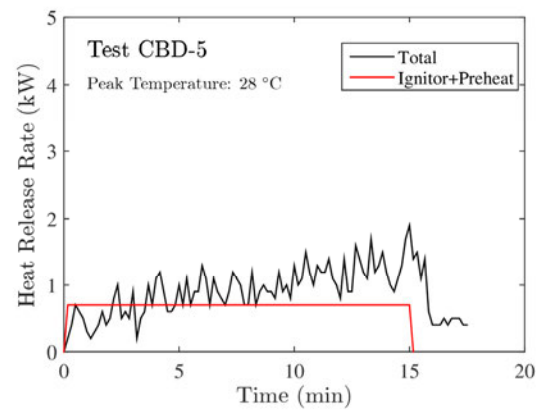
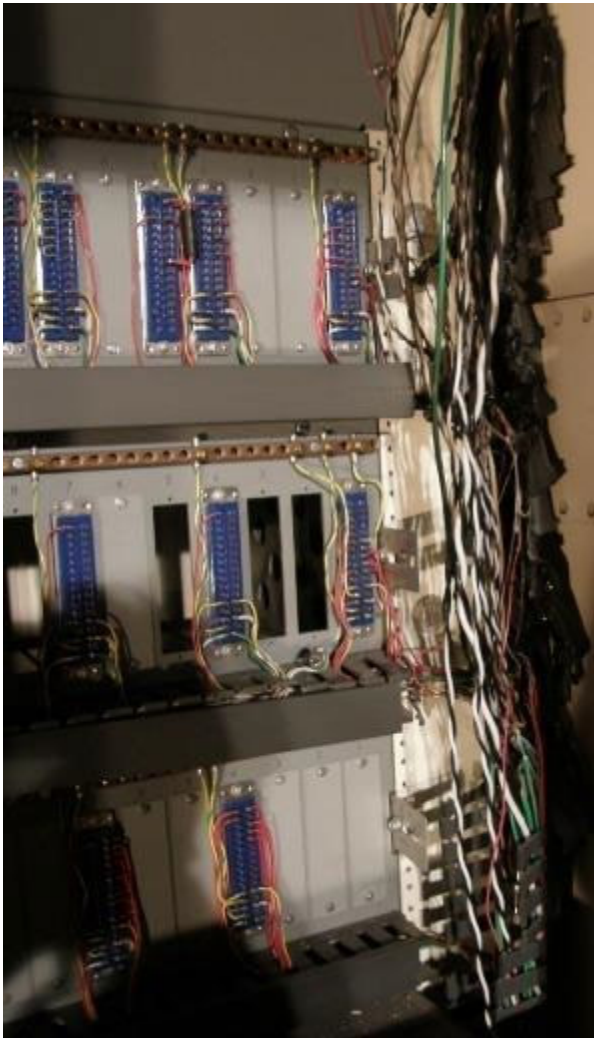
Table 5-7. Summary of Test 5

Ignition Source: 0.7 kW propane burner

Notes: The fire did not spread beyond point of origin. The burner was turned off at approximately 15 min.

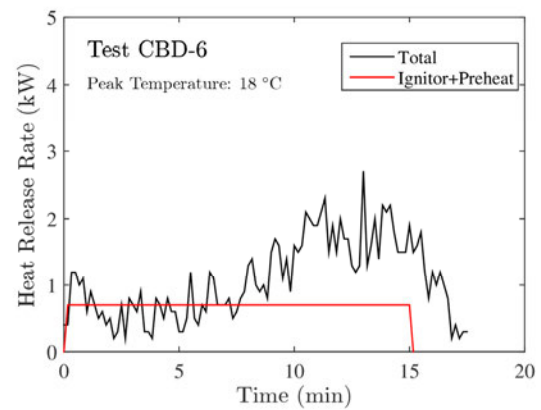
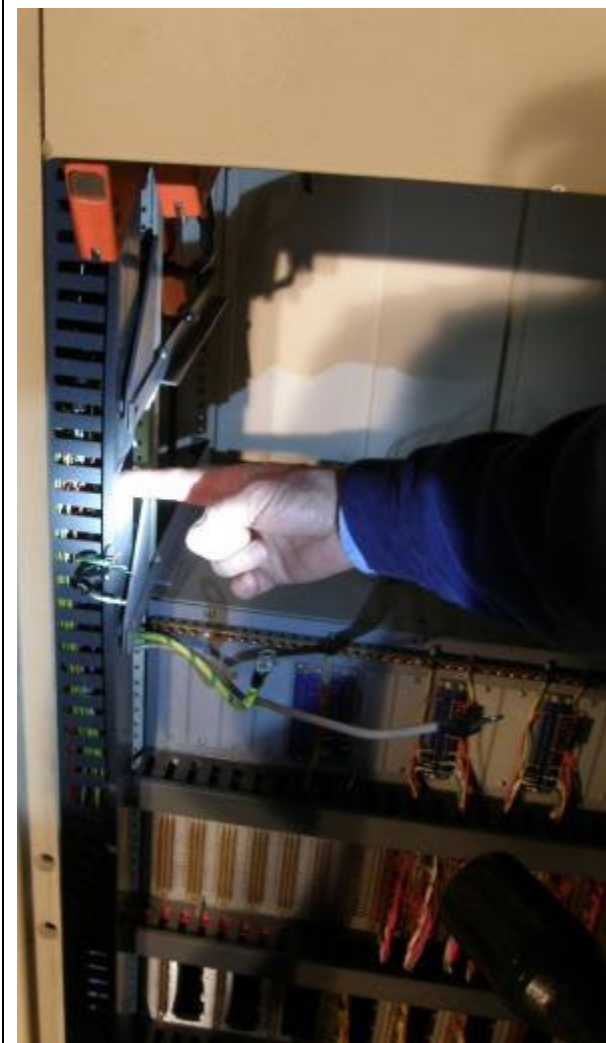
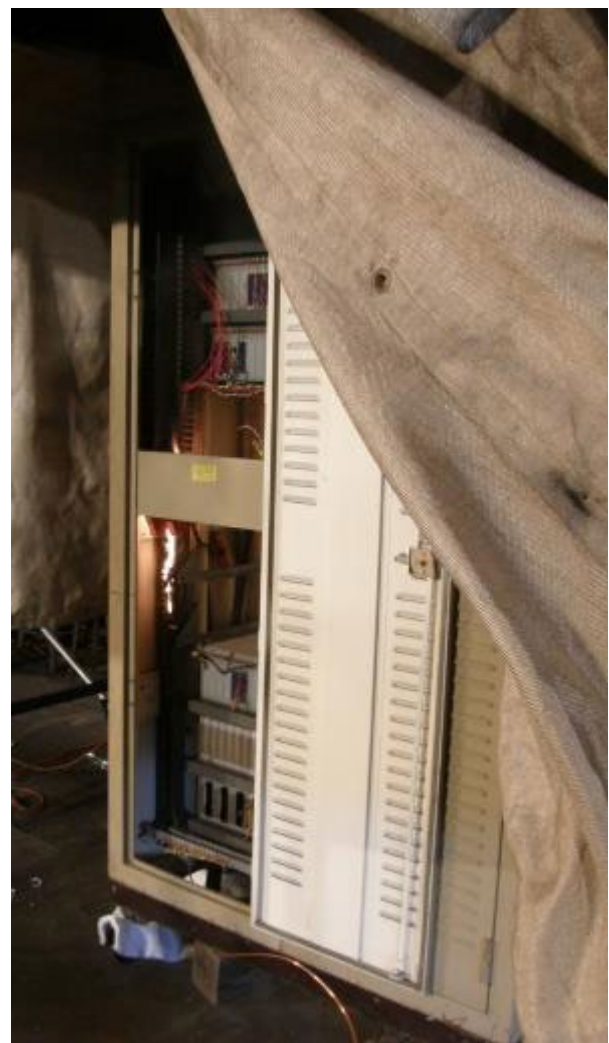
Table 5-8. Summary of Test 6

Ignition Source: 0.7 kW propane burner

Notes: The fire did not spread beyond point of origin. The plastic melted near the burner but did not appear to add much to the HRR. The burner was turned off at approximately 15 min.
