Heat Release Rates of Electrical Enclosure Fires (HELEN-FIRE)

Final Report

This report documents an experimental program to explore the heat release rate and burning behavior of electrical enclosures commonly found in nuclear power plants. Electrical enclosures are a potential source of fire in nuclear power plants because they contain both combustible materials and live electrical circuits. These fires have the potential to disrupt power, instrumentation, and control in the plant. Key parameters affecting fire in an enclosure include its size, openings, electrical voltage, and combustible load.

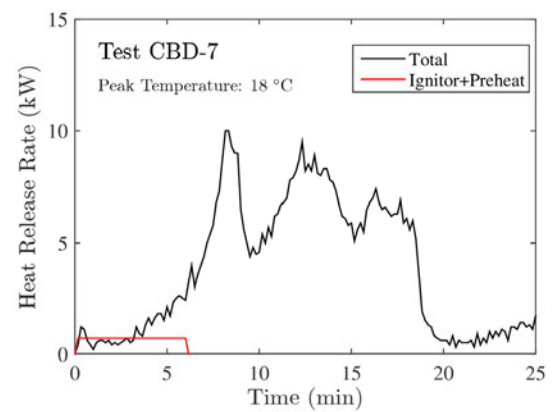
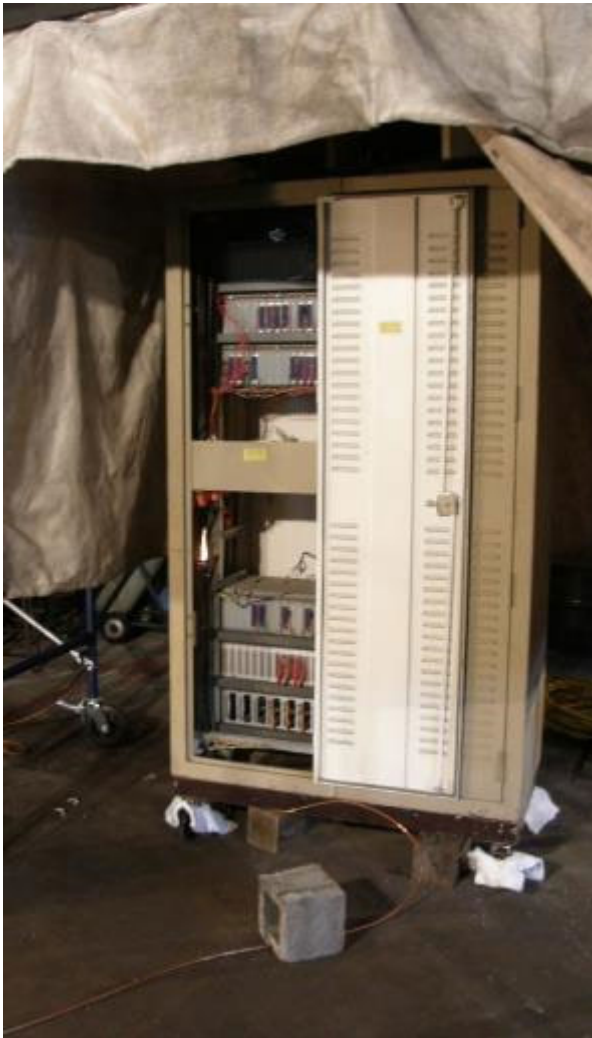
Table 5-9. Summary of Test 7

Notes: The fire spread on the plastic jacket used to harness the wires. Some of the jacketing material and loose plastic material fell to the floor where it continued to burn. The propane burner was turned off at 6 min.

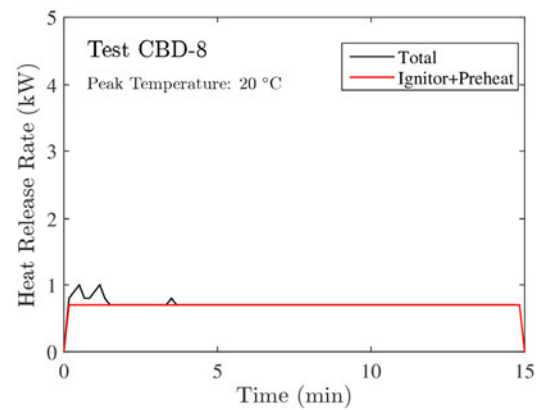
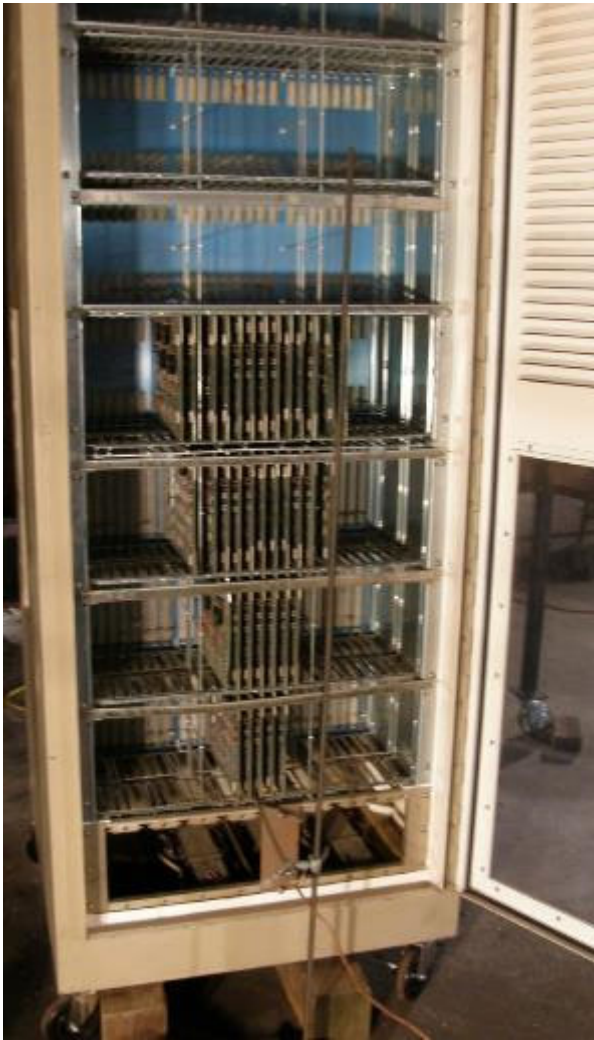
Table 5-10. Summary of Test 8

Notes: The fire was ignited between two circuit boards at the bottom of a four tier array. Each card was approximately 20 cm by 30 cm. The fire did not spread upwards, and only scorched the boards. The burner was turned off at 15 min.

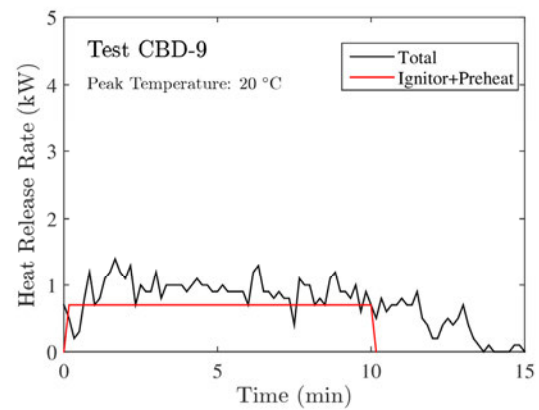
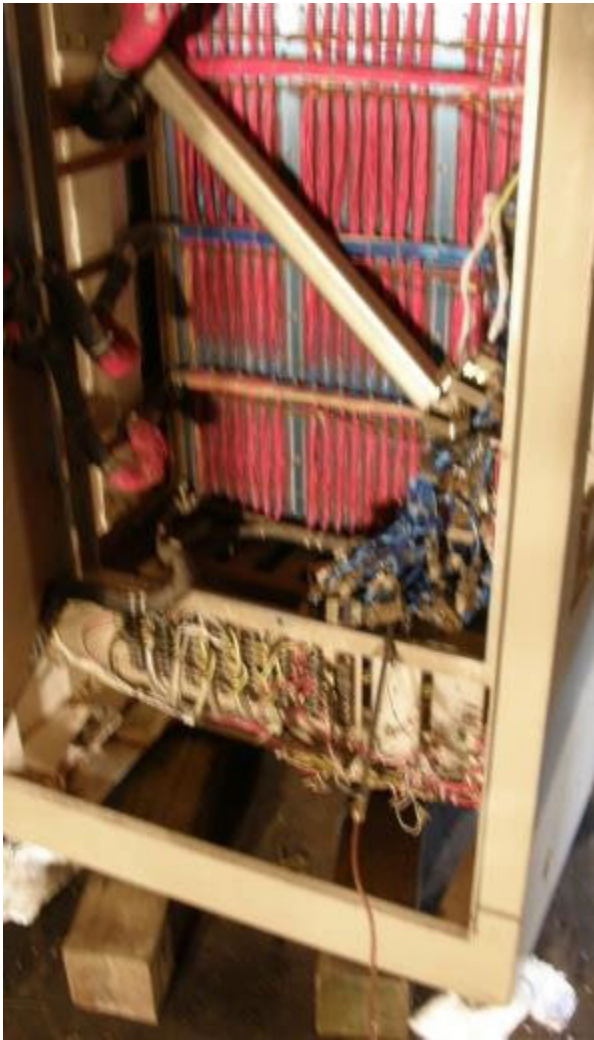
Table 5-11. Summary of Test 9

Notes: The fire did not spread beyond its point of origin (blue bundles in left photo). There was only minor scorching of the coating on the wires. The propane burner was turned off at 10 min.

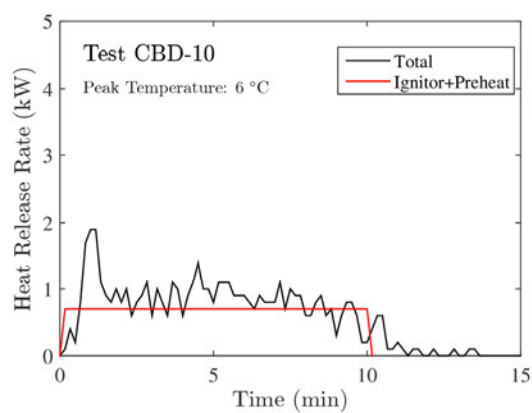
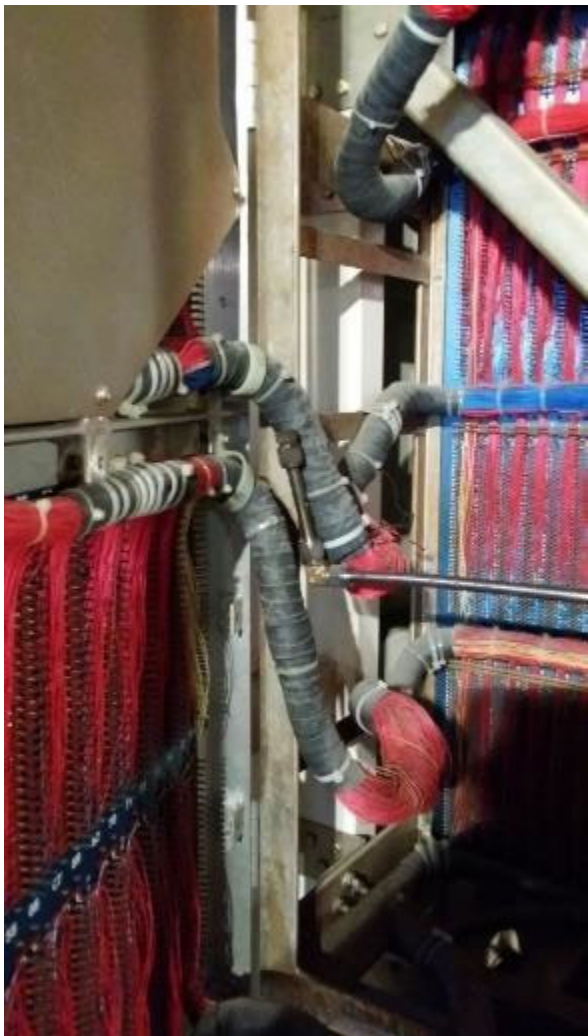
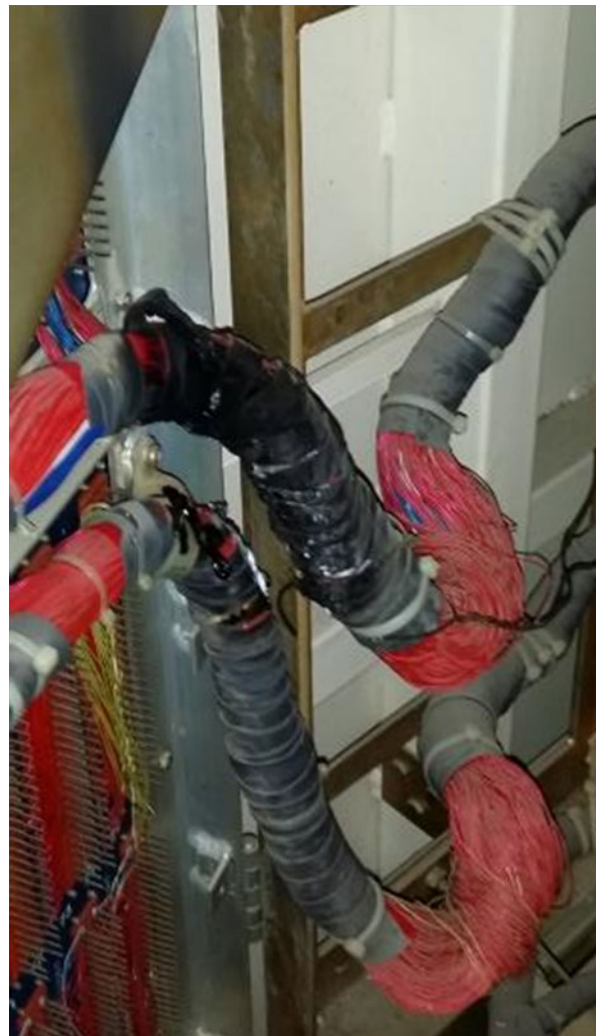
Table 5-12. Summary of Test 10

<p>Test: 10</p> <p>Enclosure: 3</p> <p>Fuel Load: Vertical bundle of relay wire bound by a rubber harness</p> <p>Ignition Source: 0.7 kW propane burner</p> <p>Ventilation: Door open</p> <p>Notes: The rubber harness material burned, but there was no measureable heat release or significant spread. The burner was turned off at 10 min.</p>

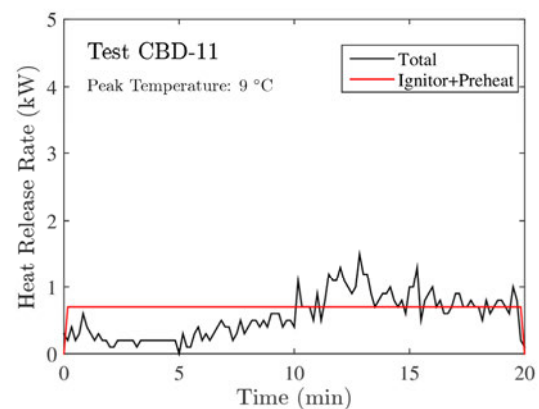
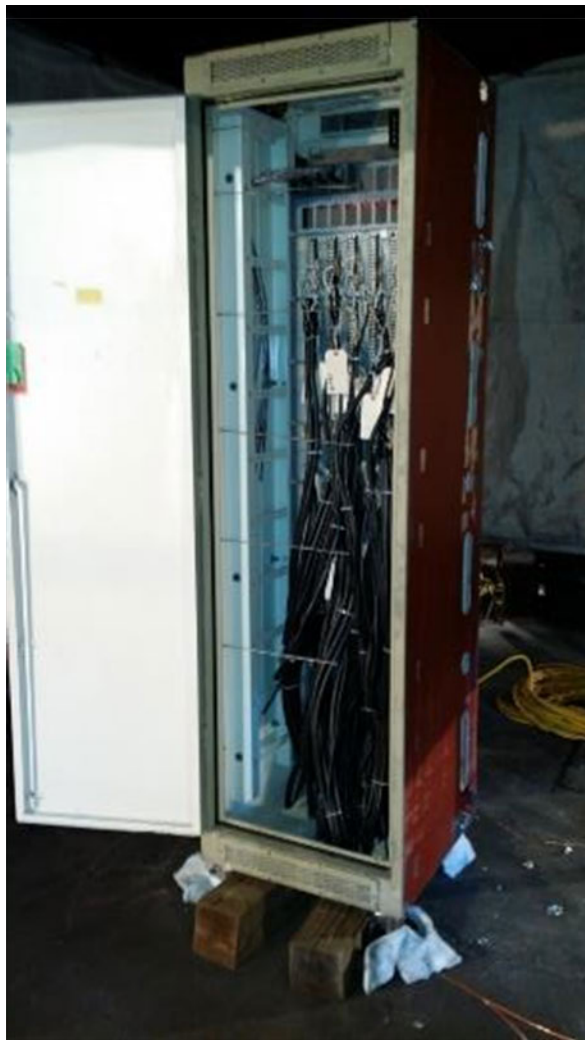
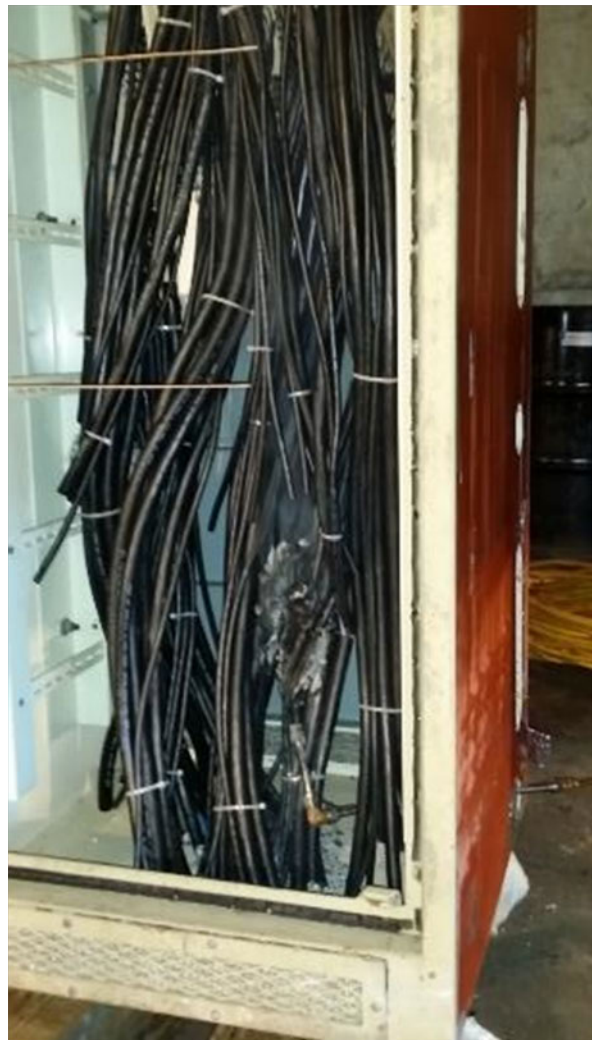
Table 5-13. Summary of Test 11

Notes: The fire burned some of the cable jackets in the immediate vicinity of the propane burner, shown at the bottom right of the enclosure in the photo on the right. The burner was turned off at approximately 20 min.

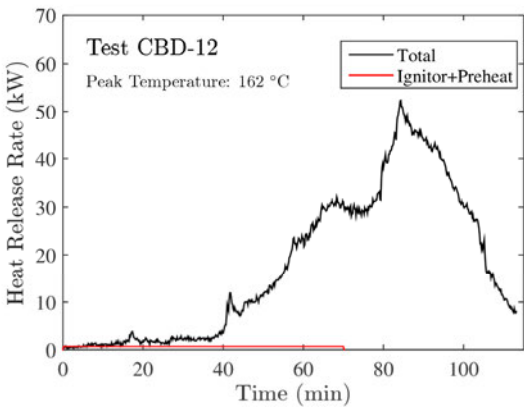
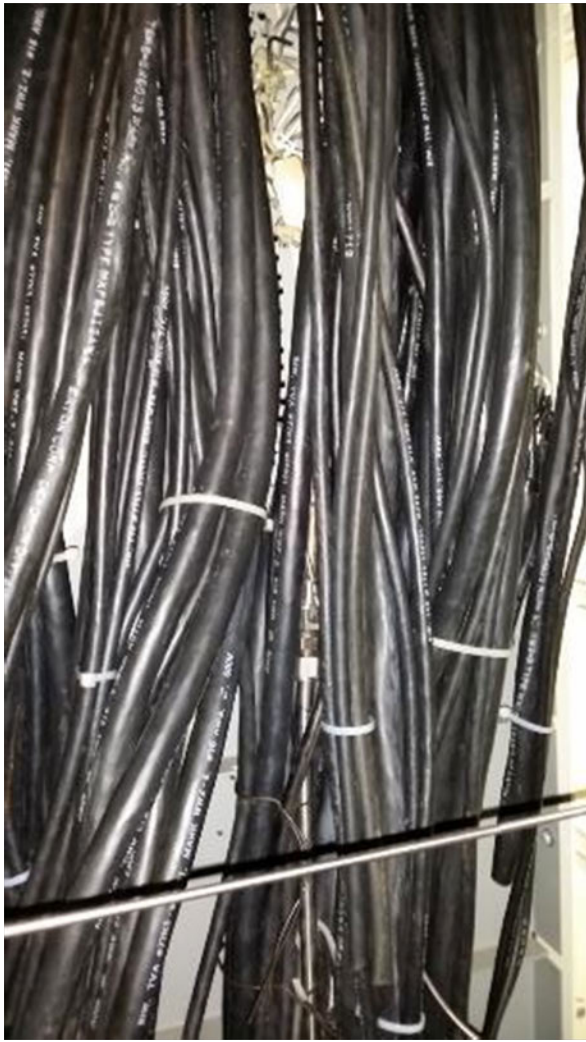
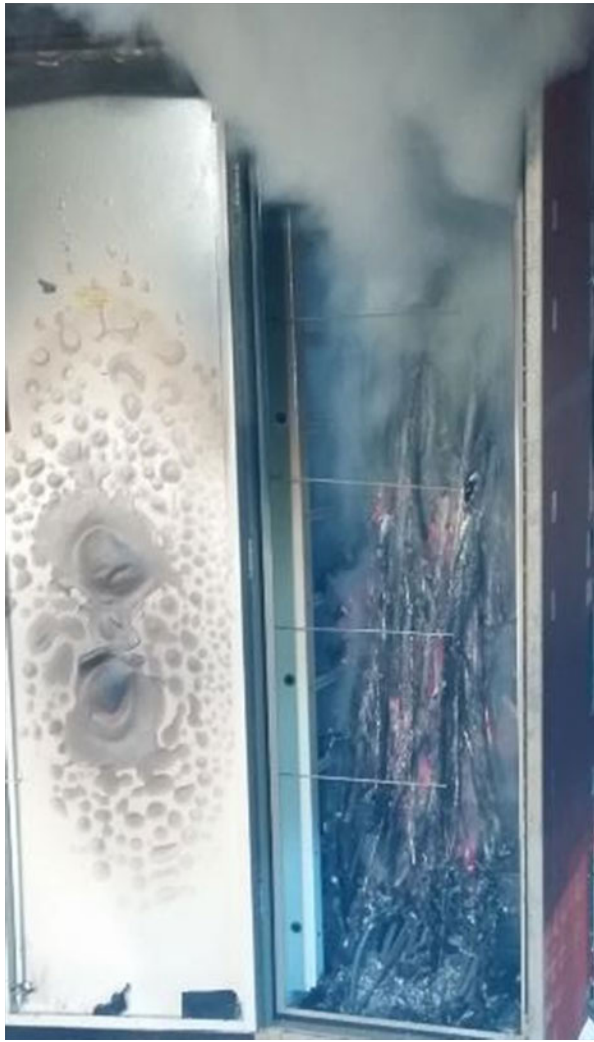
Table 5-14. Summary of Test 12

<p>Test: 12 (A,B,C)</p> <p>Enclosure: 1</p> <p>Fuel Load: Same unburned cables from Test 11</p> <p>Ignition Source: 0.7 kW propane burner</p> <p>Ventilation: Door closed, open at end of test</p> <p>Notes: The door of the enclosure was initially closed, but it was opened at approximately 40 min (B) to check on progress. The fire flared up due, presumably, to the introduction of fresh air. The door was closed at about 41 min. The door was opened at 80 min (C) and left open. The cables burned or smoldered for about an hour. All that remained was glowing char.</p>

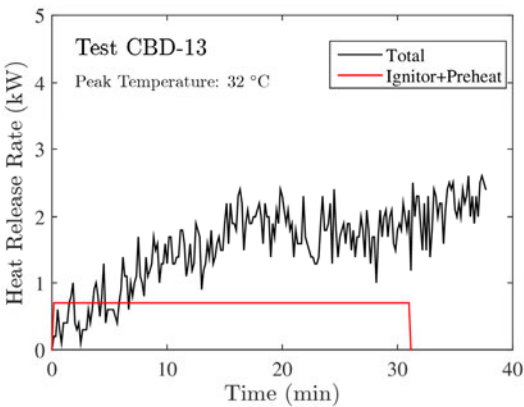
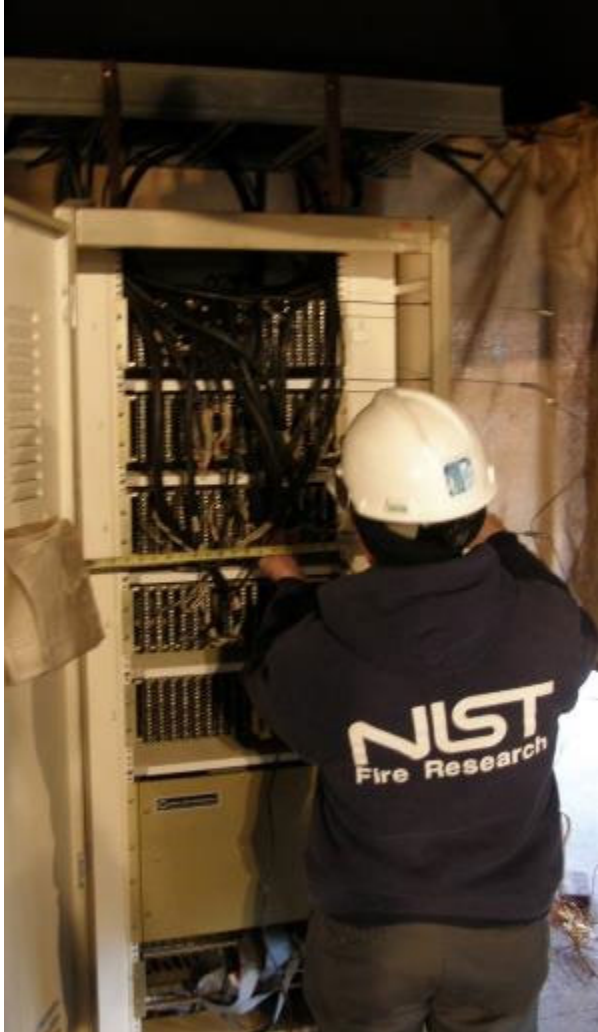
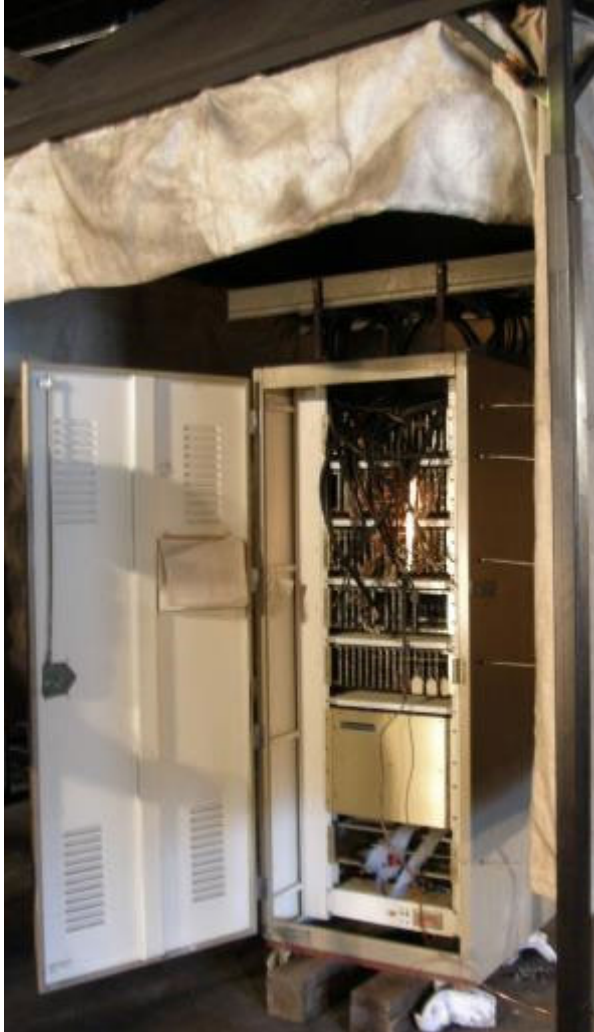
Table 5-15. Summary of Test 13

<p>Test: 13</p> <p>Enclosure: 8</p> <p>Fuel Load: Control cables originating at interior connection panel and directed through conduits at the top of the enclosure into a cable tray</p> <p>Ignition Source: 0.7 kW propane burner</p> <p>Ventilation: Door closed, opened briefly</p> <p>Notes: The door was opened at 23 min for approximately a minute and then closed again. The burner was turned off at approximately 31 min. The fire did not spread beyond its point of origin.</p>

<p>Test CBD-13 Peak Temperature: 32 °C</p> <p>Heat Release Rate (kW)</p> <p>Time (min)</p> <p>Legend: Total (black line), Ignitor+Preheat (red line)</p>

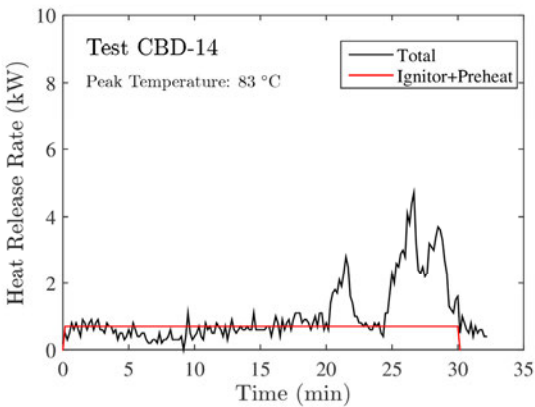
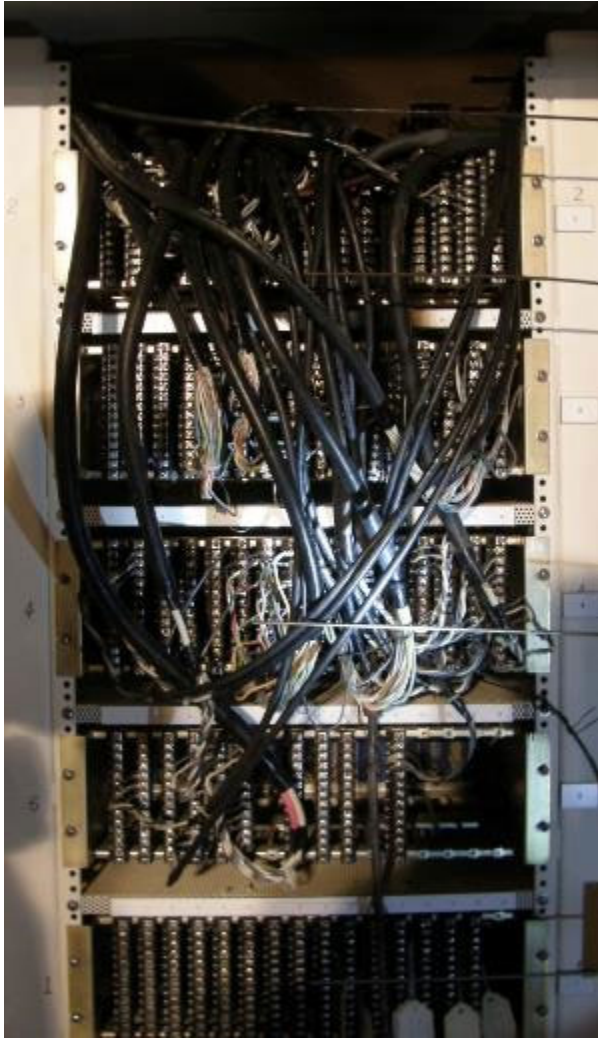
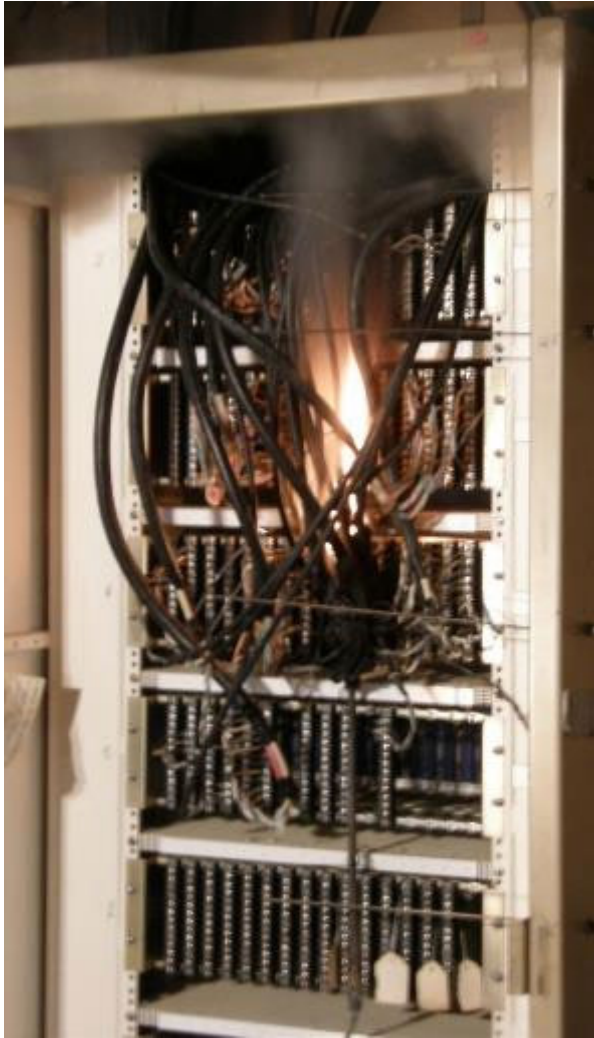
Table 5-16. Summary of Test 14

<p>Test: 14 (A,B)</p> <p>Enclosure: 8</p> <p>Fuel Load: Same as Test 13</p> <p>Ignition Source: 0.7 kW propane burner</p> <p>Ventilation: Door closed, opened briefly</p> <p>Notes: This experiment was similar to Test 13, but the cables were bundled closer together around the igniter. There was no measureable increase in the HRR for approximately 20 min, at which time the door was opened (B) and a propane blow torch was used to try to spread the fire. The test was ended at approximately 30 min.</p>

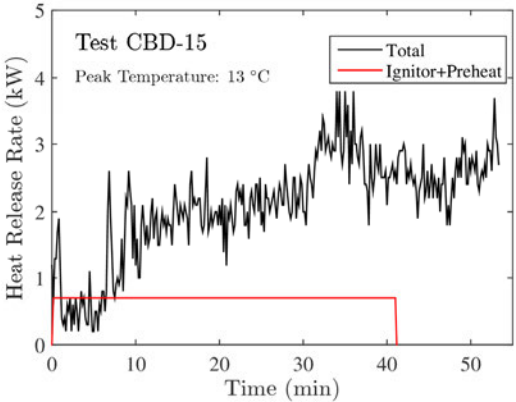
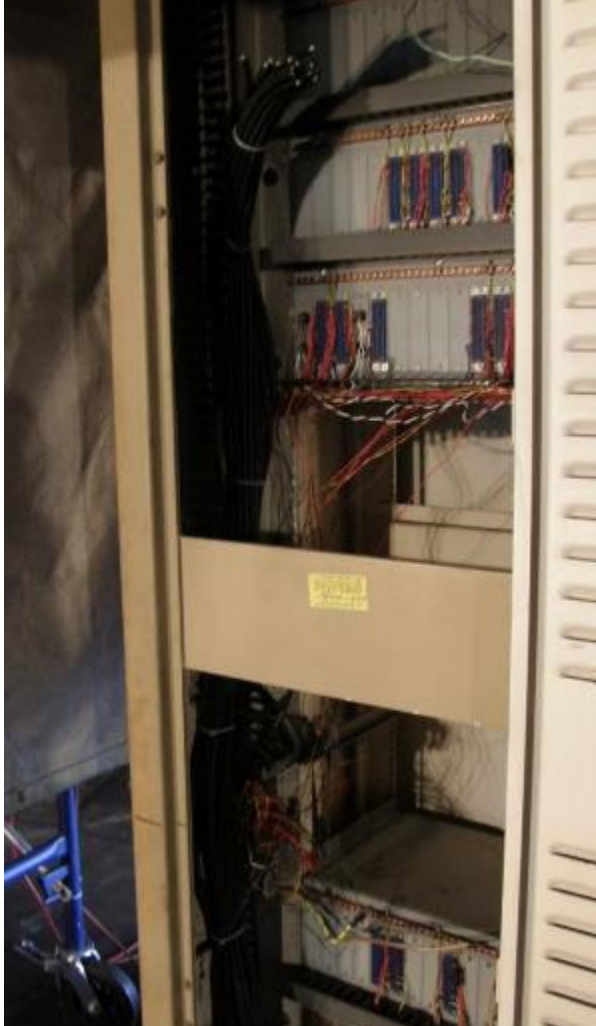
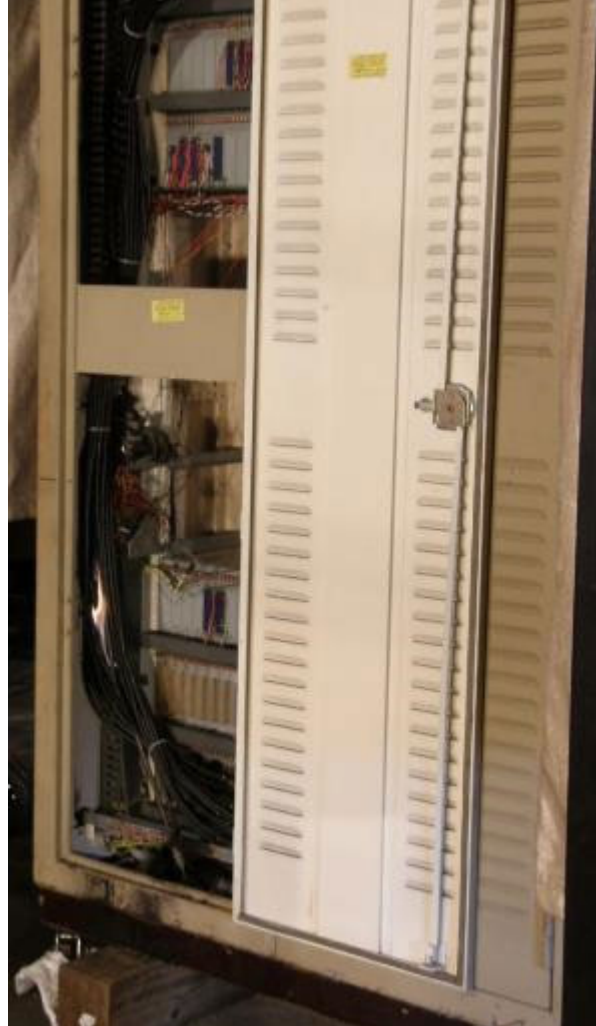
Table 5-17. Summary of Test 15

<p>Test: 15 (A,B)</p> <p>Enclosure: 5</p> <p>Fuel Load: 22 cables (#817), 1.8 m (6 ft) long, routed up left side of enclosure</p> <p>Ignition Source: 0.7 kW propane burner</p> <p>Ventilation: Door open, then closed</p> <p>Notes: The fire did not spread or grow appreciably in 30 min. At approximately 35 min (B), the door was closed to determine if this might better trap the heat and enhance burning. The burner was turned off at approximately 41 min.</p>

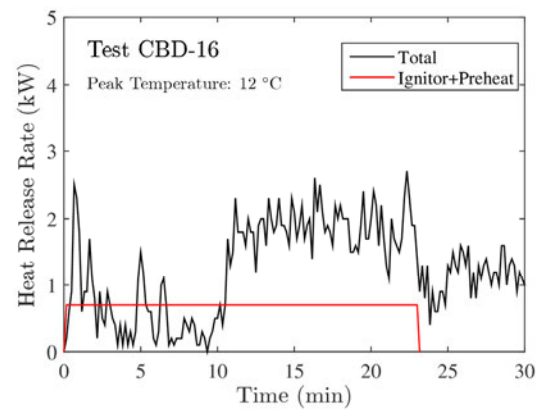
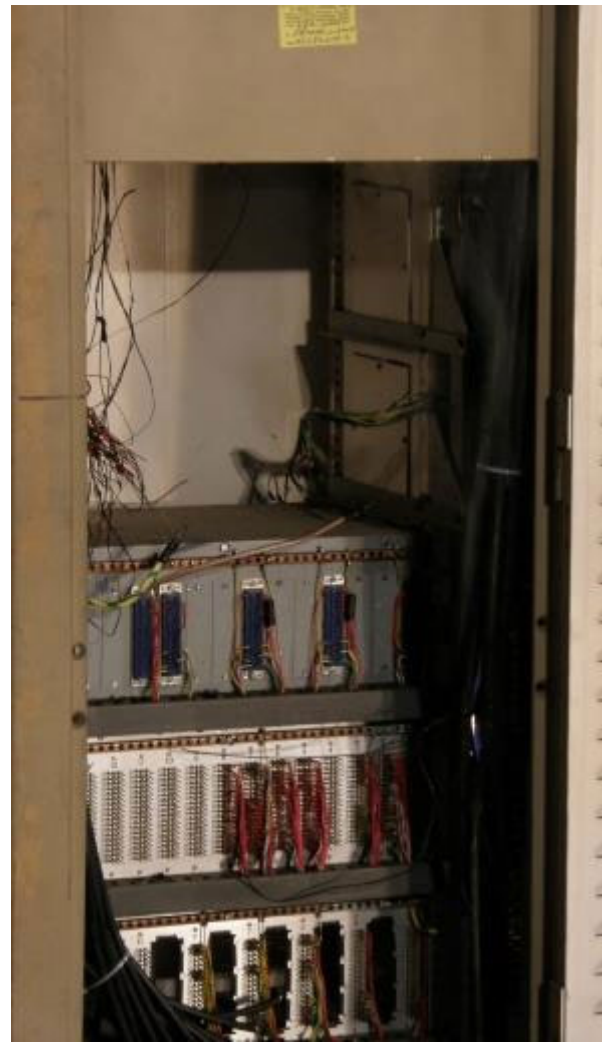
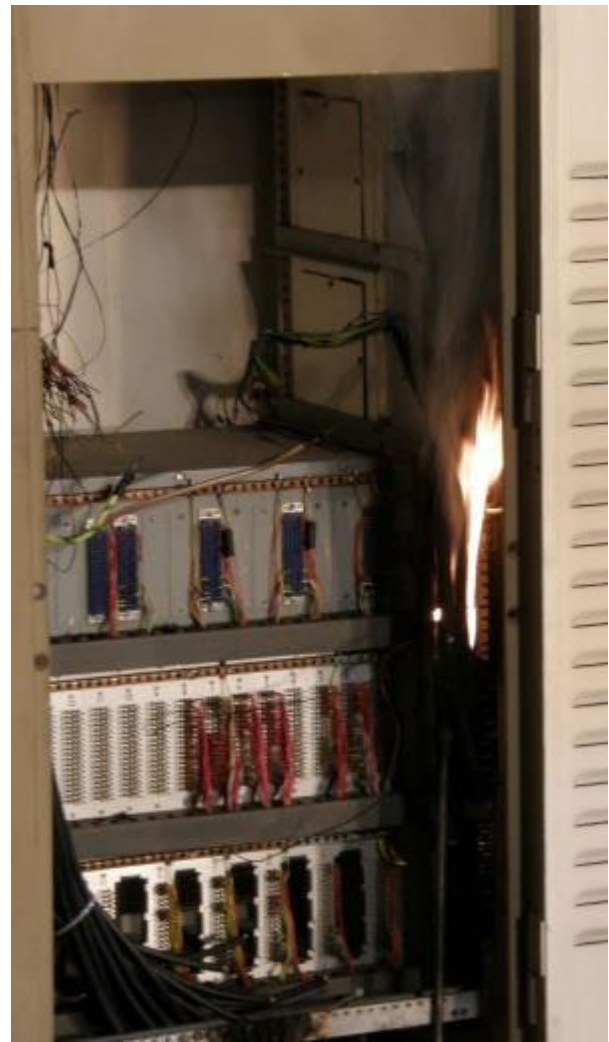
Table 5-18. Summary of Test 16

Notes: The holes of the propane burner became clogged, and the burner was cleaned at approximately 10 min. The fire did not spread beyond its point of origin. The burner was turned off at 23 min.

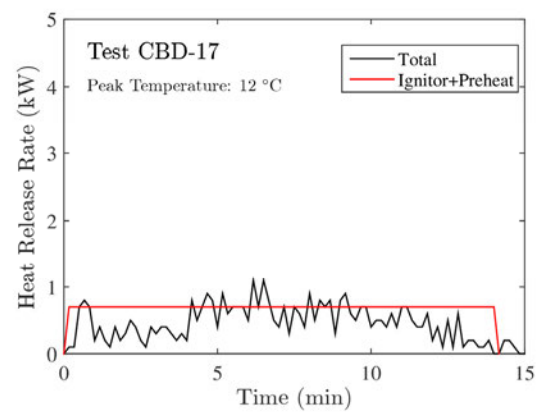
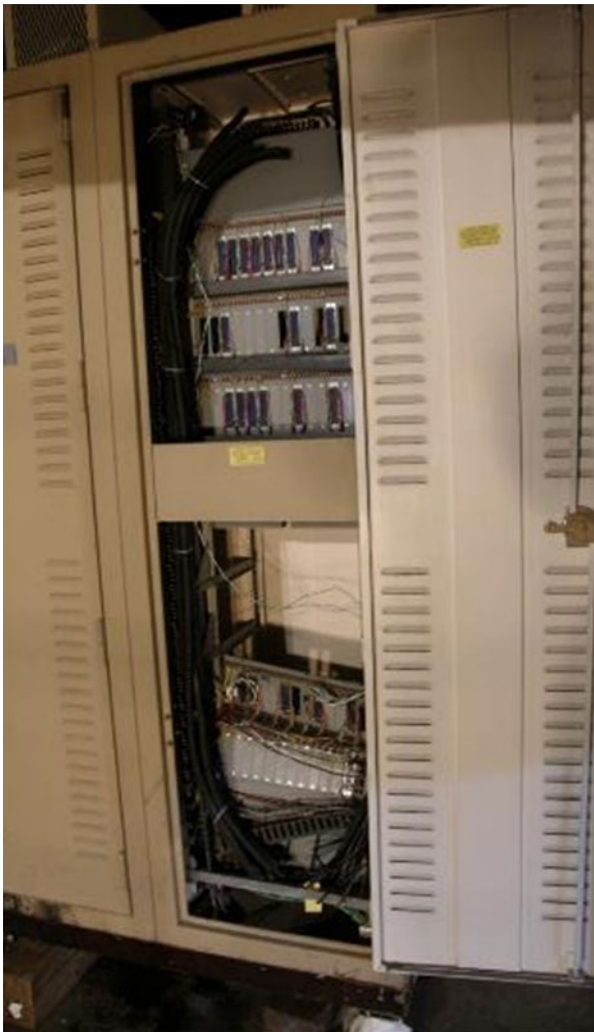
Table 5-19. Summary of Test 17

Notes: The fire did not spread beyond its point of origin. The burner was turned off at 14 min.

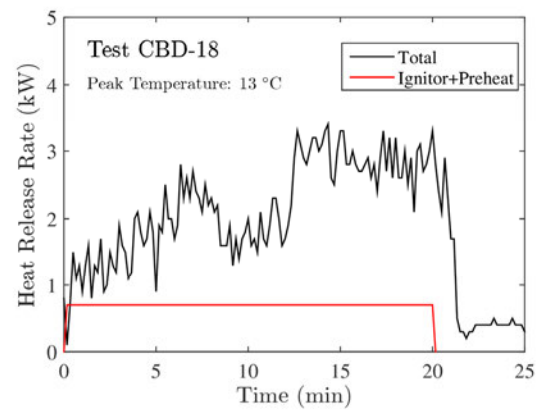
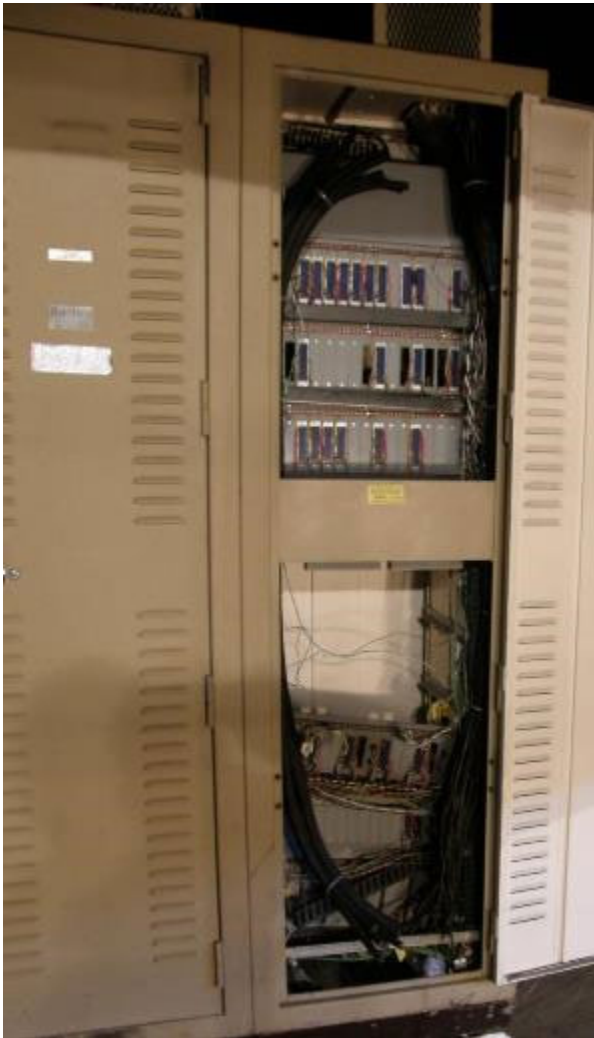
Table 5-20. Summary of Test 18

Notes: The fire spread upwards approximately 60 cm (2 ft) above the propane burner. The burner was turned off at 20 min.

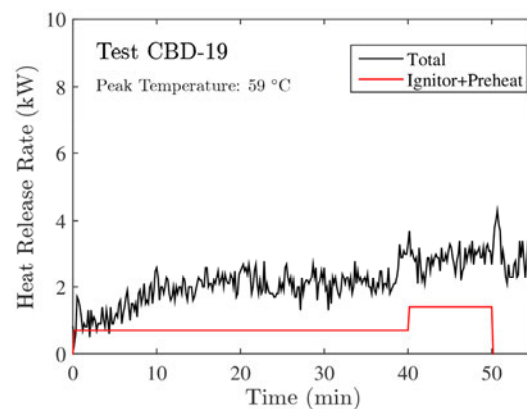
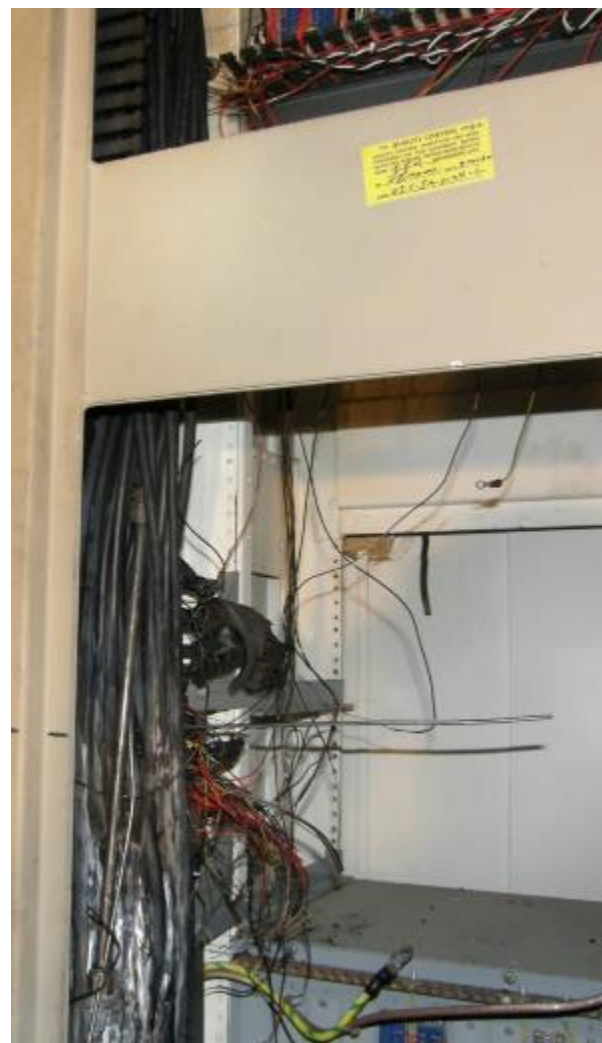
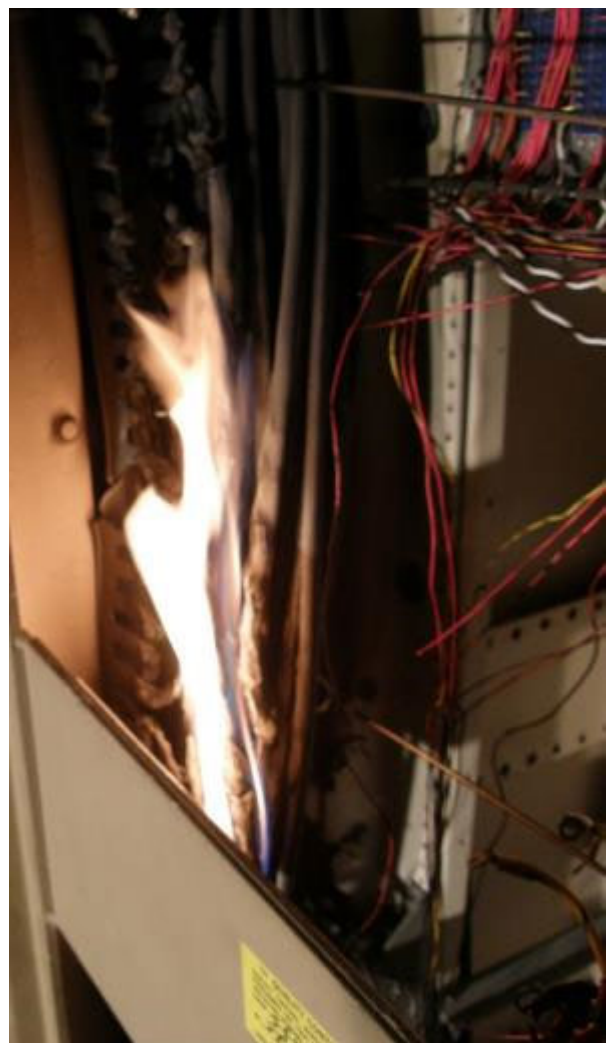
Table 5-21. Summary of Test 19

Notes: The fire did not spread beyond its point of origin. The door was opened at 24 min and at 40 min, for approximately 1 min each time. At 40 min, the propane burner was increased to 1.7 kW, but the fire still did not spread.

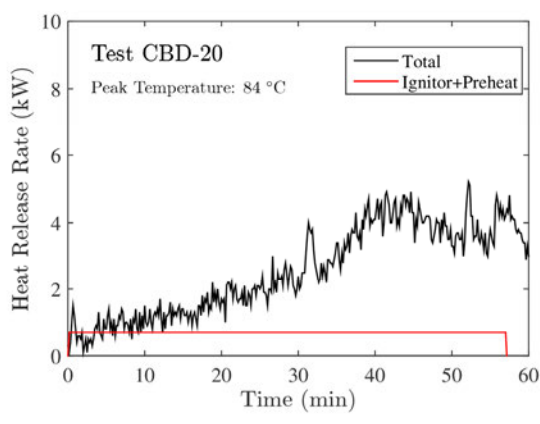
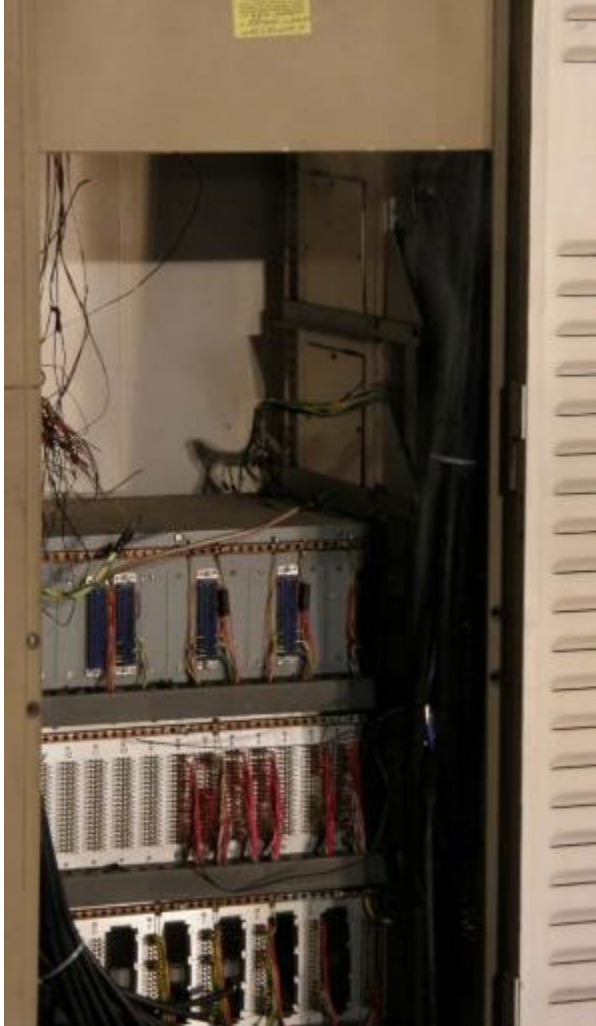
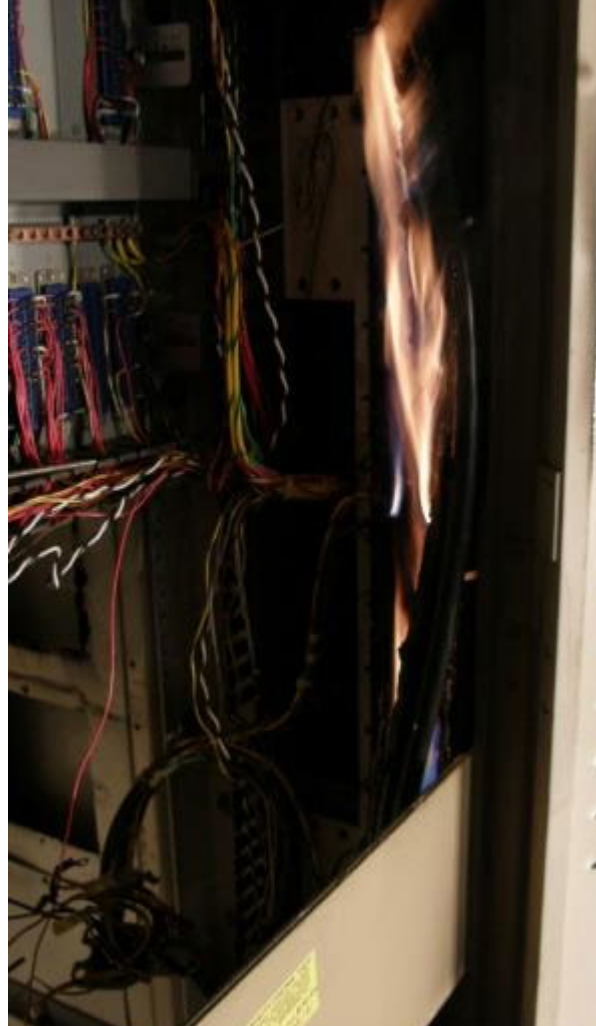
Table 5-22. Summary of Test 20

<p>Test: 20</p> <p>Enclosure: 5</p> <p>Fuel Load: 7 cables (#807), 1.8 m (6 ft) long, routed up right side of enclosure</p> <p>Ignition Source: 0.7 kW propane burner</p> <p>Ventilation: Door closed, opened briefly</p> <p>Notes: The burner was placed above the damaged cables left over from Test 16, approximately at mid-height. The flames extended about 60 cm (2 ft) above the burner. The door was opened at 30 min and at 50 min to check progress, for approximately 1 min each time. The fire did not spread beyond 60 cm (2 ft). The burner was turned off just short of an hour.</p>

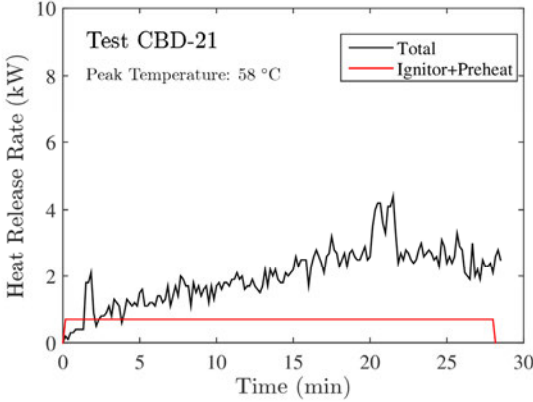
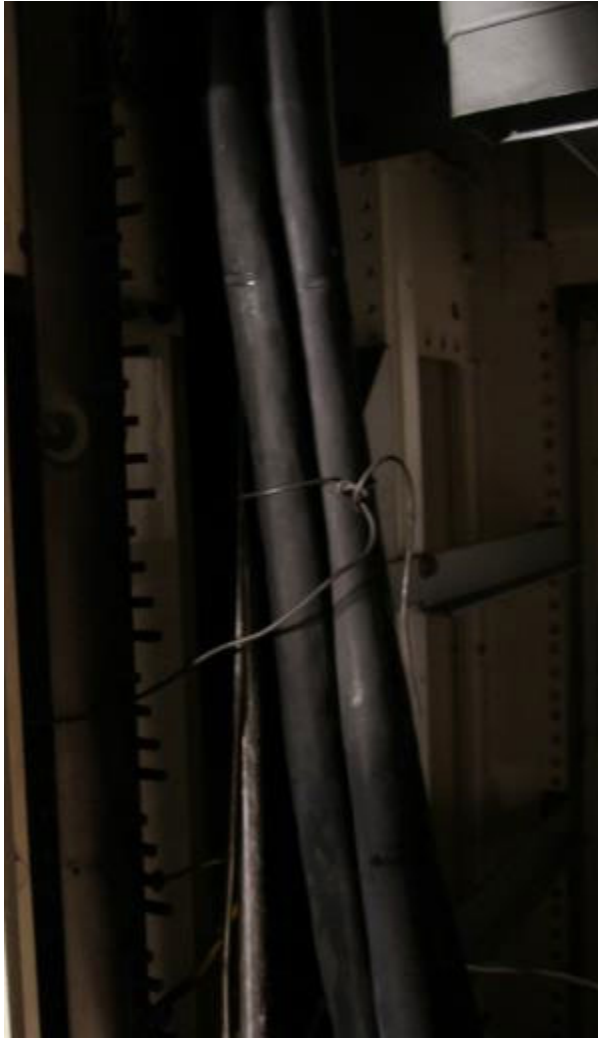
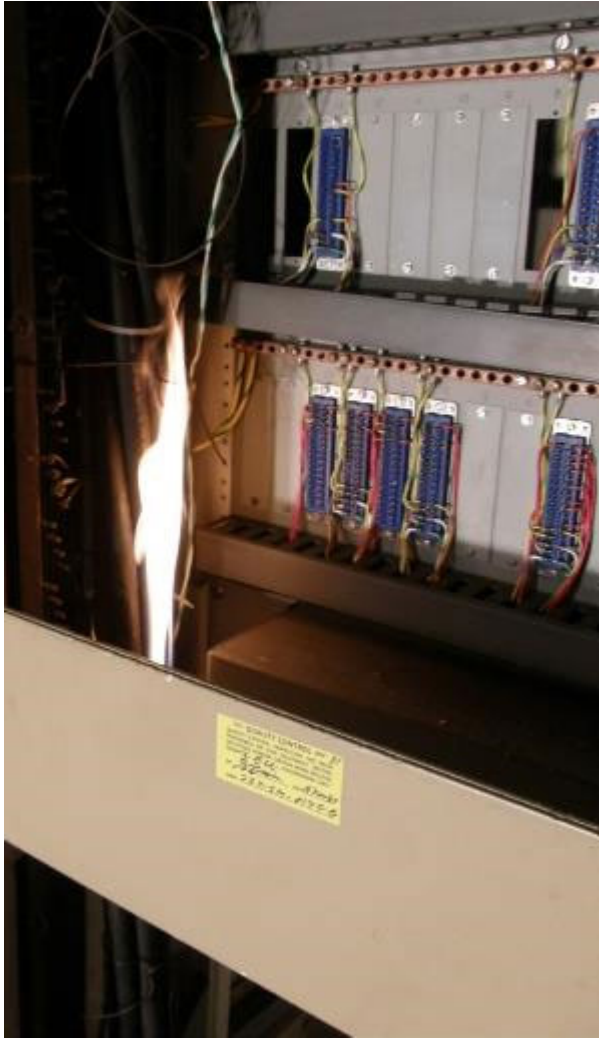
Table 5-23. Summary of Test 21

<p>Test: 21</p> <p>Enclosure: 4</p> <p>Fuel Load: 7 cables (#807), 1.8 m (6 ft) long, routed up left side of enclosure</p> <p>Ignition Source: 0.7 kW propane burner</p> <p>Ventilation: Door closed</p> <p>Notes: The fire did not spread beyond its point of origin.</p>

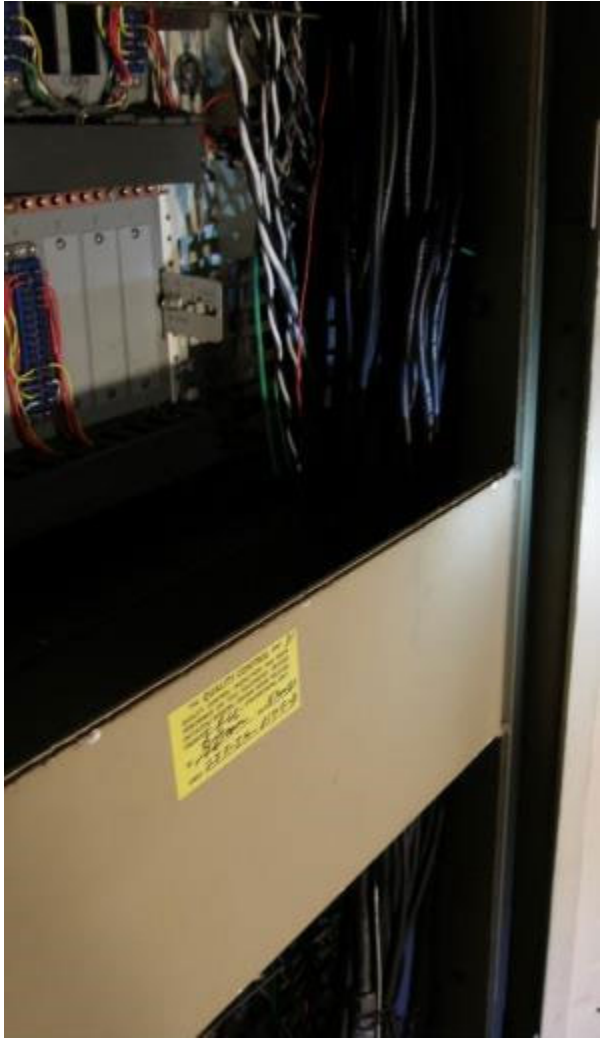
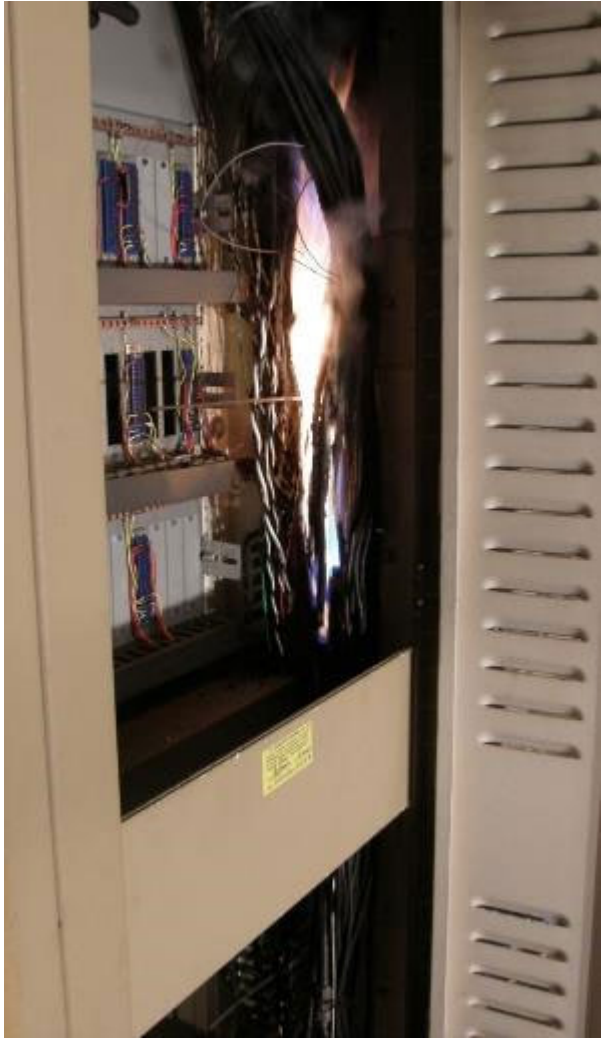
Table 5-24. Summary of Test 22

<p>Test: 22</p> <p>Enclosure: 4</p> <p>Fuel Load: 30 cables (#845), 1.8 m (6 ft) long, routed up right side of enclosure</p> <p>Ignition Source: 0.7 kW propane burner</p> <p>Ventilation: Door closed</p> <p>Notes: The fire did not spread beyond the point of origin.</p>

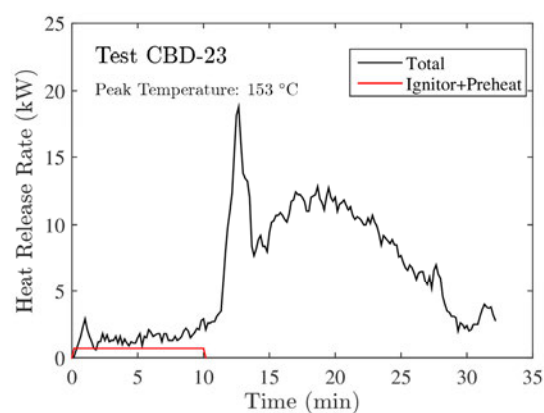
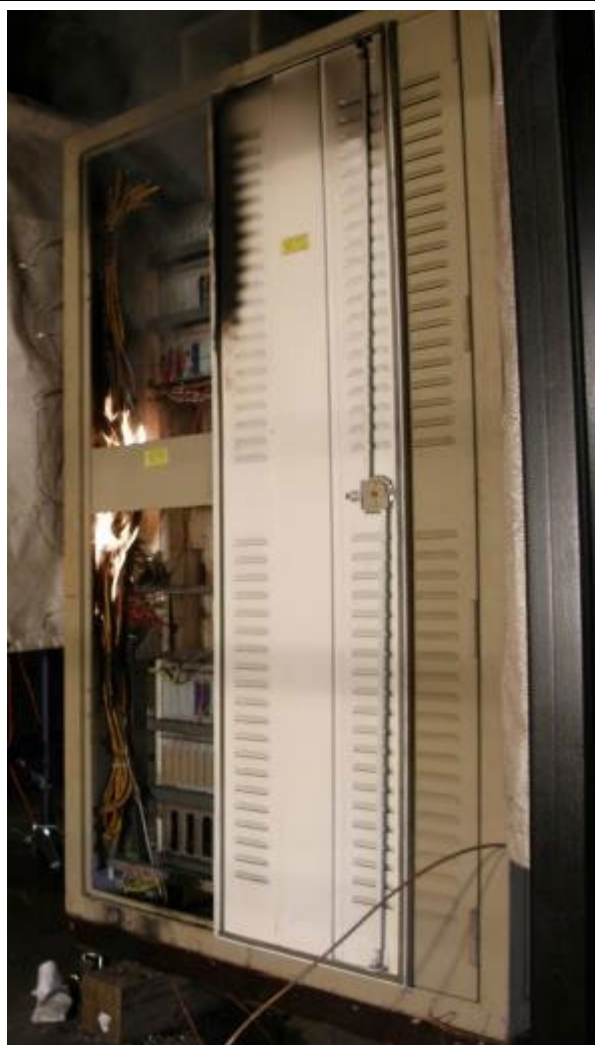
Table 5-25. Summary of Test 23

Notes: The cable was cut from old power cords that were being discarded. The fire spread rapidly upwards after approximately 10 min, at which point the bundle fell from its restraining harness and onto the floor of the enclosure where it burned for approximately 20 min.
