Heat Release Rates of Electrical Enclosure Fires (HELEN-FIRE)

Final Report

This report documents an experimental program to explore the heat release rate and burning behavior of electrical enclosures commonly found in nuclear power plants. Electrical enclosures are a potential source of fire in nuclear power plants because they contain both combustible materials and live electrical circuits. These fires have the potential to disrupt power, instrumentation, and control in the plant. Key parameters affecting fire in an enclosure include its size, openings, electrical voltage, and combustible load.

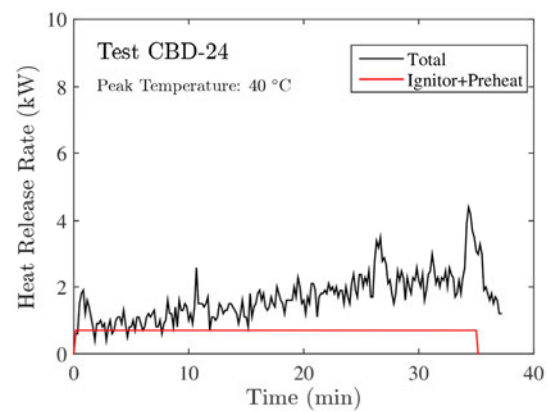
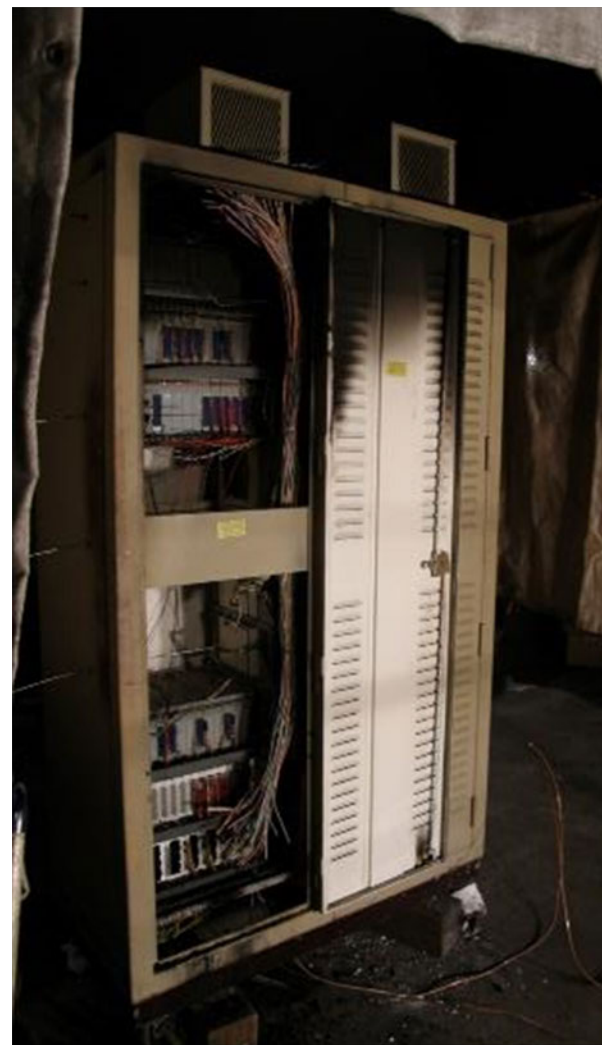
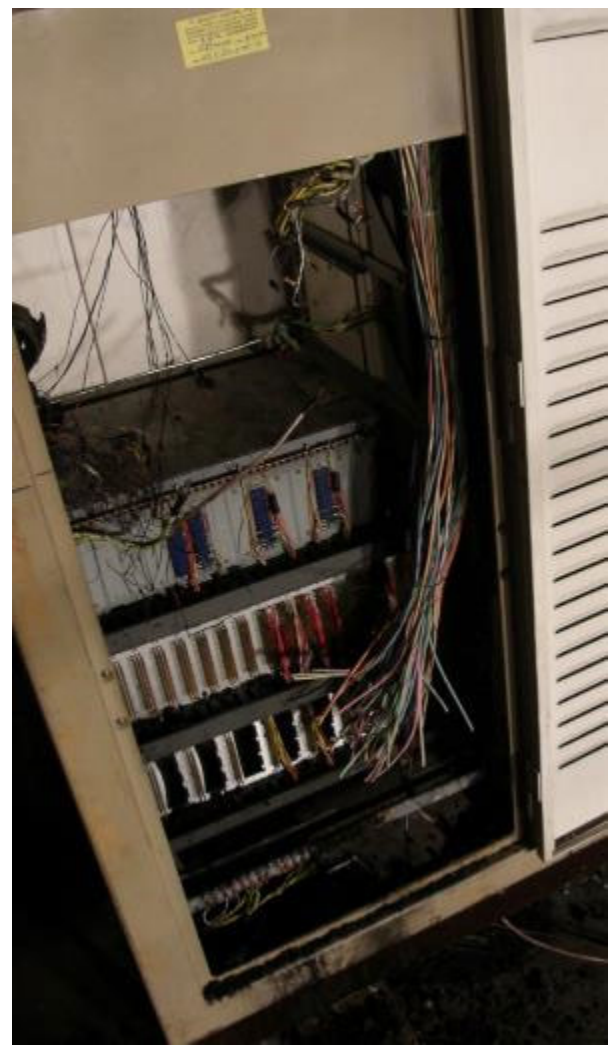
Table 5-26. Summary of Test 24

Notes: The fire did not spread beyond its point of origin. The burner was turned off at 35 min.

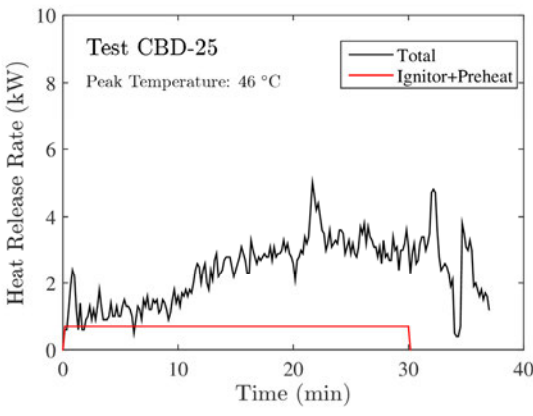
<p>Test CBD-25 Peak Temperature: 46 °C</p> <p>Heat Release Rate (kW)</p> <p>Time (min)</p> <p>Legend: Total (black line), Ignitor+Preheat (red line)</p>

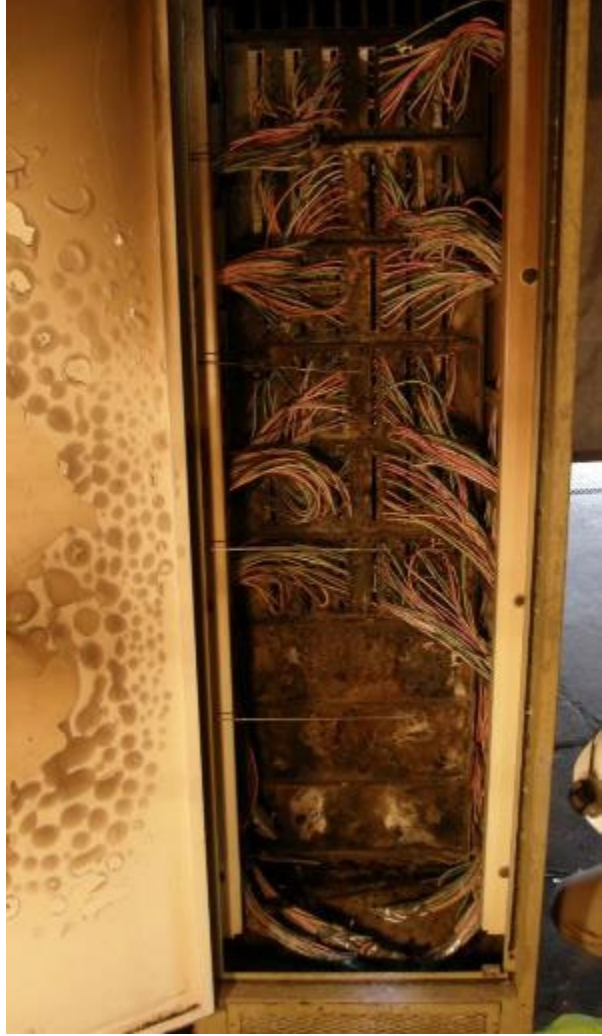
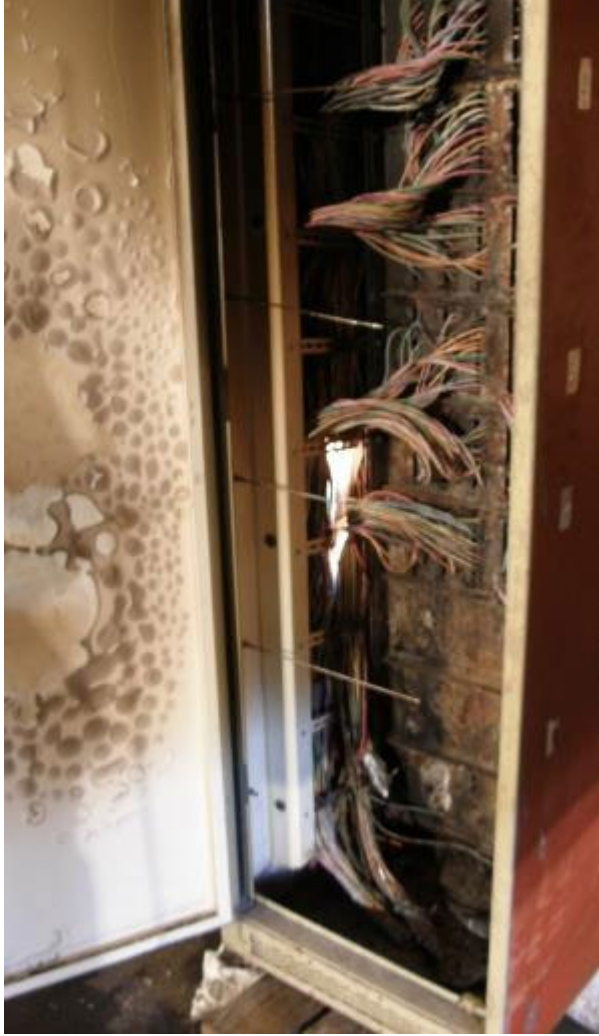
Table 5-27. Summary of Test 25

<p>Test: 25</p> <p>Enclosure: 1</p> <p>Fuel Load: 768 m (2520 ft) insulated conductors (#834) connected to center board and running down both sides of enclosure</p> <p>Ignition Source: 0.7 kW propane burner</p> <p>Ventilation: Door closed, opened briefly</p> <p>Notes: The fire spread approximately 20 cm (8 in) above the burner. The door was opened at approximately 20 min for 1 min to check progress. The fire did not spread beyond the vicinity of the burner. Based on observation, 36 cables were consumed 20 cm (8 in) above the burner.</p>

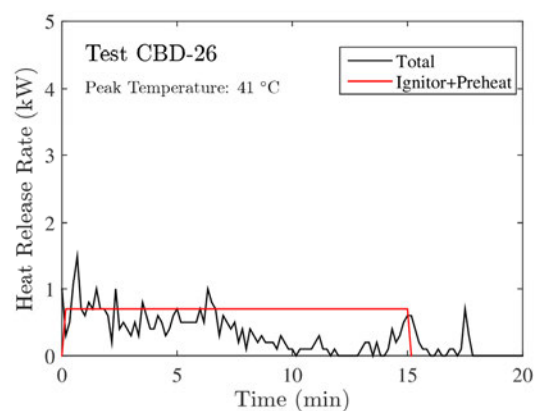
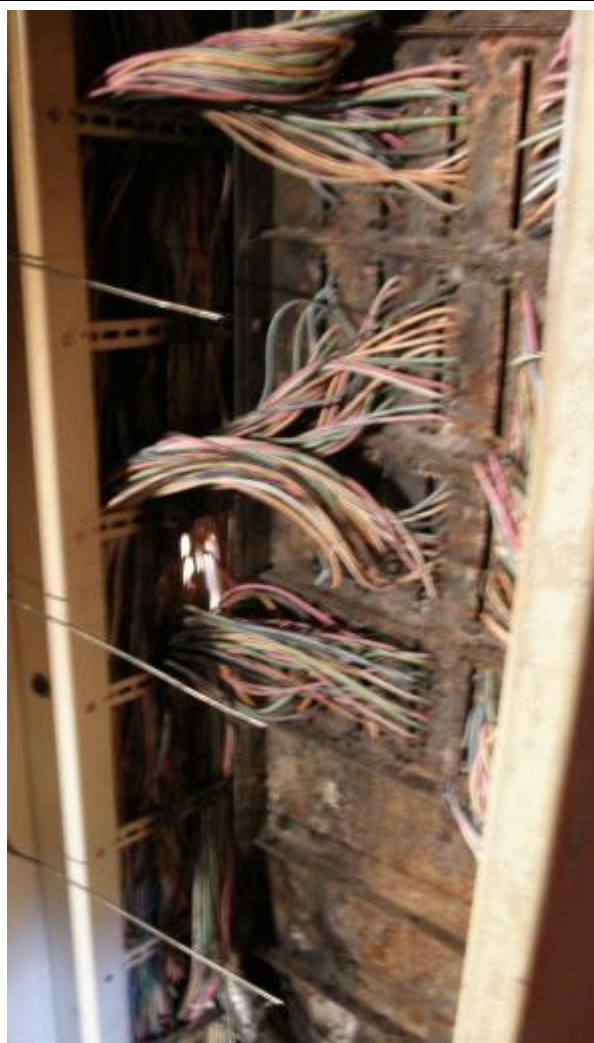
Table 5-28. Summary of Test 26

Notes: This test made use of the mostly unburned wire from Test 25. The propane burner was placed in a different position, near unburned wire. The door was opened at approximately 15 min and the test was ended at 17 min. The fire did not spread. Based on observation, 36 conductors were consumed 10 cm (4 in) above the burner.

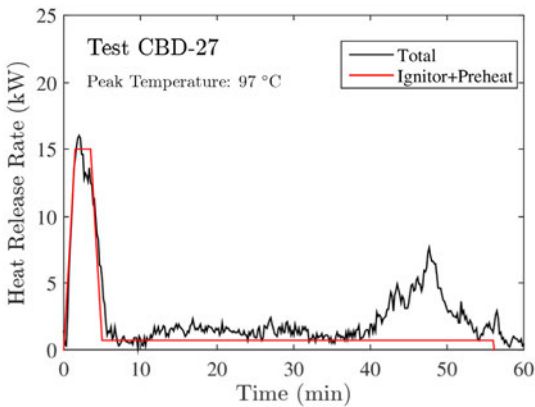
<p>Test CBD-27 Peak Temperature: 97 °C</p> <p>Heat Release Rate (kW)</p> <p>Time (min)</p> <p>Legend: Total, Ignitor+Preheat</p>

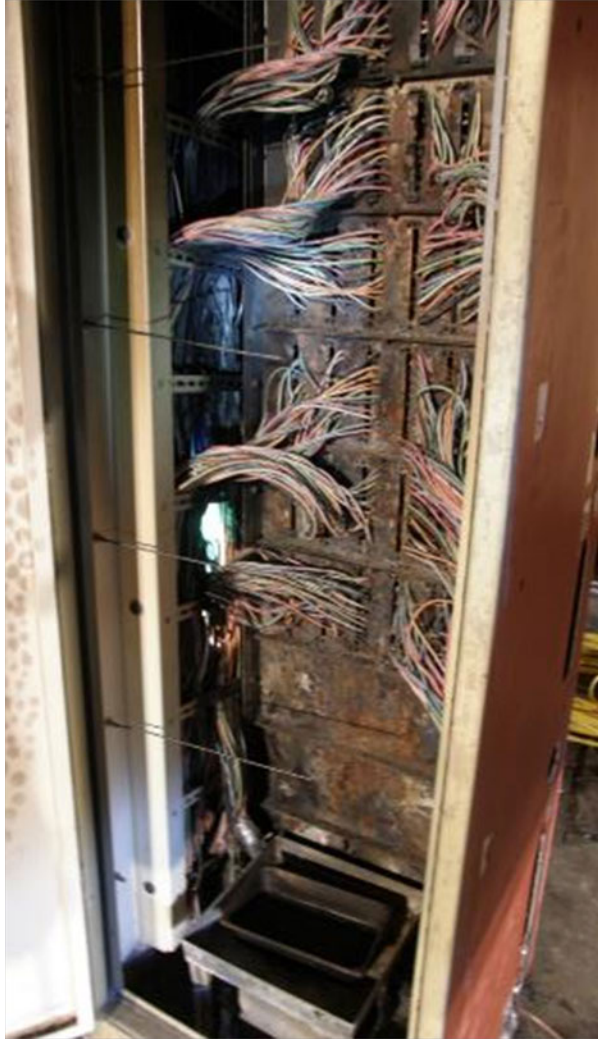
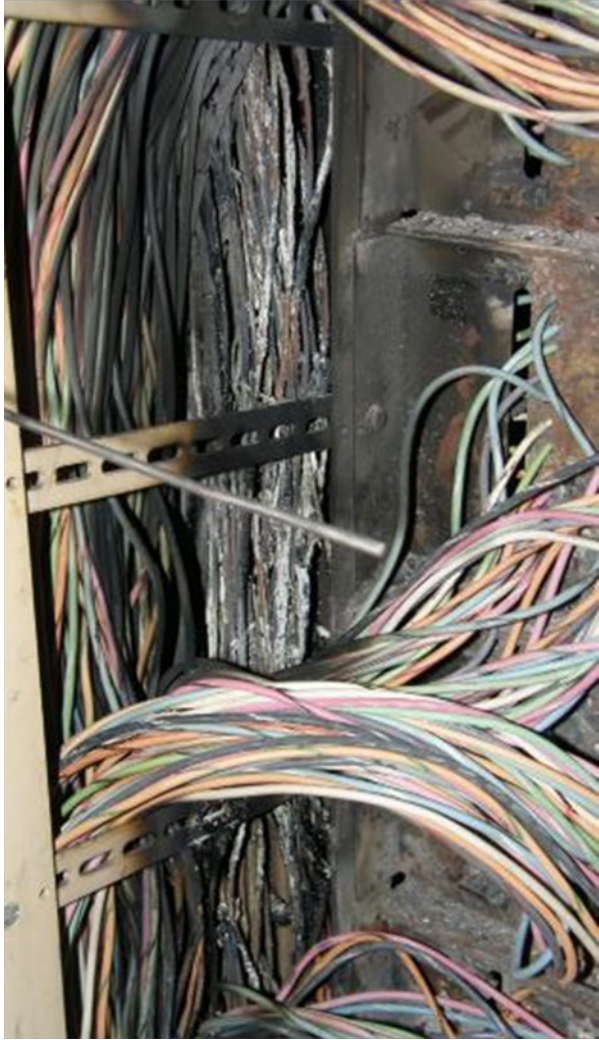
Table 5-29. Summary of Test 27

<p>Test: 27 (A,B)</p> <p>Enclosure: 1</p> <p>Fuel Load: 2.99 kg</p> <p>Ignition Source: 0.7 kW propane burner</p> <p>Preheating Source: 150 mL ethanol pan fire</p> <p>Ventilation: Door closed, opened briefly</p> <p>Notes: The ethanol was exhausted at approximately 7 min, at which time the propane burner was lit. The door was opened at 27 min and at 40 min (B), for approximately 1 min. Each time the door was opened, the cables were jostled with a crowbar. The burner was turned off at 56 min. Based on observation, 36 conductors were consumed 30 cm (1 ft) above the burner.</p>

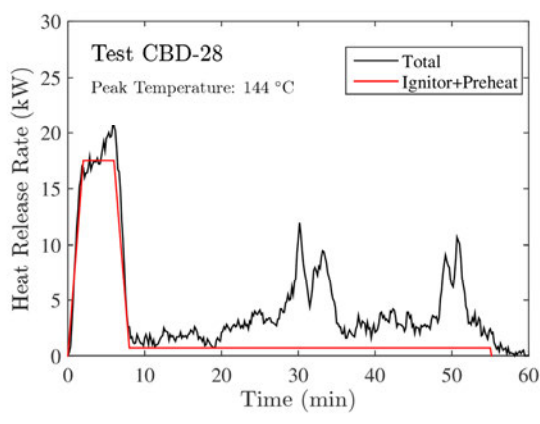
<p>Test CBD-28 Peak Temperature: 144 °C</p> <p>Heat Release Rate (kW)</p> <p>Time (min)</p> <p>Legend: Total (black line), Ignitor+Preheat (red line)</p>

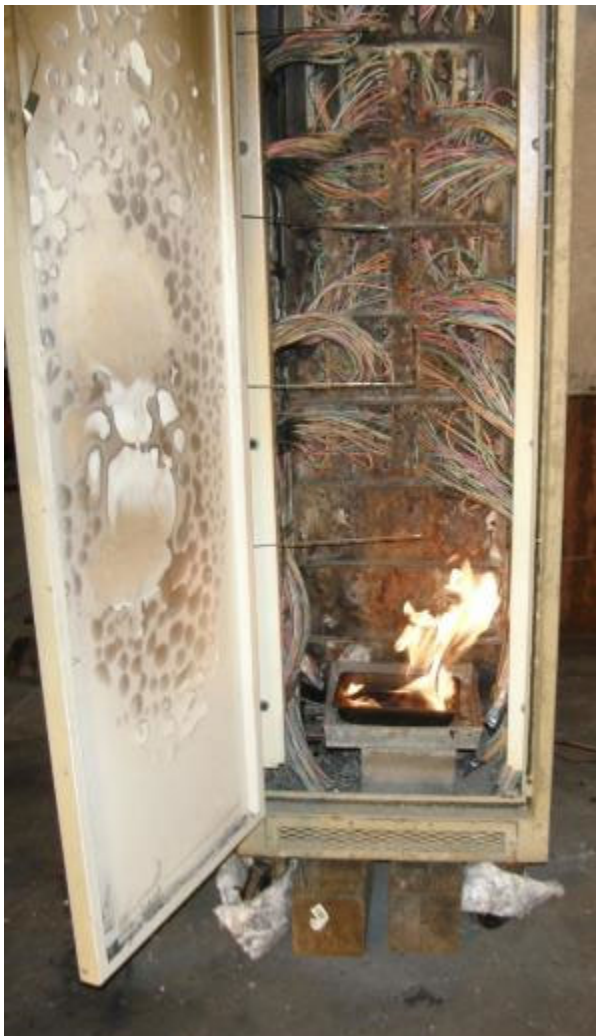
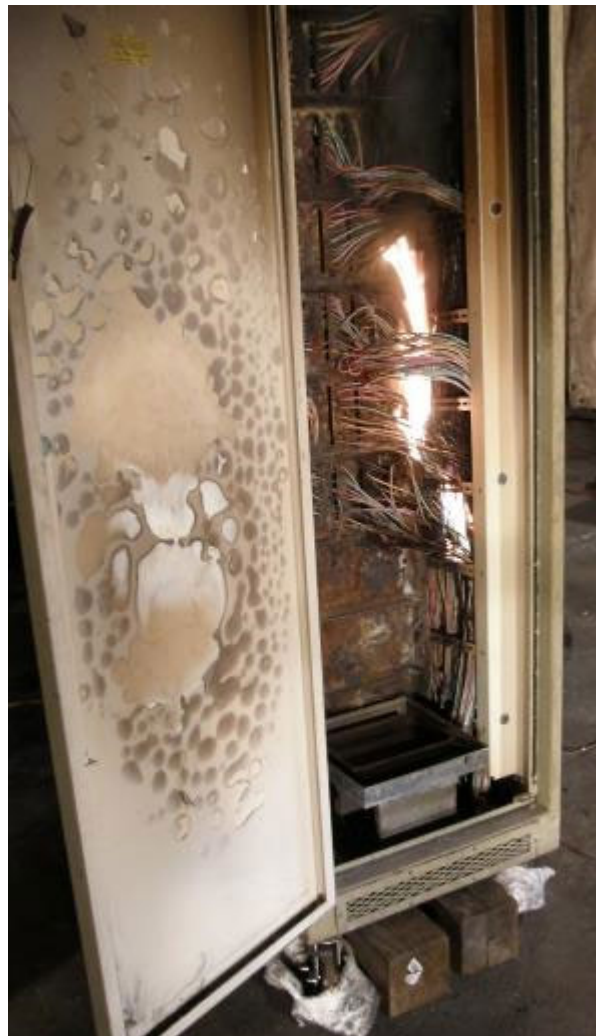
Table 5-30. Summary of Test 28

<p>Test: 28 (A,B,C)</p> <p>Enclosure: 1</p> <p>Fuel Load: 2.87 kg</p> <p>Ignition Source: 0.7 kW propane burner</p> <p>Preheating Source: 300 mL ethanol pan fire</p> <p>Ventilation: Door closed, opened briefly</p> <p>Notes: The ethanol fire was exhausted at approximately 9 min after which the propane burner was ignited. At 19 min (B), the door was opened and the wires in the vicinity of the burner were jostled with a crowbar, and the door was closed. The fire then spread upwards, approximately 0.6 m (2 ft) above the burner. The crowbar process was repeated at 40 min (C).</p>

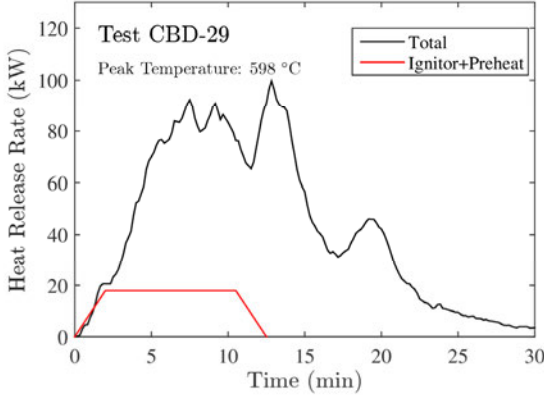
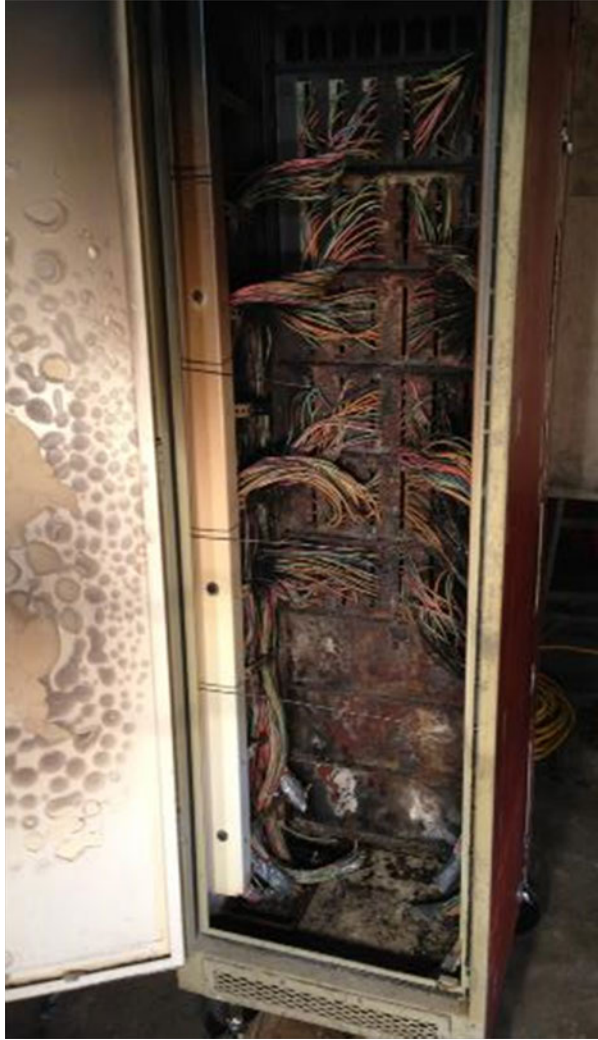
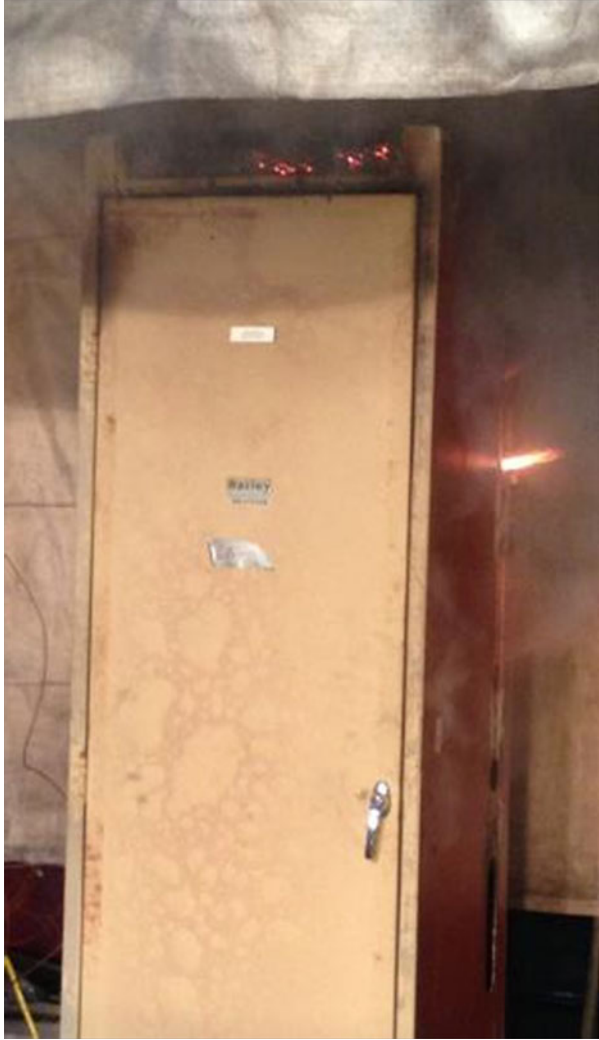
Table 5-31. Summary of Test 29

<p>Test: 29</p> <p>Enclosure: 1</p> <p>Fuel Load: 2.64 kg</p> <p>Ignition Source: 500 mL acetone pan fire</p> <p>Ventilation: Door closed</p> <p>Notes: The bottom ends of 3 bundles, each consisting of 37 insulated conductors, were placed in the 15 cm by 23 cm (6 in by 9 in) steel baking pan at the lower left side of the enclosure. The acetone burned for approximately 12 min, 30 s. The fire spread up one side of the enclosure. Half of the combustible material was consumed.</p>

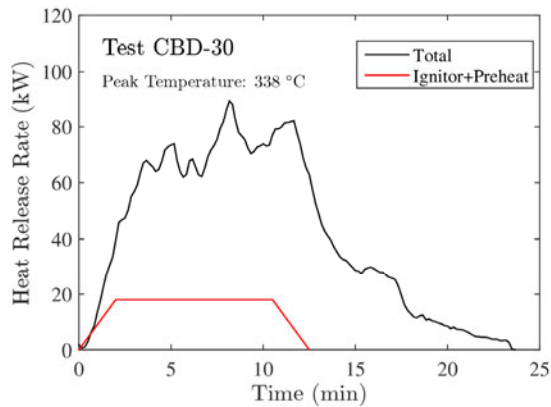
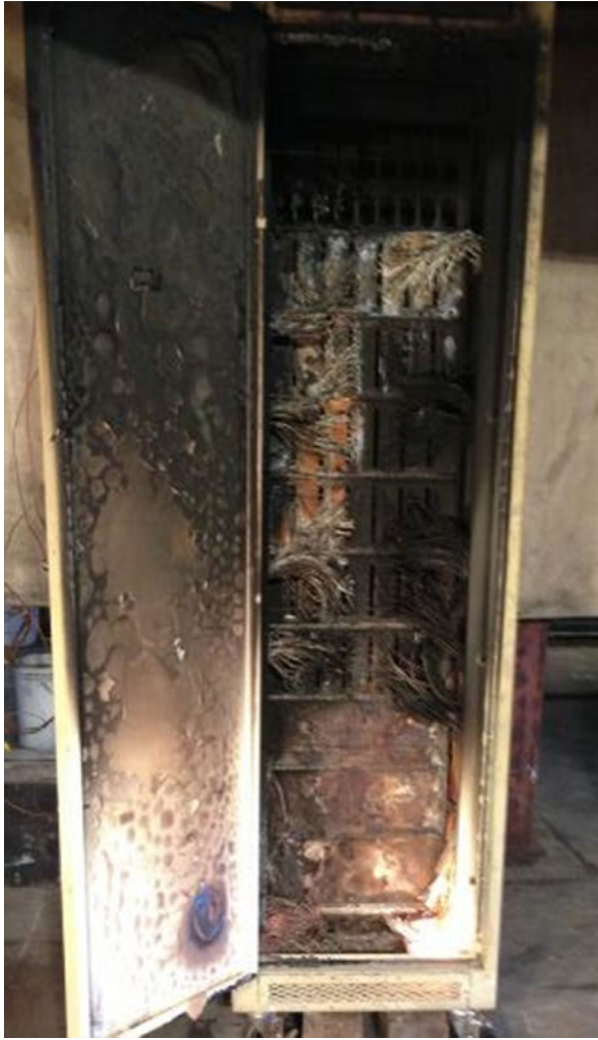
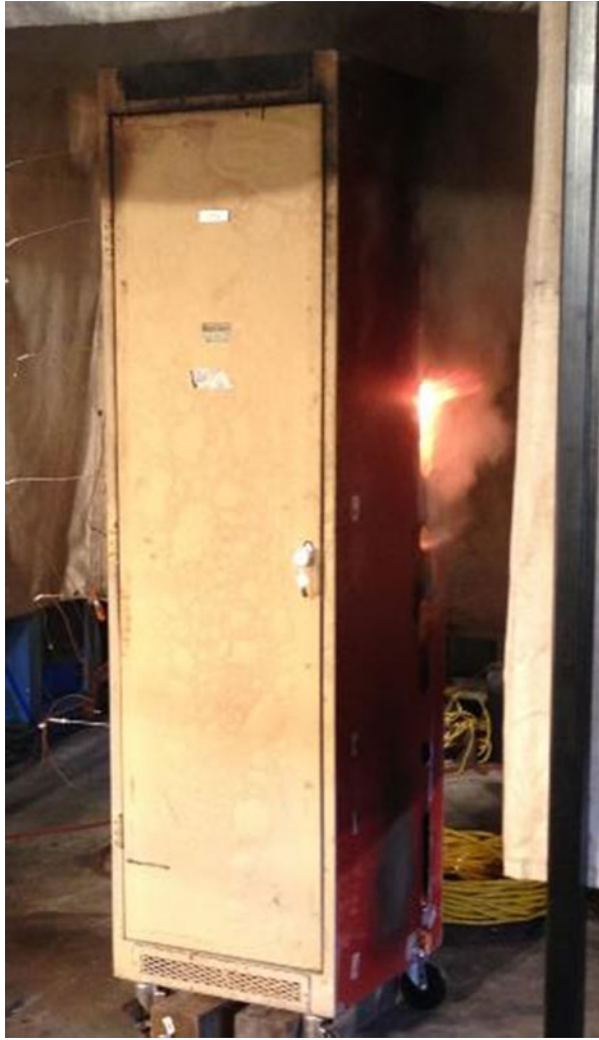
Table 5-32. Summary of Test 30

<p>Test: 30</p> <p>Enclosure: 1</p> <p>Fuel Load: 1.32 kg</p> <p>Ignition Source: 500 mL acetone pan fire</p> <p>Ventilation: Door closed</p> <p>Notes: This test was similar to Test 29, where the acetone pan was placed on the unburned right side of the enclosure. The test was terminated at approximately 23 min.</p>

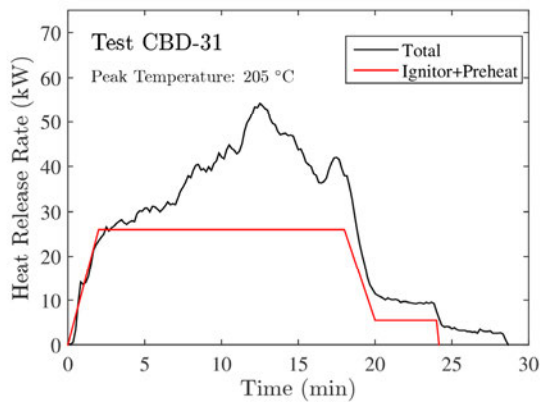
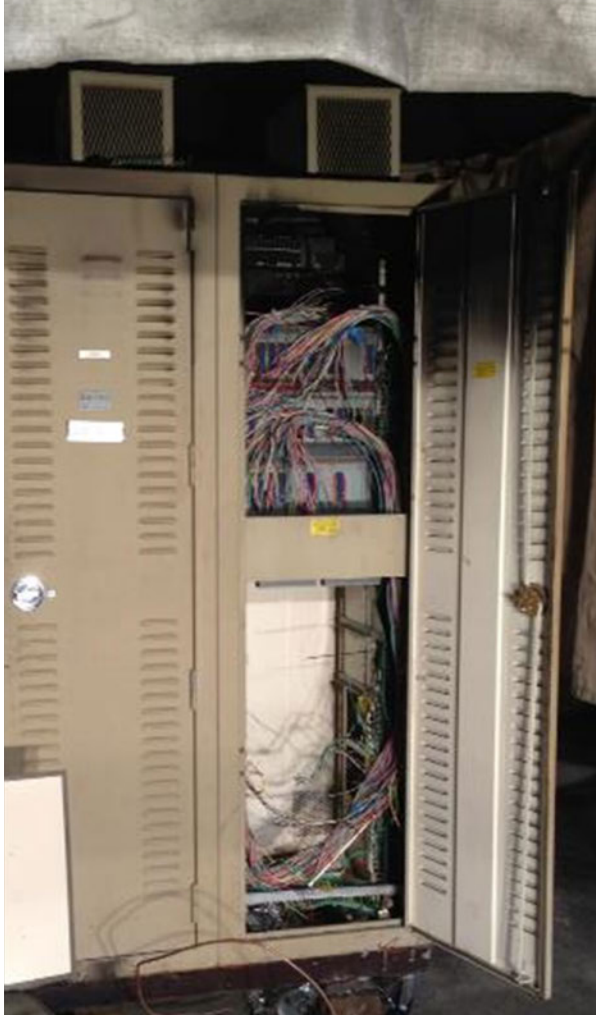
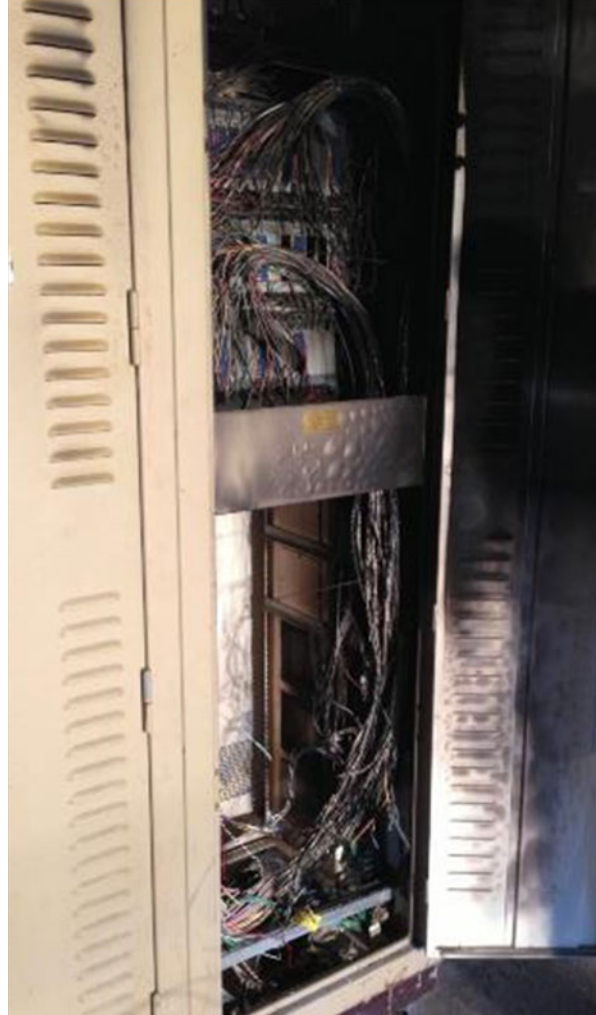
Table 5-33. Summary of Test 31

<p>Test: 31</p> <p>Enclosure: 4</p> <p>Fuel Load: 37. insulated conductors extracted from Cable #834, loosely bundled, 1.8 m (6 ft) along right side of enclosure</p> <p>Ignition Source: 5.5 kW propane burner</p> <p>Preheating Source: 1 L acetone pan fire</p> <p>Ventilation: Door closed</p> <p>Notes: The acetone pan was placed in the rear of the enclosure for the purpose of pre-heating. The acetone was exhausted at 20 min. The door was opened and the propane burner was turned off at 23 min.</p>

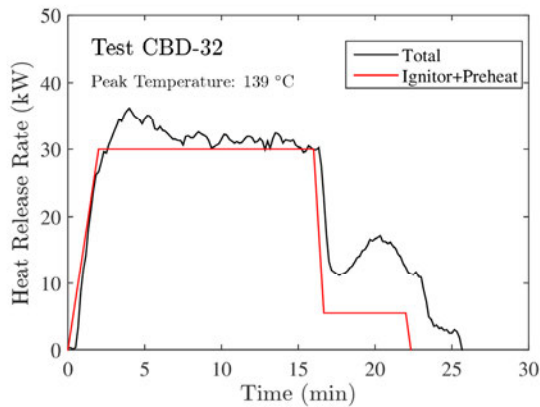
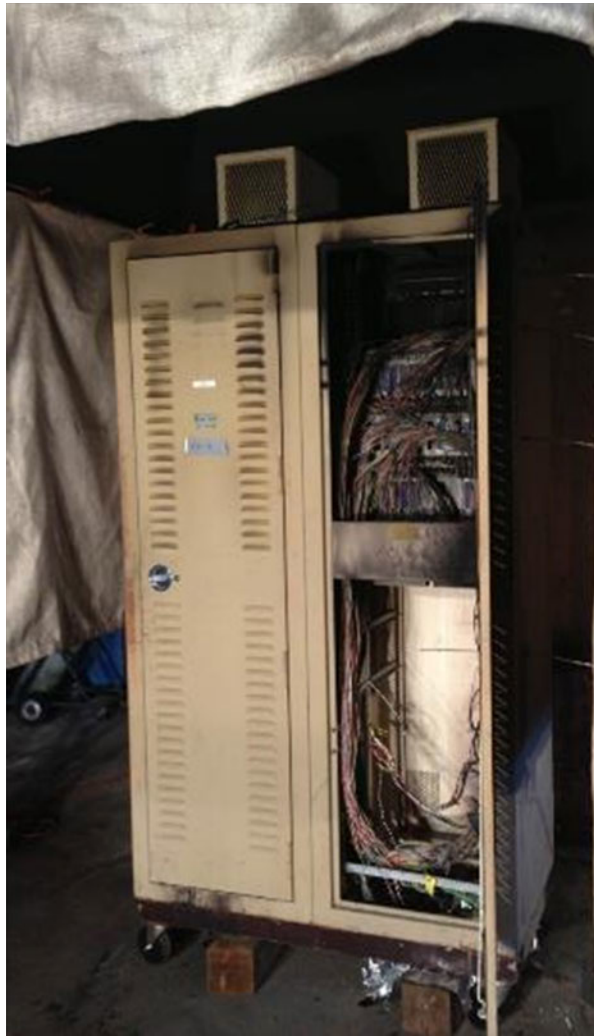
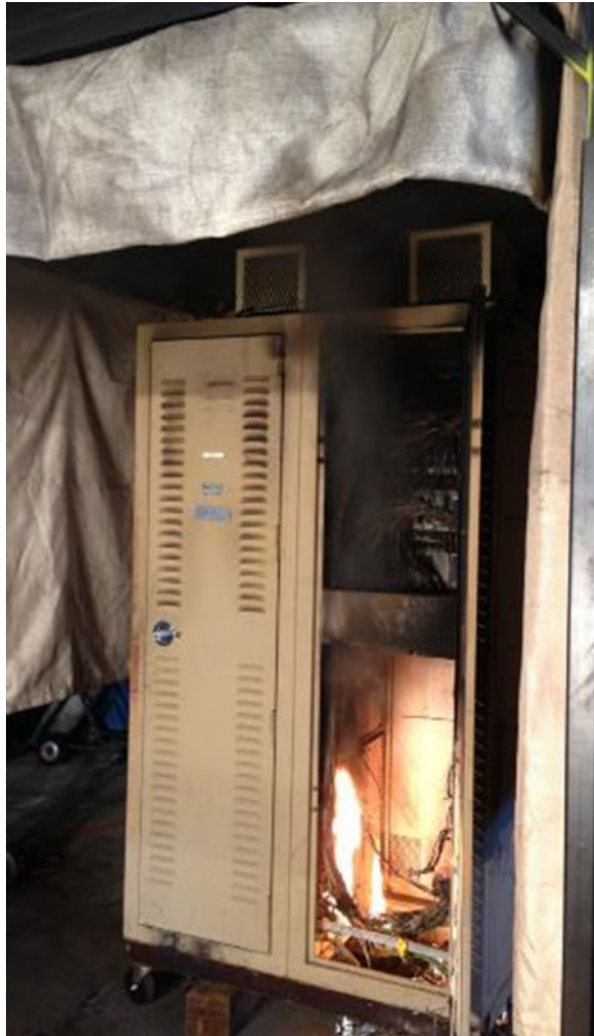
Table 5-34. Summary of Test 32

<p>Test: 32 (A,B)</p> <p>Enclosure: 4</p> <p>Fuel Load: 37 insulated conductors (#834), loosely bundled, 1.8 m (6 ft) along left side of enclosure</p> <p>Ignition Source: 5.5 kW propane burner</p> <p>Preheating Source: 1 L acetone pan fire</p> <p>Ventilation: Door closed, then opened</p> <p>Notes: The acetone was exhausted at approximately 16 min, and the propane burner was turned off at 22 min. The door was opened at 16 min (B) and remained open. The fire did not spread beyond the vicinity of the propane burner.</p>

<p>Test CBD-32 Peak Temperature: 139 °C</p> <p>Heat Release Rate (kW)</p> <p>Time (min)</p> <p>— Total — Ignitor+Preheat</p>

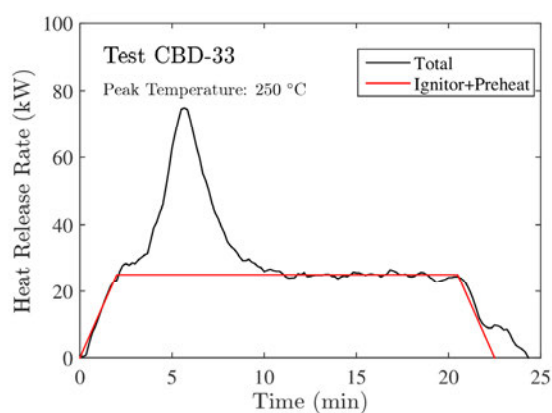
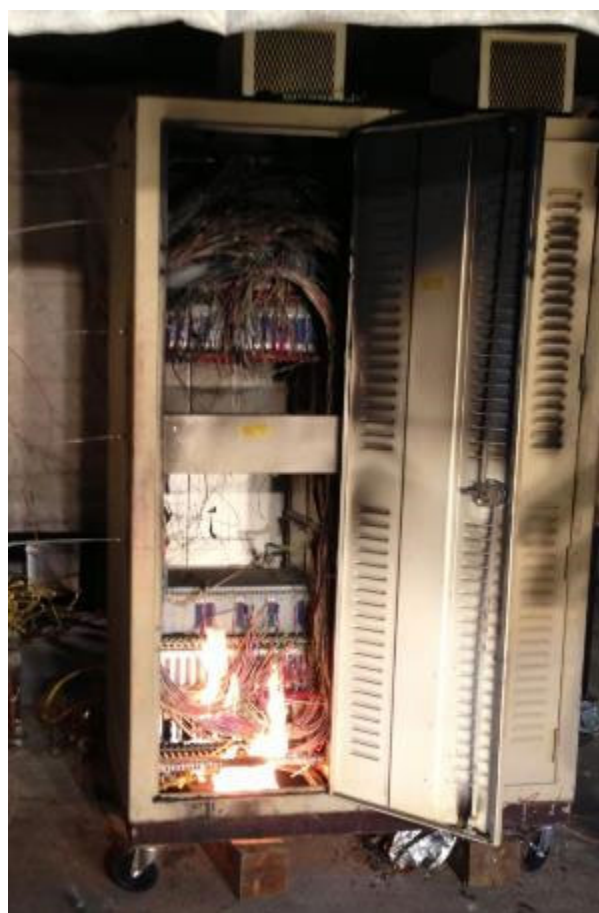
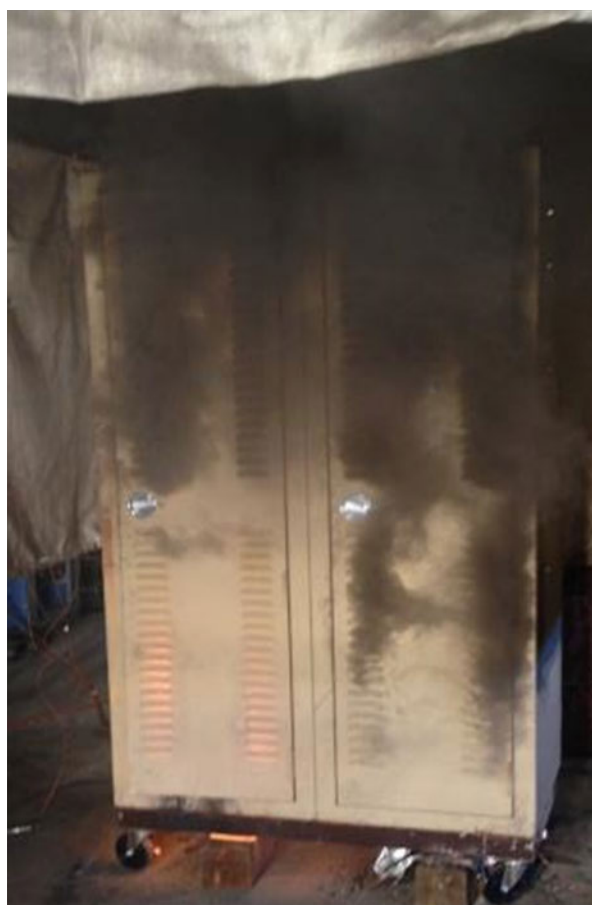
Table 5-35. Summary of Test 33

Fuel Load: 74 insulated conductors (#834), loosely bundled, 1.8 m (6 ft)

Ignition Source: 5.5 kW propane burner and 1 L acetone pan fire at the overlap region of left and right side bundles

Notes: This was an attempt to burn the wiring on both sides of the enclosure. The fire spread about one-third of the way up the left side, but within 10 min the only fuel burning was the acetone and propane. The acetone was exhausted and the burner turned off just after 20 min. Based on observation, 37 conductors were consumed 0.6 m (2 ft).

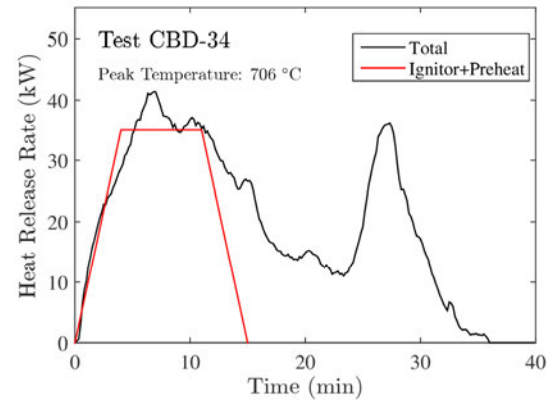
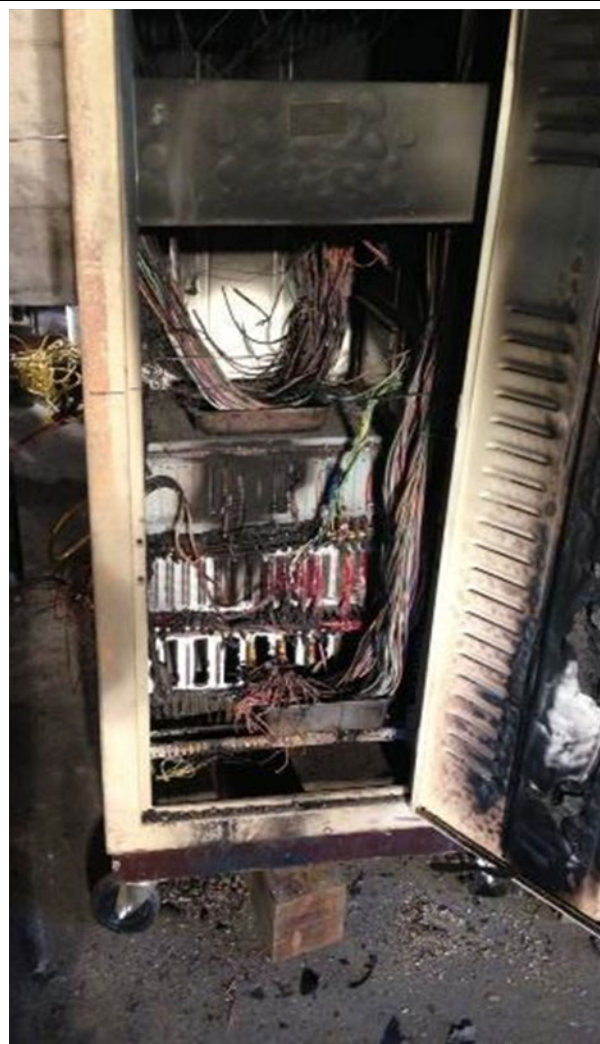
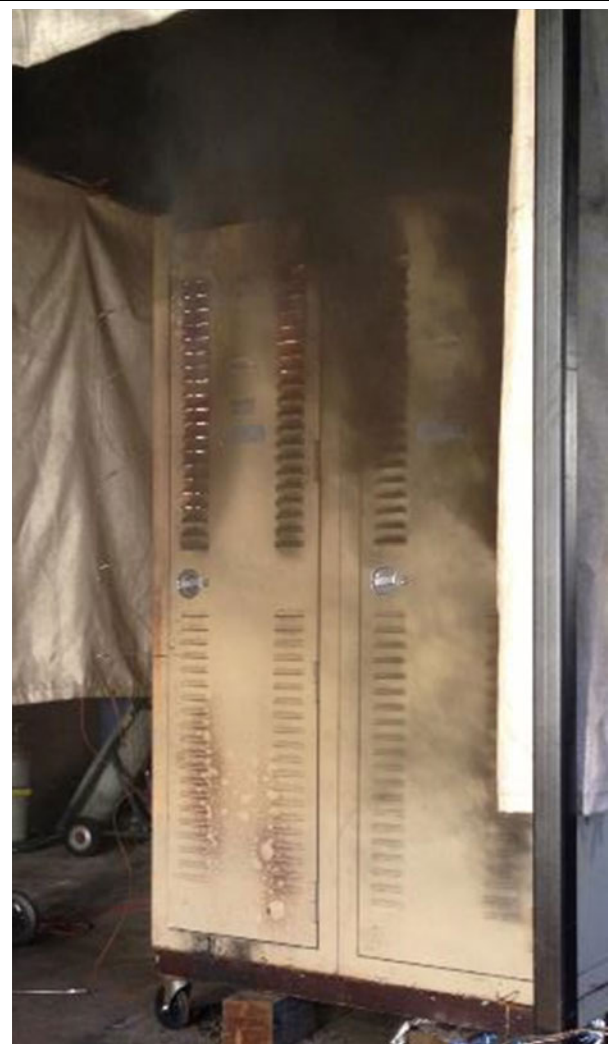
Table 5-36. Summary of Test 34

Fuel Load: 62 insulated conductors (#834), loosely bundled, 1.8 m (6 ft) long, 1.22 kg

Notes: This was an attempt to burn wire bundles left over from previous tests. The fire spread up the left side of the enclosure, and halfway up the right.

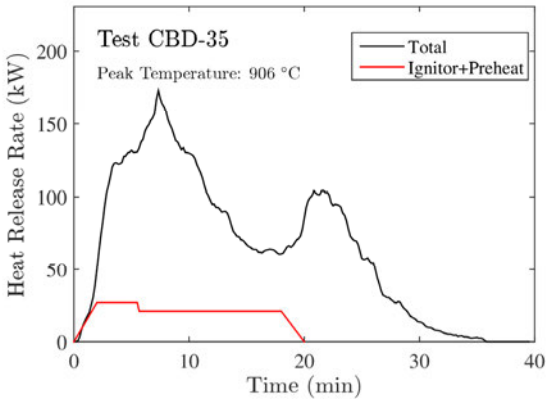
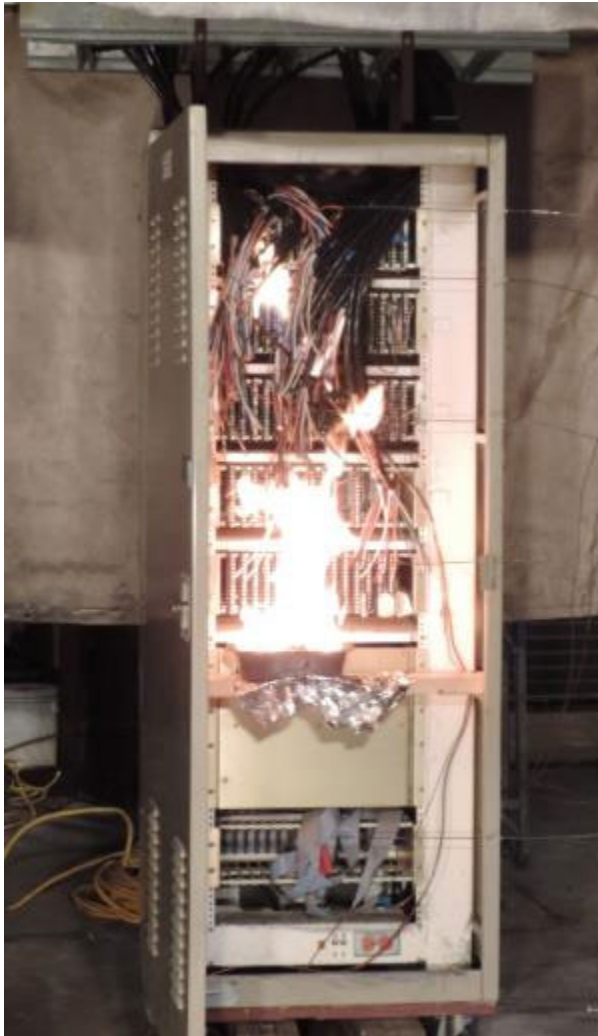
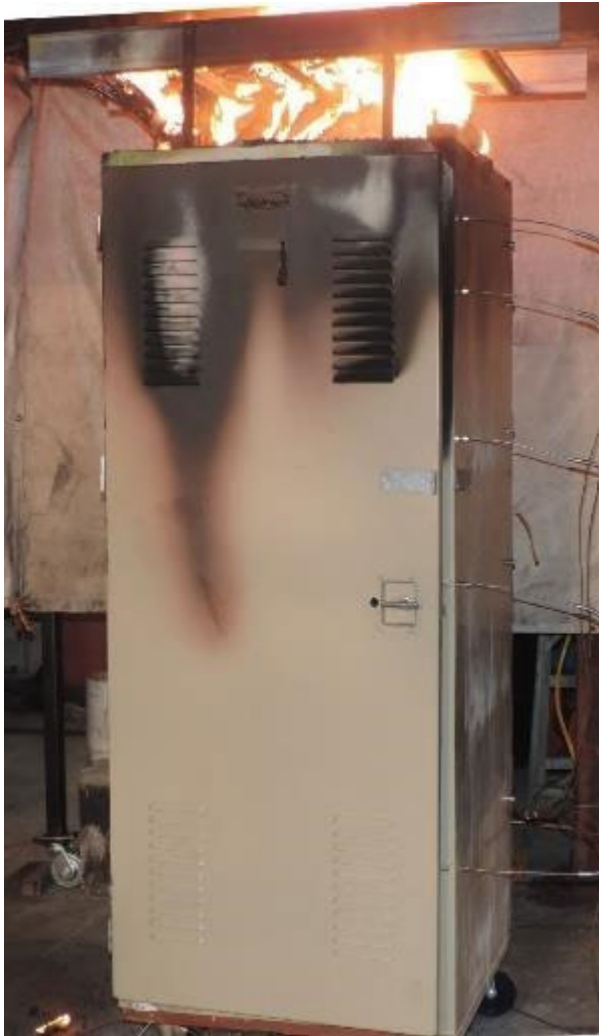
Table 5-37. Summary of Test 35

<p>Test: 35</p> <p>Enclosure: 8</p> <p>Fuel Load: 42 control cables (#807), 1.8 m (6 ft) long, routed through vertical conduits on top of enclosure into cable tray 45 cm (18 in) above</p> <p>Ignition Source: 5.5 kW propane burner within the bundled cable and 1 L acetone pan fire 60 cm (2 ft) below base of cable bundle</p> <p>Ventilation: Door closed, then opened</p> <p>Notes: The door popped open at 3 min, 20 s, due to the rapid increase in the HRR. The propane burner was turned off at 5 min, 30 s. At approximately 20 min the fire spread through the 10 conduits and burned the cables in the tray above.</p>

<p>Test CBD-35 Peak Temperature: 906 °C</p> <p>Heat Release Rate (kW)</p> <p>Time (min)</p> <p>— Total — Ignitor+Preheat</p>

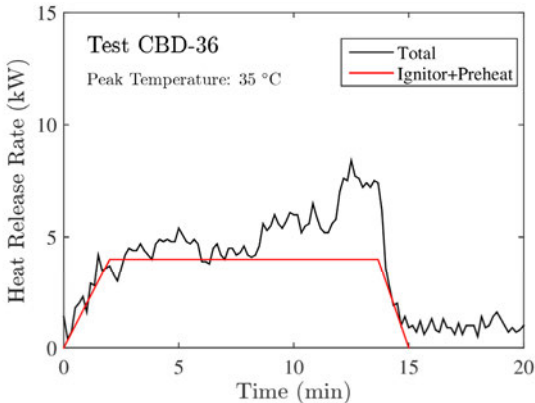
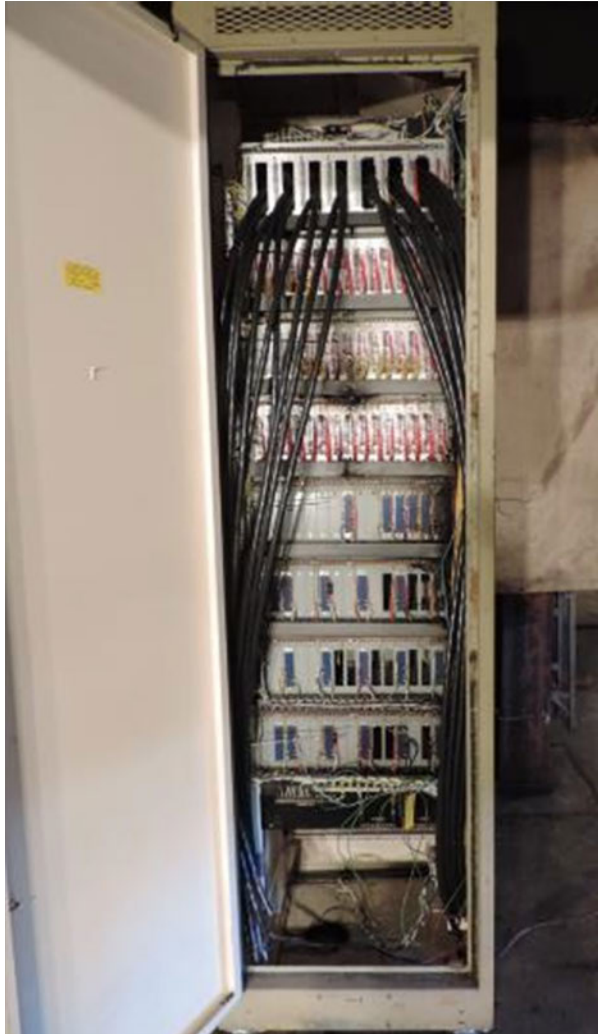
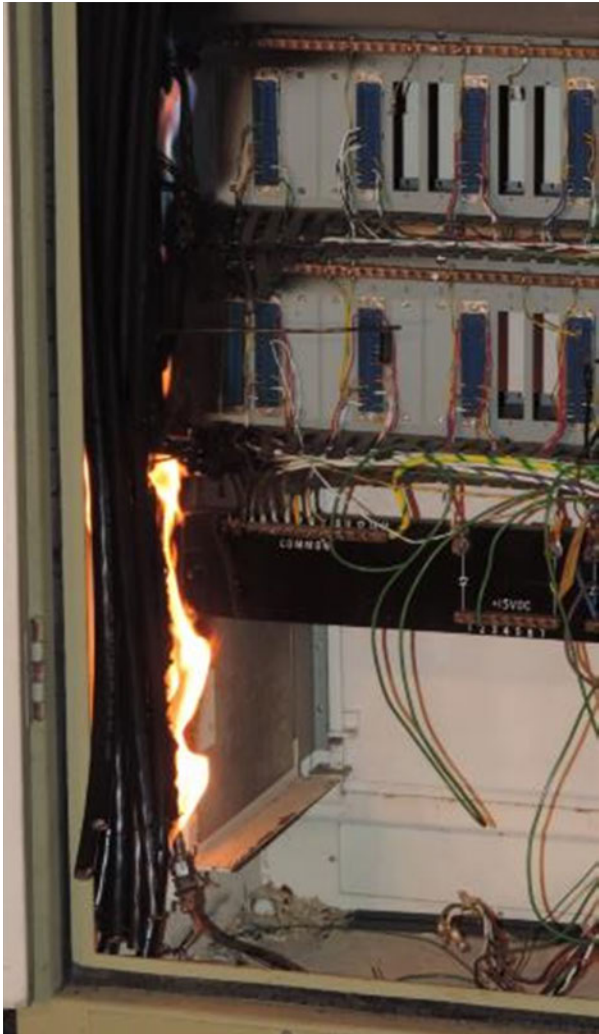
Table 5-38. Summary of Test 36

<p>Test: 36 (A,B)</p> <p>Enclosure: 2</p> <p>Fuel Load: Bundle of 10 control cables (#807), 1.8 m (6 ft) long, 2.71 kg</p> <p>Ignition Source: 4 kW propane burner</p> <p>Ventilation: Door closed, then opened</p> <p>Notes: The fire did not spread beyond its point of origin near the base of the bundle. The front door was opened at 12 min (B). The burner was turned off at approximately 14 min.</p>

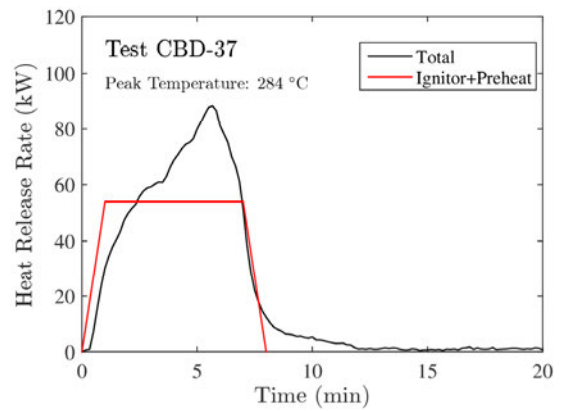
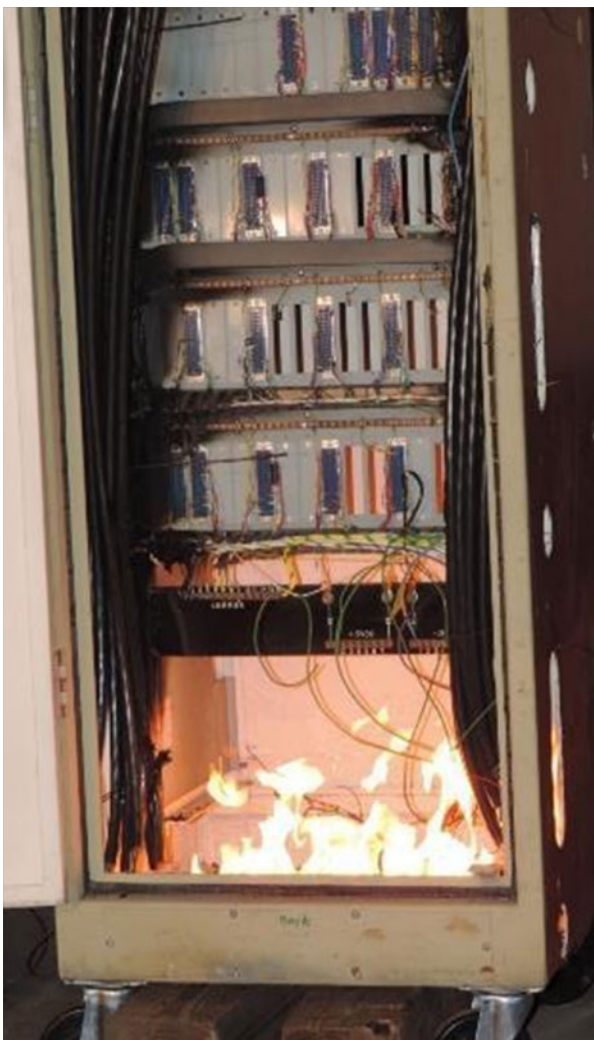
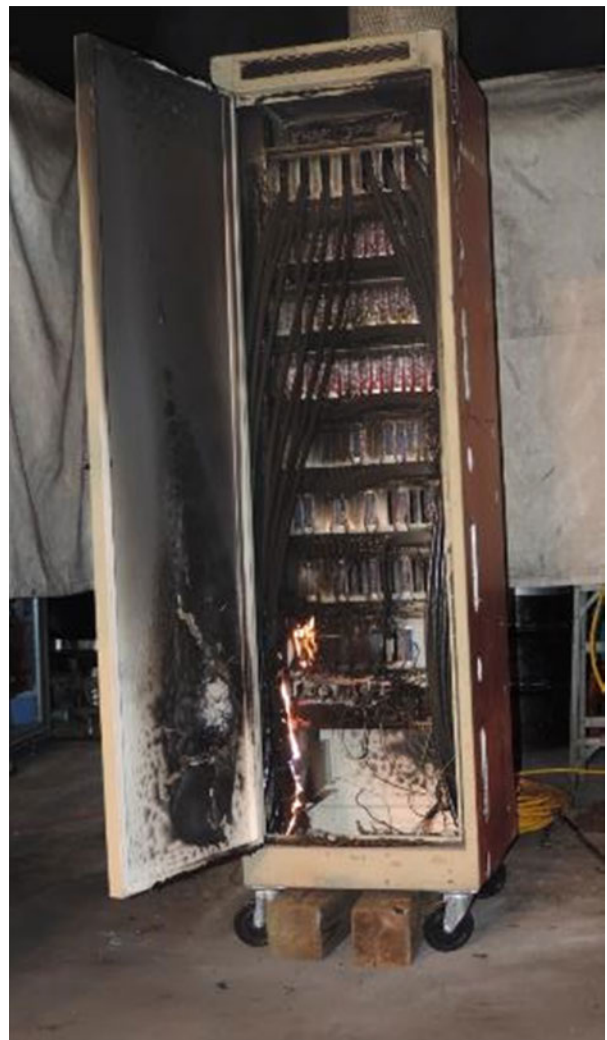
Table 5-39. Summary of Test 37

Notes: The fire spread upwards on the left side bundle, but did not spread upwards on the right. 10 control cables approximately 0.46 m (1.5 ft) on the right side were consumed,.

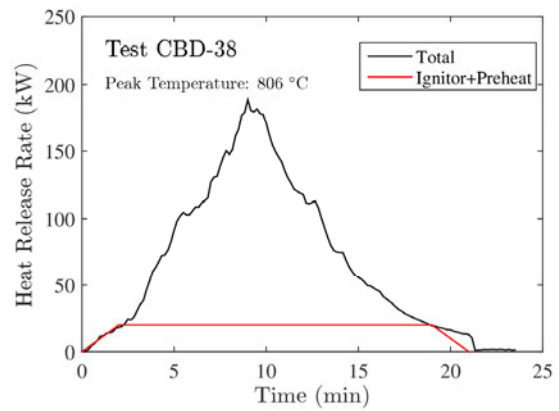
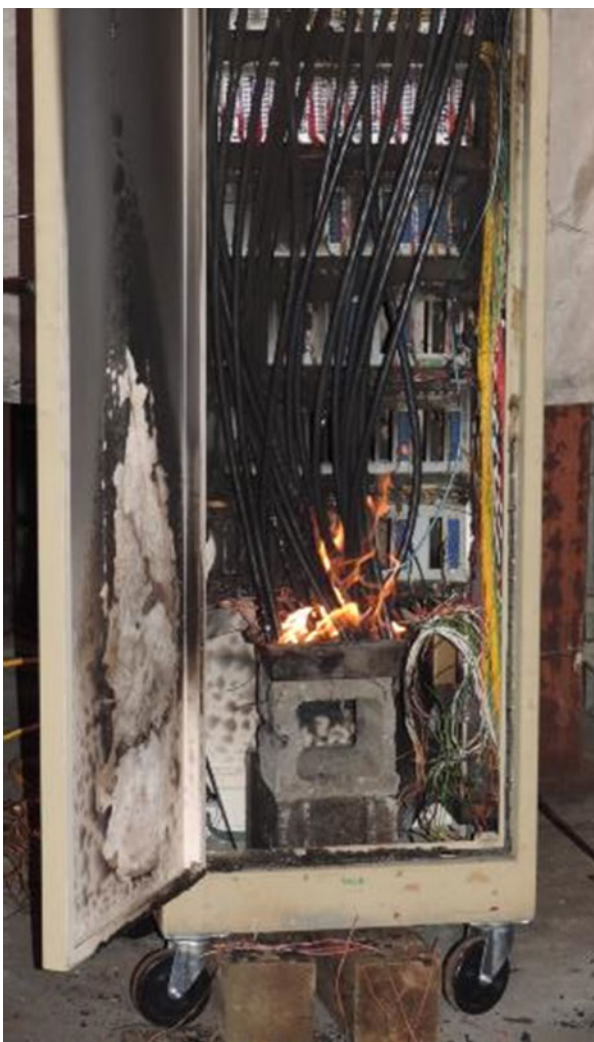
Table 5-40. Summary of Test 38

Notes: The fire consumed all of the cables within the enclosure. Flames extended outside of the access openings, reaching a height approximately 30 cm (1 ft) above the top of the enclosure. The acetone was exhausted at 21 min.
