Heat Release Rates of Electrical Enclosure Fires (HELEN-FIRE)

Final Report

This report documents an experimental program to explore the heat release rate and burning behavior of electrical enclosures commonly found in nuclear power plants. Electrical enclosures are a potential source of fire in nuclear power plants because they contain both combustible materials and live electrical circuits. These fires have the potential to disrupt power, instrumentation, and control in the plant. Key parameters affecting fire in an enclosure include its size, openings, electrical voltage, and combustible load.

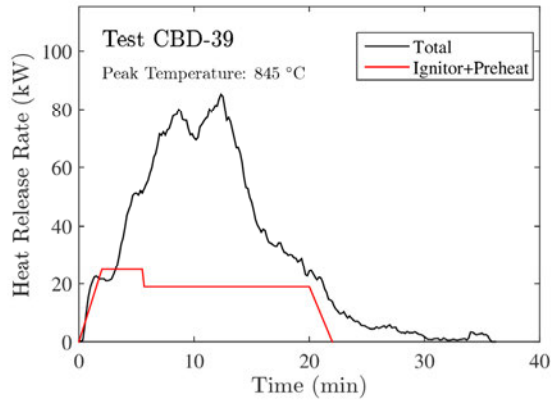
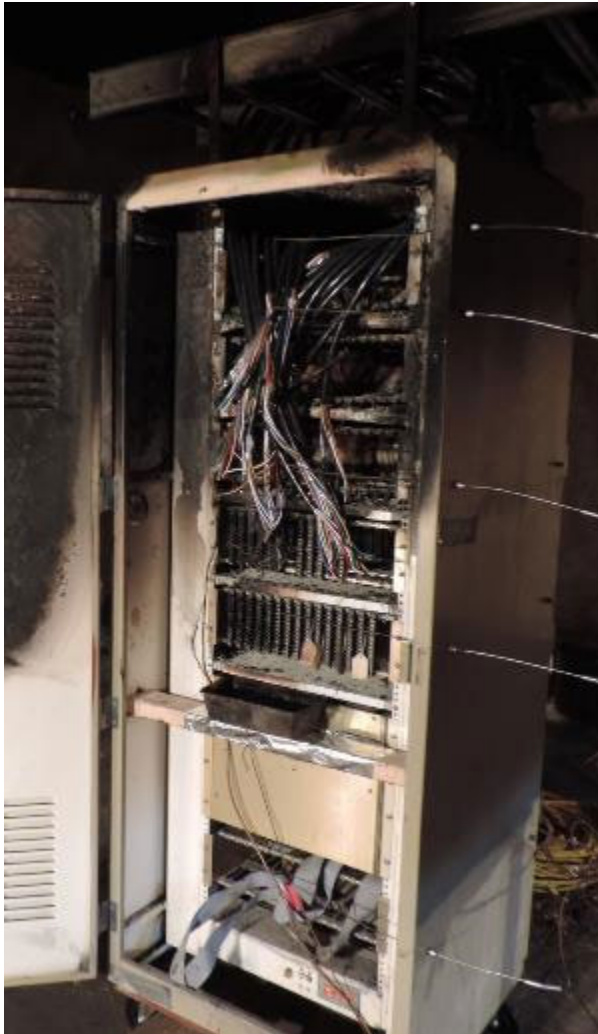
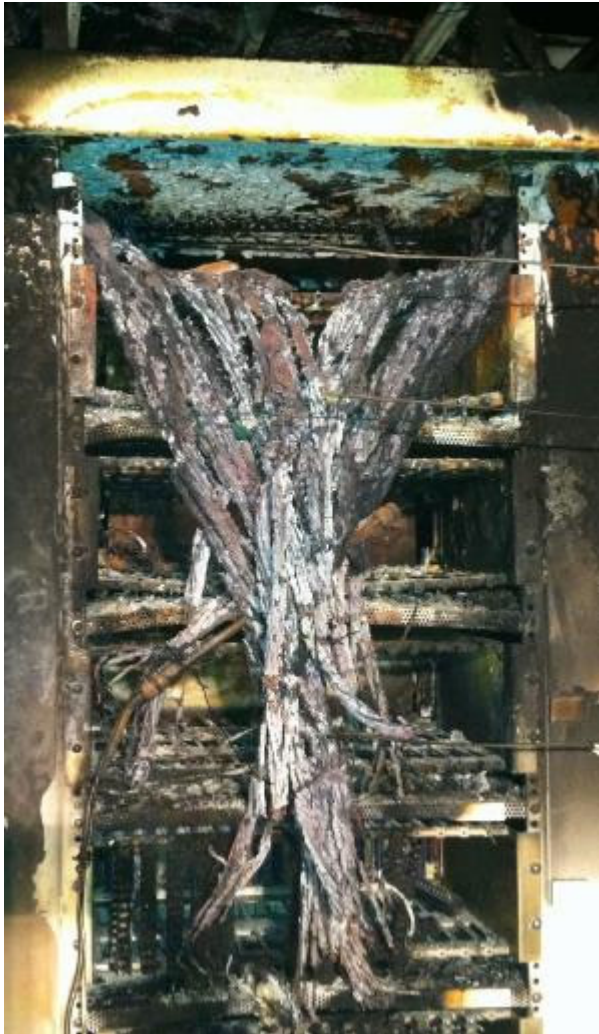
Table 5-41. Summary of Test 39

<p>Test: 39</p> <p>Enclosure: 8</p> <p>Fuel Load: 21 control cables (#807), 1.8 m (6 ft) long</p> <p>Ignition Source: 5.5 kW propane burner within the bundled cable and 1 L acetone pan fire 60 cm (2 ft) below base of cable bundle</p> <p>Ventilation: Door closed</p> <p>Notes: The fire spread upwards through the 10 conduits in the top of the enclosure and consumed the cables in the tray directly above.</p>

<p>Test CBD-39 Peak Temperature: 845 °C</p> <p>Heat Release Rate (kW)</p> <p>Time (min)</p> <p>— Total — Ignitor+Preheat</p>

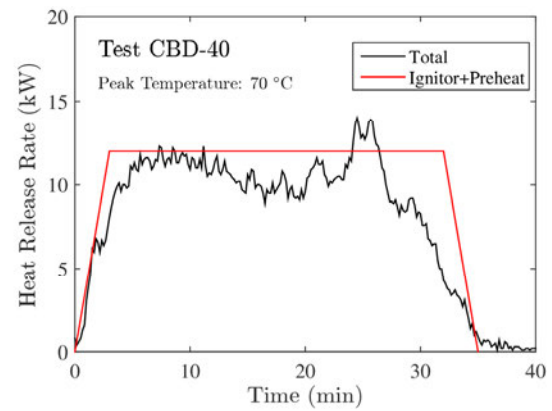
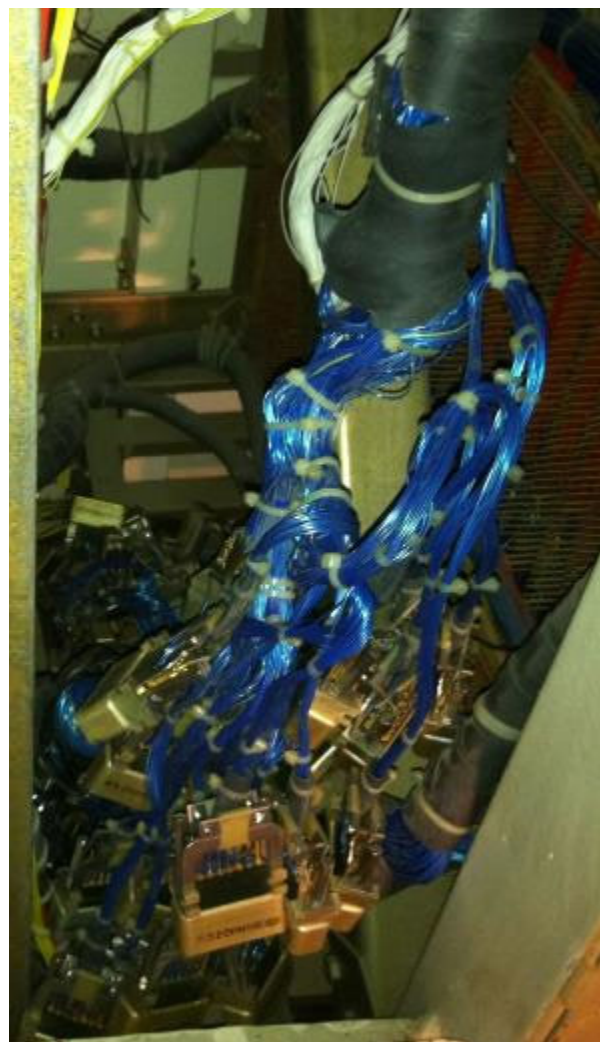
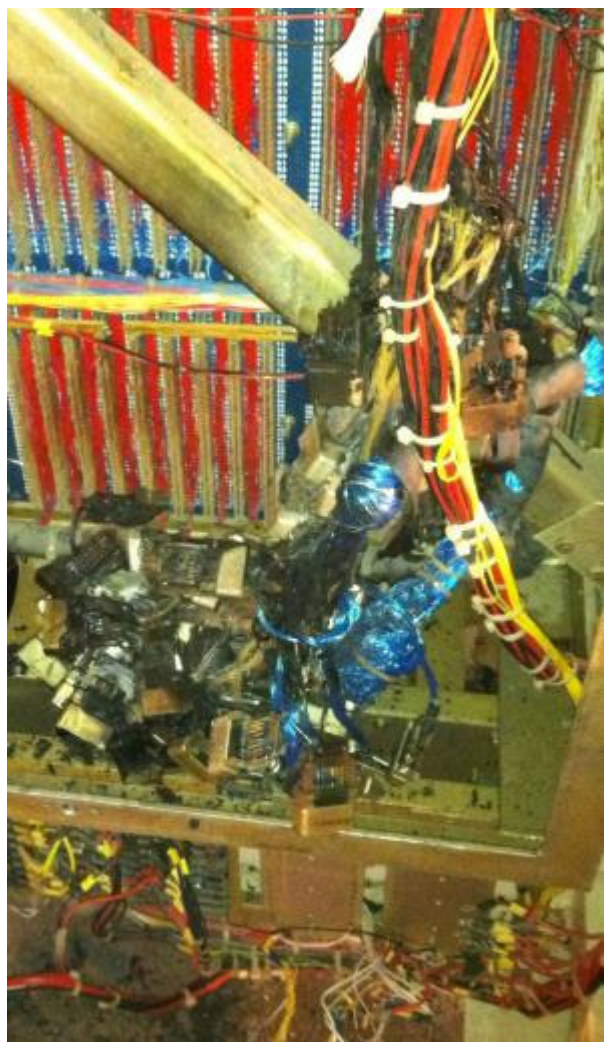
Table 5-42. Summary of Test 40

Notes: The wire and connectors were stuffed into the fuel pan. The fire did not spread beyond the pan. The wire coating appeared to blacken but did not generate any measurable heat.

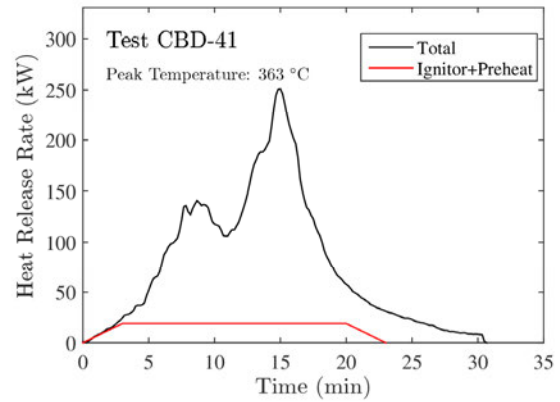
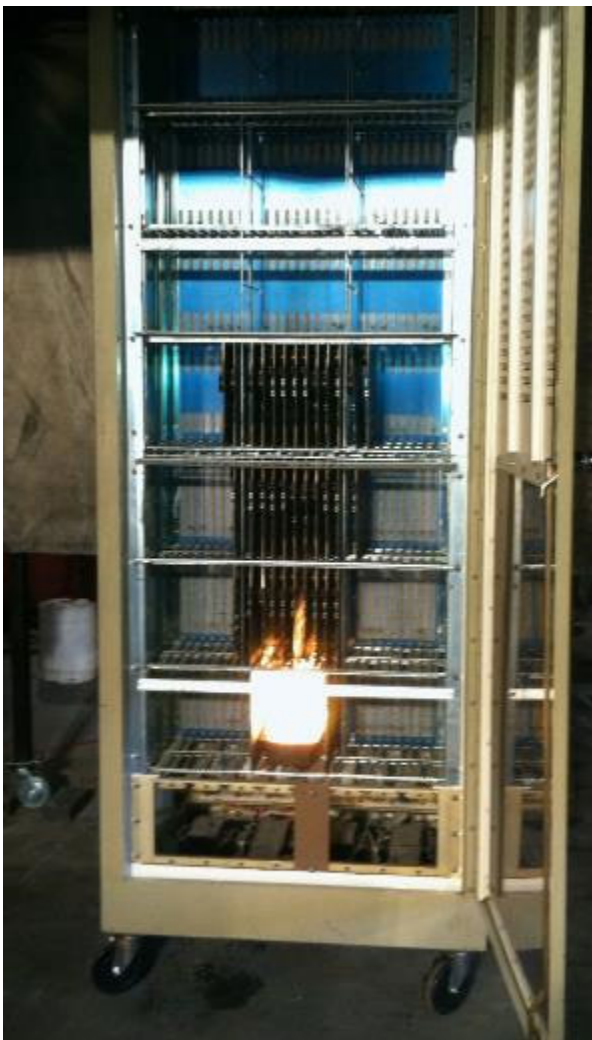
Table 5-43. Summary of Test 41

Notes: The fire spread rapidly through the circuit boards, which were arranged in multiple racks above the pan. The clear plastic panel in the front door burned through at 11 min (B), and the fire grew rapidly afterwards. The coated relay wiring on the back side of the partition between the front and middle sections burned.

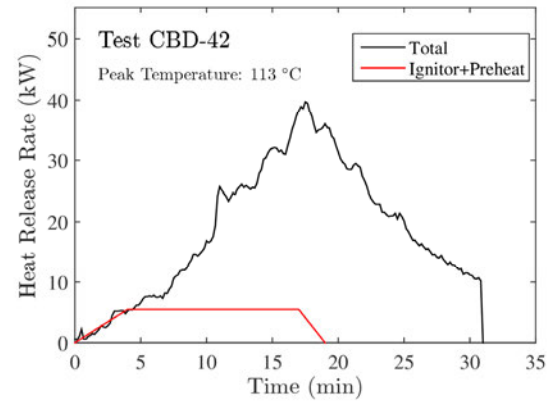
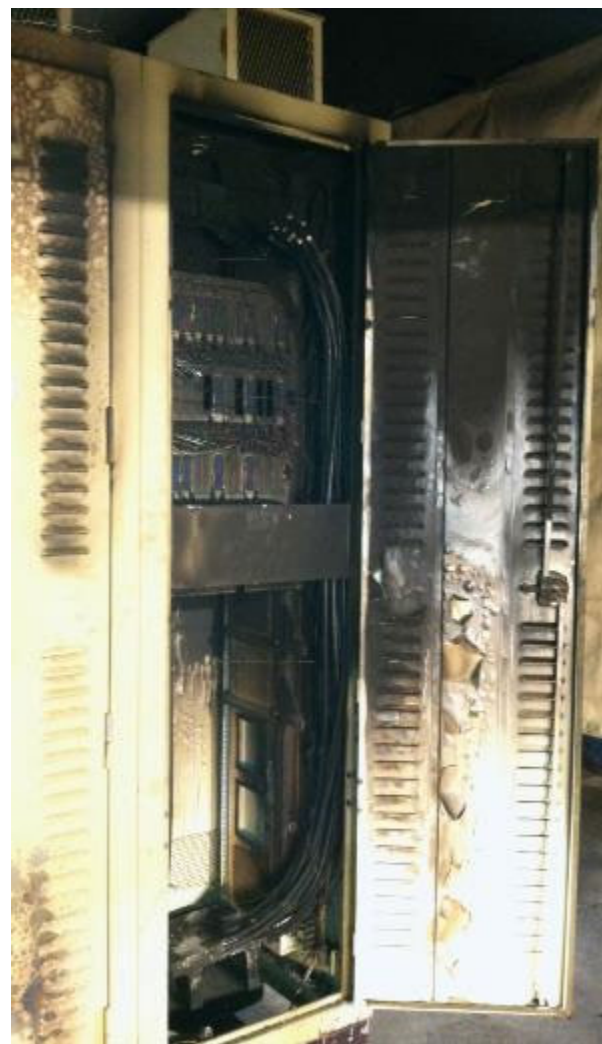
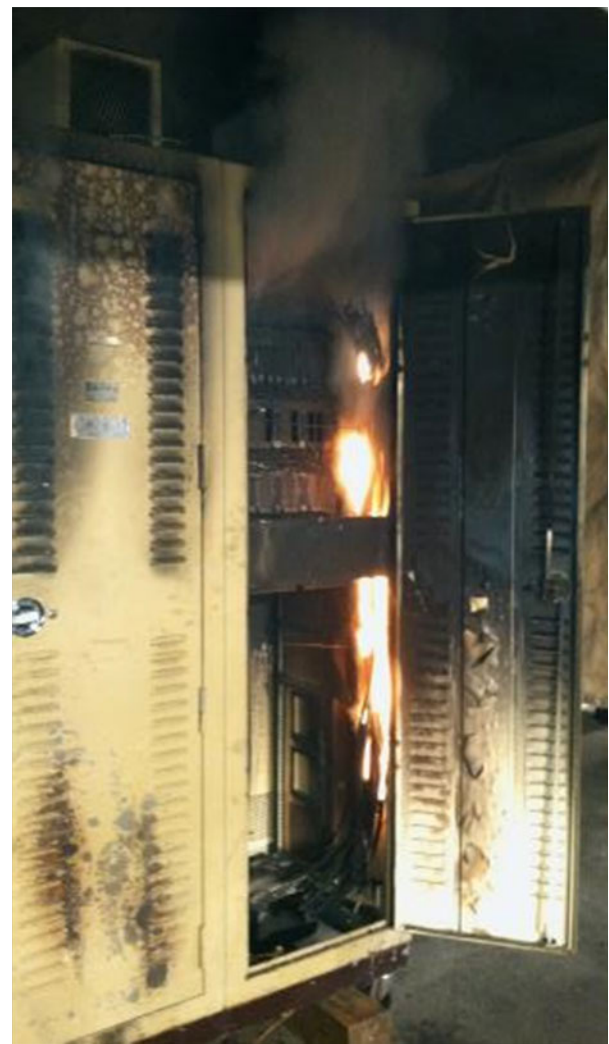
Table 5-44. Summary of Test 42

Ignition Source: 5.5 kW propane burner

Ventilation: Door closed then opened at 10 min

Notes: The fire spread upwards along the cables
in the right side of the enclosure. The door was
opened at approximately 10 min and it was left
open for the remainder of the test. The burner
was turned off at 17 min.

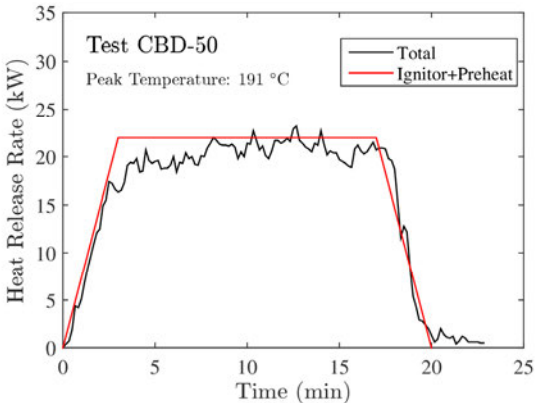
<p>Test CBD-50 Peak Temperature: 191 °C</p> <p>Heat Release Rate (kW)</p> <p>Time (min)</p>

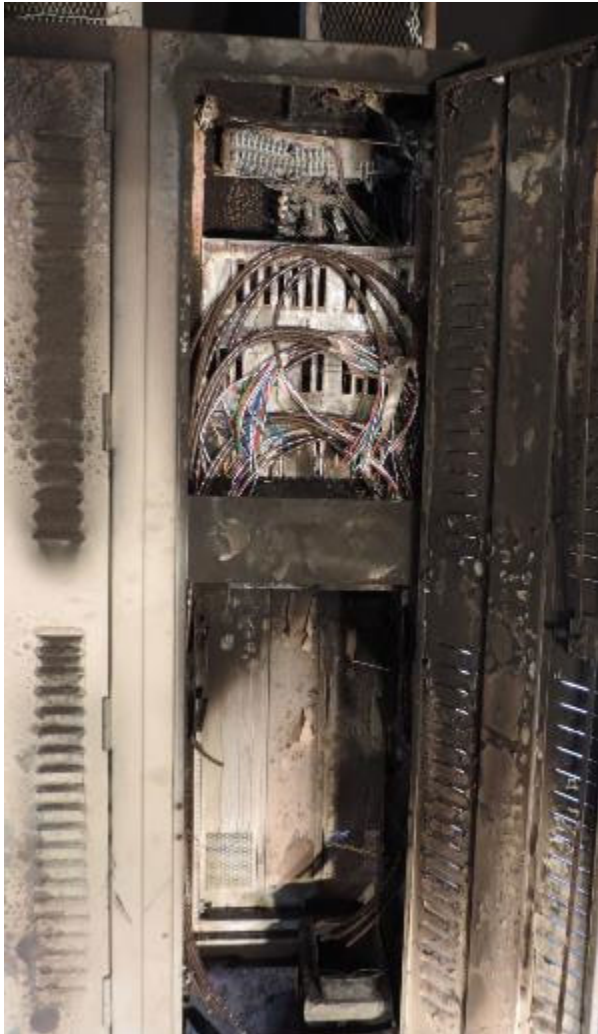
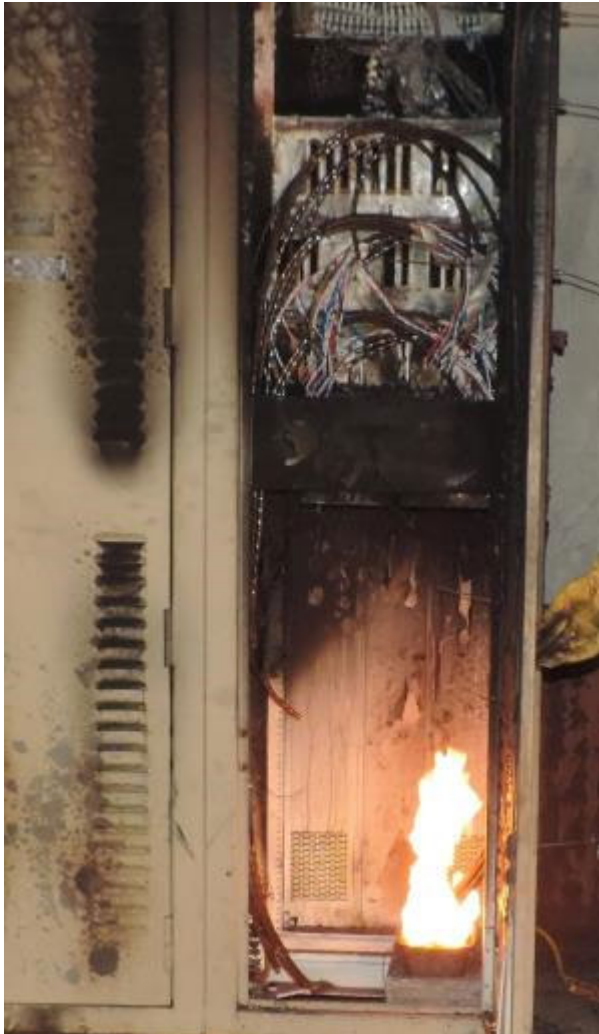
Table 5-53. Summary of Test 51

Notes: The fire spread halfway to the top of the enclosure. The propane burner was turned off at 10 min.

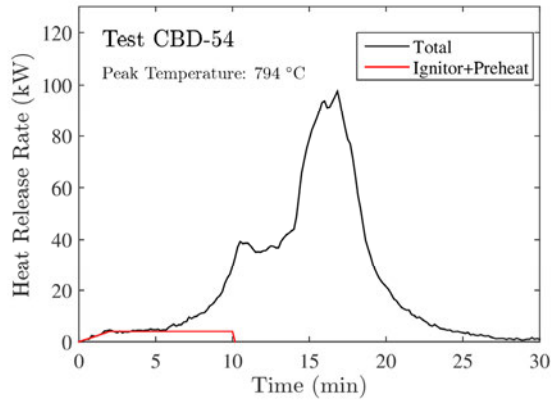
<p>Test CBD-54 Peak Temperature: 794 °C</p> <p>Heat Release Rate (kW)</p> <p>Time (min)</p> <p>Legend: Total (black line), Ignitor+Preheat (red line)</p> <p>The graph shows the heat release rate over a 30-minute period. The red line (Ignitor+Preheat) shows a small peak of about 5 kW at 10 minutes. The black line (Total) shows a much larger peak of approximately 100 kW at 17 minutes, with a secondary peak of about 40 kW at 10 minutes. The y-axis ranges from 0 to 120 kW, and the x-axis ranges from 0 to 30 minutes.</p>

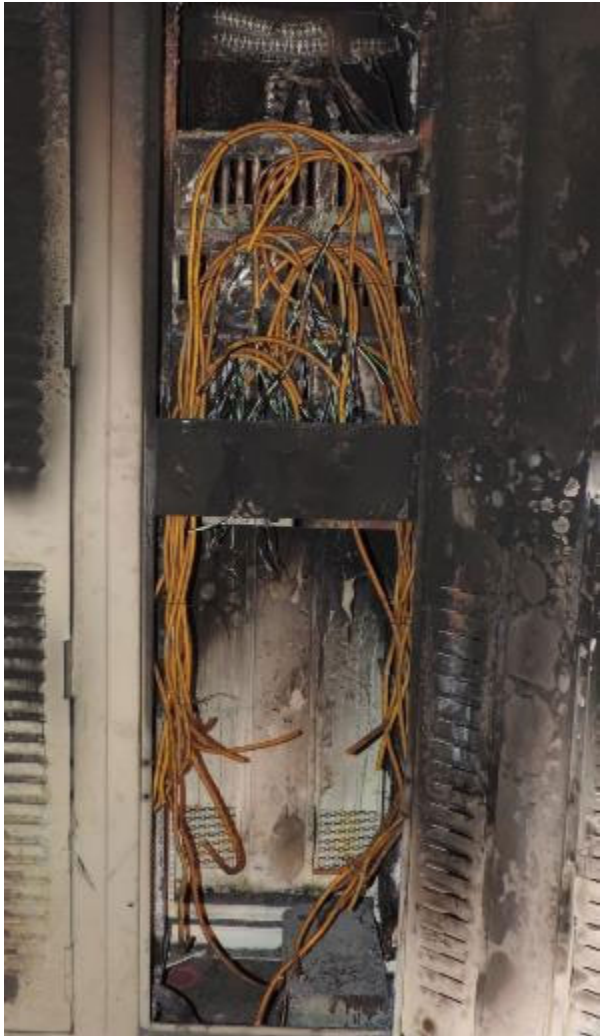
<p>A photograph showing the interior of enclosure 4. Two bundles of surplus power cord (#841) are visible, one on each side. The cords are yellow and black, and are bundled together. The enclosure is made of metal and has a door that is open.</p>

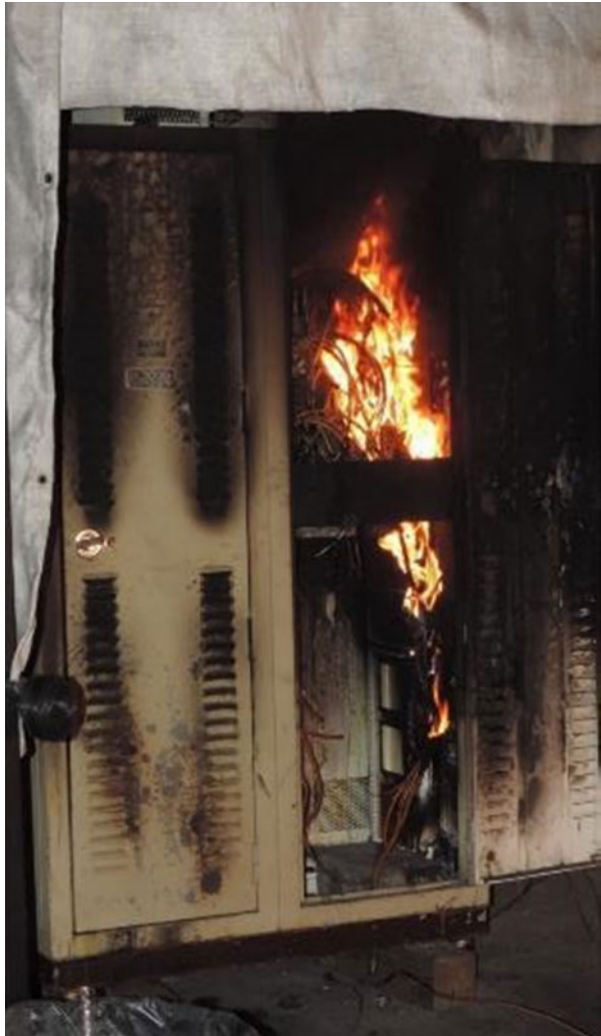
<p>A photograph showing the exterior of enclosure 4 during the fire test. The enclosure is made of metal and has a door that is open. A large fire is visible inside the enclosure, with flames and smoke. The fire is spreading up the right side of the enclosure and along the top of the bundles.</p>

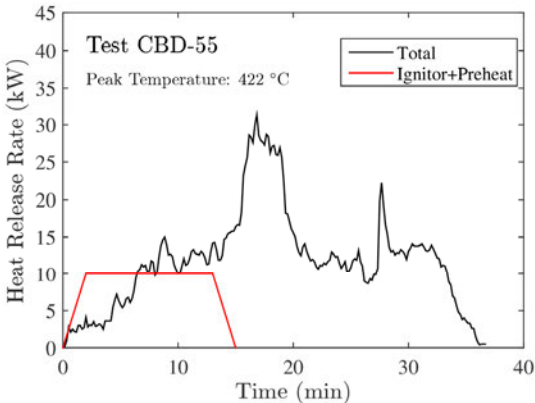
<p>Test CBD-55 Peak Temperature: 422 °C</p> <p>Heat Release Rate (kW)</p> <p>Time (min)</p> <p>— Total — Ignitor+Preheat</p>

<p>Test: 55</p> <p>Enclosure: 4</p> <p>Fuel Load: 2 bundles of surplus power cord (#841), one per side, 10 cords per bundle, 1.8 m (6 ft) long</p> <p>Ignition Source: 4 kW propane burner and 200 mL of acetone in a stainless steel cup 10 cm in diameter</p> <p>Ventilation: Door closed, then opened</p> <p>Notes: The two ignition sources were positioned beneath the two bundles, but the fire only spread upwards on the side of the propane burner. The propane burner was turned off and the acetone exhausted at 15 min. The door was opened at 27 min.</p>

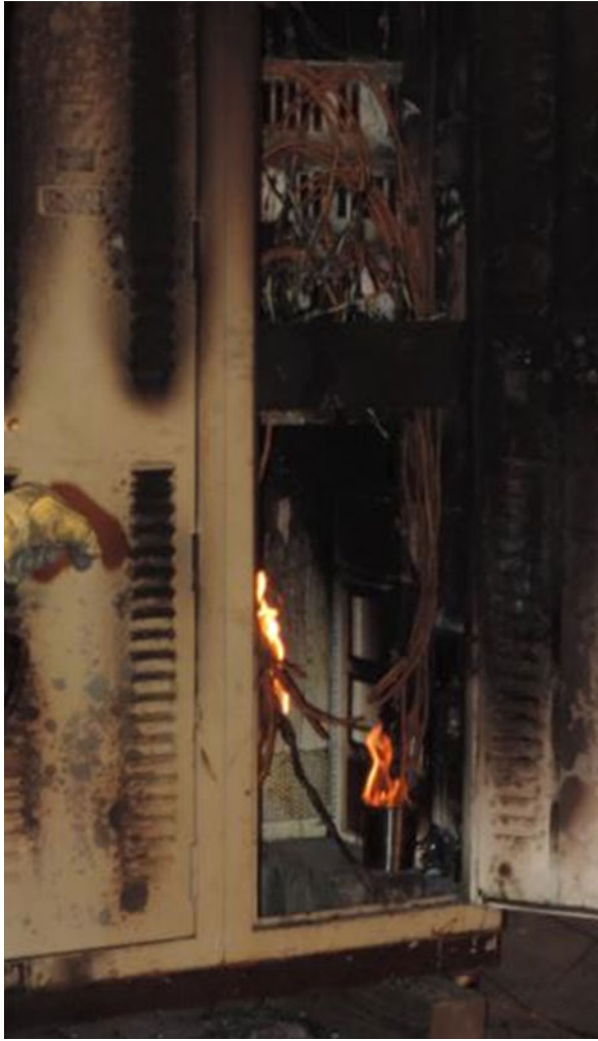
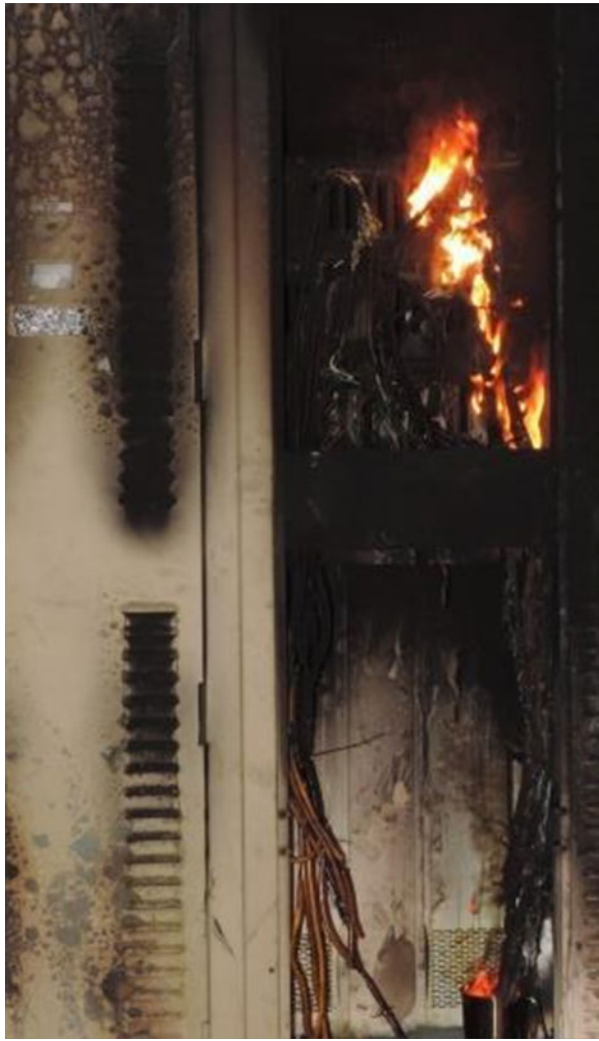
Table 5-58. Summary of Test 56

<p>Test: 56</p> <p>Enclosure: 5</p> <p>Fuel Load: 10 cable bundle (#844) routed up right side of enclosure, 1.8 m (6 ft) long</p> <p>Ignition Source: 0.8 kW propane burner</p> <p>Preheating Source: 500 mL acetone pan fire</p> <p>Ventilation: Door closed</p> <p>Notes: The acetone pan fire was used for pre-heating only and burned for about 10 min, at which time the propane burner was turned on. The propane burner was turned off at 31 min. The door was opened several times and the cables were jostled with a crowbar (photo, lower right). The fire did not spread beyond the vicinity of the burner.</p>

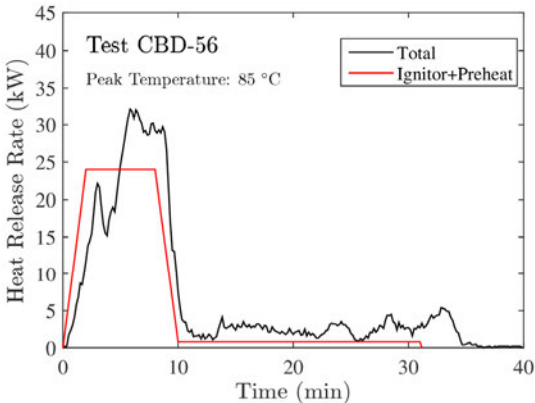
<p>Test CBD-56 Peak Temperature: 85 °C</p> <p>Heat Release Rate (kW)</p> <p>Time (min)</p> <p>— Total — Ignitor+Preheat</p>

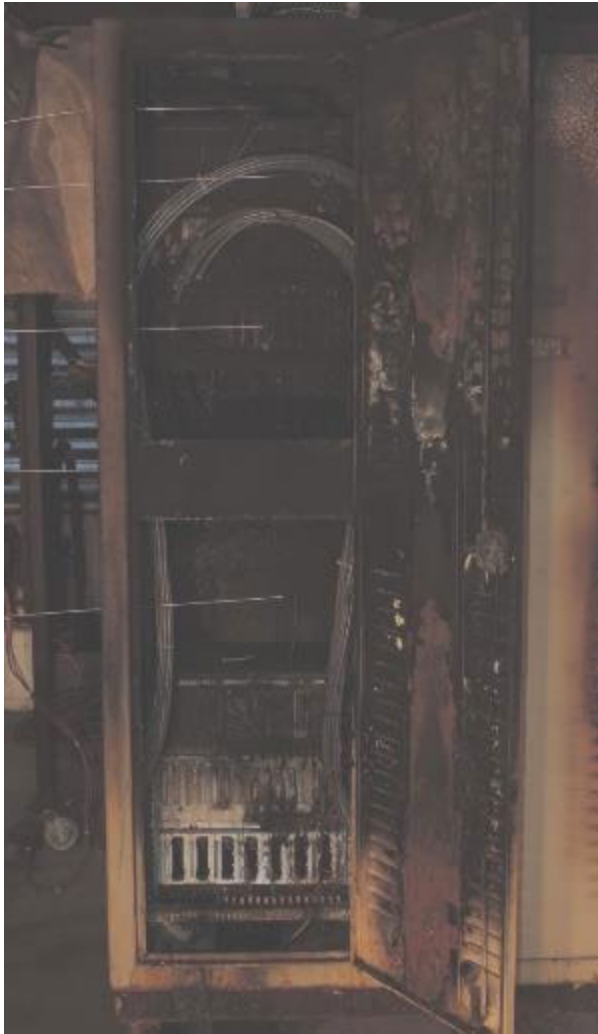
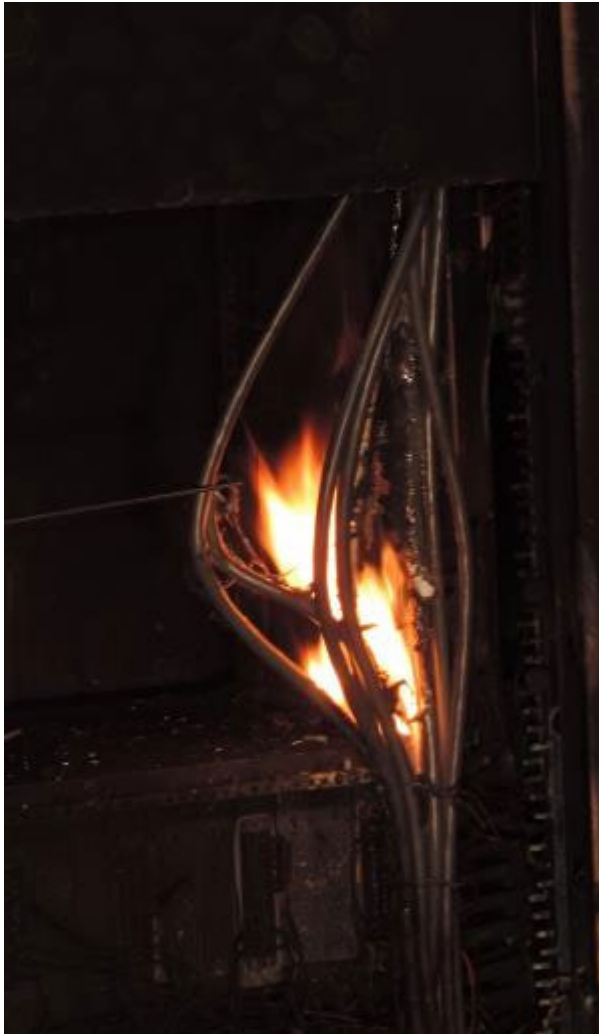
Notes: The acetone pan fire was used for preheating only and burned for about 18 min. The propane burner was lit at the start of the test. The propane burner was turned off at 23 min. The fire did not spread beyond the vicinity of the propane burner.

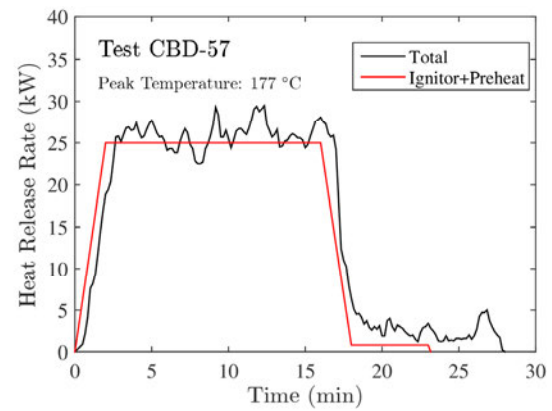
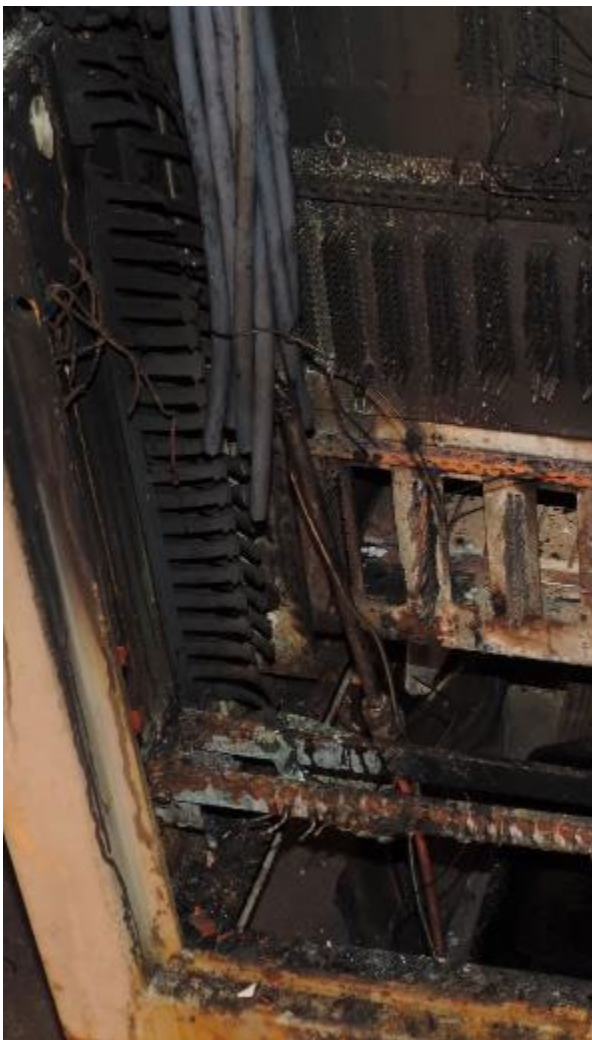
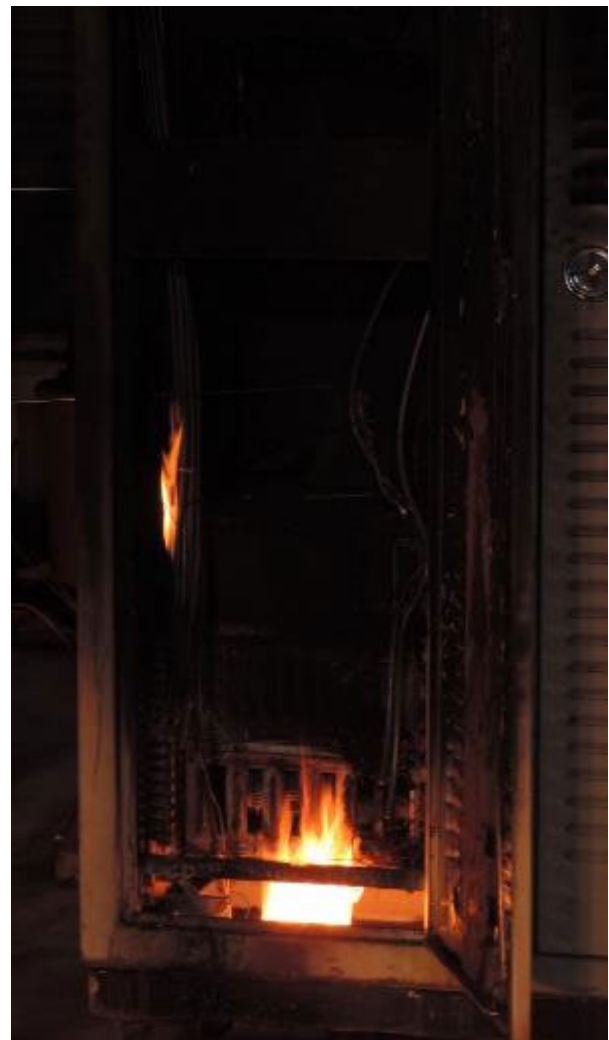
Table 5-60. Summary of Test 58

Notes: The acetone pan fire burned for about 17 min, at which point the propane burner was turned off. The fire spread to the top of the bundle, burning mainly the stripped cable.

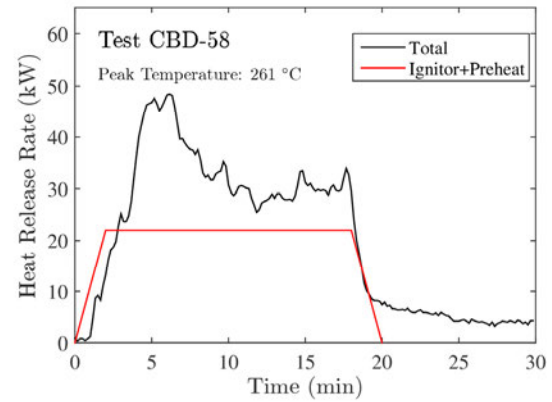
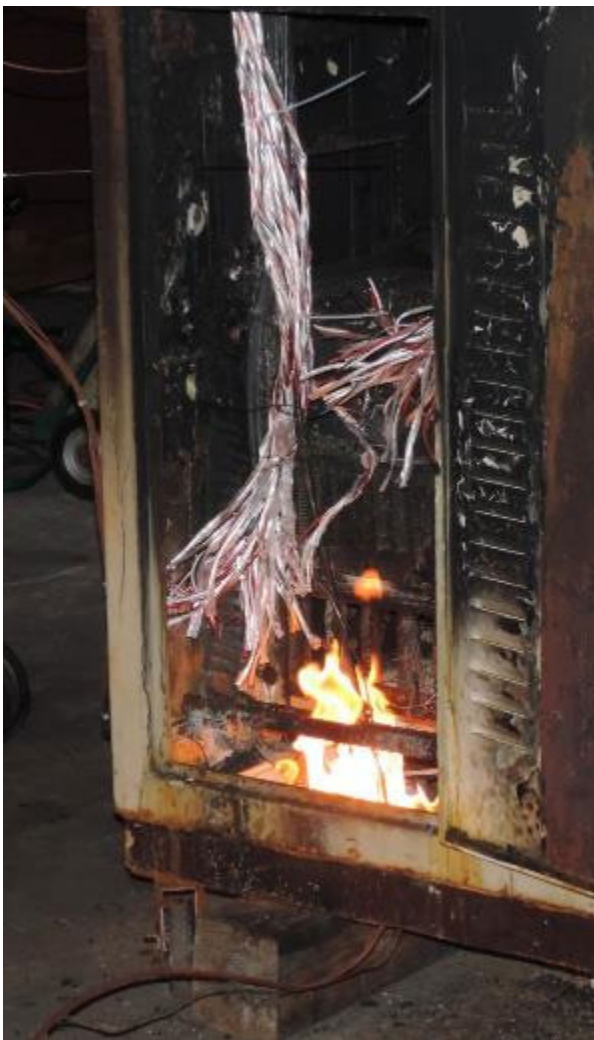
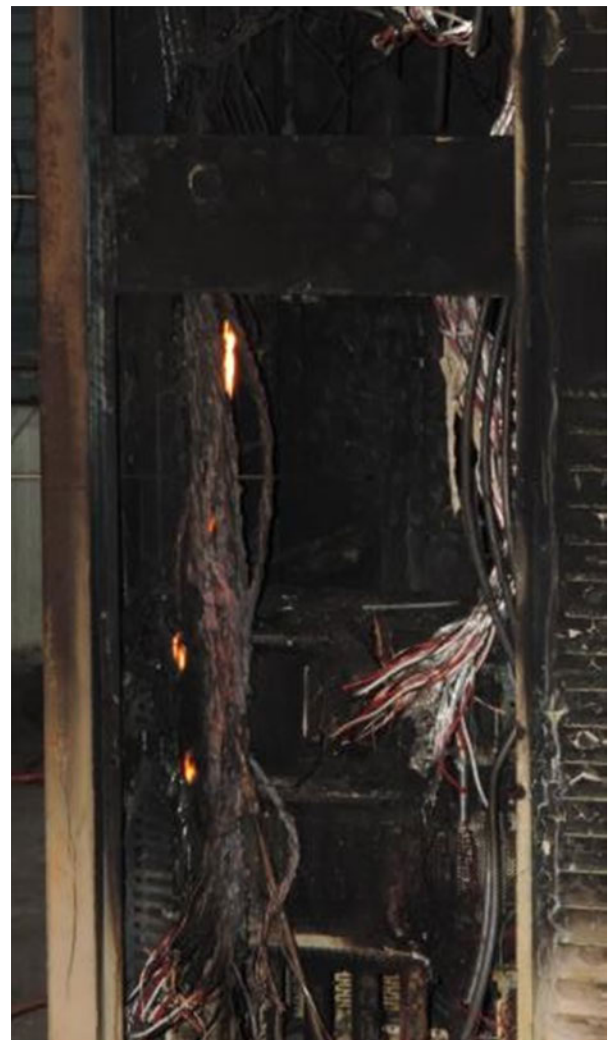
Table 5-61. Summary of Test 59

<p>Test: 59 (A,B)</p> <p>Enclosure: 5</p> <p>Fuel Load: 10 jacketed cables and 10 stripped cables (#844), 1.8 m (6 ft) long. The jacketed cable was left over from Tests 56 and 57.</p> <p>Ignition Source: 0.8 kW propane burner</p> <p>Ventilation: Door open</p> <p>Notes: The propane burner was increased to 2 kW after 10 min, 30 s, at which point the fire began to spread upwards, extending about 60 cm above the burner by 20 min. At 21 min (B), the cable bundle was loosened with a crowbar, and the fire spread to the top of the enclosure. The burner was turned off at 34 min.</p>

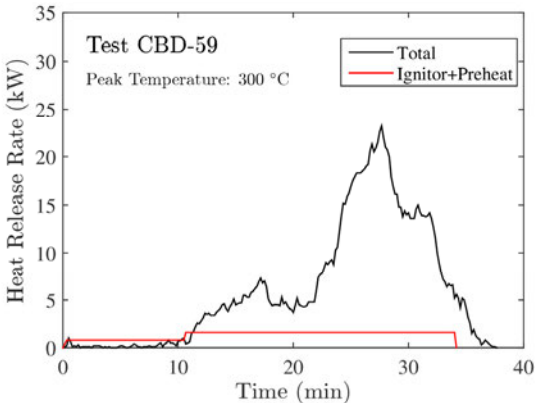
<p>Test CBD-59 Peak Temperature: 300 °C</p> <p>Heat Release Rate (kW)</p> <p>Time (min)</p> <p>Legend: Total (black line), Ignitor+Preheat (red line)</p>

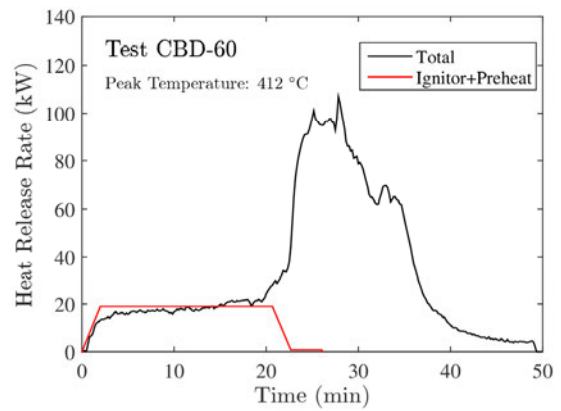
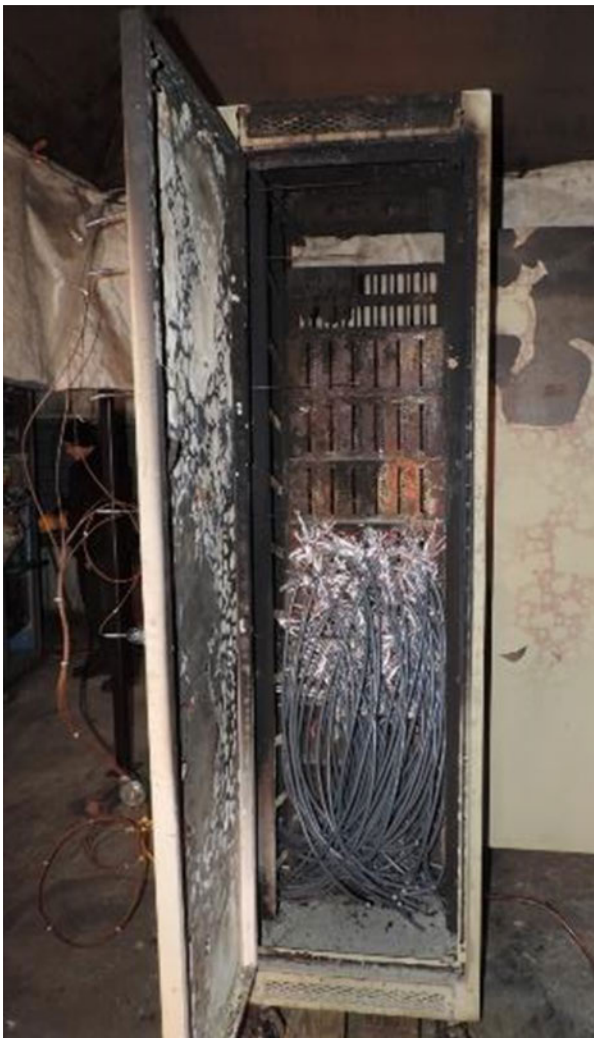
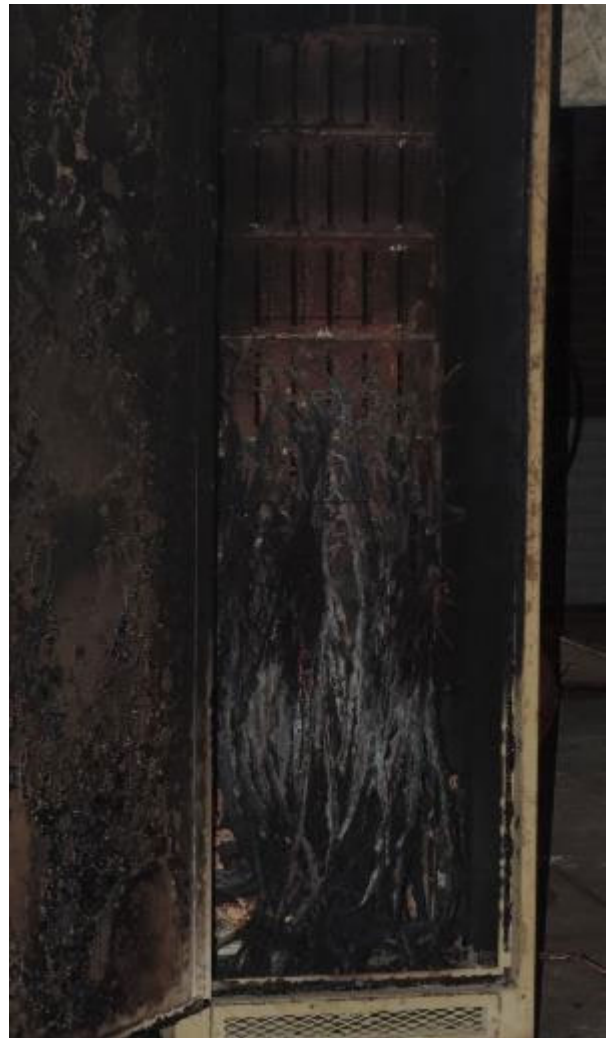
Table 5-63. Summary of Test 61

<p>Test: 61</p> <p>Enclosure: 1</p> <p>Fuel Load: 60 cables (#807) of various lengths; 63 m (208 ft) total</p> <p>Ignition Source: 0.8 kW propane burner</p> <p>Preheating Source: 1 L acetone pan fire</p> <p>Ventilation: Door closed</p> <p>Notes: The acetone pan was placed at the back of the enclosure behind a steel partition, and it burned for 20 min. At 21 min, the cables were jostled with a crowbar. At 25 min, the door was opened. The propane burner was turned off at 28 min. The fire did not spread beyond the vicinity of the propane burner. No appreciable combustible material lost.</p>

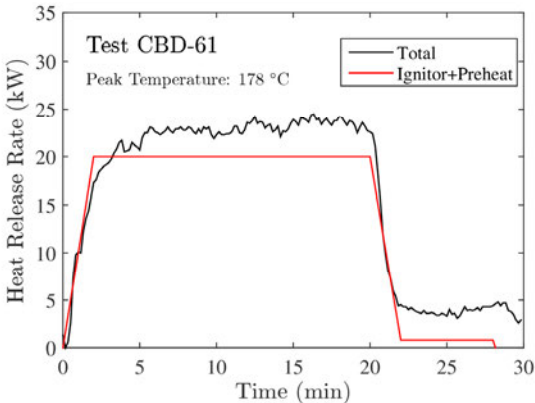
<p>Test CBD-61 Peak Temperature: 178 °C</p> <p>Heat Release Rate (kW)</p> <p>Time (min)</p> <p>— Total — Ignitor+Preheat</p>

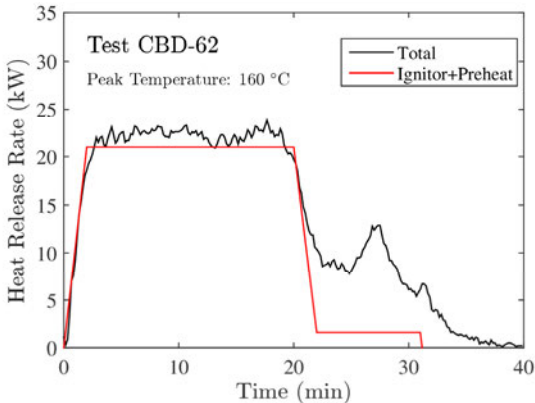
<p>Test CBD-62 Peak Temperature: 160 °C</p> <p>Heat Release Rate (kW)</p> <p>Time (min)</p> <p>Legend: Total, Ignitor+Preheat</p>

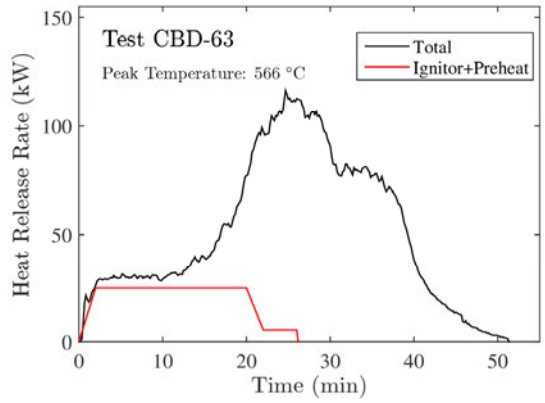
<p>Test CBD-63</p> <p>Peak Temperature: 566 °C</p> <p>Heat Release Rate (kW)</p> <p>Time (min)</p> <p>— Total</p> <p>— Ignitor+Preheat</p>

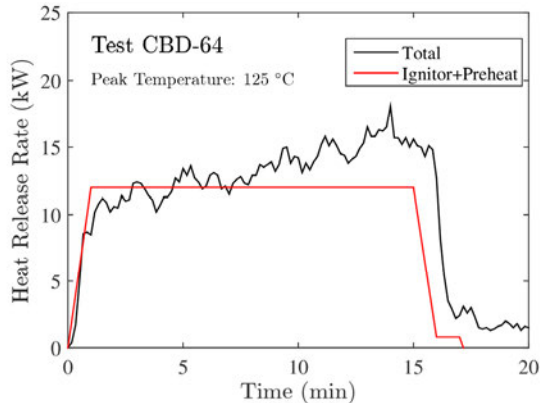
<p>Test CBD-64 Peak Temperature: 125 °C</p> <p>Heat Release Rate (kW)</p> <p>Time (min)</p> <p>Legend: Total, Ignitor+Preheat</p>

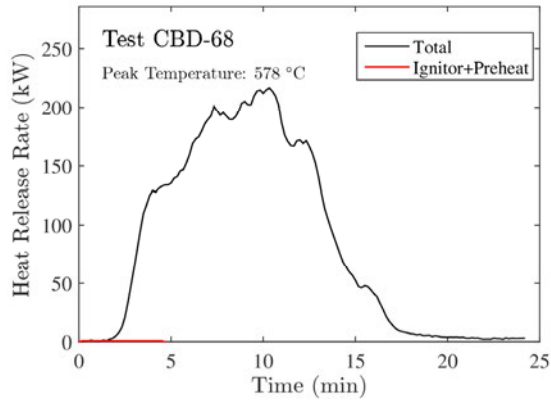
<p>Test CBD-68</p> <p>Peak Temperature: 578 °C</p> <p>Heat Release Rate (kW)</p> <p>Time (min)</p> <p>Legend: Total, Ignitor+Preheat</p>

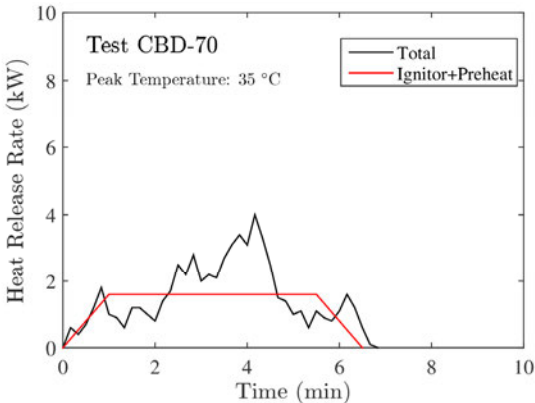
Table 5-72. Summary of Test 70

<p>Test: 70</p> <p>Enclosure: 1</p> <p>Fuel Load: 420 insulated conductors extracted from Cable #834; 540 m (1770 ft) total</p> <p>Ignition Source: 1.6 kW propane burner</p> <p>Ventilation: Door closed</p> <p>Notes: The door was opened at 5 min, 30 s and left open. The propane was turned off at this time. The fire did not spread beyond the vicinity of the igniter. No appreciable combustible mass lost.</p>

<p>Test CBD-70 Peak Temperature: 35 °C</p>

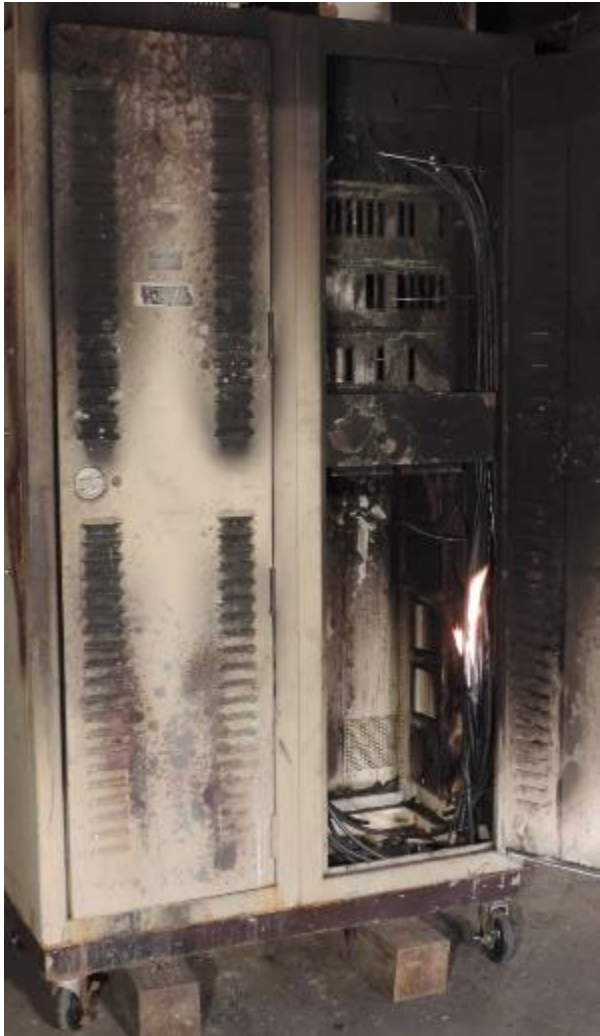
Table 5-74. Summary of Test 72

<p>Test: 72</p> <p>Enclosure: 4</p> <p>Fuel Load: 10 cable bundle (#813), 1.8 m (6 ft) long</p> <p>Ignition Source: 0.8 kW propane burner</p> <p>Ventilation: Door closed, then opened</p> <p>Notes: The door was opened at 12 min and the cables were jostled with a crowbar. The propane was turned off at 16 min. The fire did not spread beyond the vicinity of the burner. The HRR oxygen measurement malfunctioned during this experiment, and it is assumed that the HRR is only that of the ignition source.</p>	<p>The oxygen consumption calorimeter malfunctioned. No HRR data available.</p>

A photograph of a large, light-colored metal enclosure on wheels. The enclosure door is open, revealing a fire burning inside. The fire is concentrated in the lower right area of the enclosure. The interior of the enclosure shows various components, including what appears to be a propane burner and some wiring. The exterior of the enclosure shows signs of wear and discoloration.

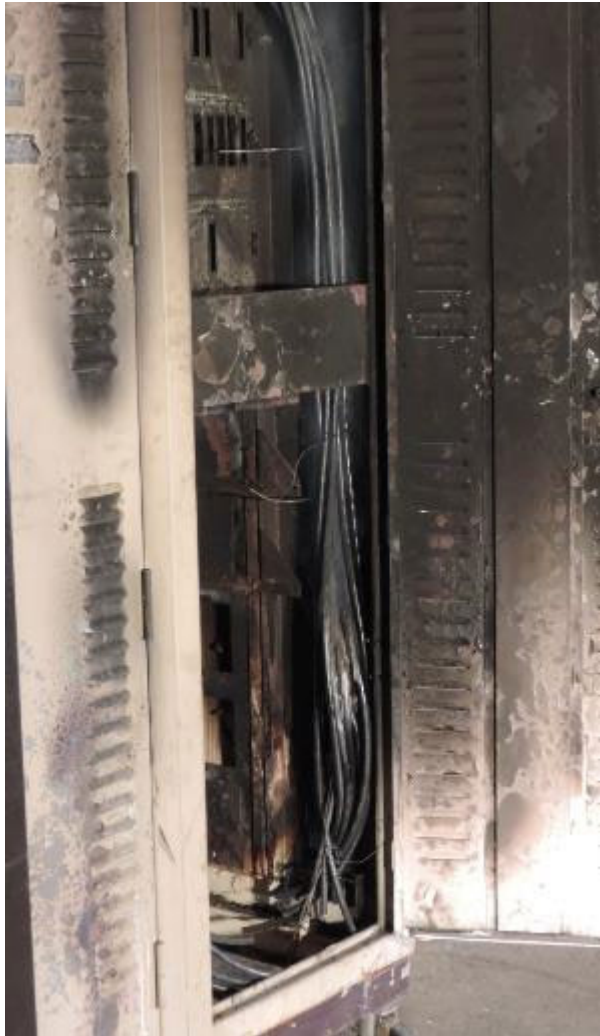
A close-up photograph of the interior of the test enclosure. It shows a bundle of black cables hanging vertically. A fire is burning at the bottom of the enclosure, near the cables. The fire is bright orange and yellow. The interior of the enclosure is dark, and the fire is the primary light source.

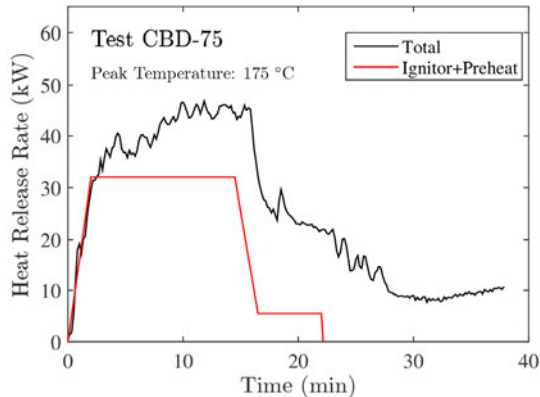
Table 5-77. Summary of Test 75

<p>Test: 75</p> <p>Enclosure: 4</p> <p>Fuel Load: 10 cable bundle (#813), 1.8 m (6 ft) long</p> <p>Ignition Source: 5.5 kW propane burner</p> <p>Preheating Source: 1 L acetone pan fire</p> <p>Ventilation: Door closed, then opened</p> <p>Notes: The acetone pan fire did not directly impinge upon the cables. The acetone was exhausted at 16 min, 30 s. The door was open at 18 min and left open. The propane was turned off at 22 min, 30 s. The fire spread 0.9 m (3 ft) above the burner.</p>

<p>Test CBD-75 Peak Temperature: 175 °C</p> <p>Heat Release Rate (kW)</p> <p>Time (min)</p> <p>— Total — Ignitor+Preheat</p>

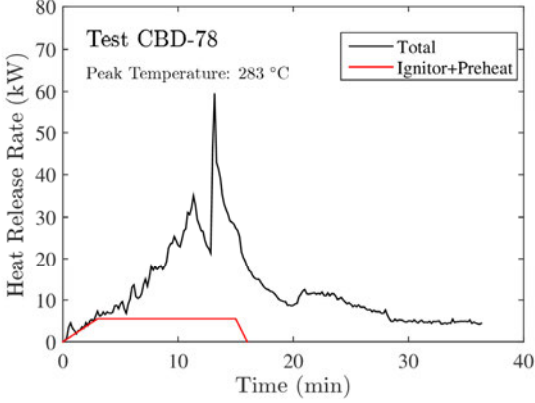
Table 5-80. Summary of Test 78

<p>Test: 78 (A,B)</p> <p>Enclosure: 5</p> <p>Fuel Load: 10 cable bundle (#809), 1.8 m (6 ft) long</p> <p>Ignition Source: 5.5 kW propane burner</p> <p>Ventilation: Door closed, then opened</p> <p>Notes: The fire spread steadily to the top of the bundle. The burner was turned off at 15 min. The door was opened at 12 min 30 sec (B), and remained open.</p>

<p>Test CBD-78 Peak Temperature: 283 °C</p> <p>Heat Release Rate (kW)</p> <p>Time (min)</p> <p>— Total — Ignitor+Preheat</p>

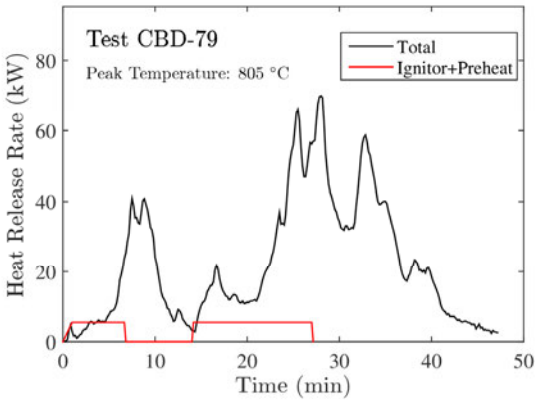
Table 5-81. Summary of Test 79

<p>Test: 79 (A,B)</p> <p>Enclosure: 4</p> <p>Fuel Load: 310 insulated wires stripped from Cable #834, 1.8 m (6 ft) long, arranged in 4 loose bundles</p> <p>Ignition Source: 5.5 kW propane burner</p> <p>Ventilation: Door closed, then opened</p> <p>Notes: The propane burner was turned off at 6 min, 40 s. The door was opened at 12 min (B). The propane burner was relit at 14 min and the door was left open. The wires were jostled at 19 min with a crowbar, after which the fire spread to the top of the bundle. The propane burner was turned off at 27 min.</p>

<p>Test CBD-79 Peak Temperature: 805 °C</p> <p>Heat Release Rate (kW)</p> <p>Time (min)</p> <p>— Total — Ignitor+Preheat</p>

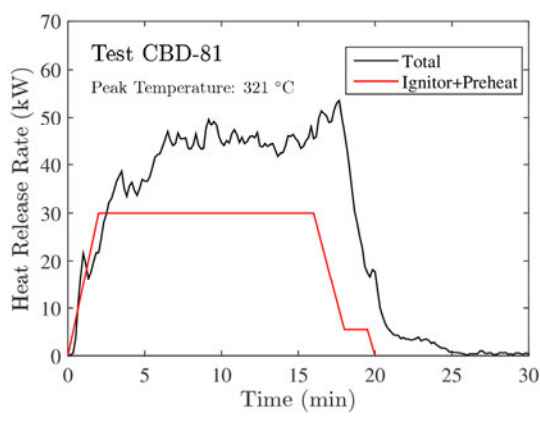
Table 5-83. Summary of Test 81

<p>Test: 81</p> <p>Enclosure: 5</p> <p>Fuel Load: 10 cable bundle (#813), 1.8 m (6 ft) long</p> <p>Ignition Source: 5.5 kW propane burner and 1 L acetone pan fire</p> <p>Ventilation: Door closed, then opened</p> <p>Notes: The acetone pan fire was placed near the base of the cable bundle. The acetone was exhausted at 18 min. The door was opened at 19 min and the propane burner was turned off at 19 min, 30 s. The fire spread approximately 30 cm (1 ft) above burner.</p>

<p>Test CBD-81 Peak Temperature: 321 °C</p> <p>Heat Release Rate (kW)</p> <p>Time (min)</p> <p>Legend: Total, Ignitor+Preheat</p>

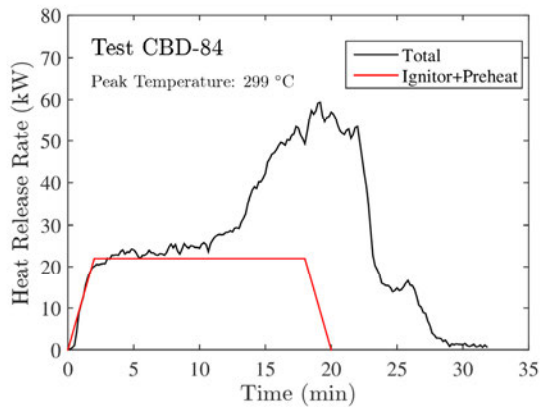
<p>Test CBD-84 Peak Temperature: 299 °C</p> <p>Heat Release Rate (kW)</p> <p>Time (min)</p> <p>— Total — Ignitor+Preheat</p>

<p>Test: 84</p> <p>Enclosure: 7</p> <p>Fuel Load: 36 cable bundle (#818), 2.4 m (8 ft) long</p> <p>Ignition Source: 0.8 kW propane burner</p> <p>Preheating Source: 1 L acetone pan fire</p> <p>Ventilation: Door open</p> <p>Notes: The acetone pan fire did not directly impinge on the cables. The burner was placed within a coiled bundle of cable inside of a small box whose front panel had been removed. The fire eventually spread upwards through access holes in the top of the box. The fire reached the top of the enclosure but did not spread horizontally.</p>
