Heat Release Rates of Electrical Enclosure Fires (HELEN-FIRE)

Final Report

This report documents an experimental program to explore the heat release rate and burning behavior of electrical enclosures commonly found in nuclear power plants. Electrical enclosures are a potential source of fire in nuclear power plants because they contain both combustible materials and live electrical circuits. These fires have the potential to disrupt power, instrumentation, and control in the plant. Key parameters affecting fire in an enclosure include its size, openings, electrical voltage, and combustible load.

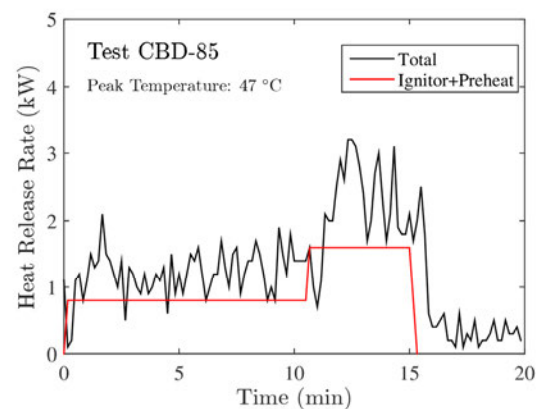
Notes: The cables originated in a small box whose side panel had been removed. The propane burner was tied to the cables inside of the enclosure. The burner was increased to 1.6 kW at 10 min, 30 s. The burner was turned off at 15 min. No appreciable combustible mass lost.

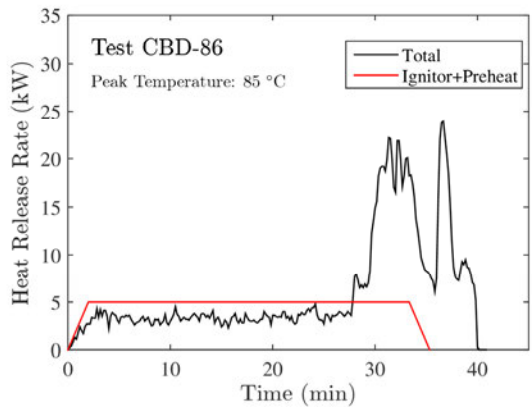
<p>Test CBD-86 Peak Temperature: 85 °C</p> <p>Heat Release Rate (kW)</p> <p>Time (min)</p> <p>Legend: Total, Ignitor+Preheat</p>

<p>Test: 86 (A,B)</p> <p>Enclosure: 7</p> <p>Fuel Load: Same as Test 85</p> <p>Ignition Source: 500 mL acetone pan fire</p> <p>Ventilation: Door open</p> <p>Notes: The acetone was poured into a stainless steel beaker with a 10 cm (4 in) opening. The cables inside the small box burned, but the fire did not spread through the conduits at the top. The cables were jostled with a crowbar at 27 min 30 sec (B), 29 min, and 31 min.</p>

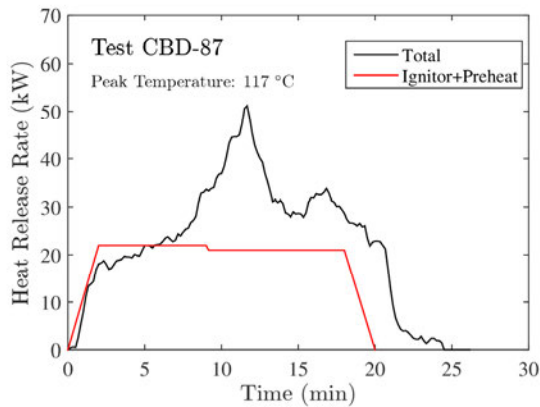
<p>Test CBD-87 Peak Temperature: 117 °C</p> <p>Heat Release Rate (kW)</p> <p>Time (min)</p> <p>Legend: Total, Ignitor+Preheat</p>

<p>Test: 87</p> <p>Enclosure: 7</p> <p>Fuel Load: 36 cables (#818), 2.4 m (8 ft) long, routed up left right side of enclosure</p> <p>Ignition Source: 0.8 kW propane burner</p> <p>Preheating Source: 1 L acetone pan fire</p> <p>Ventilation: Door closed</p> <p>Notes: The acetone pan fire did not directly impinge upon the cables. The propane burner was turned off at 9 min. The door was opened at 21 min, 20 s, at which time the fire was out. The cable burned 1.2 m (4 ft) above the burner.</p>

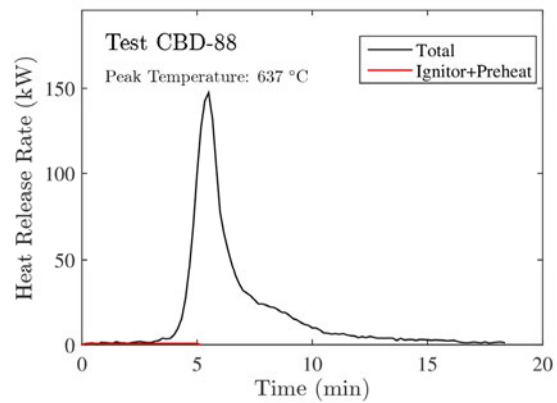
Notes: The propane burner was turned off at 5 min. The fire spread upwards and horizontally over all of the wire except a small amount hanging down at the end. The door was opened at 13 min 30 sec.

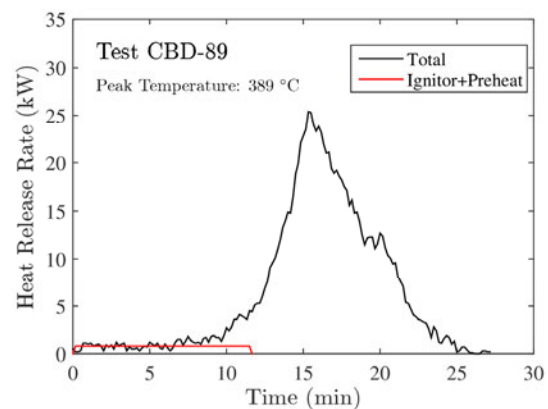
Notes: The burner was turned off at 11 min, 30 s. The fire spread more slowly than Test 88, and it consumed only the vertical portion of the bundles. The door was opened at 20 min 45 sec and left open.

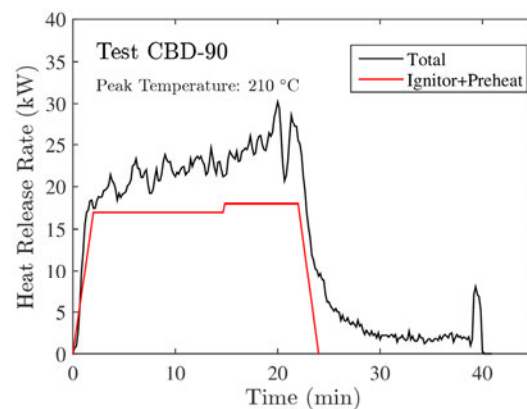
Notes: The acetone pan fire did not impinge upon the cables. The propane burner was increased to 1.6 kW at 14 min, 40 s. The door was opened at 15 min and again at 23 min. The fire spread slowly upwards, but only burned the vertical portion of the bundle, approximately 1.2 m (4 ft) above the burner.

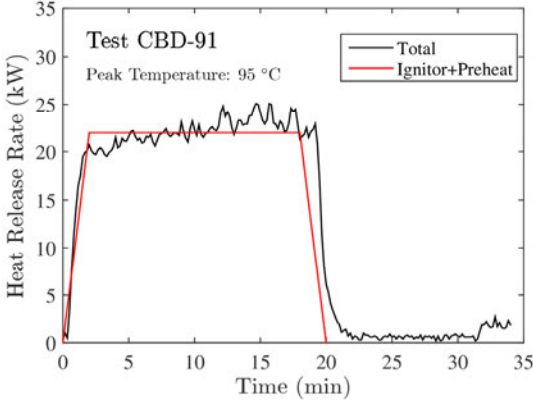
<p>Test CBD-91 Peak Temperature: 95 °C</p> <p>Heat Release Rate (kW)</p> <p>Time (min)</p> <p>— Total — Ignitor+Preheat</p>

<p>Test: 91</p> <p>Enclosure: 7</p> <p>Fuel Load: 5.9 kg of SIS wire hung along top and right side of enclosure</p> <p>Ignition Source: 1.6 kW propane burner</p> <p>Preheating Source: 1 L acetone pan fire</p> <p>Ventilation: Door closed, open briefly</p> <p>Notes: The acetone pan fire did not directly impinge upon the wire. The door was opened at 10 min to check the burner. The acetone was exhausted and the burner turned off at 20 min. No appreciable combustible mass lost.</p>

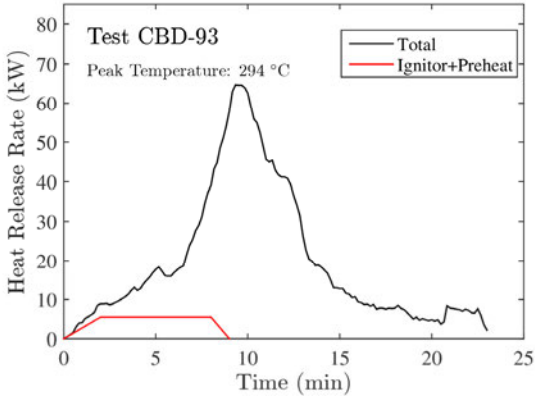
<p>Test CBD-93 Peak Temperature: 294 °C</p> <p>Heat Release Rate (kW)</p> <p>Time (min)</p> <p>— Total — Ignitor+Preheat</p>

<p>Test: 93</p> <p>Enclosure: 7</p> <p>Fuel Load: 72 cables (#833), arranged in 4 bundles, 2.4 m (8 ft) long, originating in open box on right side of enclosure</p> <p>Ignition Source: 5.5 kW propane burner</p> <p>Ventilation: Door closed, then opened</p> <p>Notes: The propane burner was turned off at 8 min. The door was opened at 14 min, 30 s, and left open after that time. The fire spread vertically but not horizontally. A few flames were seen extending just beyond the louvers at the top of the enclosure.</p>

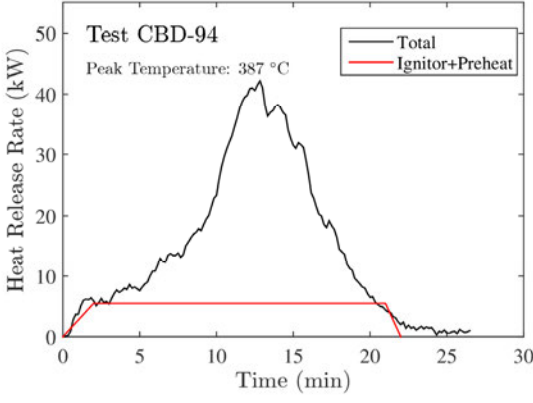
<p>Test CBD-94</p> <p>Peak Temperature: 387 °C</p> <p>Heat Release Rate (kW)</p> <p>Time (min)</p> <p>Legend: Total (black line), Ignitor+Preheat (red line)</p>

<p>Test: 94</p> <p>Enclosure: 7</p> <p>Fuel Load: 24 cables (#814) in 4 bundles of 6, 2.4 m (8 ft) long, routed up the left side and across brackets running along the top</p> <p>Ignition Source: 5.5 kW propane burner</p> <p>Ventilation: Door closed, then opened</p> <p>Notes: The door was opened at 20 min and left open. The propane burner was turned off at 21 min. The fire spread vertically and approximately 30 cm (1 ft) horizontally.</p>

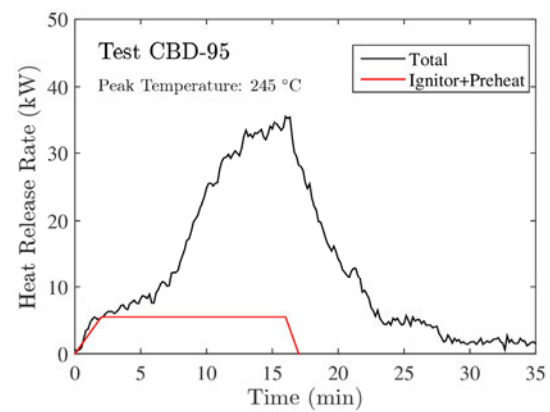
Notes: The burner was turned off at 16 min. The door was opened at 22 min and left open. The fire spread vertically and approximately 30 cm (1 ft) horizontally.

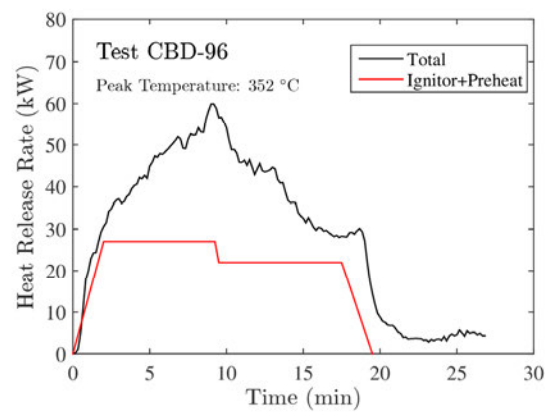
Notes: The acetone pan fire did not impinge upon the cables. The propane burner was turned off at 9 min and the acetone was exhausted at 19 min, 30 s, when the door was opened. The fire spread vertically but not horizontally.

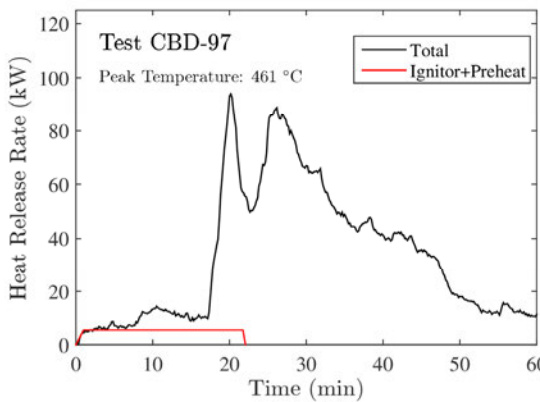
<p>Test CBD-97 Peak Temperature: 461 °C</p> <p>Heat Release Rate (kW)</p> <p>Time (min)</p> <p>Legend: Total (black line), Ignitor+Preheat (red line)</p>

<p>Test: 97 (A,B)</p> <p>Enclosure: 6</p> <p>Fuel Load: 108 cables (#833), arranged in 6 bundles, 2.4 m (8 ft) long, originating in a junction box in the center of the enclosure, running vertically, then horizontally</p> <p>Ignition Source: 5.5 kW propane burner</p> <p>Ventilation: Door closed</p> <p>Notes: The door was opened at 16 min, 30 s (B), and the cables were jostled with a crow bar, leading to a rapid increase in the HRR and spread. The propane burner was turned off at 21 min, 45 s. The door was opened at 38 min and left open. The fire spread both vertically and horizontally.</p>

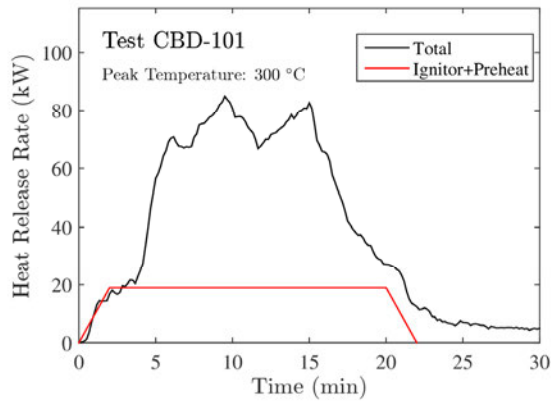
Table 5-103. Summary of Test 101

<p>Test: 101</p> <p>Enclosure: 6</p> <p>Fuel Load: The unburned right side portion of the cables from Test 100, approximately 1.2 m (4 ft) of horizontal cable extending downward into fuel pan. Approximately 3.9 kg.</p> <p>Ignition Source: 1 L acetone pan fire</p> <p>Ventilation: Door closed, then opened</p> <p>Notes: The fire spread rapidly upwards and then horizontally. The right hand photo below shows the fire spreading in the horizontal direction when looking through an opening on the front side of the enclosure. The door was opened at 19 min and left open. The acetone was exhausted at 22 min.</p>

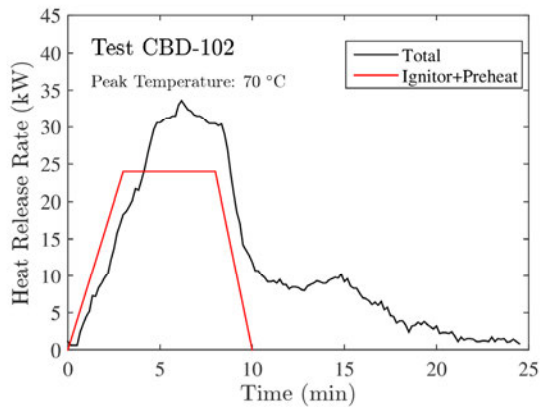
Table 5-104. Summary of Test 102

<p>Test: 102</p> <p>Enclosure: 6</p> <p>Fuel Load: 60 insulated wires extracted from Cable #834, routed through a horizontal duct with 20 cm (8 in) square cross section and 5 cm (2 in) openings every 30 cm (1 ft)</p> <p>Ignition Source: 500 mL acetone pan fire</p> <p>Ventilation: Door open</p> <p>Notes: The acetone pan was placed 5 cm (2 in) below an opening in the bottom of the duct (below left). The acetone was exhausted by 10 min, and the fire continued to spread slowly inside the duct. The fire spread to the end of the duct (below right) but did not burn the wire outside the duct.</p>

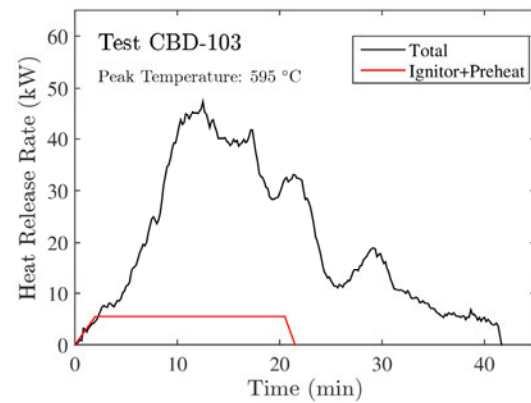
Table 5-105. Summary of Test 103

Test: 103

Ignition Source: 5.5 kW propane burner

Ventilation: Door closed

Notes: The propane burner was turned off at 20 min, 30 s. The doors were opened at 37 min. The fire spread approximately 2 m (6 ft) from left to right along the top of the enclosure. The photo at right shows the furthest extent of the fire.

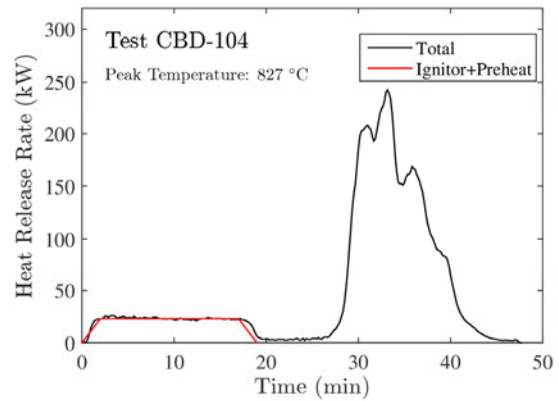
Table 5-106. Summary of Test 104

Test: 104

Ignition Source: 0.8 kW propane burner

Ventilation: Door open

Notes: The acetone pan fire was placed in the back of the enclosure, behind a steel partition. The burner was increased to 1.6 kW at 17 min. The acetone was exhausted at 19 min, but the fire had not spread. The cables were jostled at 24 min with a crowbar, after which the fire grew and spread.

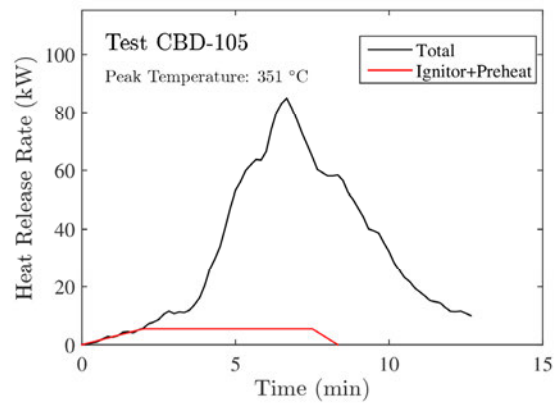
Table 5-107. Summary of Test 105

Test: 105

Ignition Source: 5.5 kW propane burner

Ventilation: Door closed

Notes: The burner was positioned among the cables routed up the right side of the enclosure. The fire spread to the top of the enclosure in 6 min. The burner was turned off at 7 min, 30 s. The door was opened at 9 min. The fire did not spread to the left side of the enclosure. Approximately half of the combustible mass was consumed.

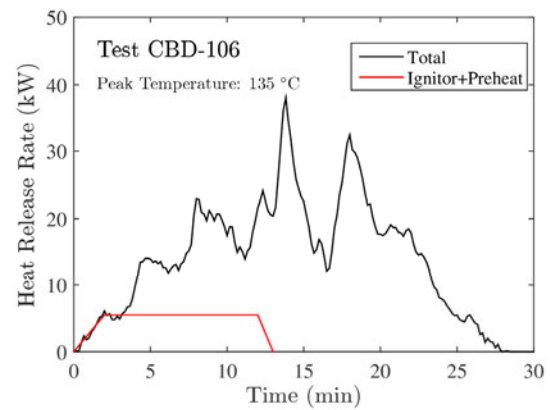
Table 5-108. Summary of Test 106

Test: 106 (A,B)

Ignition Source: 5.5 kW propane burner

Ventilation: Door closed, then opened

Notes: The door was opened at 9 min and left open (B). The propane burner was turned off at 12 min. The cables were jostled with a crowbar at 14 min (below right). The fire spread to the top of the left side of the enclosure.

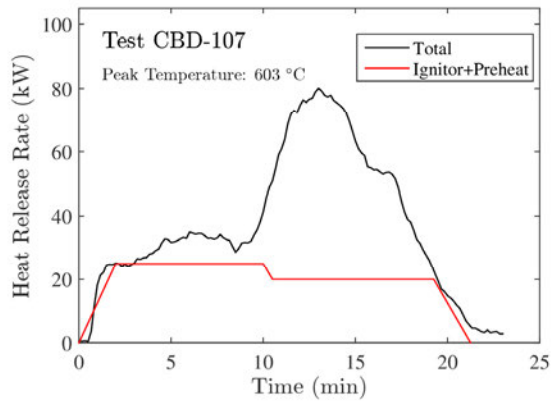
Table 5-109. Summary of Test 107

<p>Test: 107</p> <p>Enclosure: 1</p> <p>Fuel Load: 280 insulated conductors (#834), arranged in 4 bundles, 1.8 m (6 ft) long, hanging in front of steel partition</p> <p>Ignition Source: 5.5 kW propane burner</p> <p>Ventilation: Door open</p> <p>Notes: The acetone pan was placed in the back of the enclosure behind a steel partition. The propane burner was turned off at 10 min. The fire consumed the insulation of the two left bundles completely, and burned some of the right two bundles. Approximately, three-quarters of the combustible material was burned.</p>

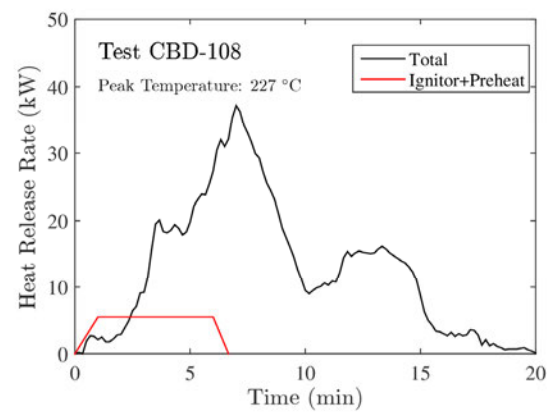
Table 5-110. Summary of Test 108

Test: 108

Ignition Source: 5.5 kW propane burner

Ventilation: Door closed, then opened

Notes: The propane burner was turned off at
6 min. The door was opened at 11 min. All of
the remaining cable insulation from Test 107
was consumed.

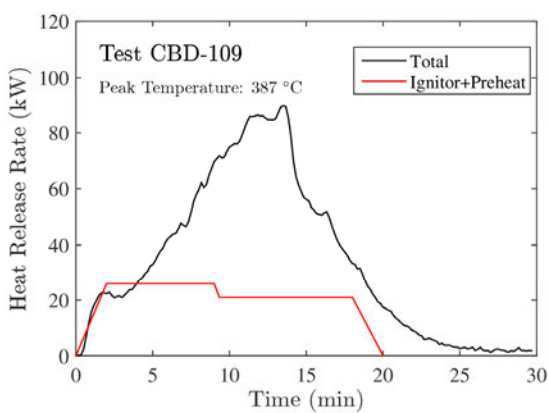
Table 5-111. Summary of Test 109

<p>Test: 109</p> <p>Enclosure: 8</p> <p>Fuel Load: 30 cables (#814), 2.4 m (8 ft) long, routed through 10 conduits in top of enclosure into a tray 45 cm (18 in) above</p> <p>Ignition Source: 5.5 kW propane burner</p> <p>Preheating Source: 1 L acetone pan fire</p> <p>Ventilation: Door closed, then opened</p> <p>Notes: The acetone pan was placed in the back of the enclosure, away from the cables. The propane burner was turned off at 9 min. The door was opened at 20 min and left open. The fire consumed the cable within the enclosure, and scorched approximately 15 cm (6 in) of cable outside.</p>

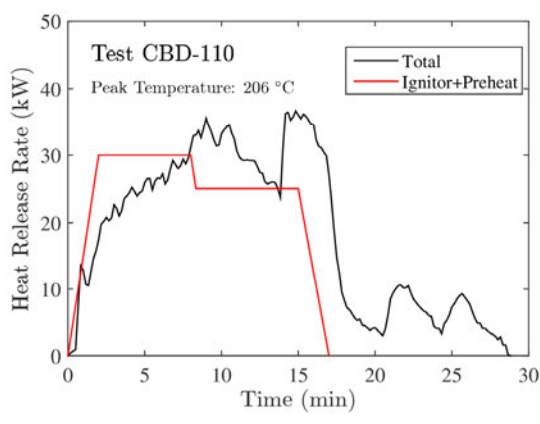
Table 5-112. Summary of Test 110

<p>Test: 110 (A,B)</p> <p>Enclosure: 4</p> <p>Fuel Load: 10 cables (#844), 1.8 m (6 ft) long, routed up right side of enclosure</p> <p>Ignition Source: 5.5 kW propane burner</p> <p>Preheating Source: 1 L acetone pan fire</p> <p>Ventilation: Door closed, then opened</p> <p>Notes: The acetone pan fire did not directly impinge upon the cables. The propane burner was turned off at 8 min. The door was opened at 13 min, 30 s (B). The acetone was exhausted at 17 min. The cables were jostled at 20 min and at 24 min, at which times the fire spread upward, gradually reaching within 30 cm (1 ft) of the top.</p>

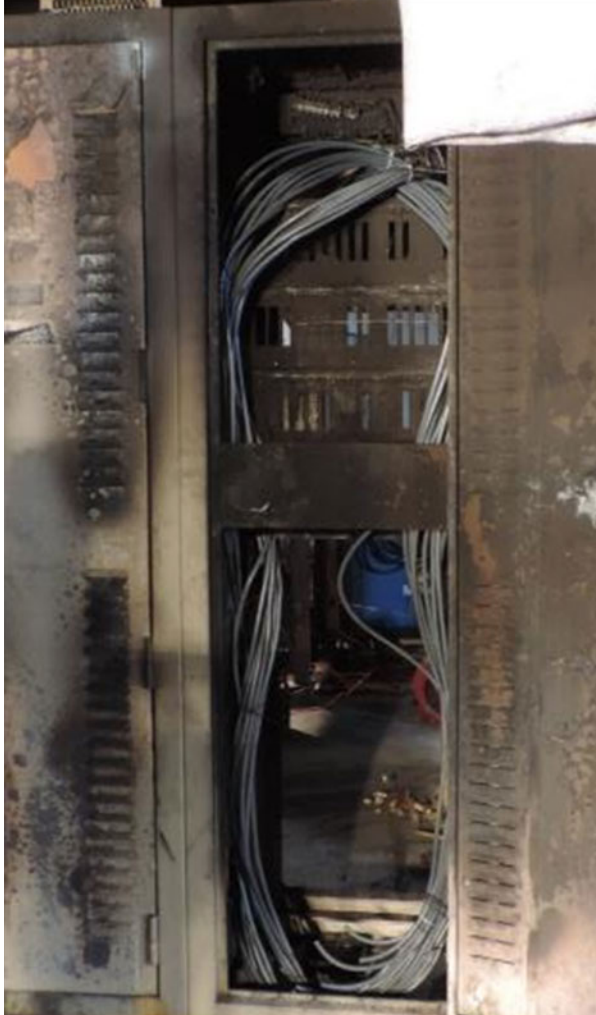
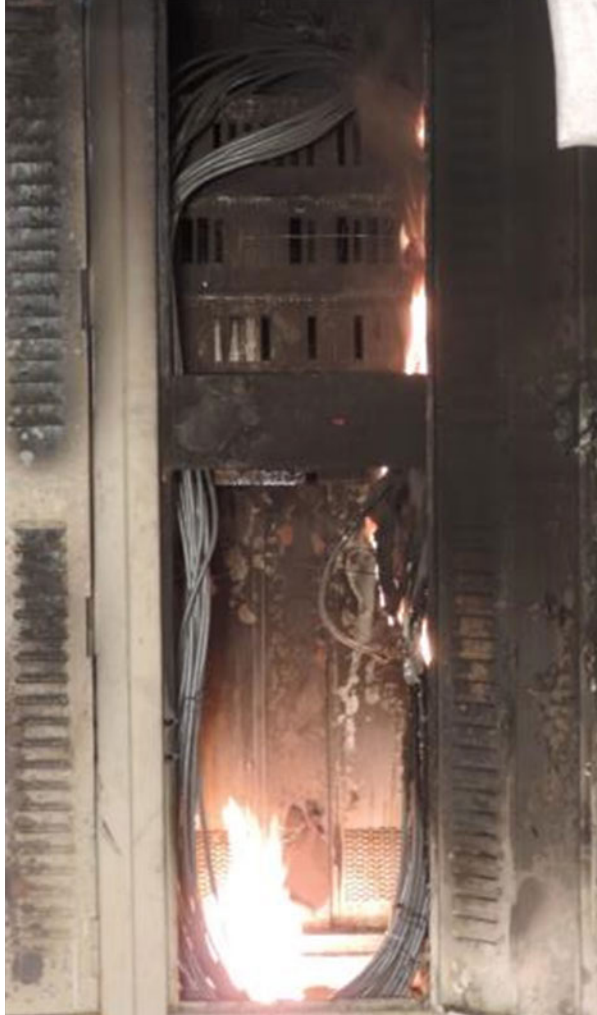
<p>Test CBD-110 Peak Temperature: 206 °C</p> <p>Heat Release Rate (kW)</p> <p>Time (min)</p> <p>— Total — Ignitor+Preheat</p>

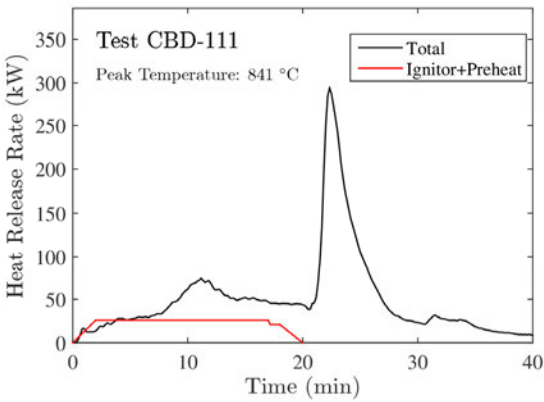
Table 5-113. Summary of Test 111

<p>Test: 111 (A,B)</p> <p>Enclosure: 5</p> <p>Fuel Load: 2 bundles of 20 cables each (#845), one on each side of enclosure, 2.4 m (8 ft) long</p> <p>Ignition Source: 5.5 kW propane burner</p> <p>Preheating Source: 1 L acetone pan fire</p> <p>Ventilation: Door closed, then opened</p> <p>Notes: The acetone pan was placed on a ledge at the mid-height of the enclosure. It did not directly impinge upon the cables. The propane burner was positioned at intersection of two bundles at base of enclosure. It was turned off at 17 min. The door was opened at 20 min and left open (B). The fire spread rapidly on both sides following the door opening. All of the cable insulation was consumed.</p>

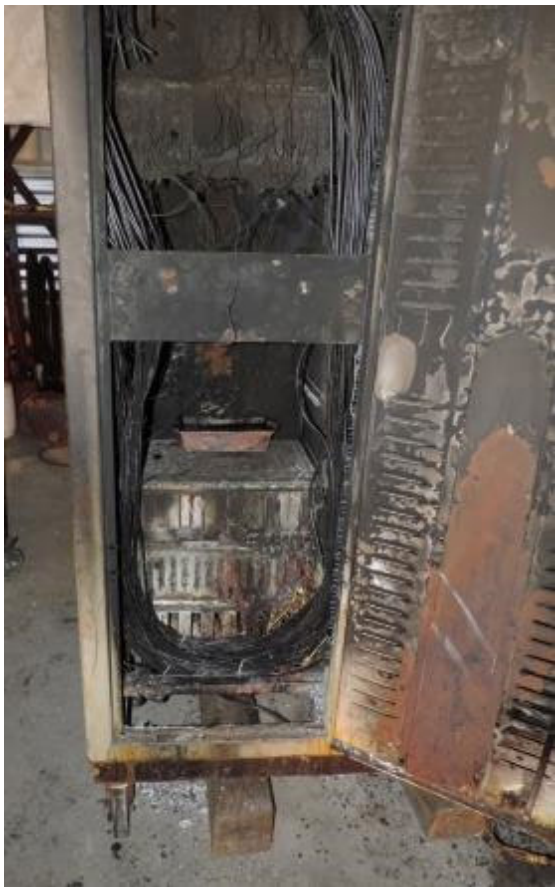
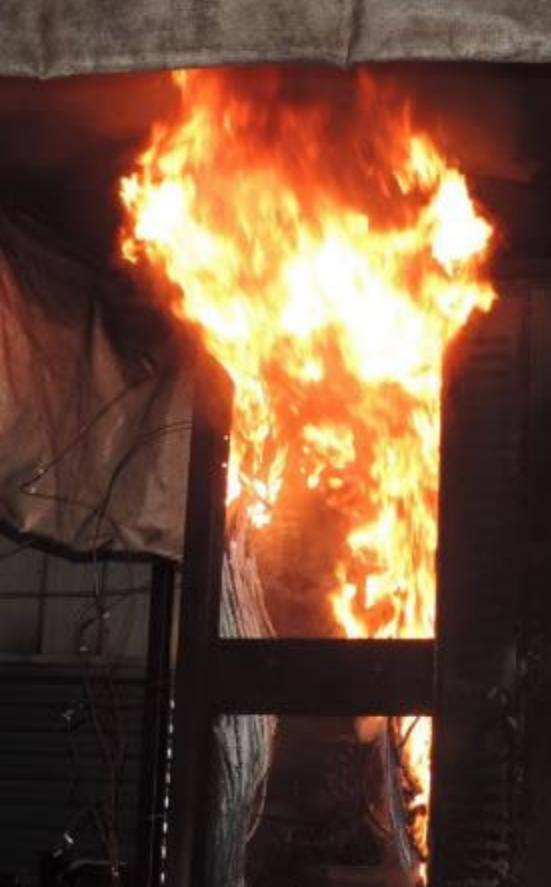
<p>Test CBD-111 Peak Temperature: 841 °C</p> <p>Heat Release Rate (kW)</p> <p>Time (min)</p> <p>Legend: Total (black line), Ignitor+Preheat (red line)</p>

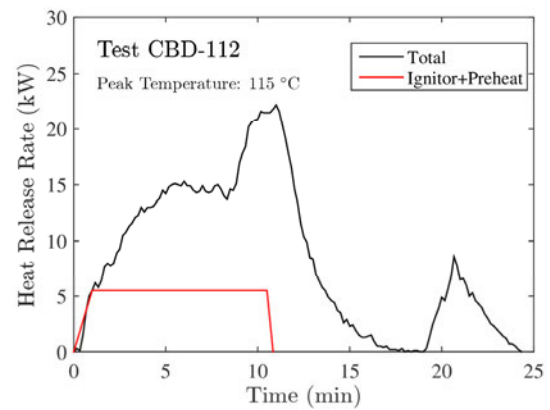
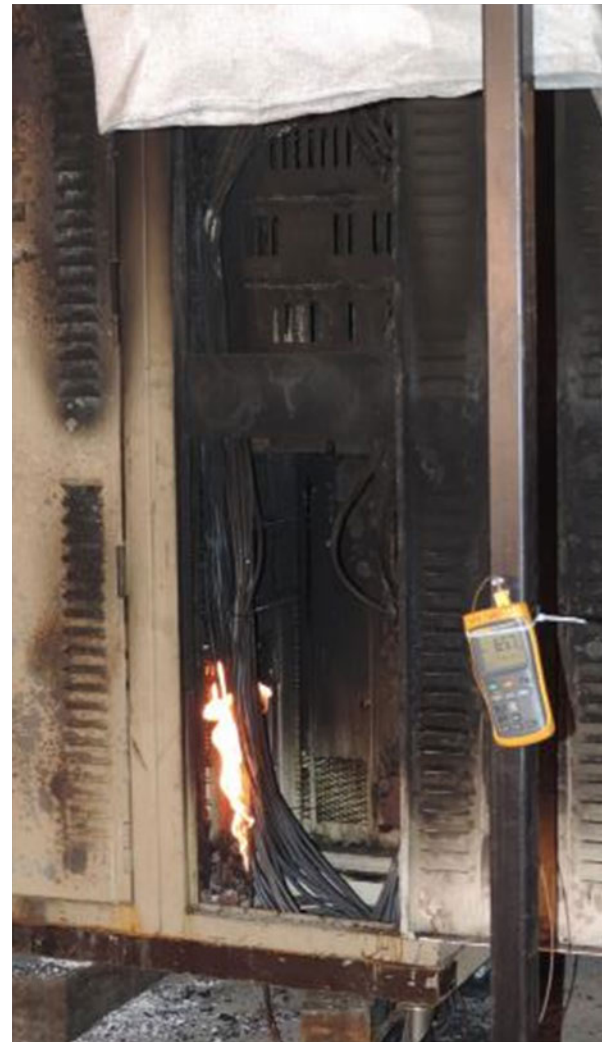
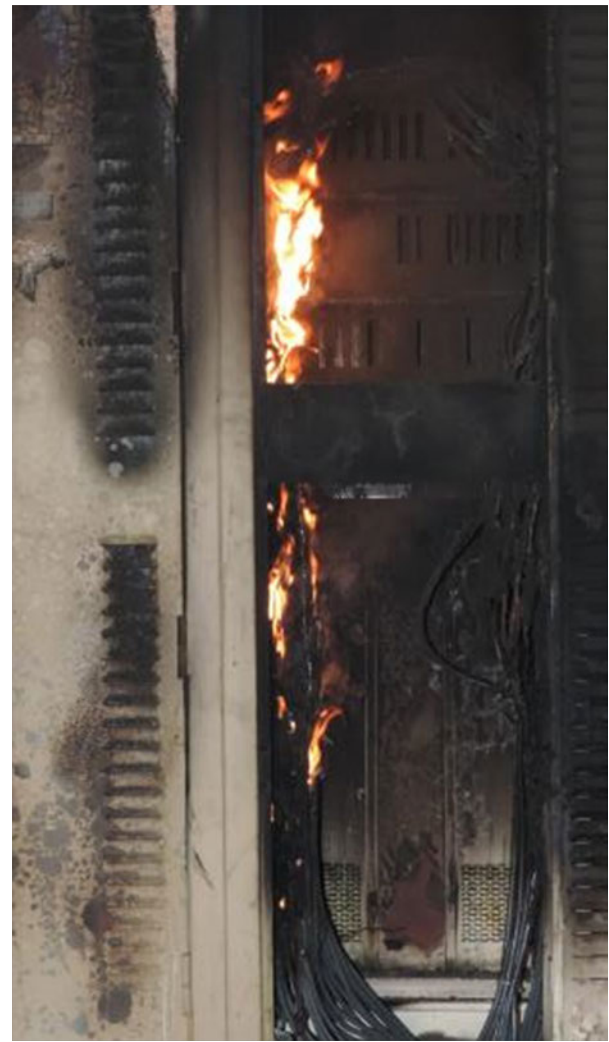
Table 5-114. Summary of Test 112

Notes: The propane burner was turned off at 10 min, 30 s. The fire sustained itself, but gradually weakened and stopped spreading 1.2 m (4 ft) above the burner. The cables were jostled with a crowbar at 19 min and the fire spread approximately 30 cm (1 ft) further.

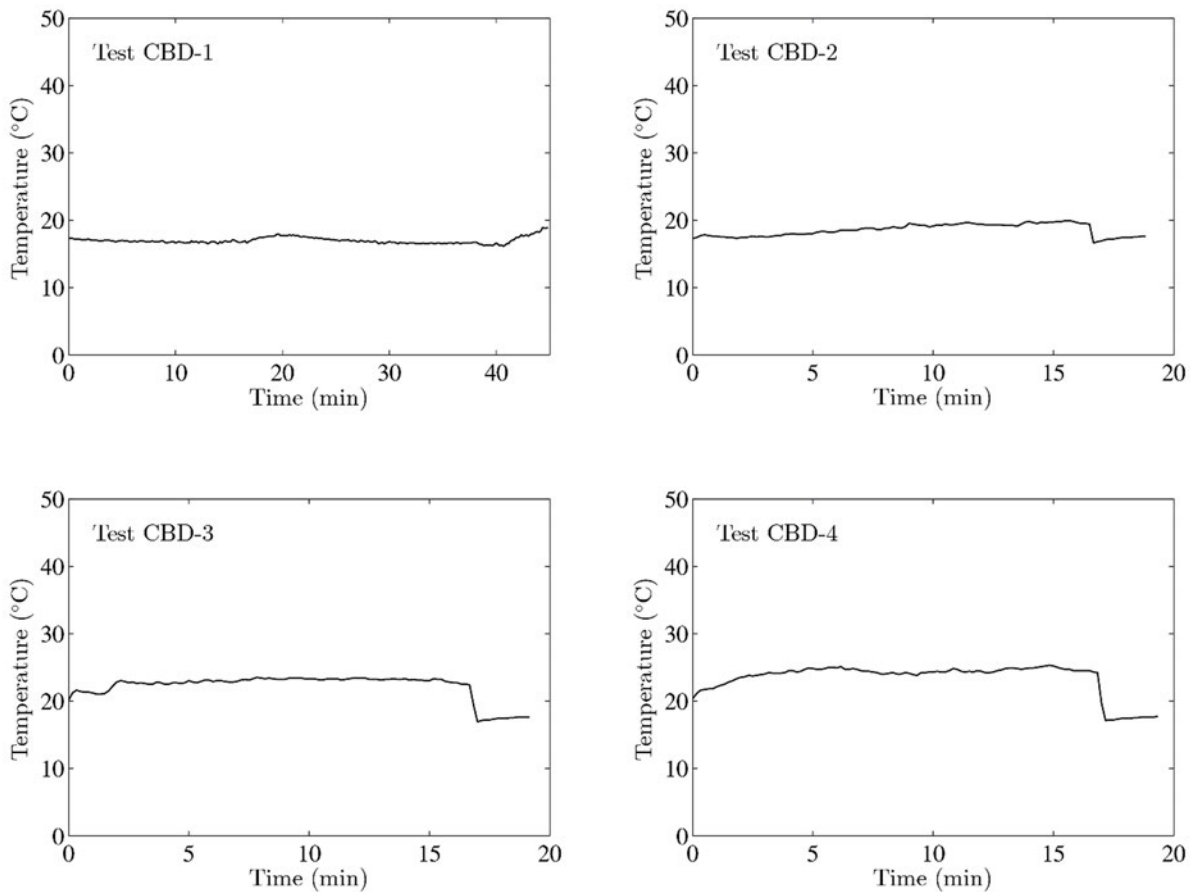
Figure A-1. Enclosure temperatures, Tests 1-4.

Near-ceiling temperature measurements for each experiment are listed on the following pages. Shown is the measurement nearest to the ceiling of the enclosure, typically about 15 cm (6 in) below and centered from left to right.

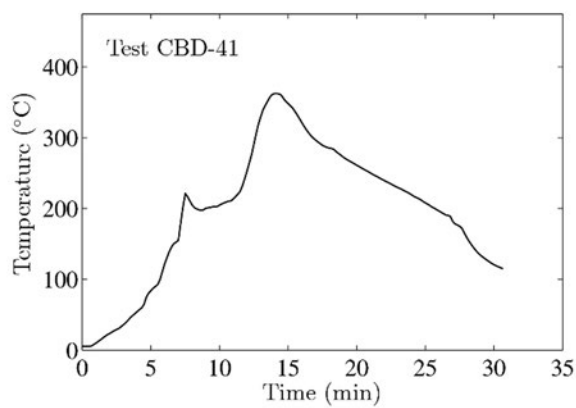
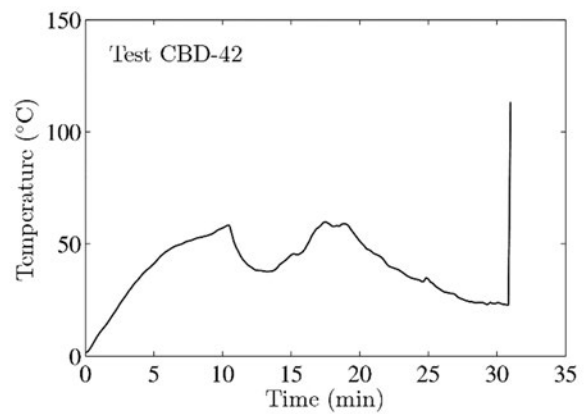
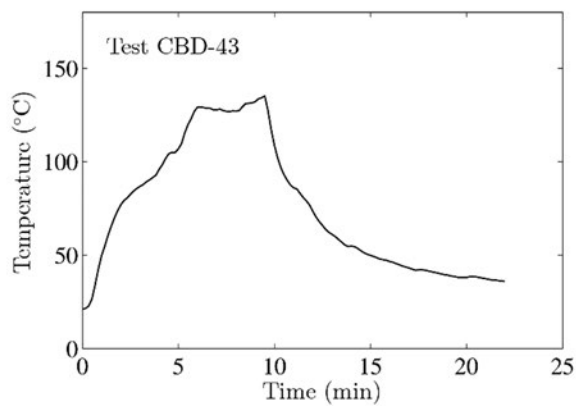
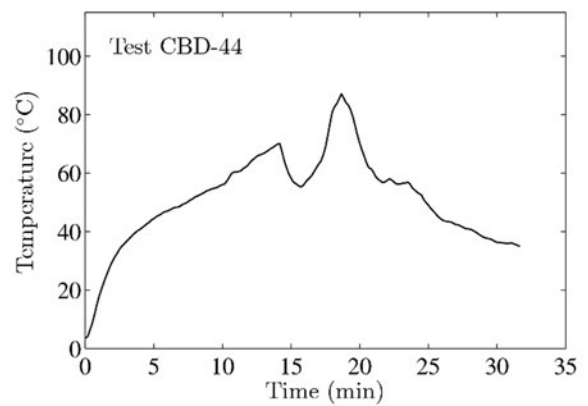
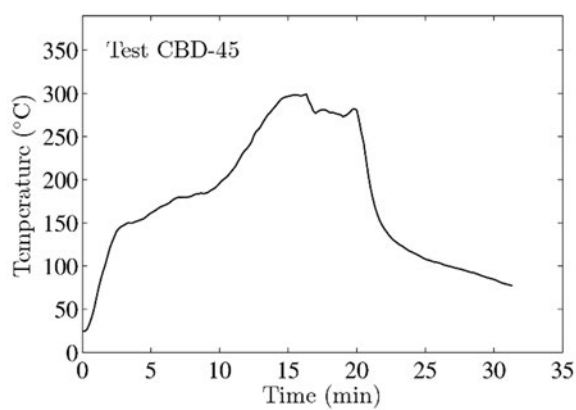
Figure A-8. Enclosure temperatures, Tests 41-46.

Enclosure temperatures were not measured for Test CBD-46.
