Duke Energy Florida  
**Levy Nuclear Plant**  
**Units 1 and 2**  
**Part 2, Final Safety Analysis Report**

Map of Local Tectonic Features

FIGURE 2.5.1-228

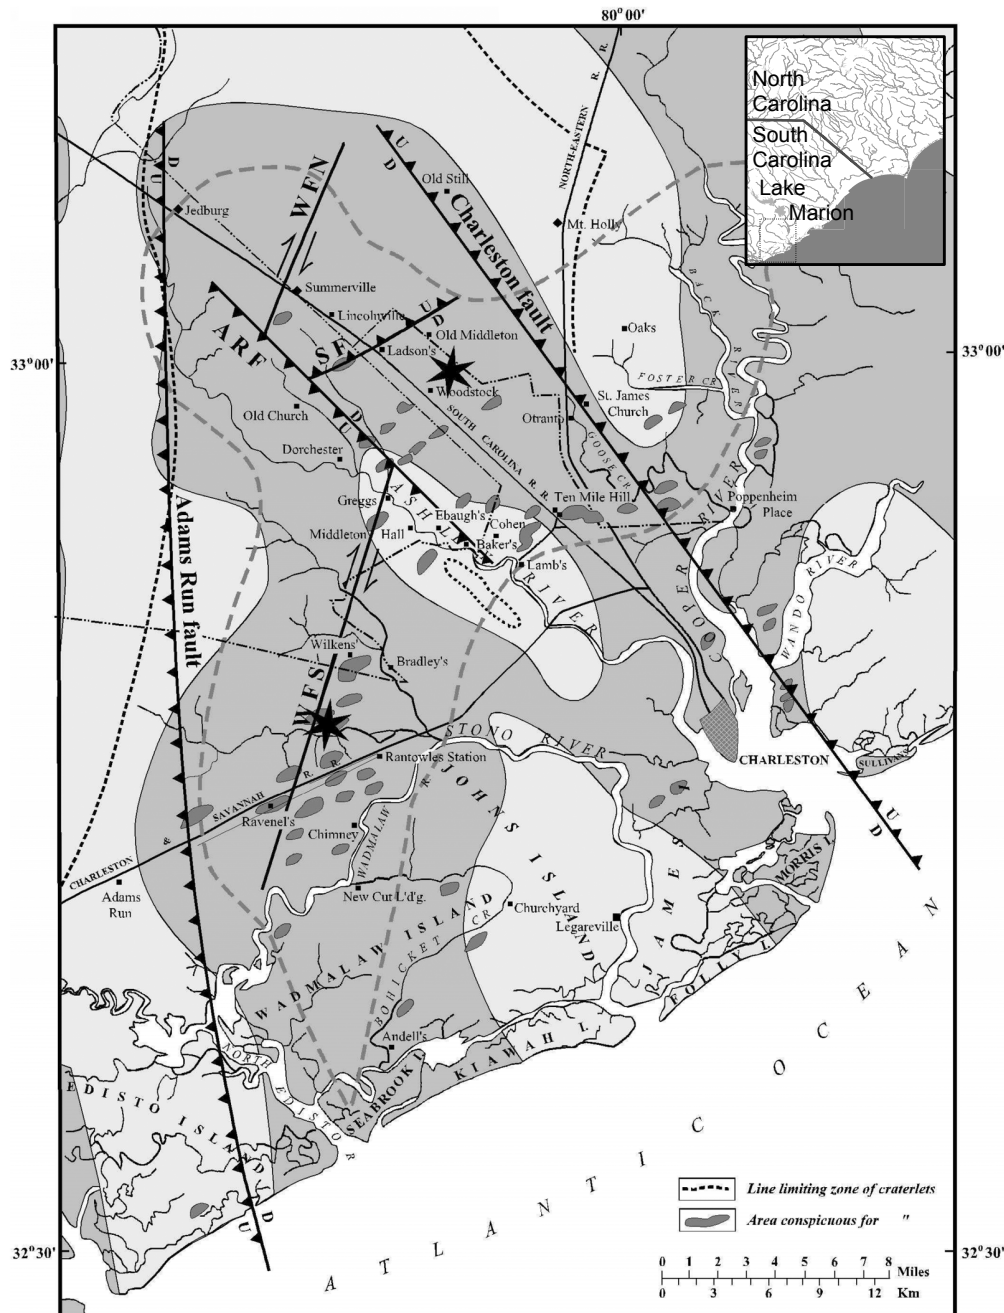
Map of local tectonic features from Weems and Lewis (2002). Figure shows the distribution of 1886 liquefaction features ("craterlets"), isoseismal boundaries (irregular gray dashed line), and two epicenters (starburst symbols) located by Dutton and Sloan (in Dutton, 1890). The positions of the Charleston fault, Adams Run fault, Woodstock fault northern segment (WFN), Woodstock fault southern segment (WFS), Ashley River fault (ARF), and the Summerville fault (SF) are indicated as black lines. Lighter gray areas are regions that have shown persistently upward relative movement over the past 34 m.y. (Weems and Lewis, 2002).
