Duke Energy Florida
**Levy Nuclear Plant
Units 1 and 2**
Part 2, Final Safety Analysis Report

Fracture Pattern of the Northern Part
of the Florida Peninsula
FIGURE 2.5.3-202

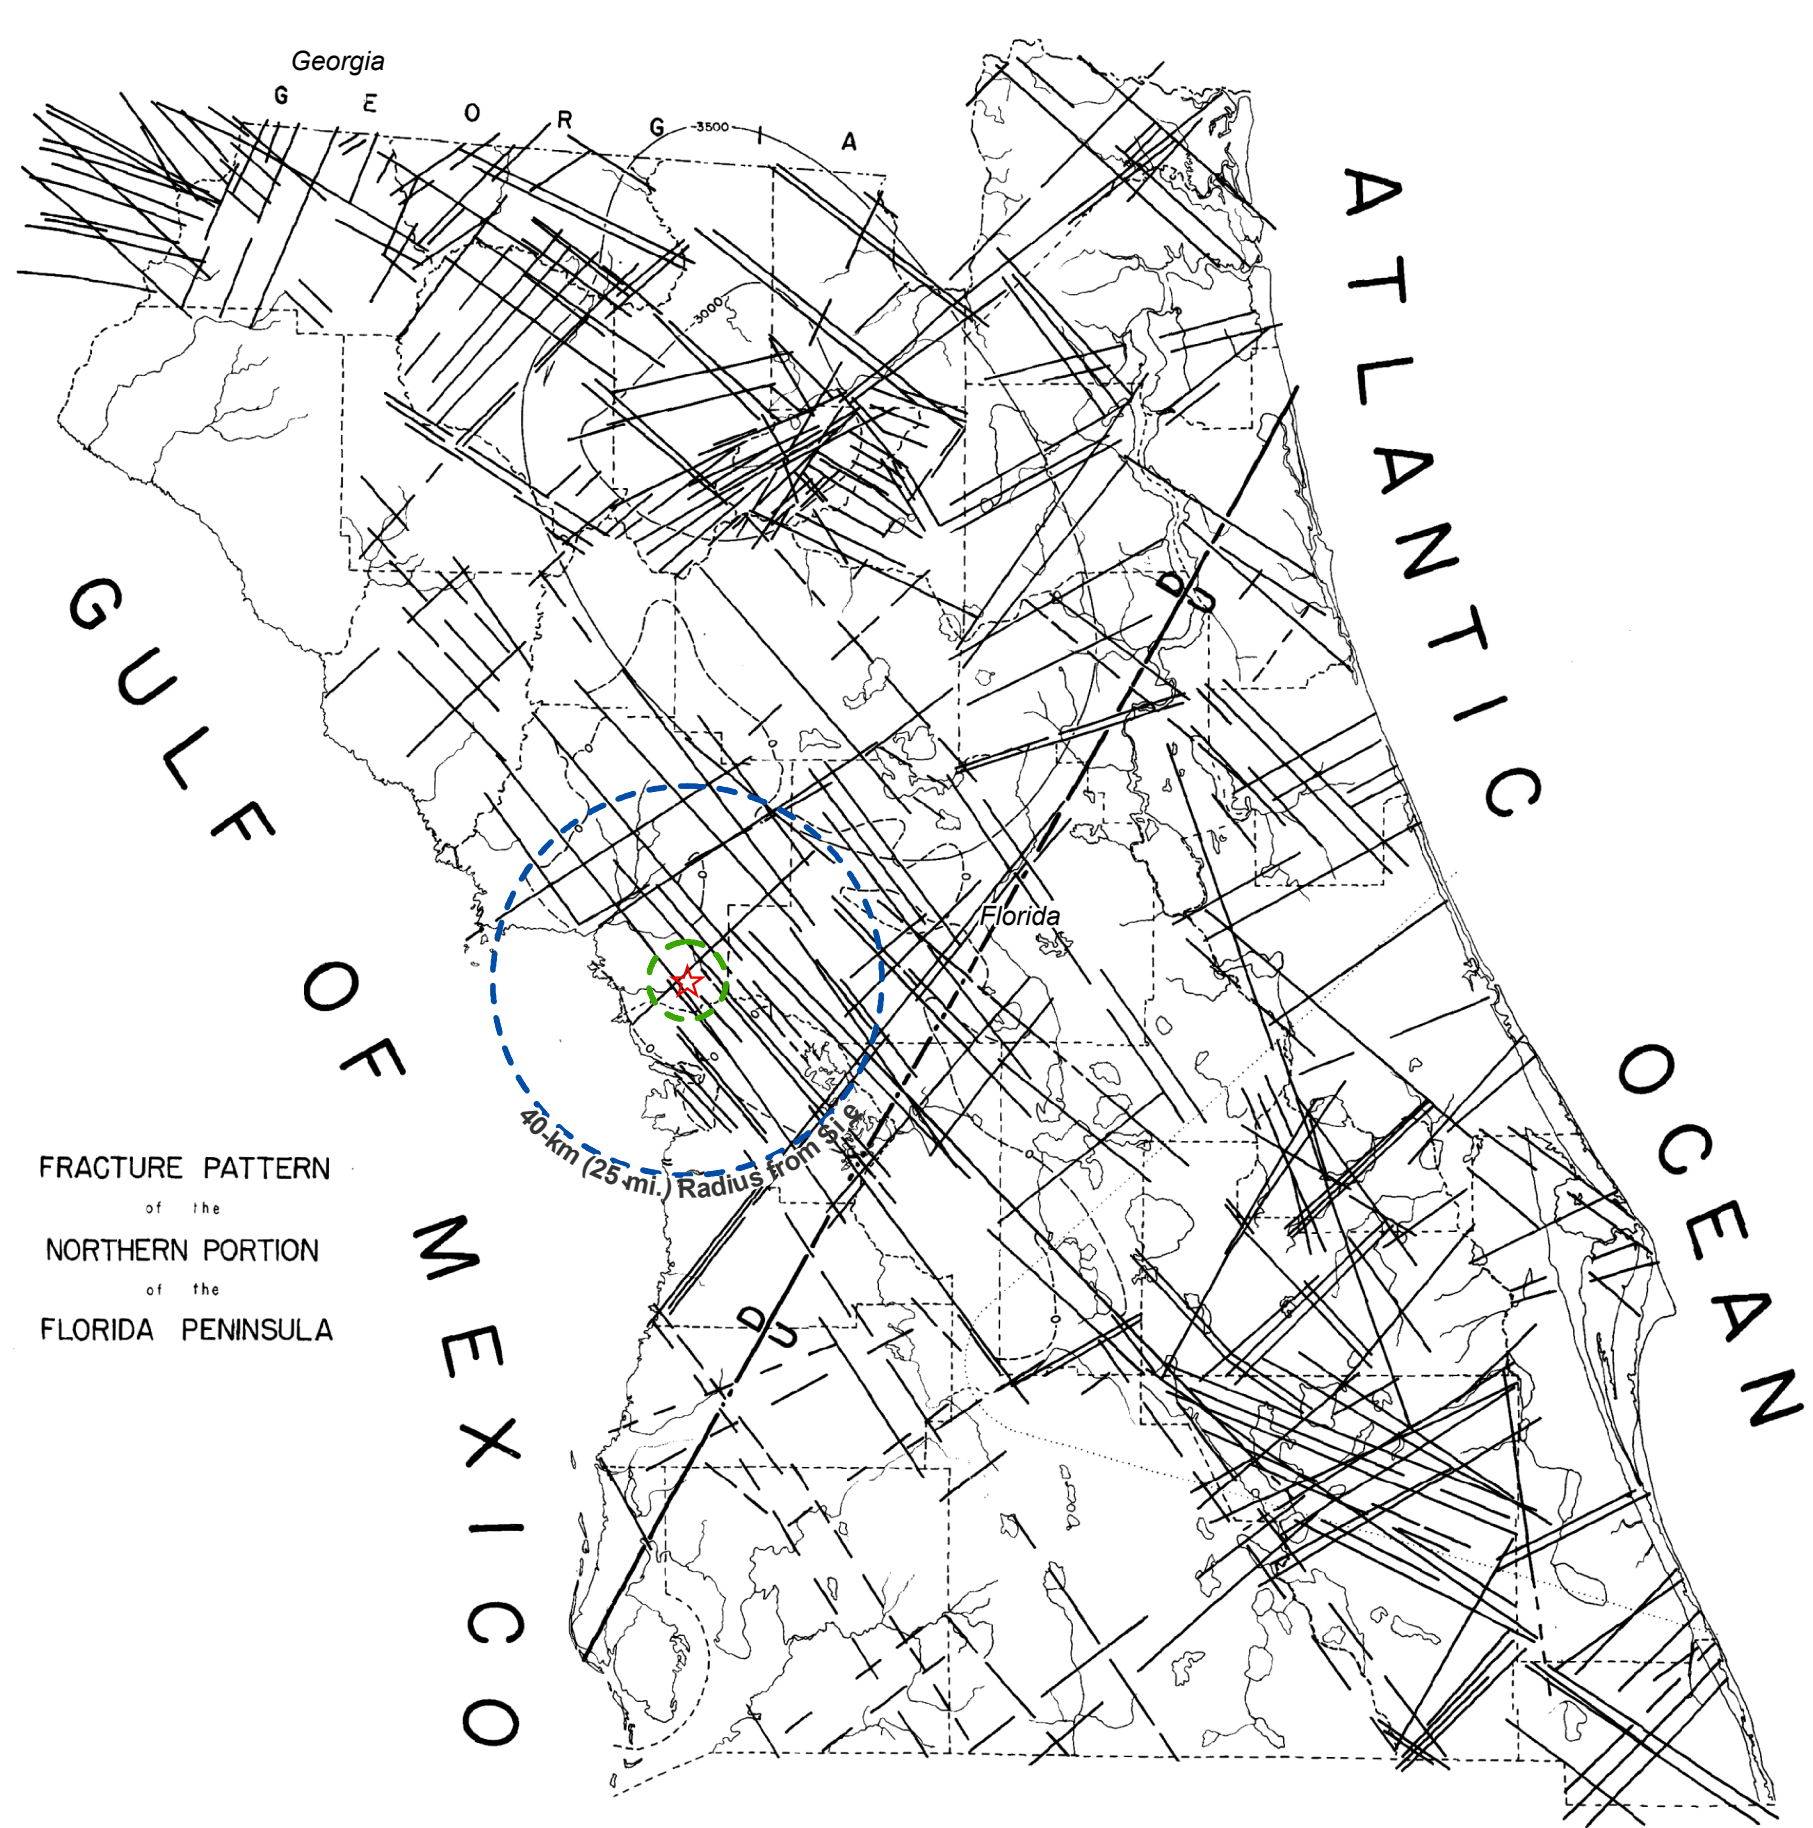
FRACTURE PATTERN
of the
NORTHERN PORTION
of the
FLORIDA PENINSULA

Source: Vernon (1951)
