Duke Energy Florida
**Levy Nuclear Plant
Units 1 and 2
Part 2, Final Safety Analysis Report**

Postulated Faults and Fractures (Lineaments)
within the LNP Site Area Shown on Hillshade
Relief Map Derived from LIDAR Data
FIGURE 2.5.3-214 Rev 6

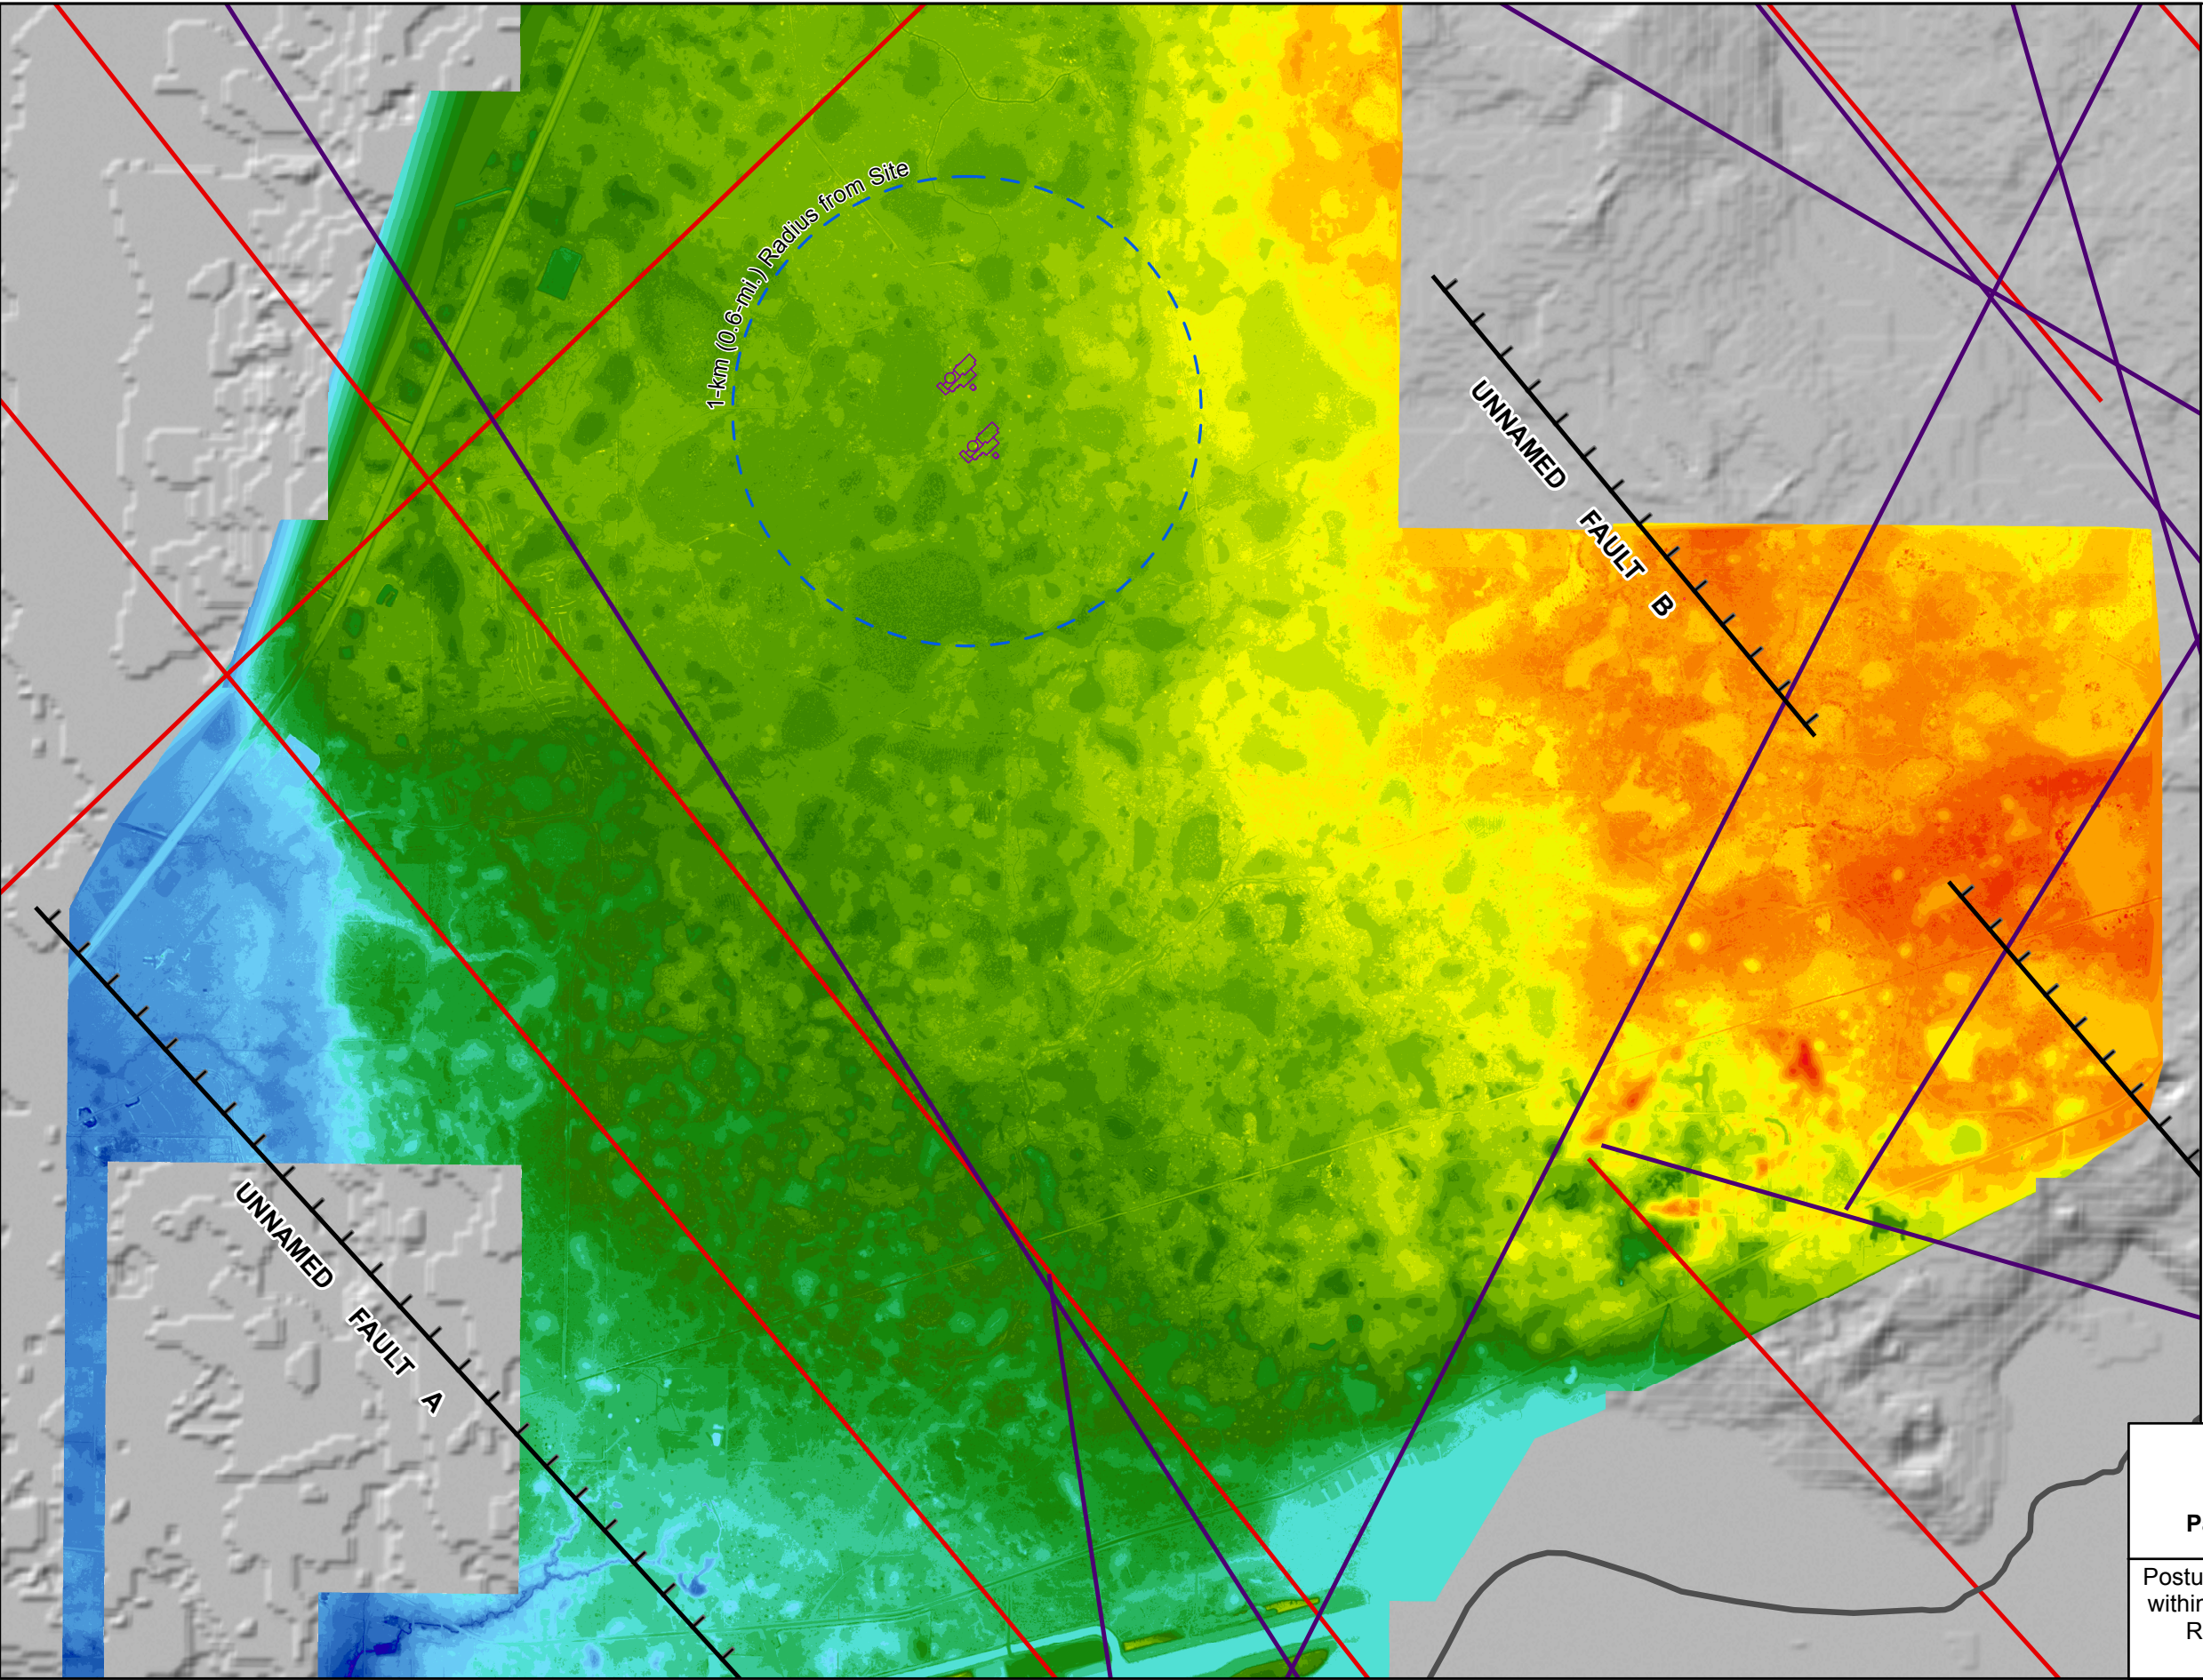
- 1-km (0.6-mi.) Radius from Site
- AP1000 Structures
- Postulated Faults
Ticks indicate downthrown side.
(Source: Vernon, 1951)
- Regional Fractures
(Source: Vernon, 1951)
- Lineaments
(Source: Florida DOT, 1973)
