**Levy Nuclear Plant  
Units 1 and 2  
Part 2, Final Safety Analysis Report**

Diagrams Illustrating the Orientation of  
A) Fracture Sets in Bedrock Exposures  
and B) Lineaments in the LNP Site Location

FIGURE 2.5.3-224

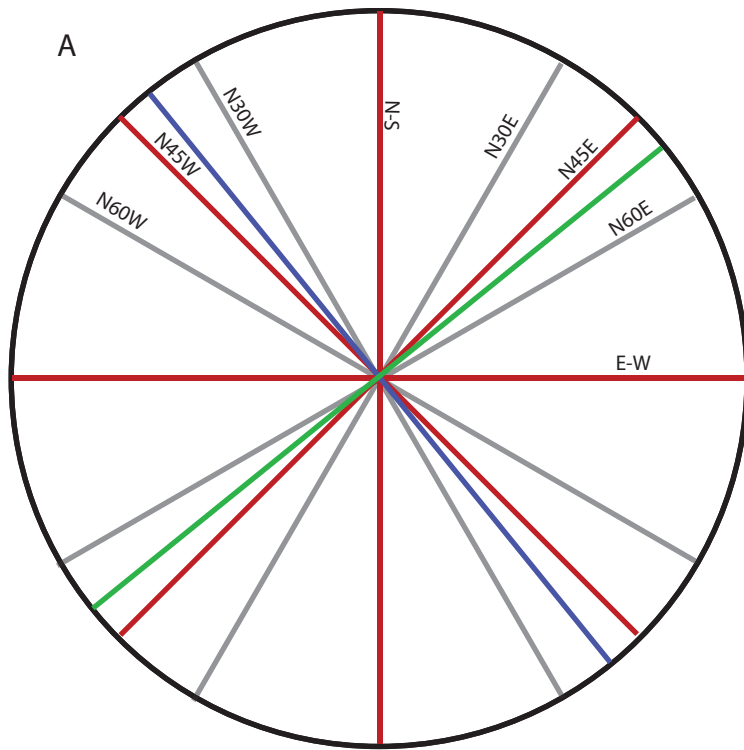
A: Joint orientations observed in Crystal River Unit No. 3 Excavation (no information on frequency or number of observations) (CR3 FSAR, 1973).

- Primary orthogonal joint systems
- Secondary orthogonal joint systems

Gulf Hammock Quarry and Wacasassa River Exposures

- Primary set
- Orthogonal set

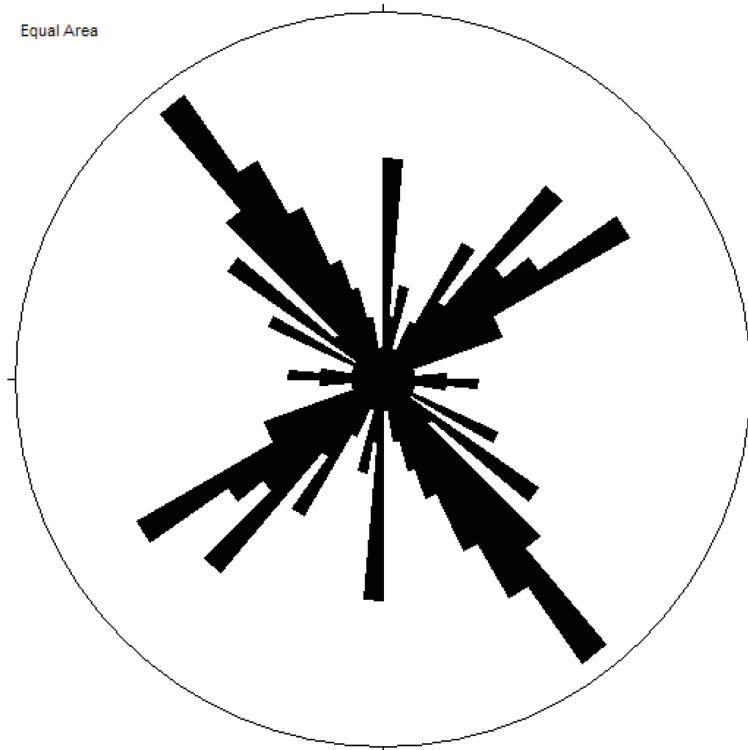
B: Rose diagram showing orientation and frequency of mapped lineaments within the site location (1-km [0.6-mi.] radius)
