WLS COL 2.4-2

WILLIAM STATES LEE III
NUCLEAR STATION UNITS 1 & 2

Discharge Rating Curve,
Ninety-Nine Islands Dam

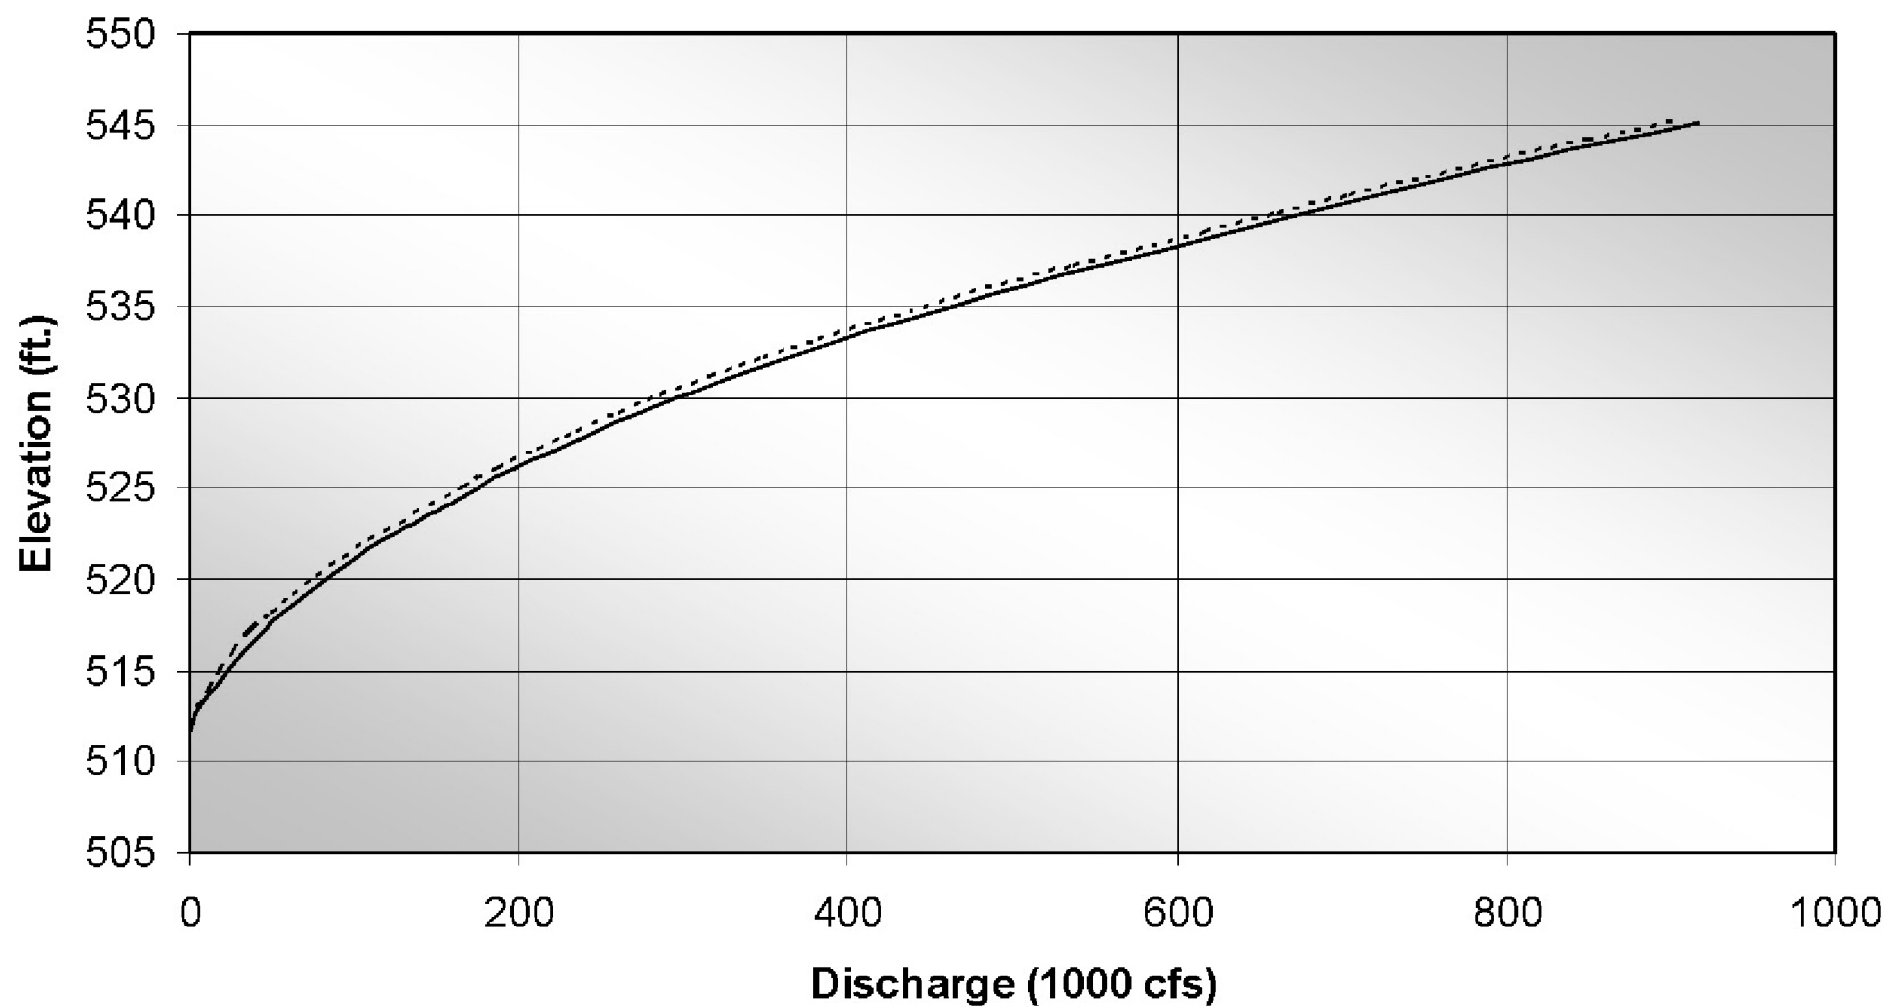
FIGURE 2.4.3-213

— flashboard failure at 6 ft. no flashboard failure
