WILLIAM STATES LEE III  
NUCLEAR STATION UNITS 1 & 2

FIGURE 2.4.4-205 Rev 7

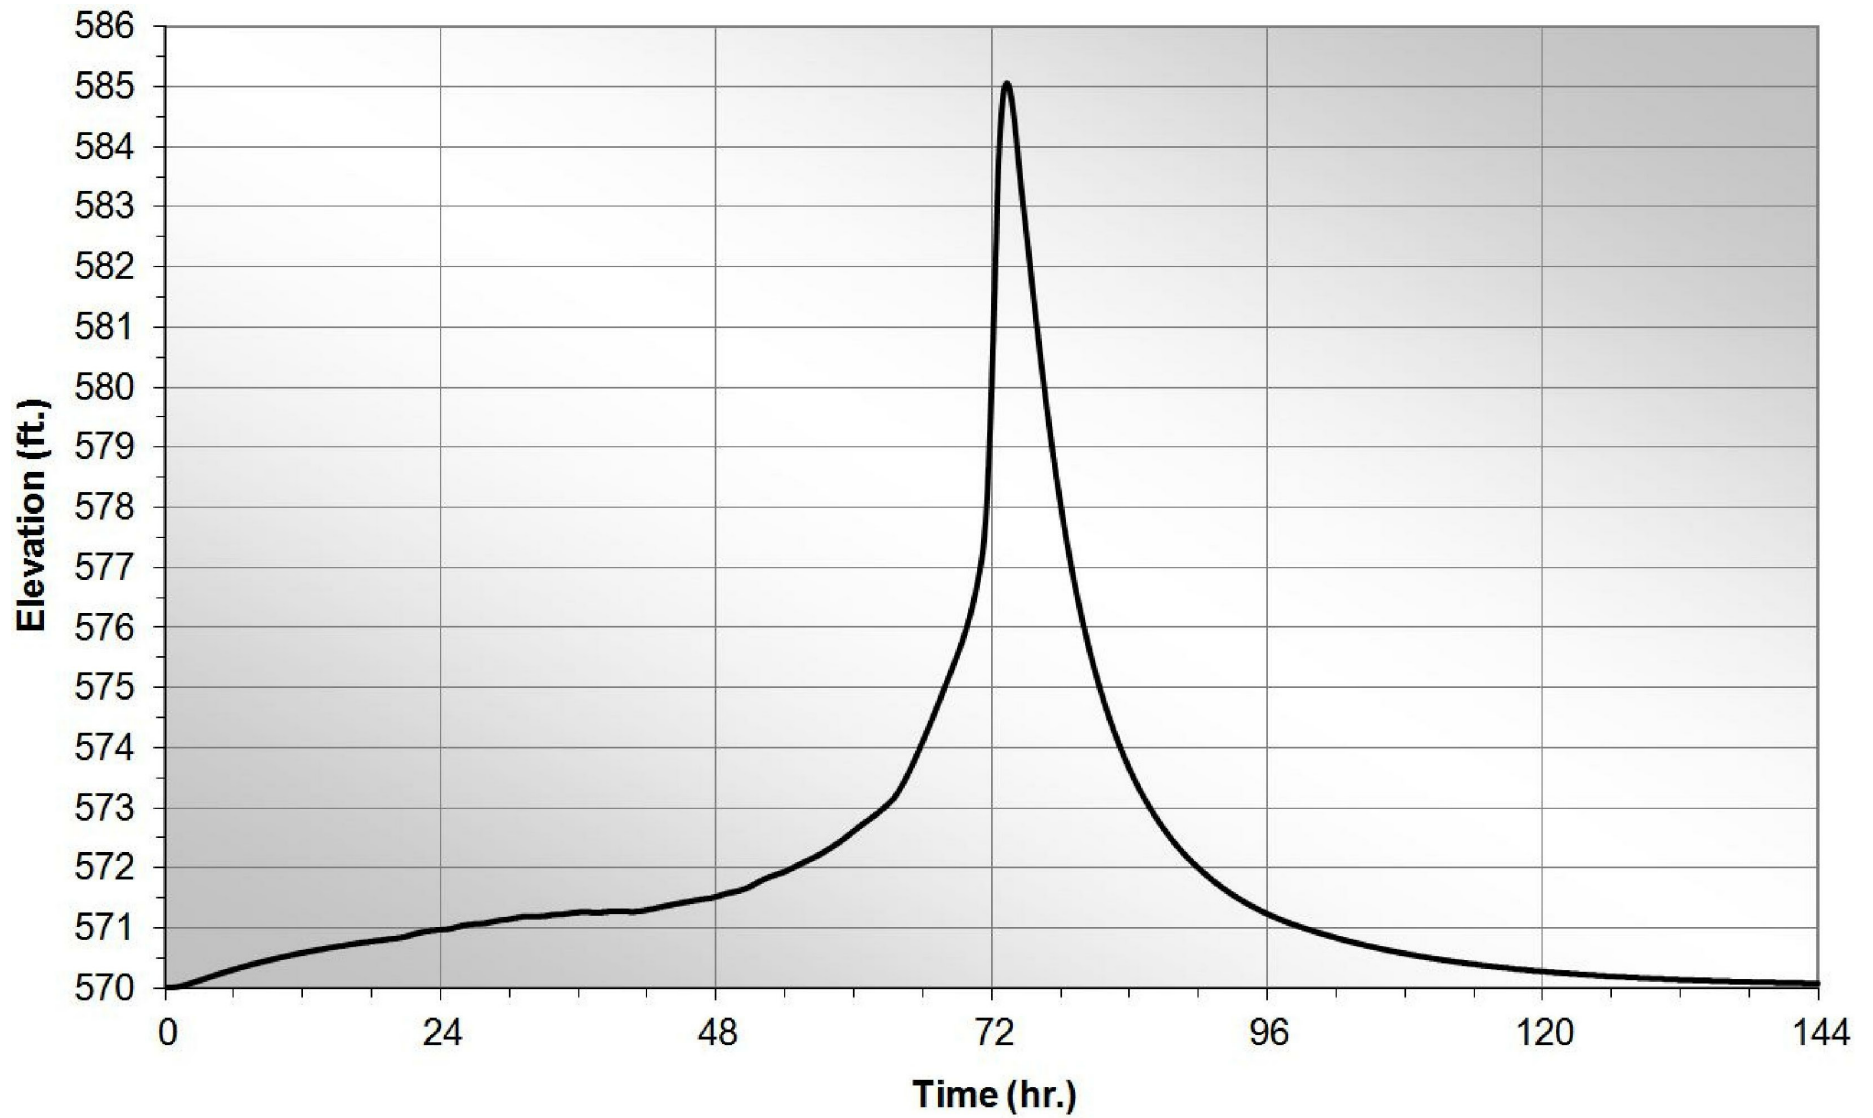
Flood El. Hydrograph Make-Up Pond B  
With Upper Arm Dam Failure,  
72-hr. Local Intense Precipitation
