### **Track Change Version Final Status Survey Final Report Volume 5, Chapter 1, Revision 1 Piping Survey Areas (PSA) Overview**

**Westinghouse Electric Company LLC, Hematite Decommissioning Project**

#### Final Status Survey Final Report Volume 5, Chapter 1

**TITLE:** Piping Survey Areas (PSA) Overview

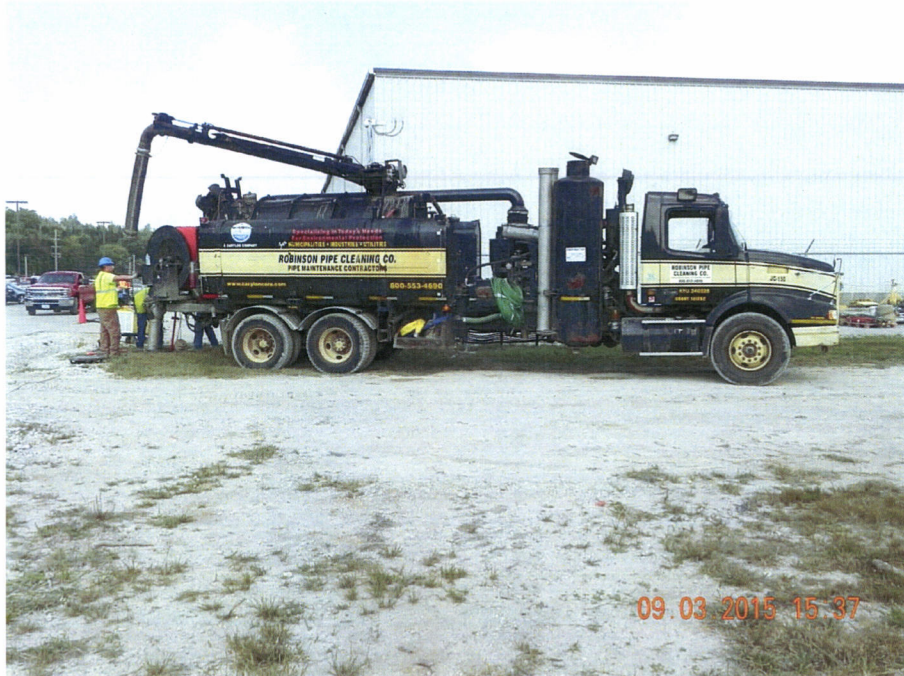
**Figure 2-4**  
**Pipe Cleaning Contractor**

Prior to FSS of the storm water drain piping, a contractor that specializes in storm water drain piping clean out was utilized to flush/clean all of the storm water drain piping that will remain at license termination. Figure 2-4 through Figure 2-6 are photographs of the contractor performing storm water drain piping cleaning. Figure 2-7 through Figure 2-10 are photographs that provide examples of the pre and post cleaning condition of the storm drain manholes and piping.

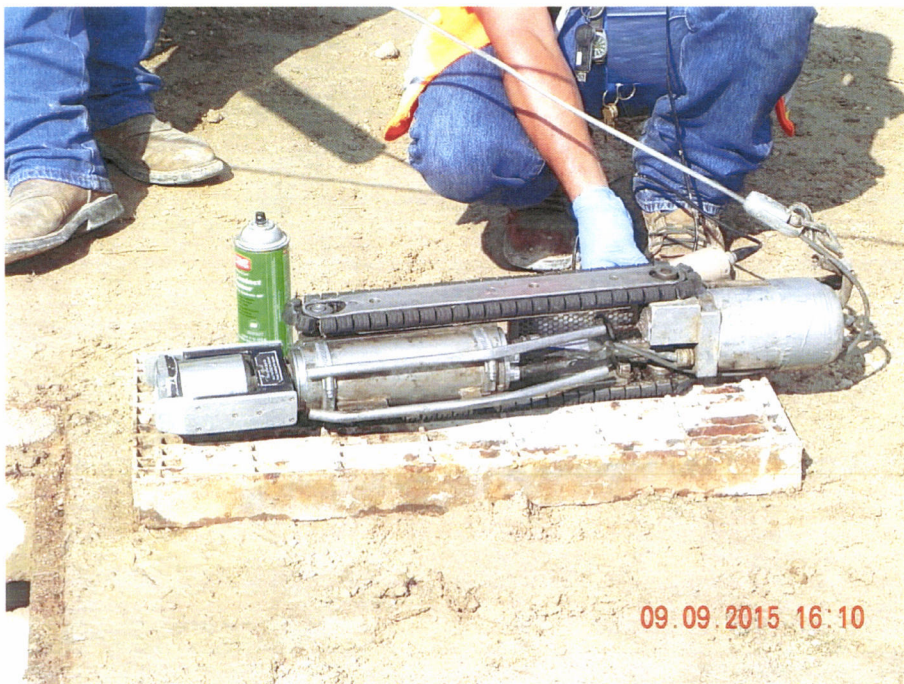
**Figure 2-5**  
**Pipe Cleaning Crawler Unit**

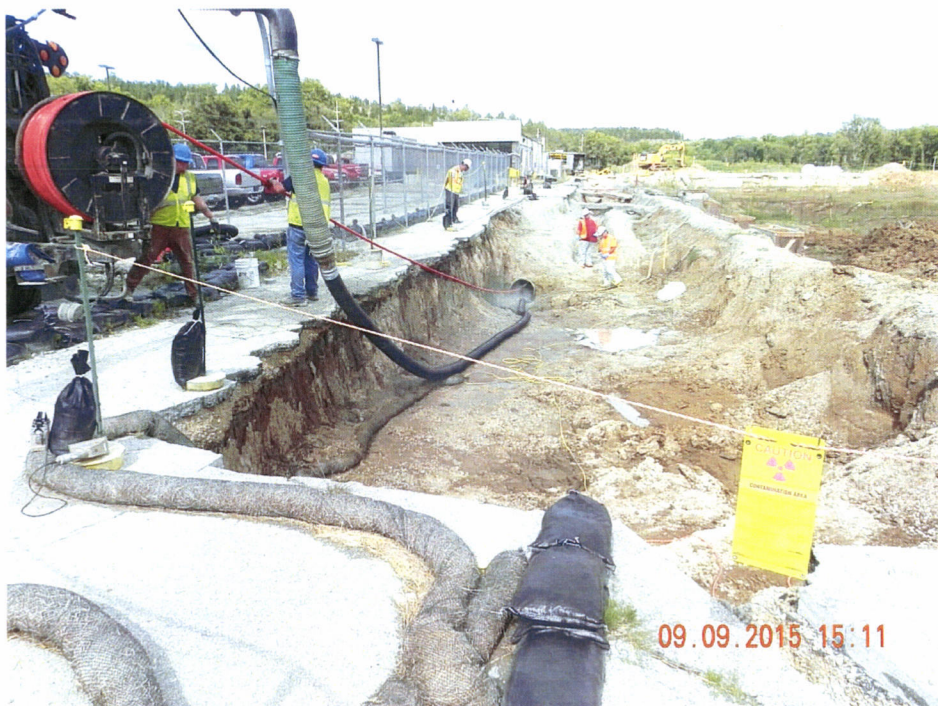
**Figure 2-6**  
**Pipe Cleaning of Storm Water Drain Piping**

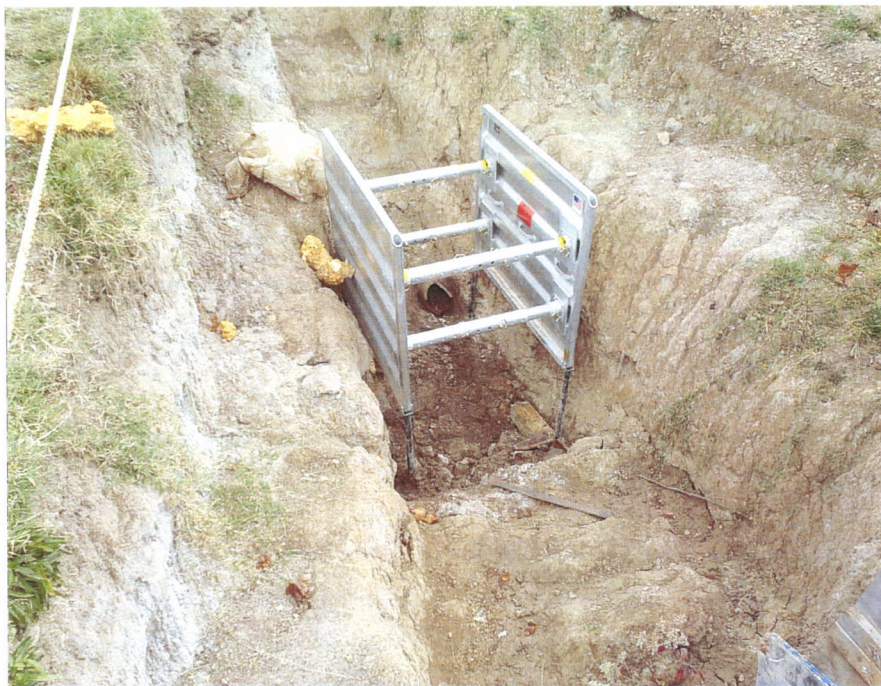
**Figure 2-11**  
**Access to the SWTP Piping**

“mid-section” of SWTP piping (SAN-1 on Figure2-3) is 293 feet in length and has been abandoned in place. This section of piping was cleaned by the contractor performing the storm water drain piping. Figure 2-11 is a photograph showing the access point of the SWTP pipe for cleaning and FSS.

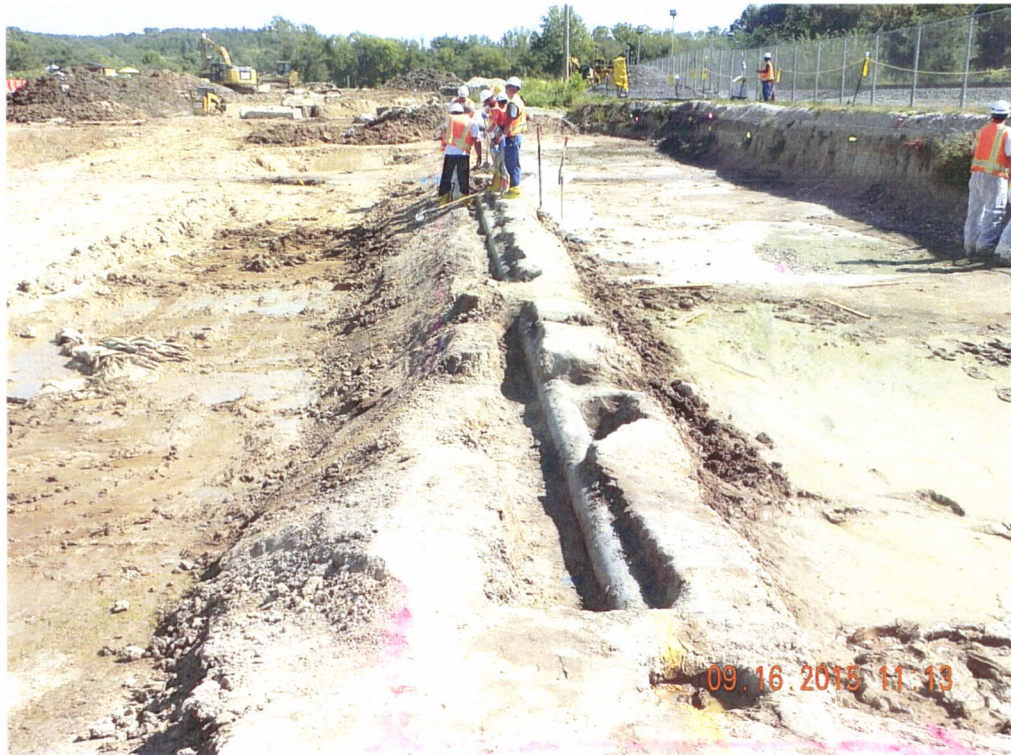
**Figure 2-12**  
**Natural Gas Pipe Line (during soil remediation)**

An 8 inch diameter high pressure natural gas transmission pipe line runs the length of the southeast border of the Hematite Site. The NGP was installed in 1956 and is a sole source of natural gas for local communities. Soil impacted by former Site operations was located near the NGP and was remediated. As the NGP has been active since its installation it does not present a condition in which the internals of the NGP would have become contaminated. Figure 2-12 is a photograph of the NGP during soil remediation operations.

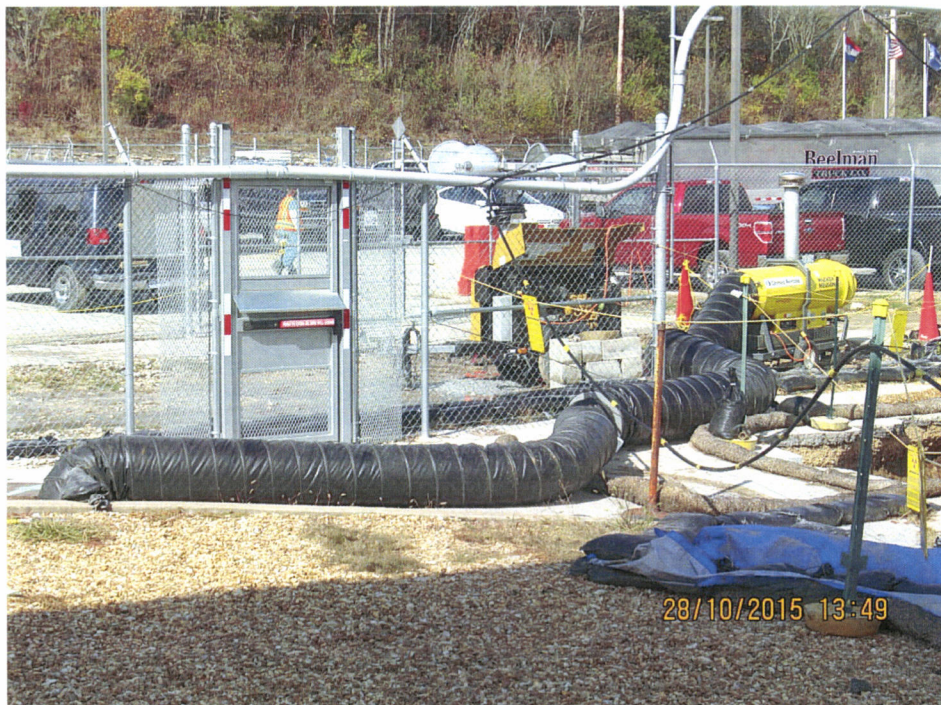
**Figure 2-14**  
**Heating/Ventilation Unit Drying a Section of Storm Water Drain Piping**

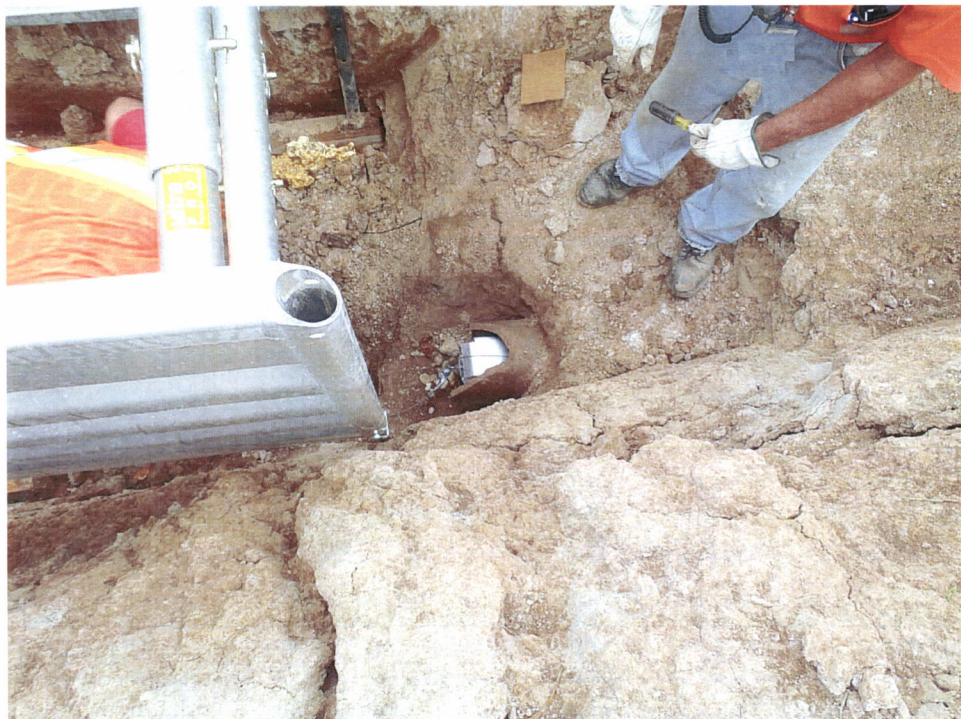
**Figure 2-15**  
**Detector Unit Accessing the SWTP Piping**
