**Figure 4-14**  
**Temperature Profiles for EOS-HSM loaded with EOS-37PTH DSC at**  
**Off-Normal Cold Storage Condition (Load Case #4)**  
 2 Pages

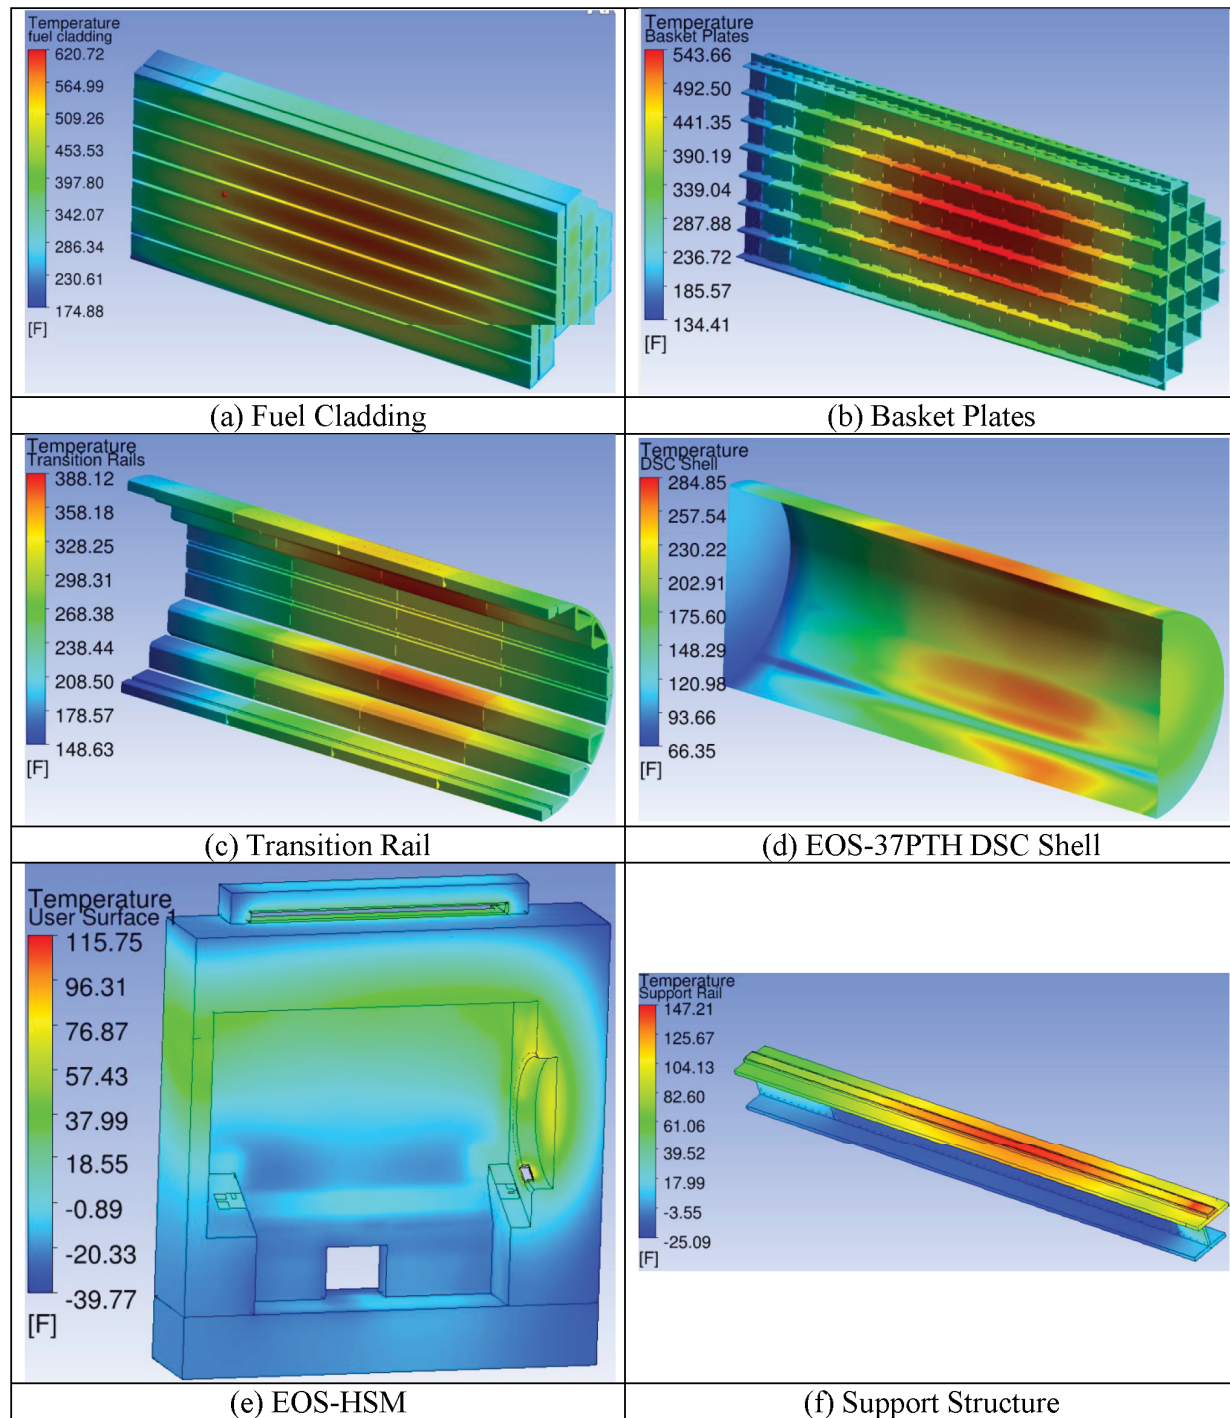
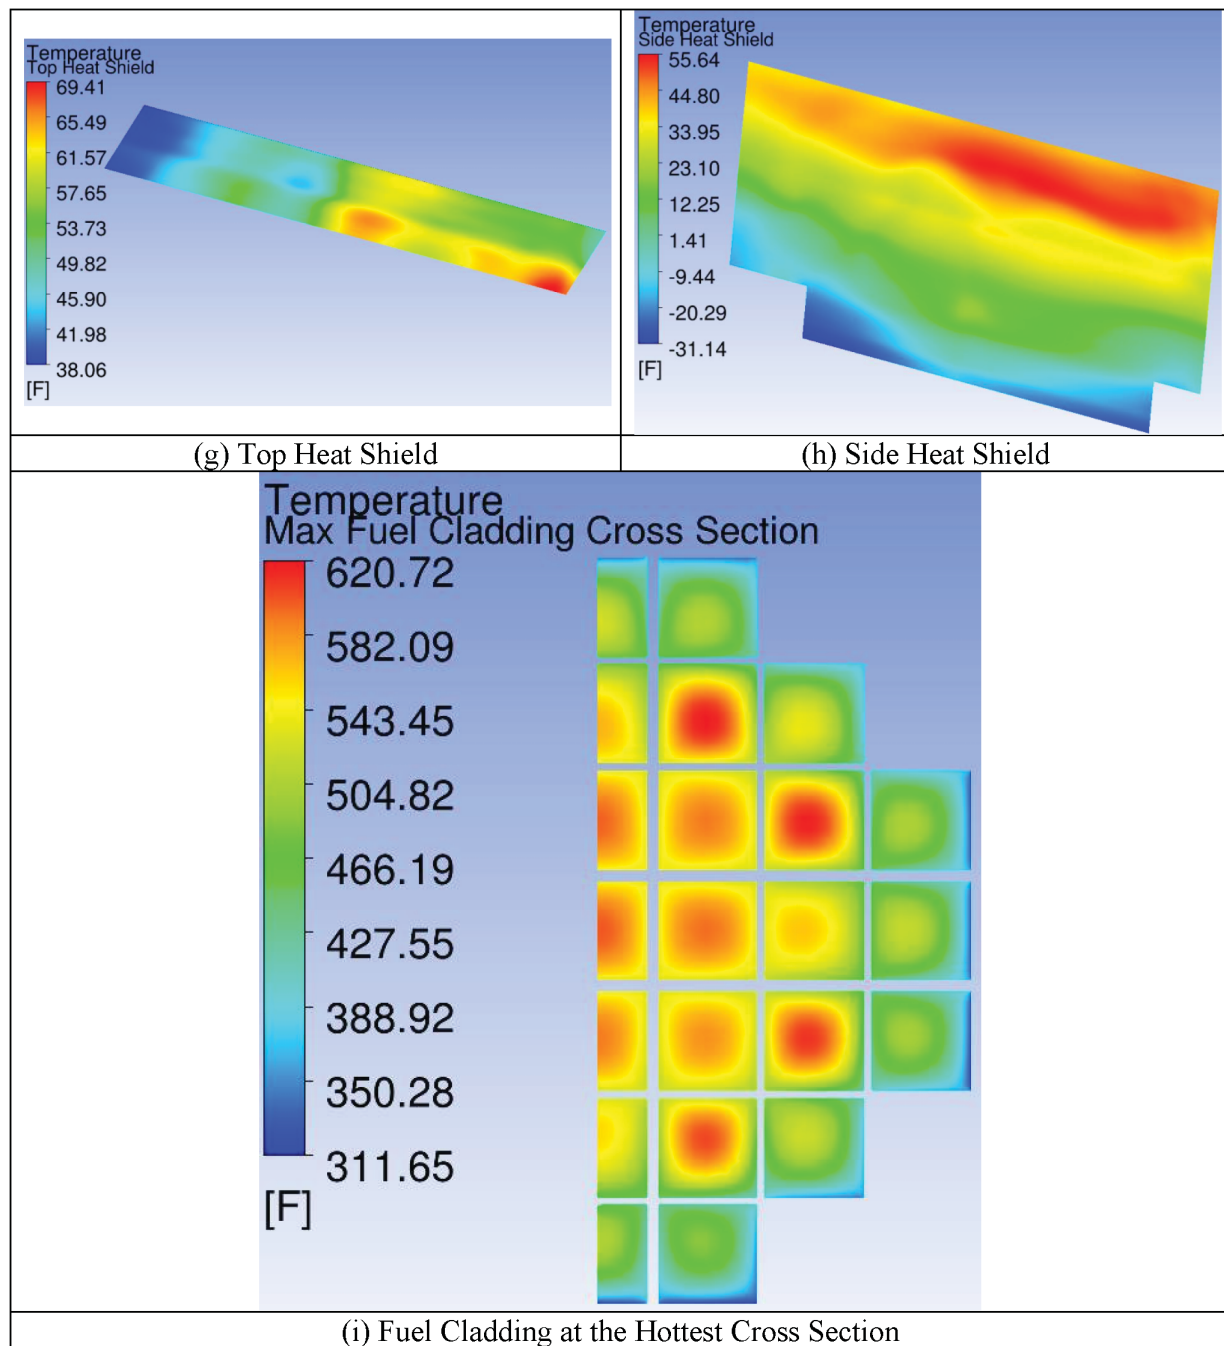
**Figure 4-14**  
**Temperature Profiles for EOS-HSM loaded with EOS-37PTH DSC at**  
**Off-Normal Cold Storage Condition (Load Case #4)**  
 2 Pages

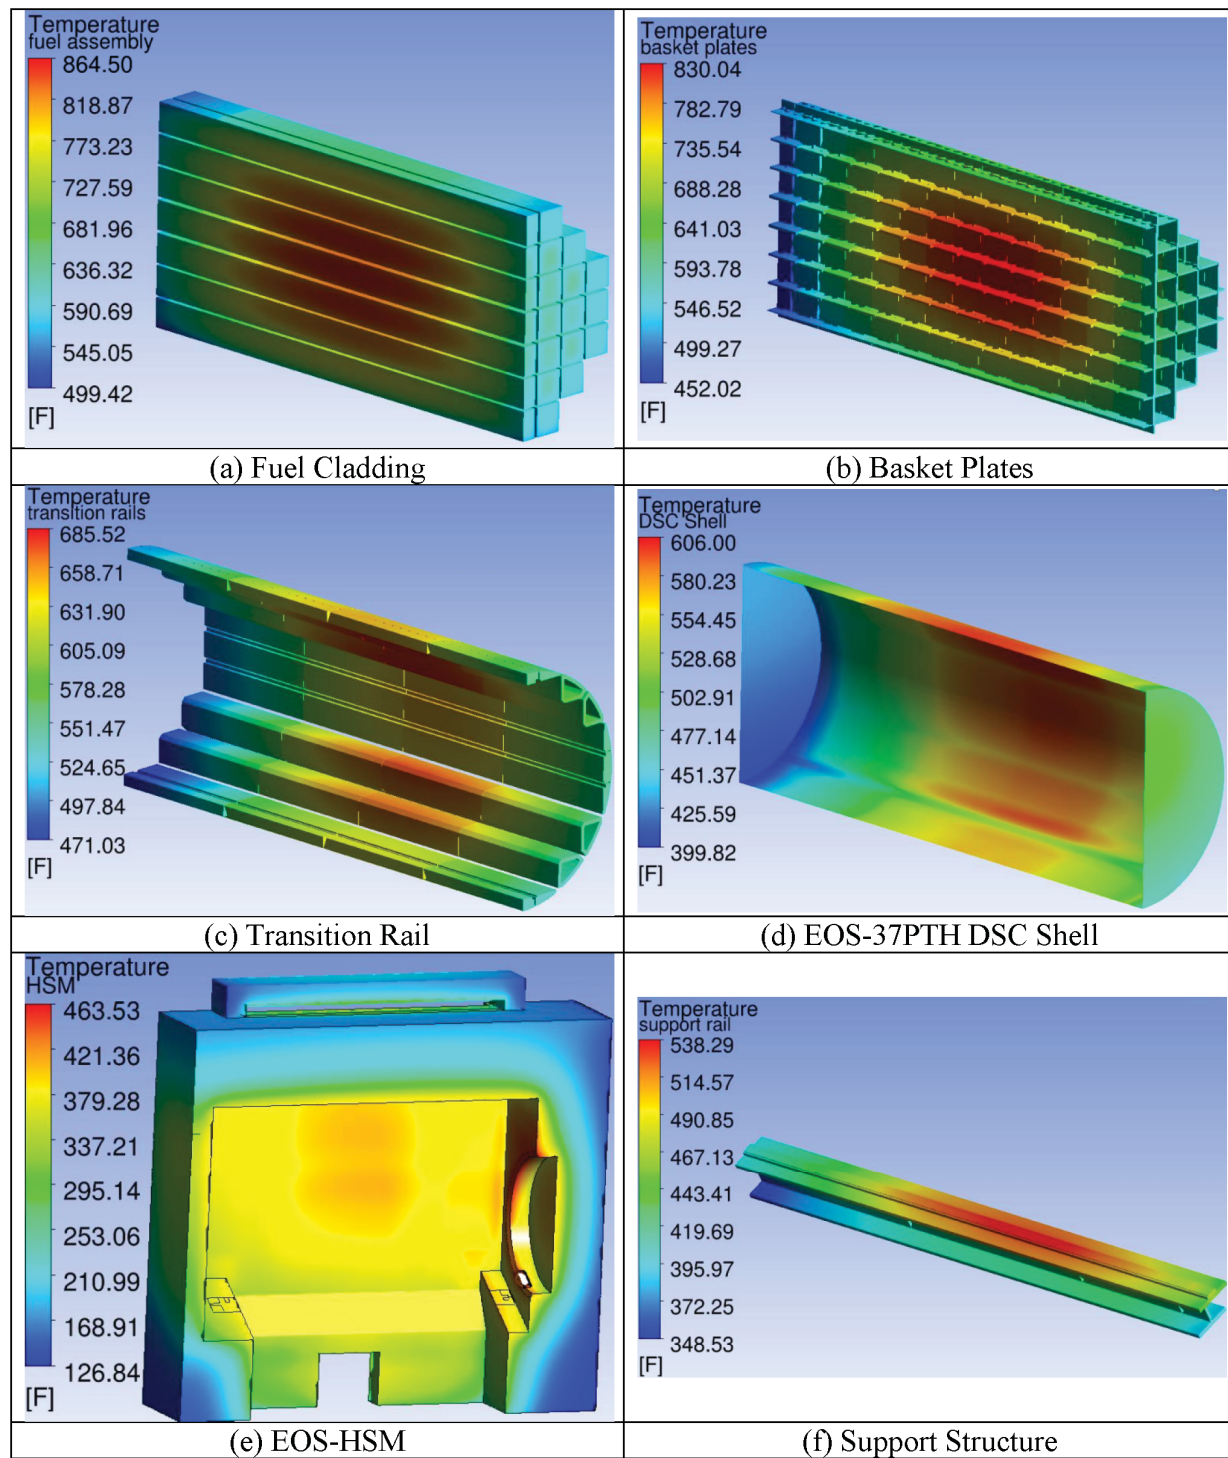
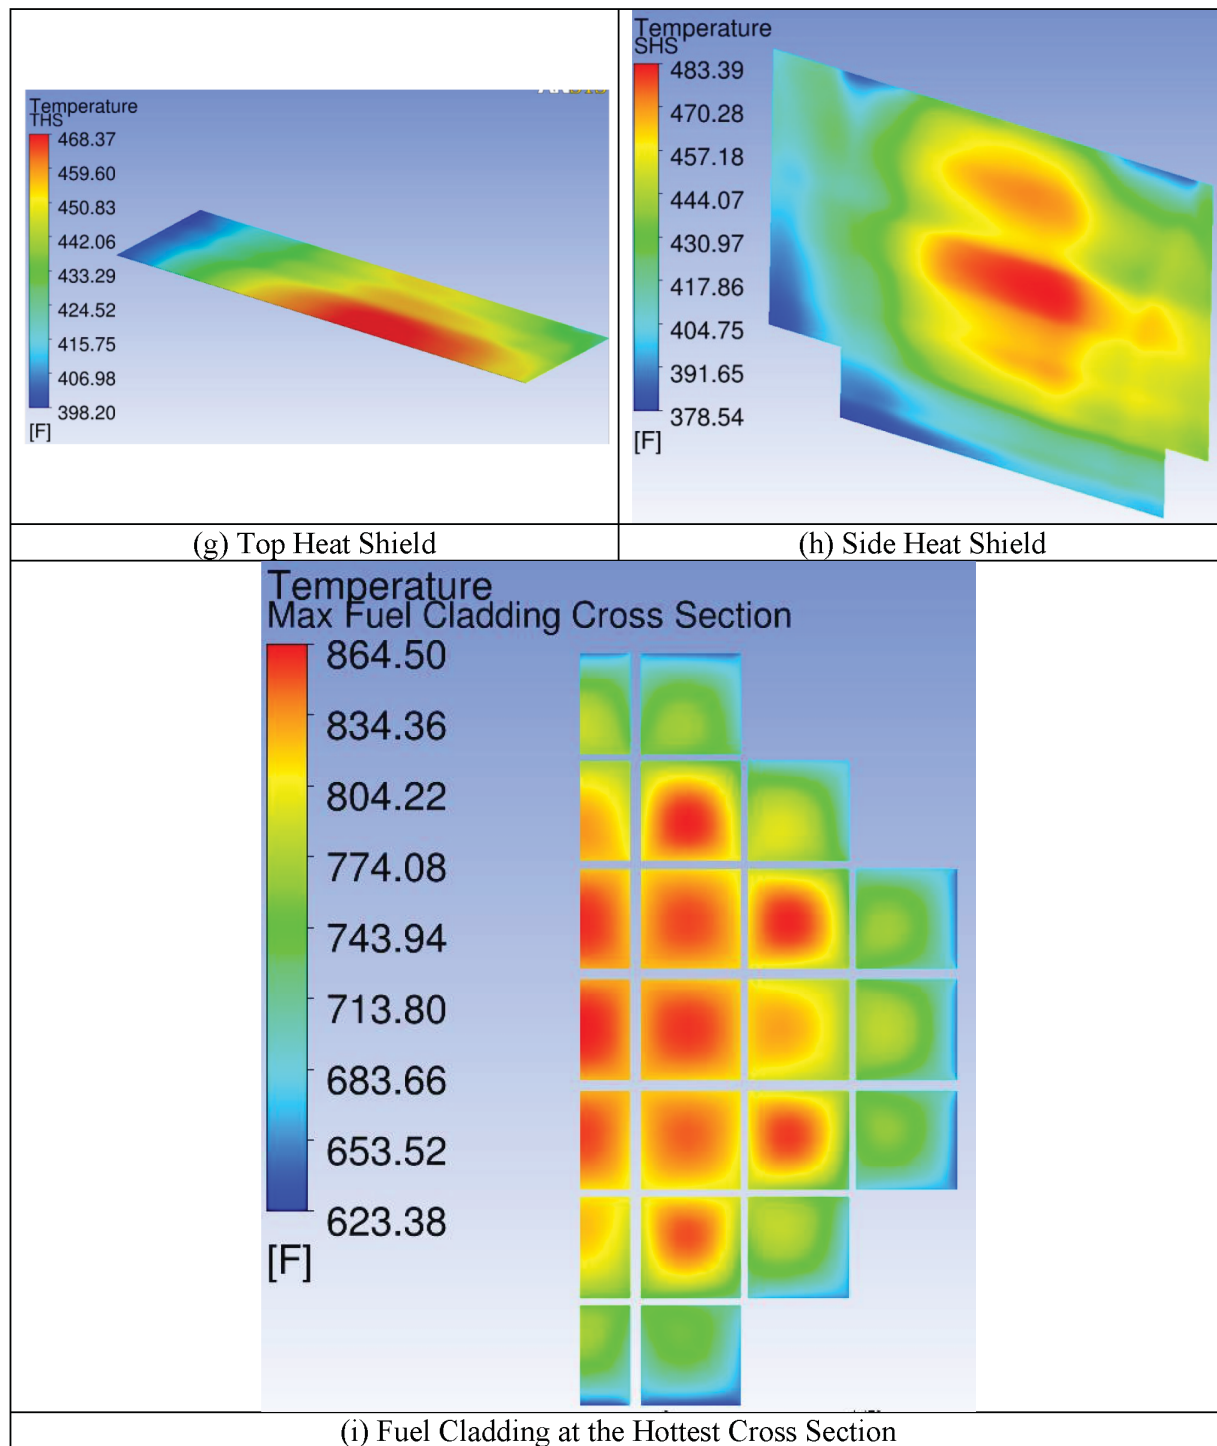
**Figure 4-15**  
**Temperature Profiles for EOS-HSM loaded with EOS-37PTH DSC at**  
**Accident Storage Condition for 40 hours (Load Case #5)**  
 2 Pages

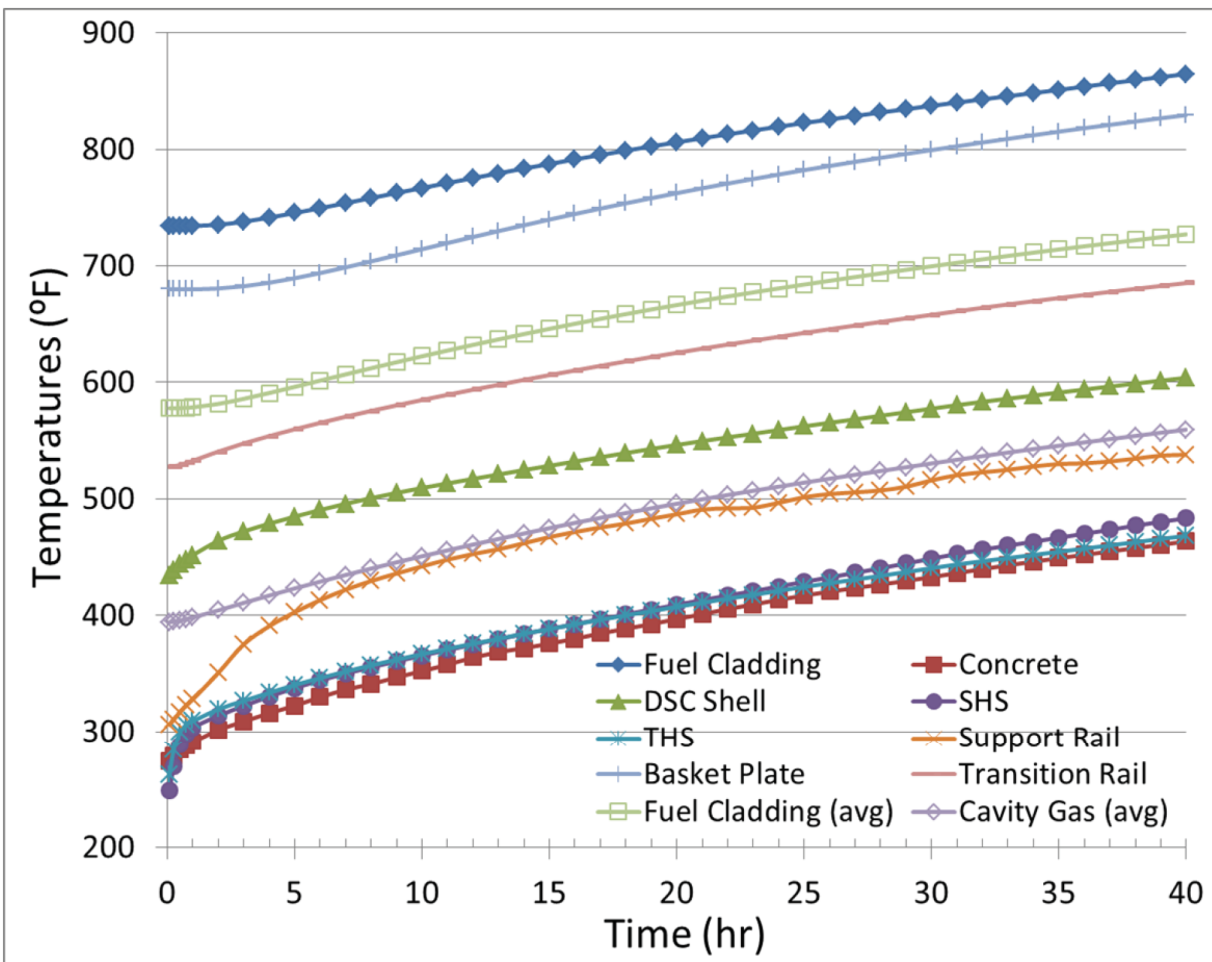
**Figure 4-16**  
**Maximum and Average Temperature Histories of Key Components in**  
**EOS-HSM loaded with EOS-37PTH DSC at Blocked Vent Accident**  
**Condition (Load Case #5)**

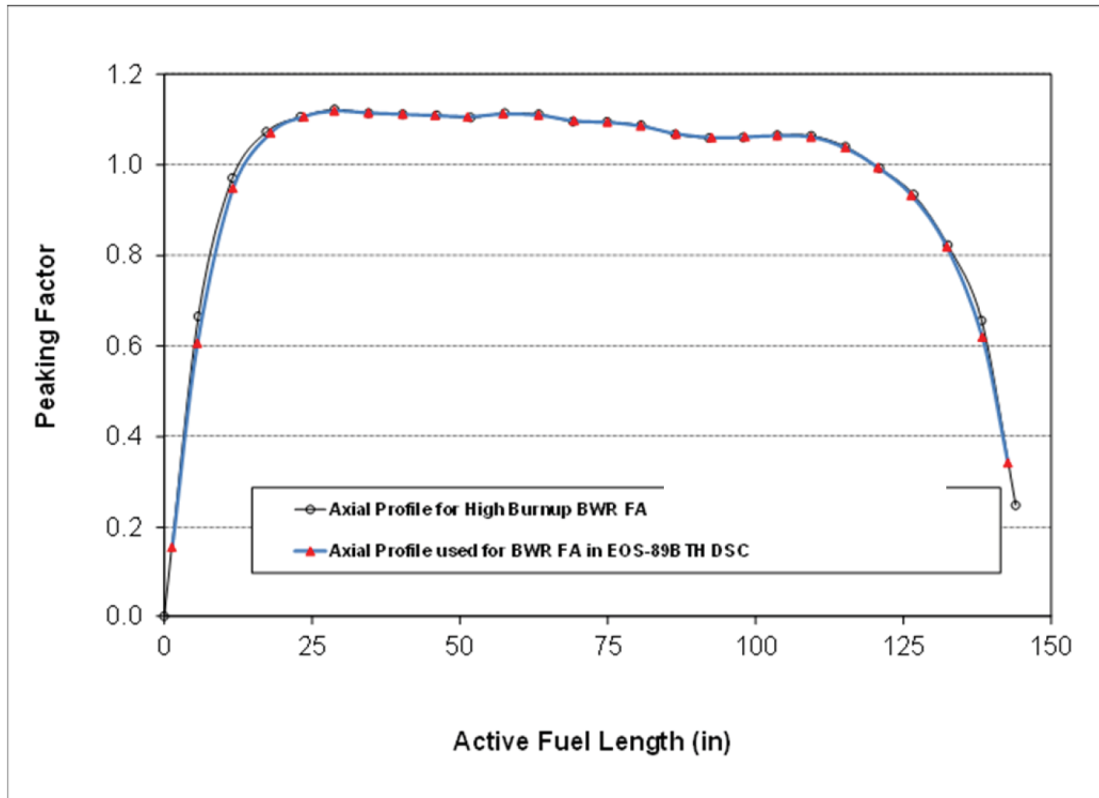
**Figure 4-25**  
**Peaking Factor Curve for BWR Fuel Assemblies**

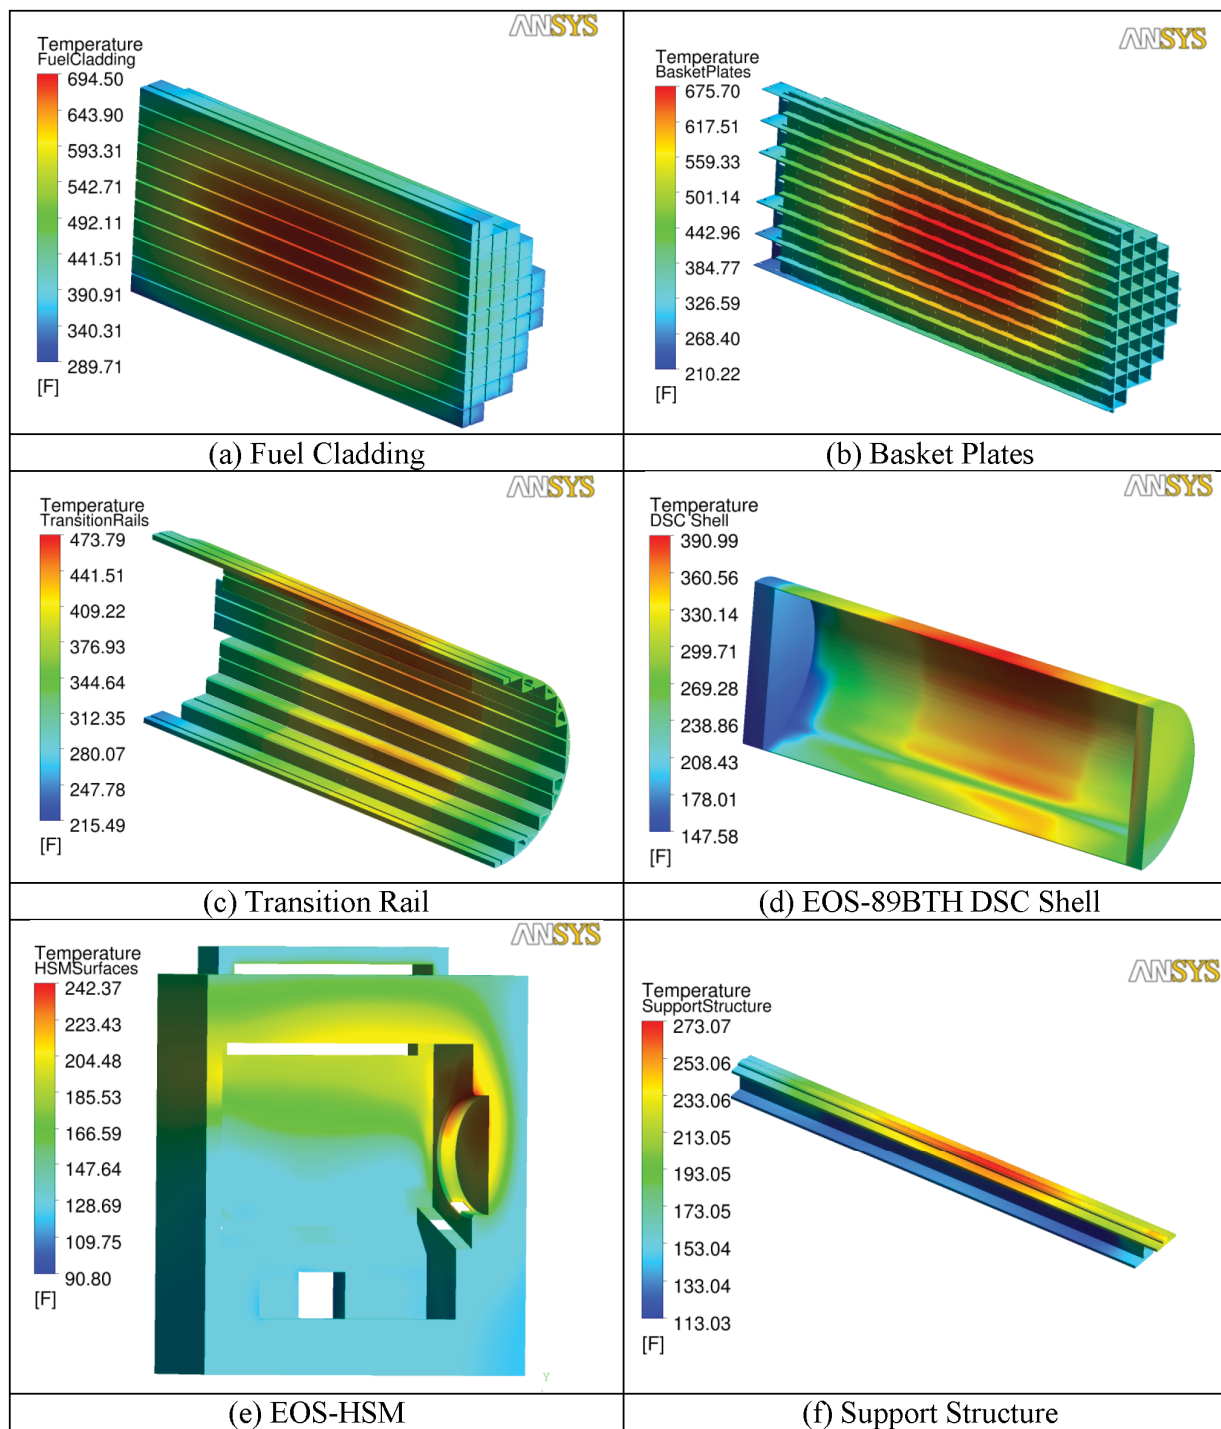
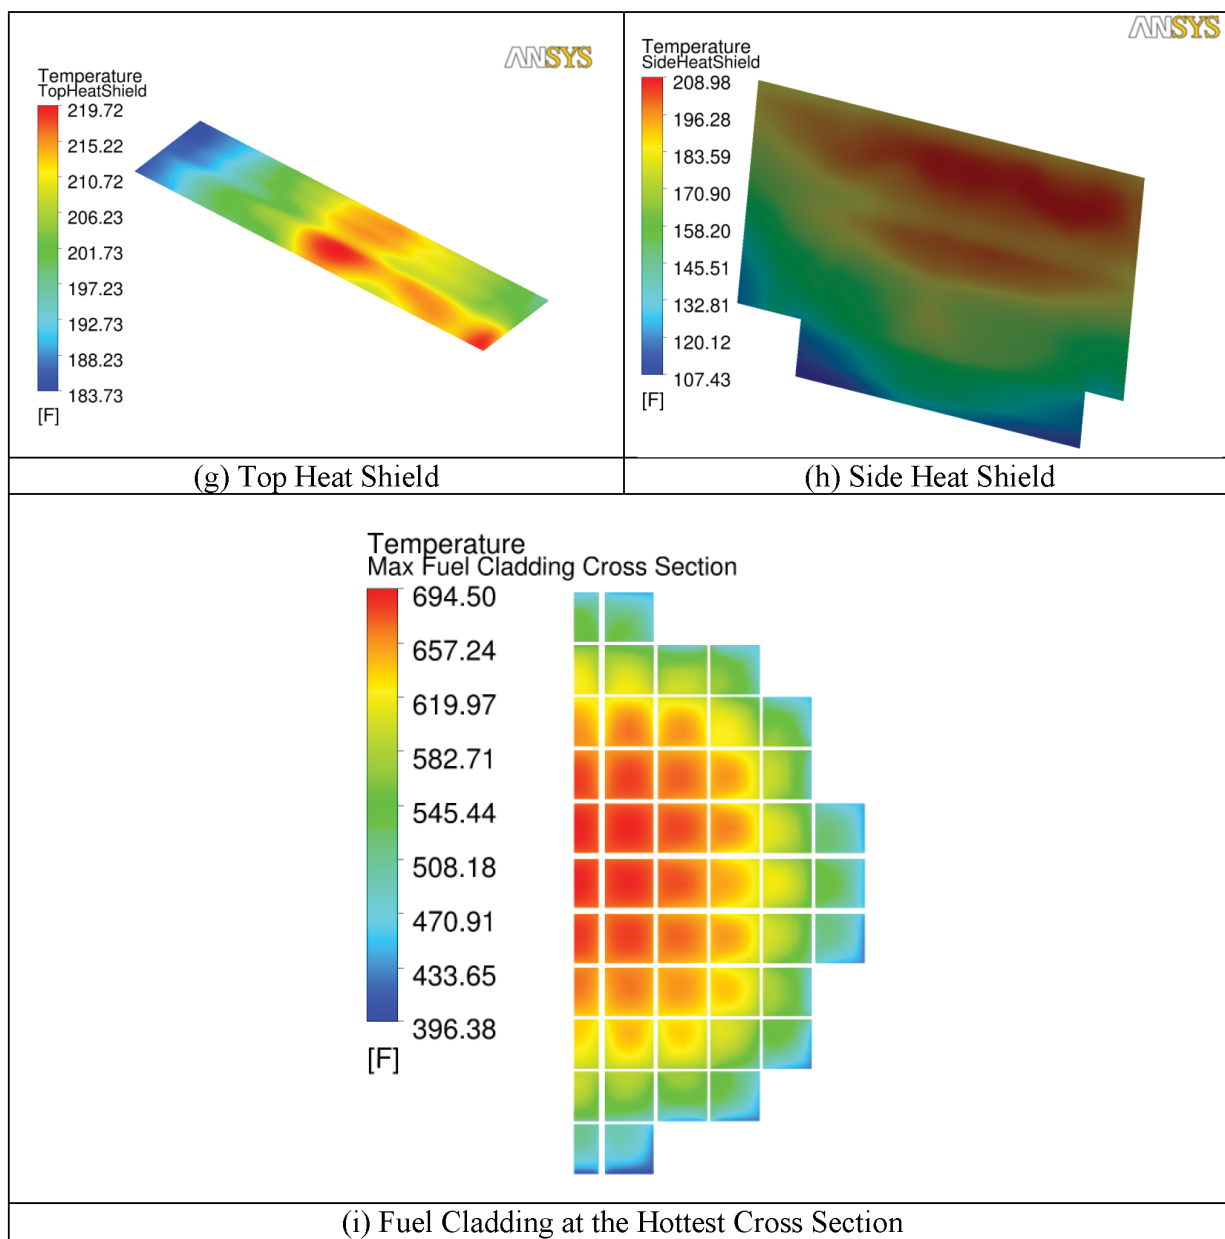
**Figure 4-27**  
**Temperature Profiles for EOS-HSM loaded with EOS-89BTH DSC at**  
**Normal Hot Storage Condition (Load Case #1a)**  
 2 Pages

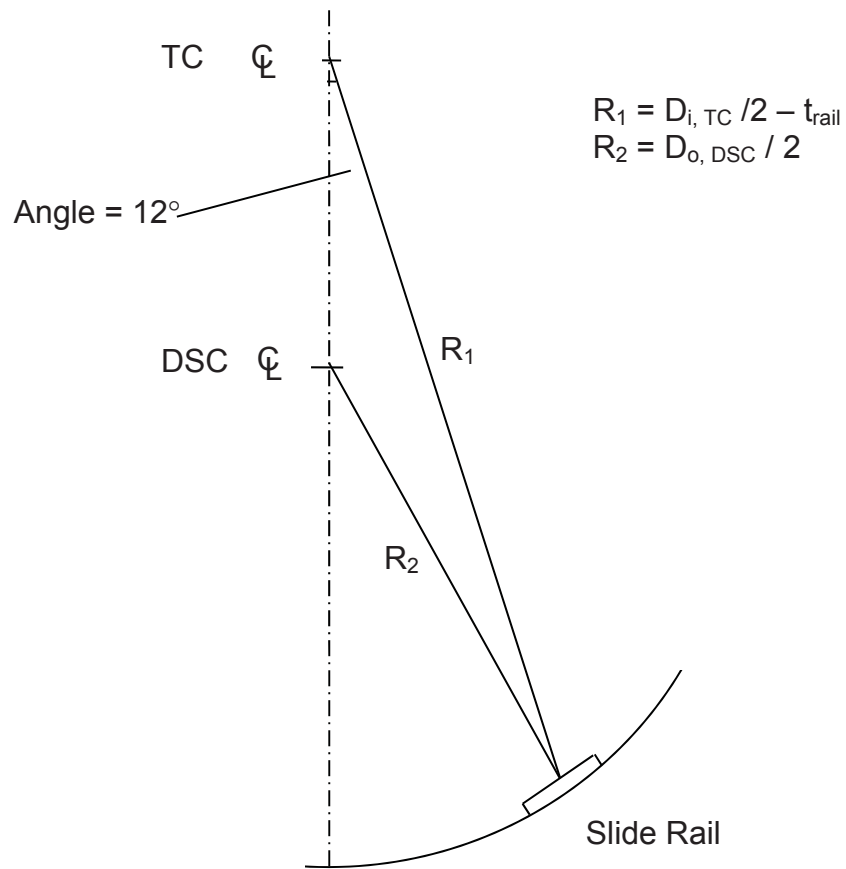
**Figure 4-28**  
**Location of DSC within TC during Horizontal Transfer Operations**
