Subject: Westinghouse Hematite Decommissioning Project - Request for NRC Review of
Final Status Survey Final Report Volume 3, Chapter 1, Land Survey Areas (LSA)
Overview, Revision 3 (License No. SNM-00033, Docket No. 070-00036)

Final Status Survey Final Report Volume 3, Chapter 1

Land Survey Areas (LSA) Overview, Revision 3

Westinghouse Electric Company LLC, Hematite Decommissioning Project

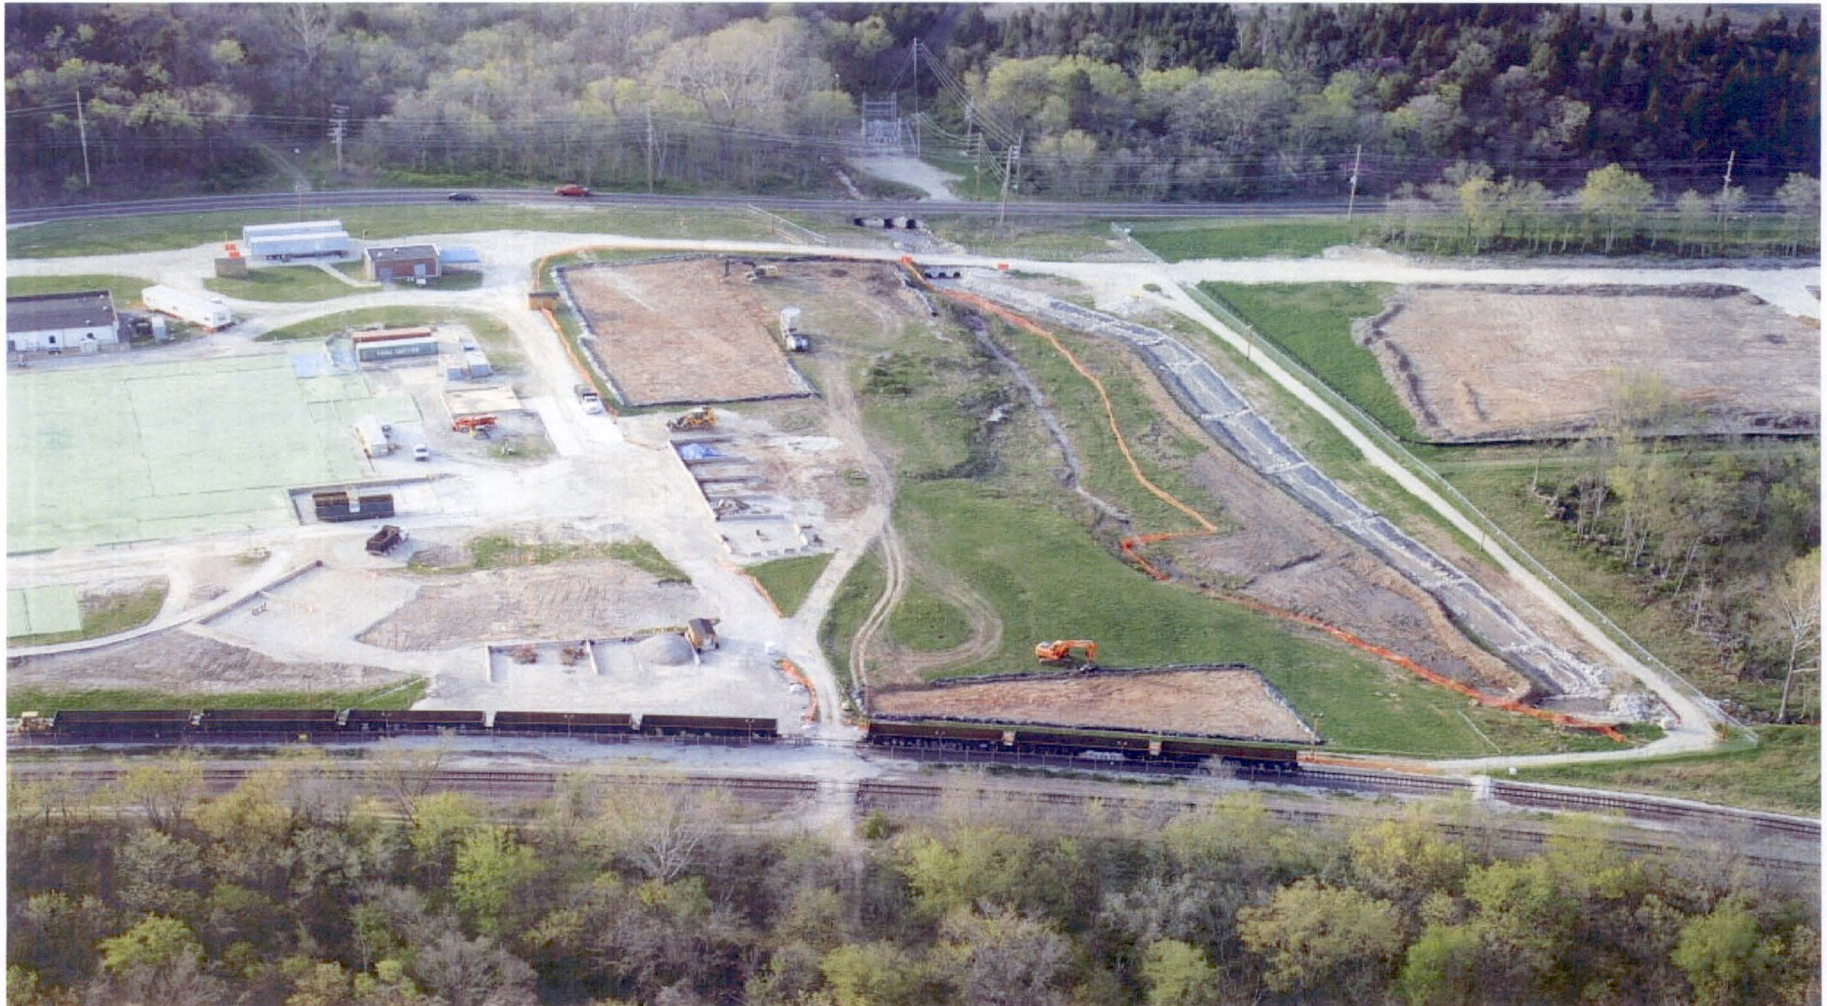
Figure 2-9

**Burial Pit Area March 2012 (Looking NW)
The Removal of Overburden Soil Has Commenced**

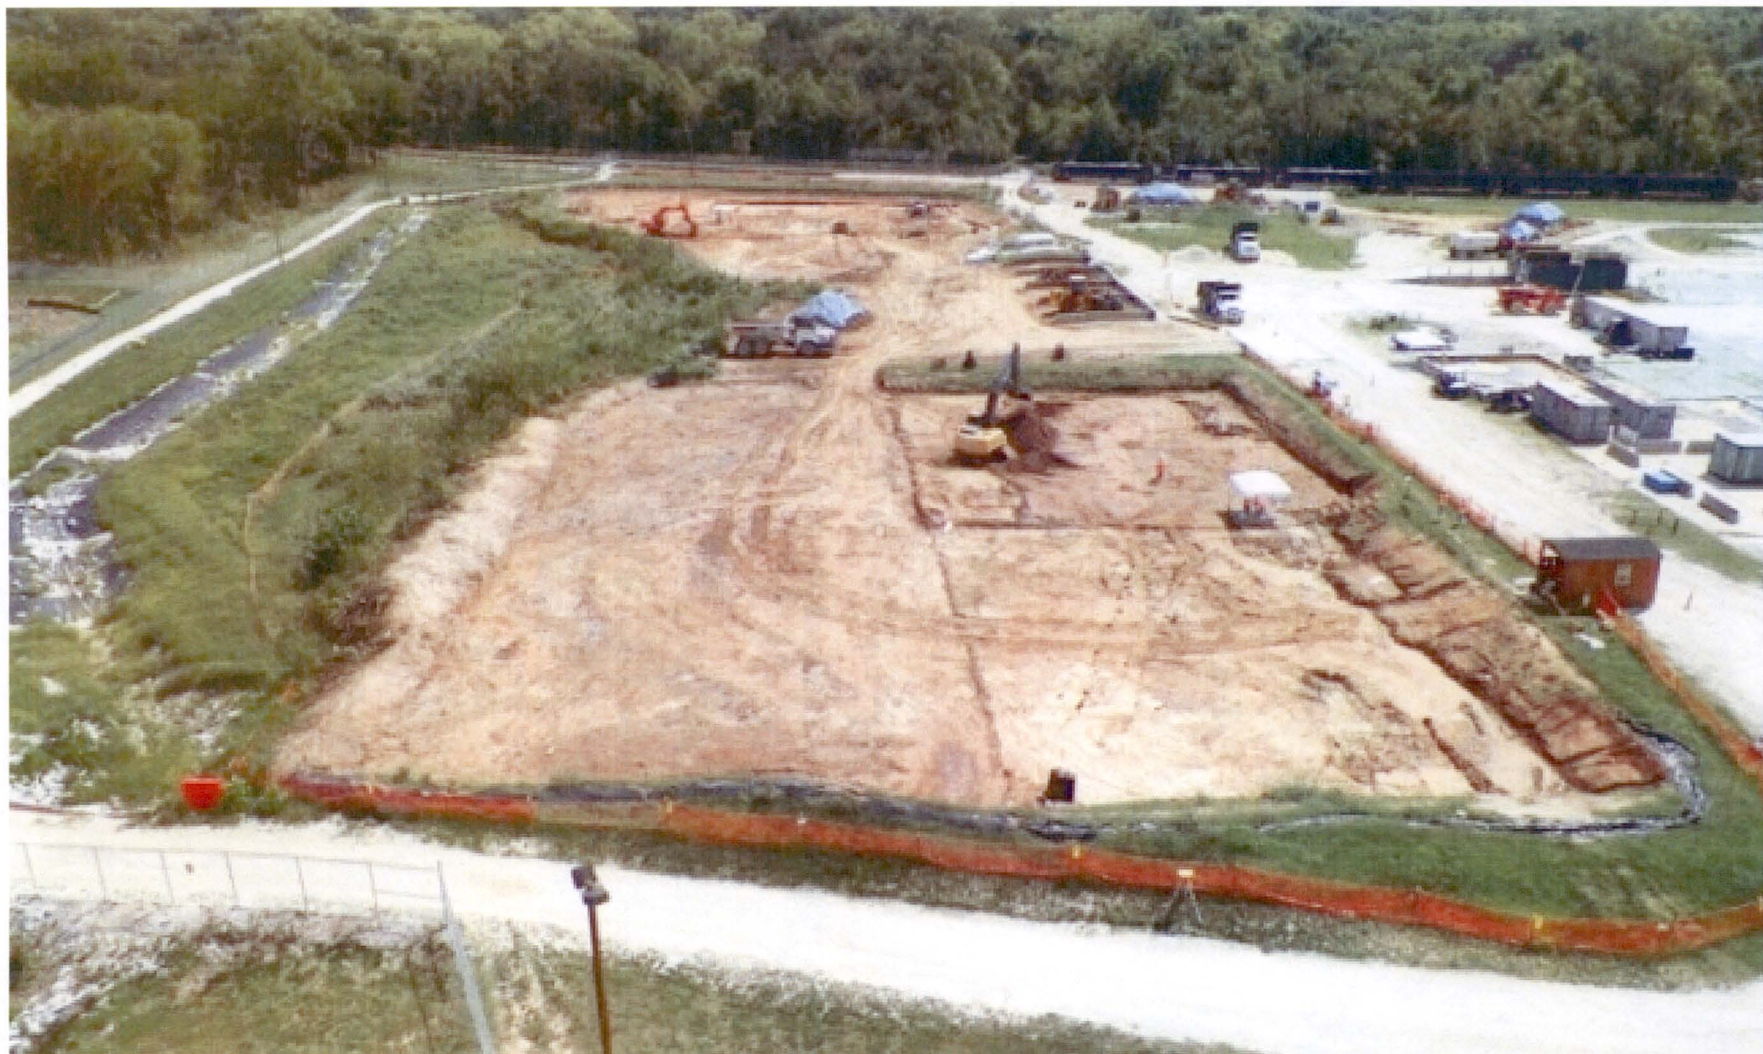
Figure 2-10

Burial Pit Area September 2012 (Looking SE)

The Top Layer of Overburden Which Contained the Sod Has Been Removed and Remediation Is Well Under Way

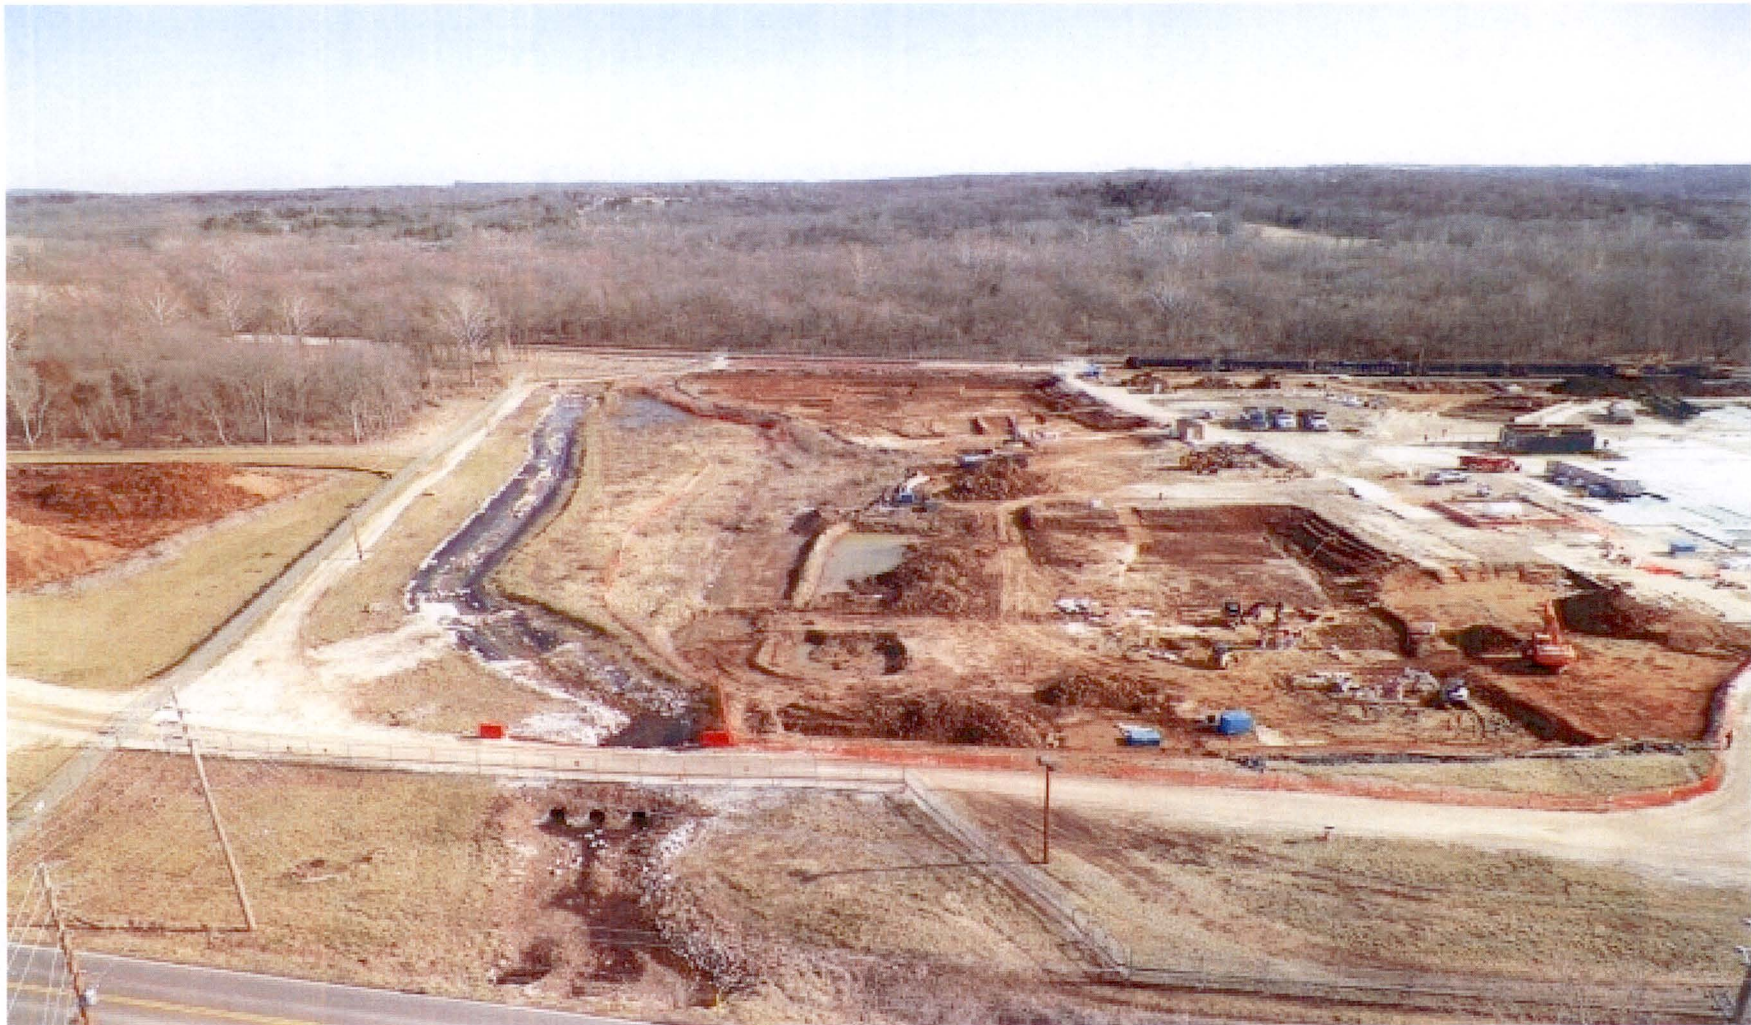
Figure 2-11

Burial Pit Area March 2013 (Looking SE)

Remediation in Some Areas Is to Significant Depths Much of the Burial Pit Area Elevation Is Below That of the Northeast Site Creek

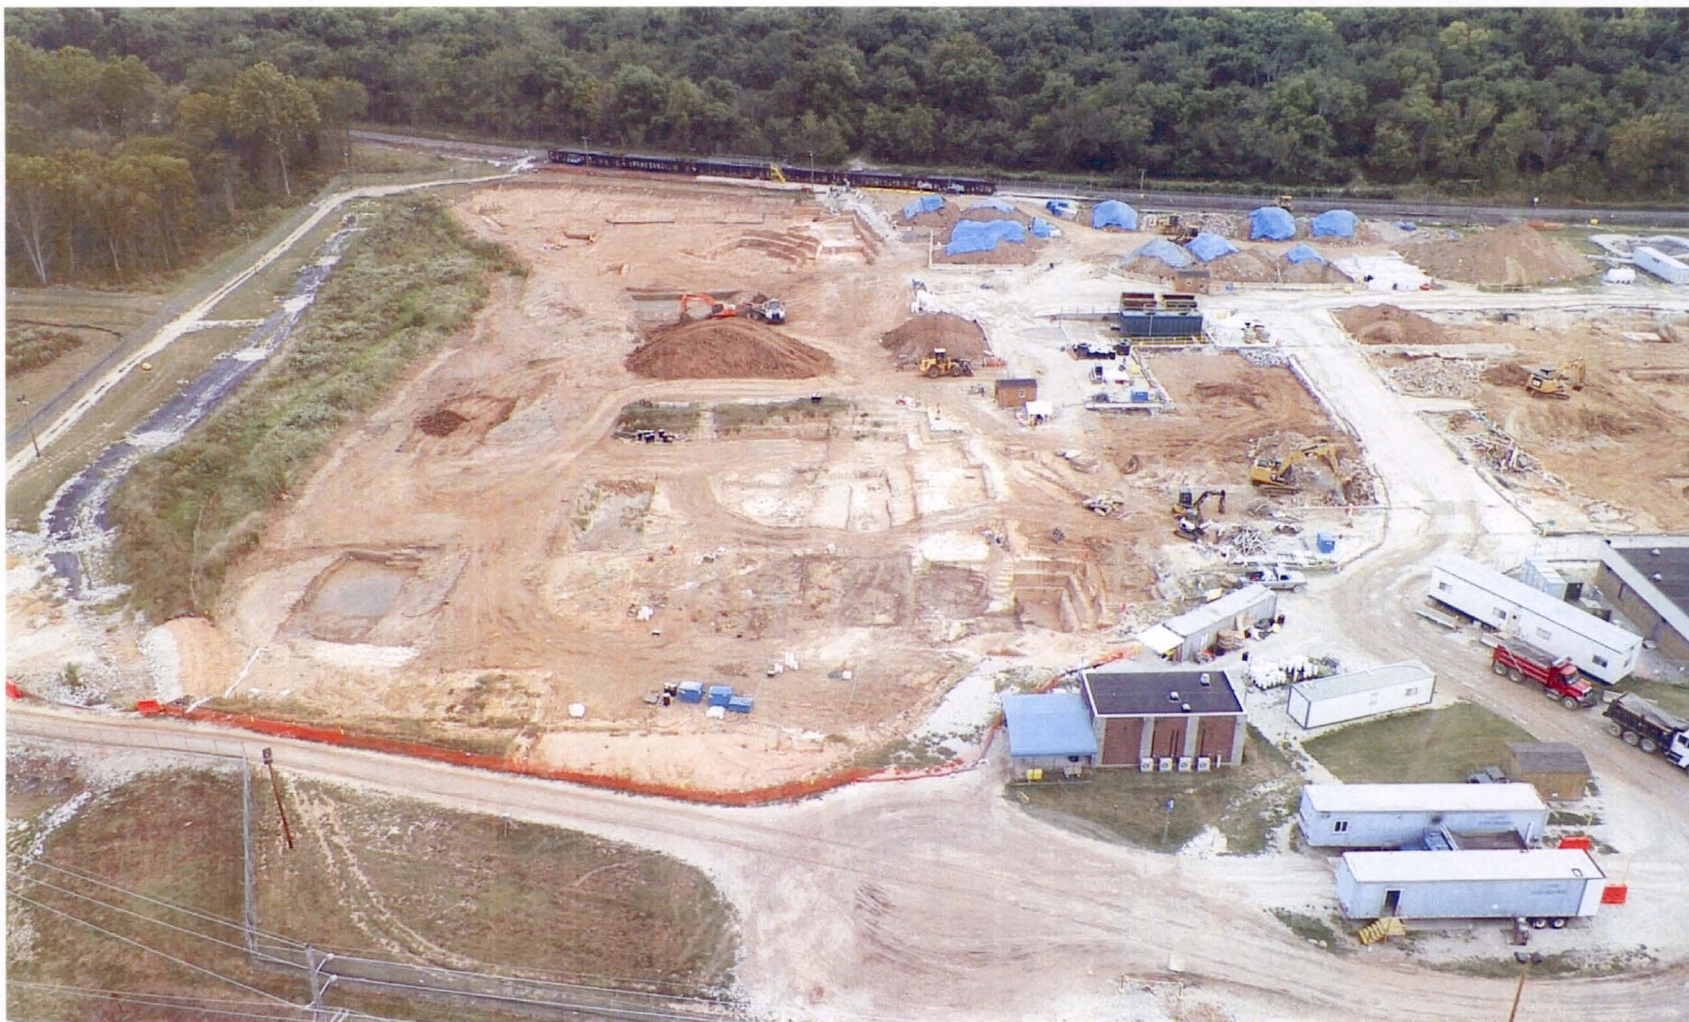
Figure 2-12

Burial Pit Area September 2013 (Looking SE)

A Significant Portion of Remediation of the Burial Pit Area Proper Has Been Completed: Remediation of Non-Burial Pit Areas Has Been Expanded To the Northeast Site Creek to the Left and Towards the Former Process Building Area to the Right

These undocumented burials were also believed to have been in the same general area as the Documented Burial Pits, and/or were in the proximity of site buildings in the eastern portion of the Central Tract (see Figure 2-12). Also, no specific information was located that indicated the specific nature of the waste material buried in these undocumented burial pits. Additionally, no evidence was found to indicate that burial of known uranium bearing materials (i.e., levels greater than free-release criteria) occurred during this time period.

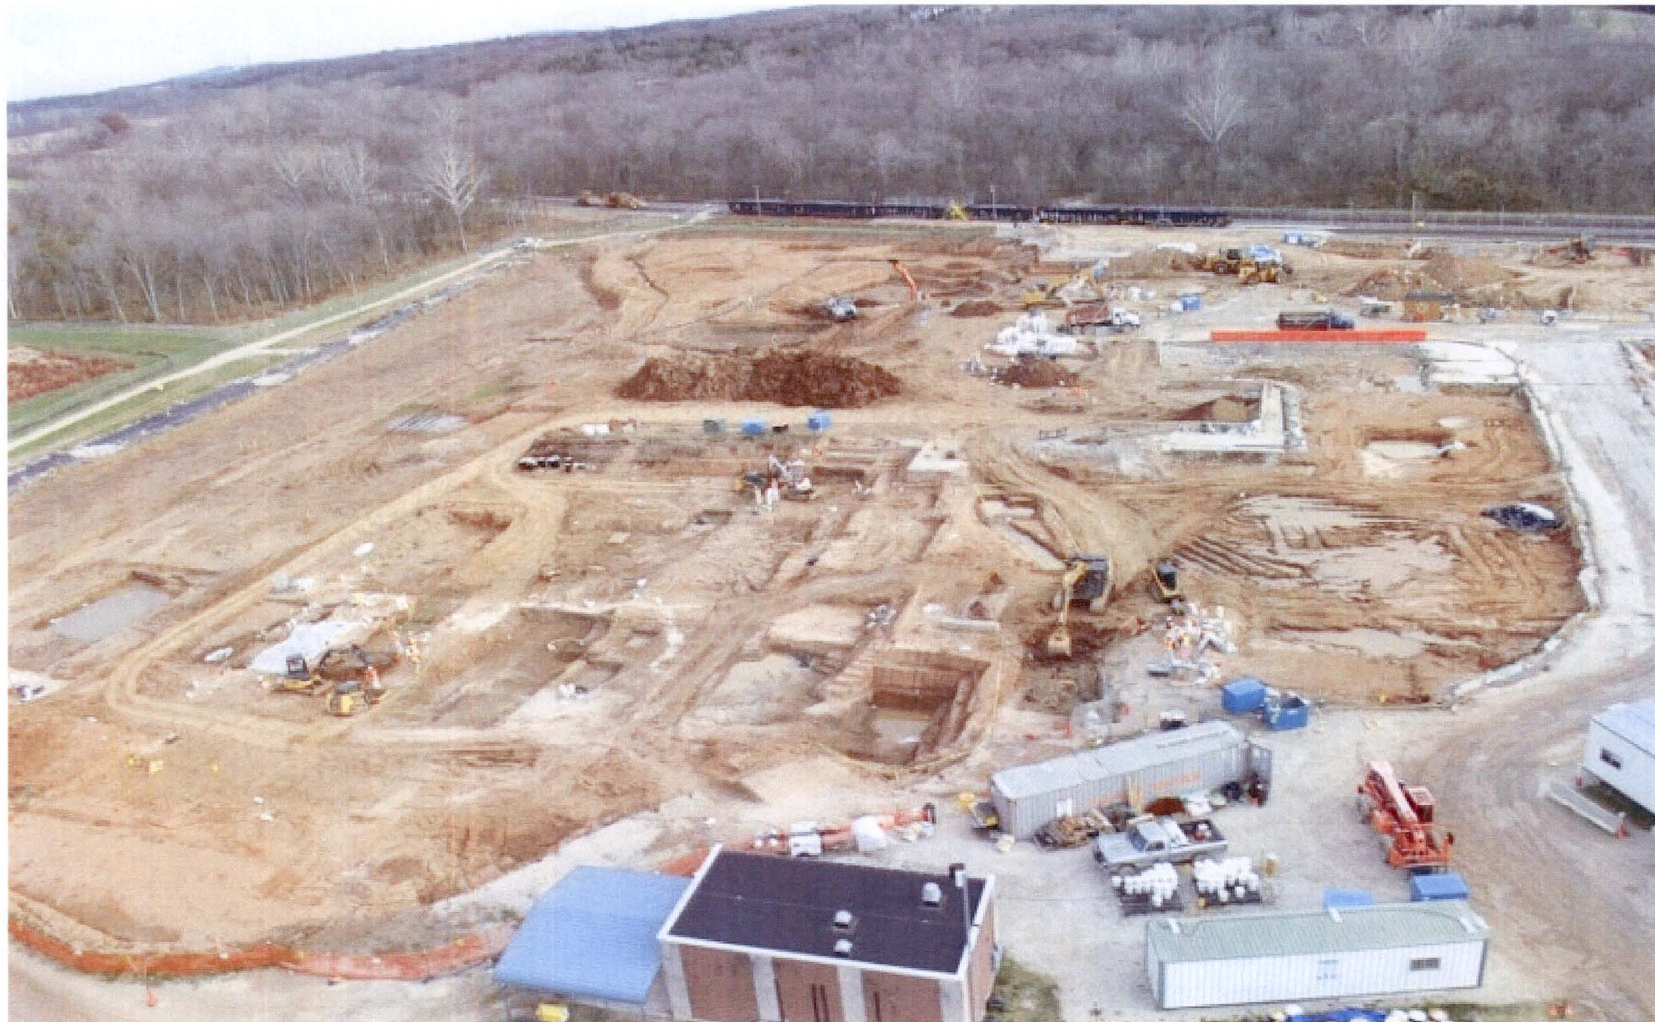
Figure 2-13

Burial Pit Area November 2013 (Looking SE)

The Geometric Shape of the Excavations Indicate the Ability of the Excavation Process to Identify Burial Pits and Remediate to a Depth that Ensures the Burial Pit Has Been Removed

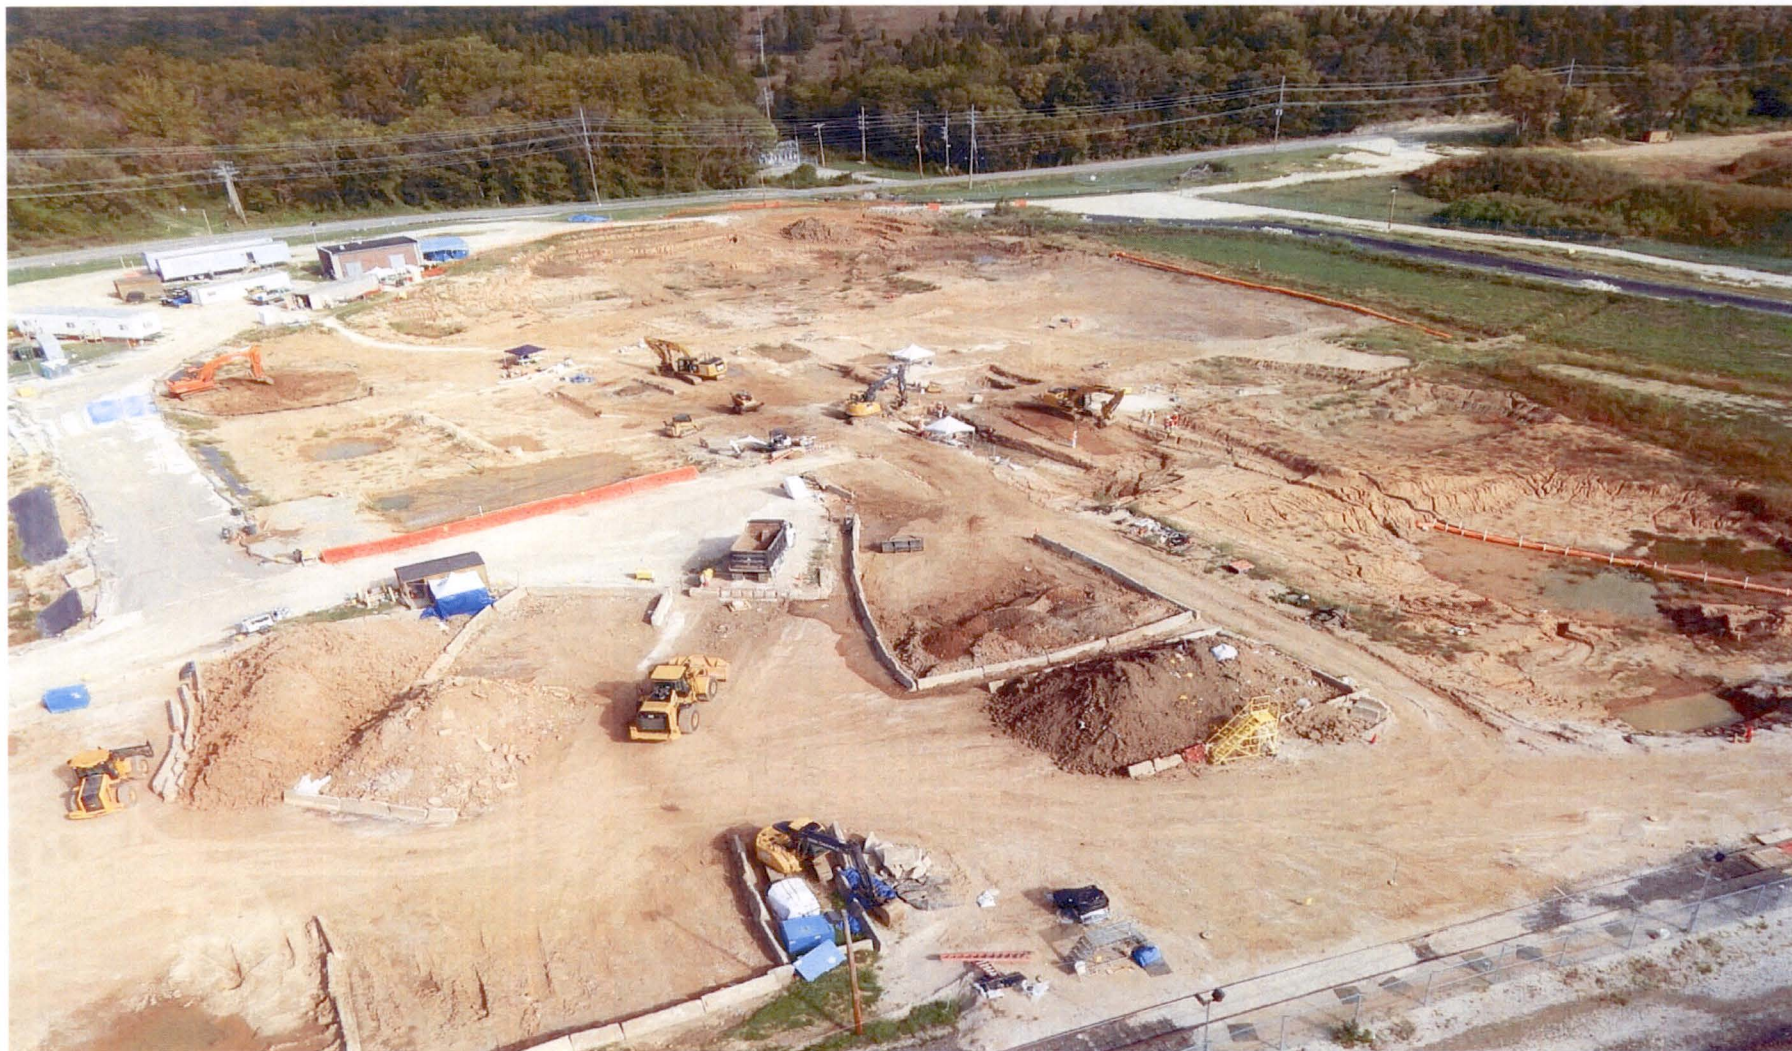
Figure 2-14
Burial Pit Area September 2014 (Looking North)
Remediation of the Burial Pit Area Proper Is Nearly Complete

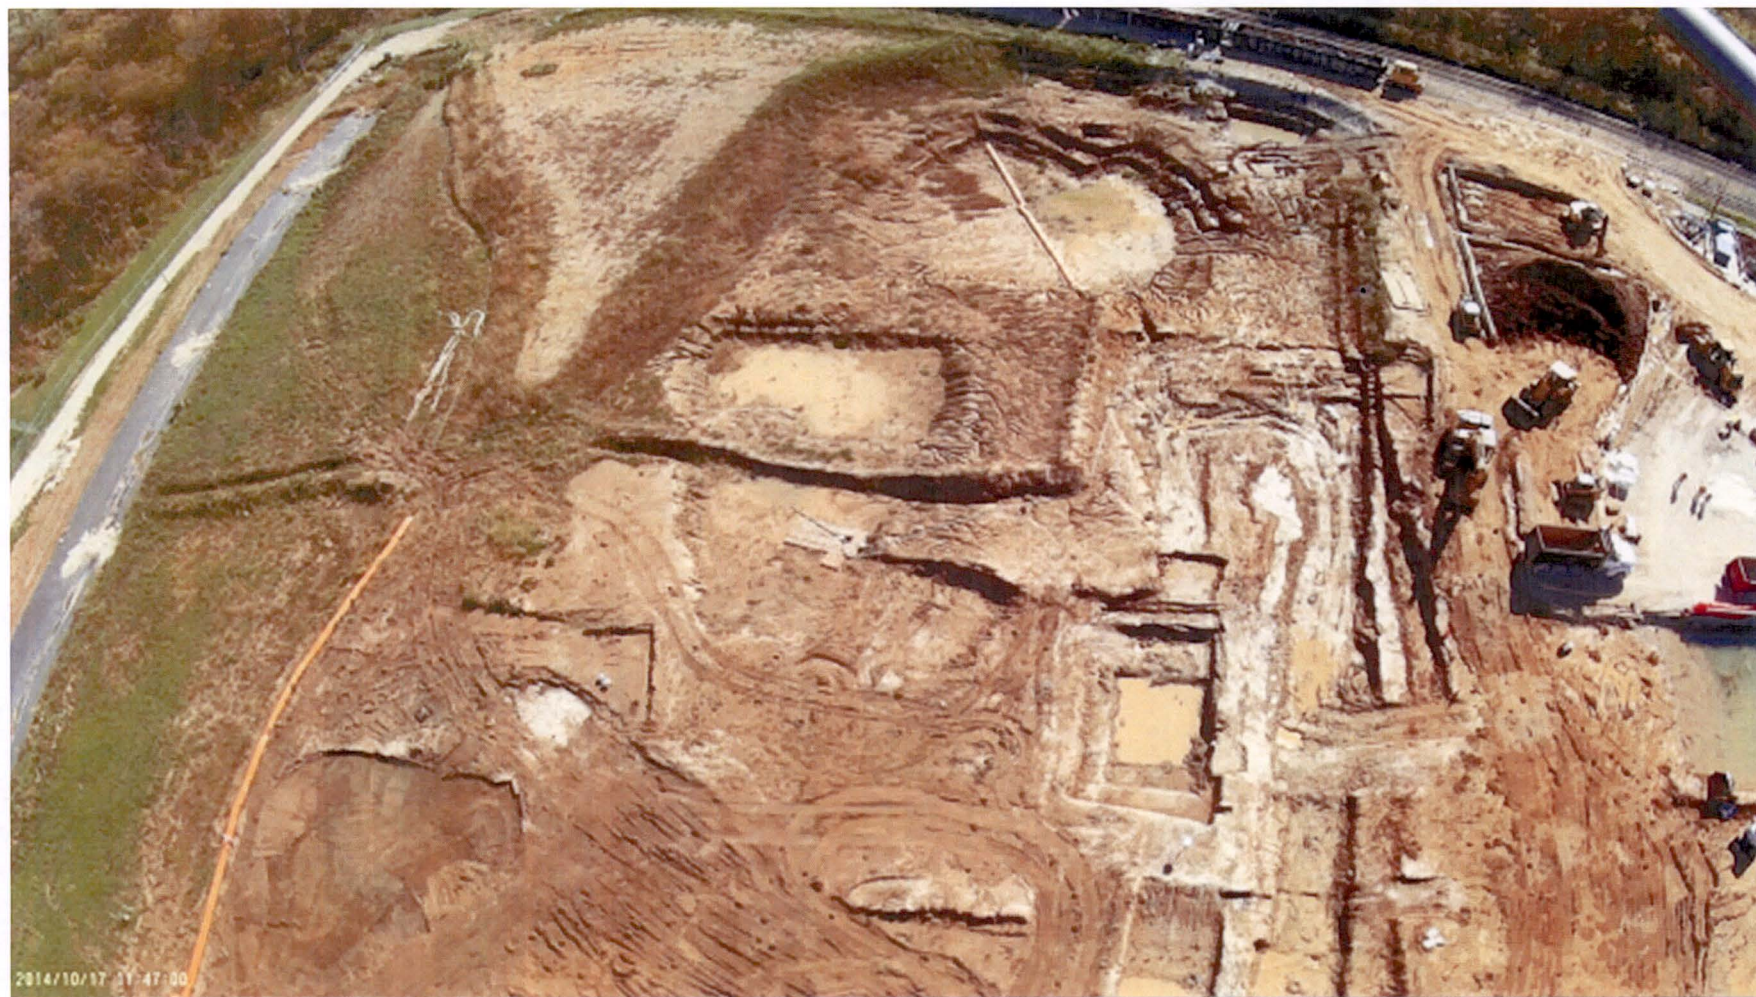
Figure 2-15

Burial Pit Area October 2014 (Looking South)

Shortly After This Photograph Was Taken All Visual Inspections and Radiological Surveys Associated With the Burial Pit Area Were Completed and the Data Indicated That the Burial Pit Area Remediation Was Complete

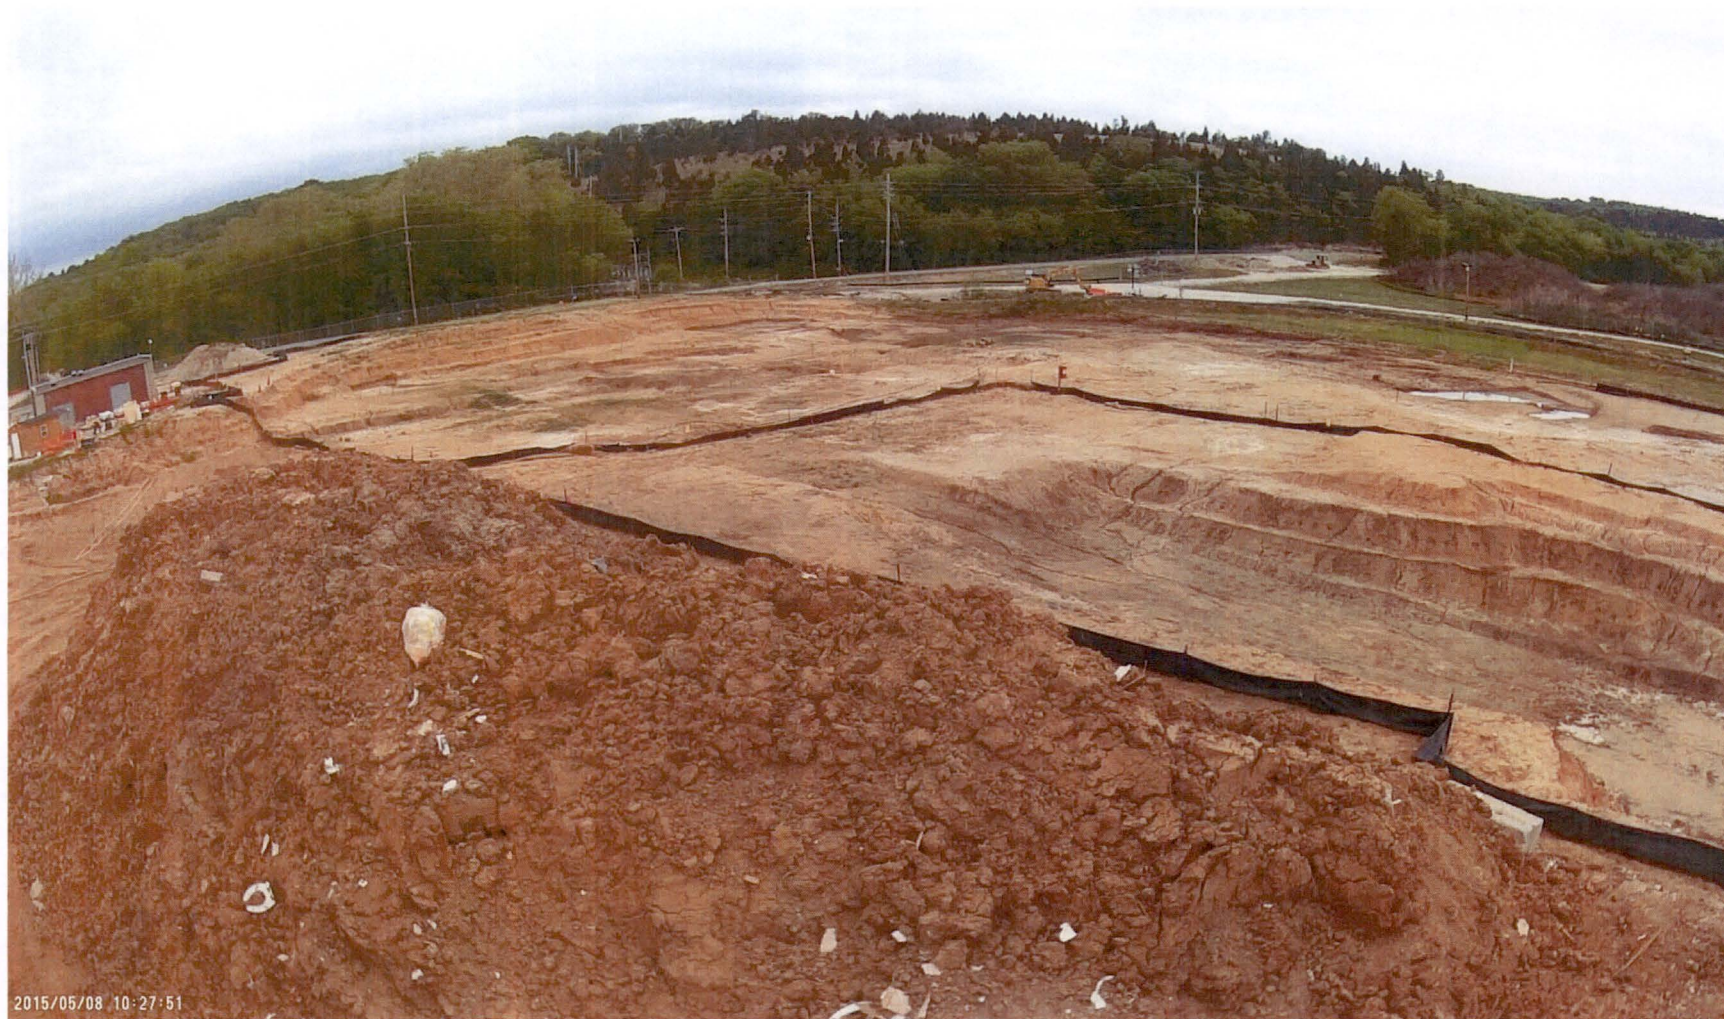
Figure 2-16

Burial Pit Area May 2015 (Looking North)
Photograph of the Burial Pit Area Prepared for Final Status Survey
The Silt Fence Is In Place for Isolation and Control of the Area

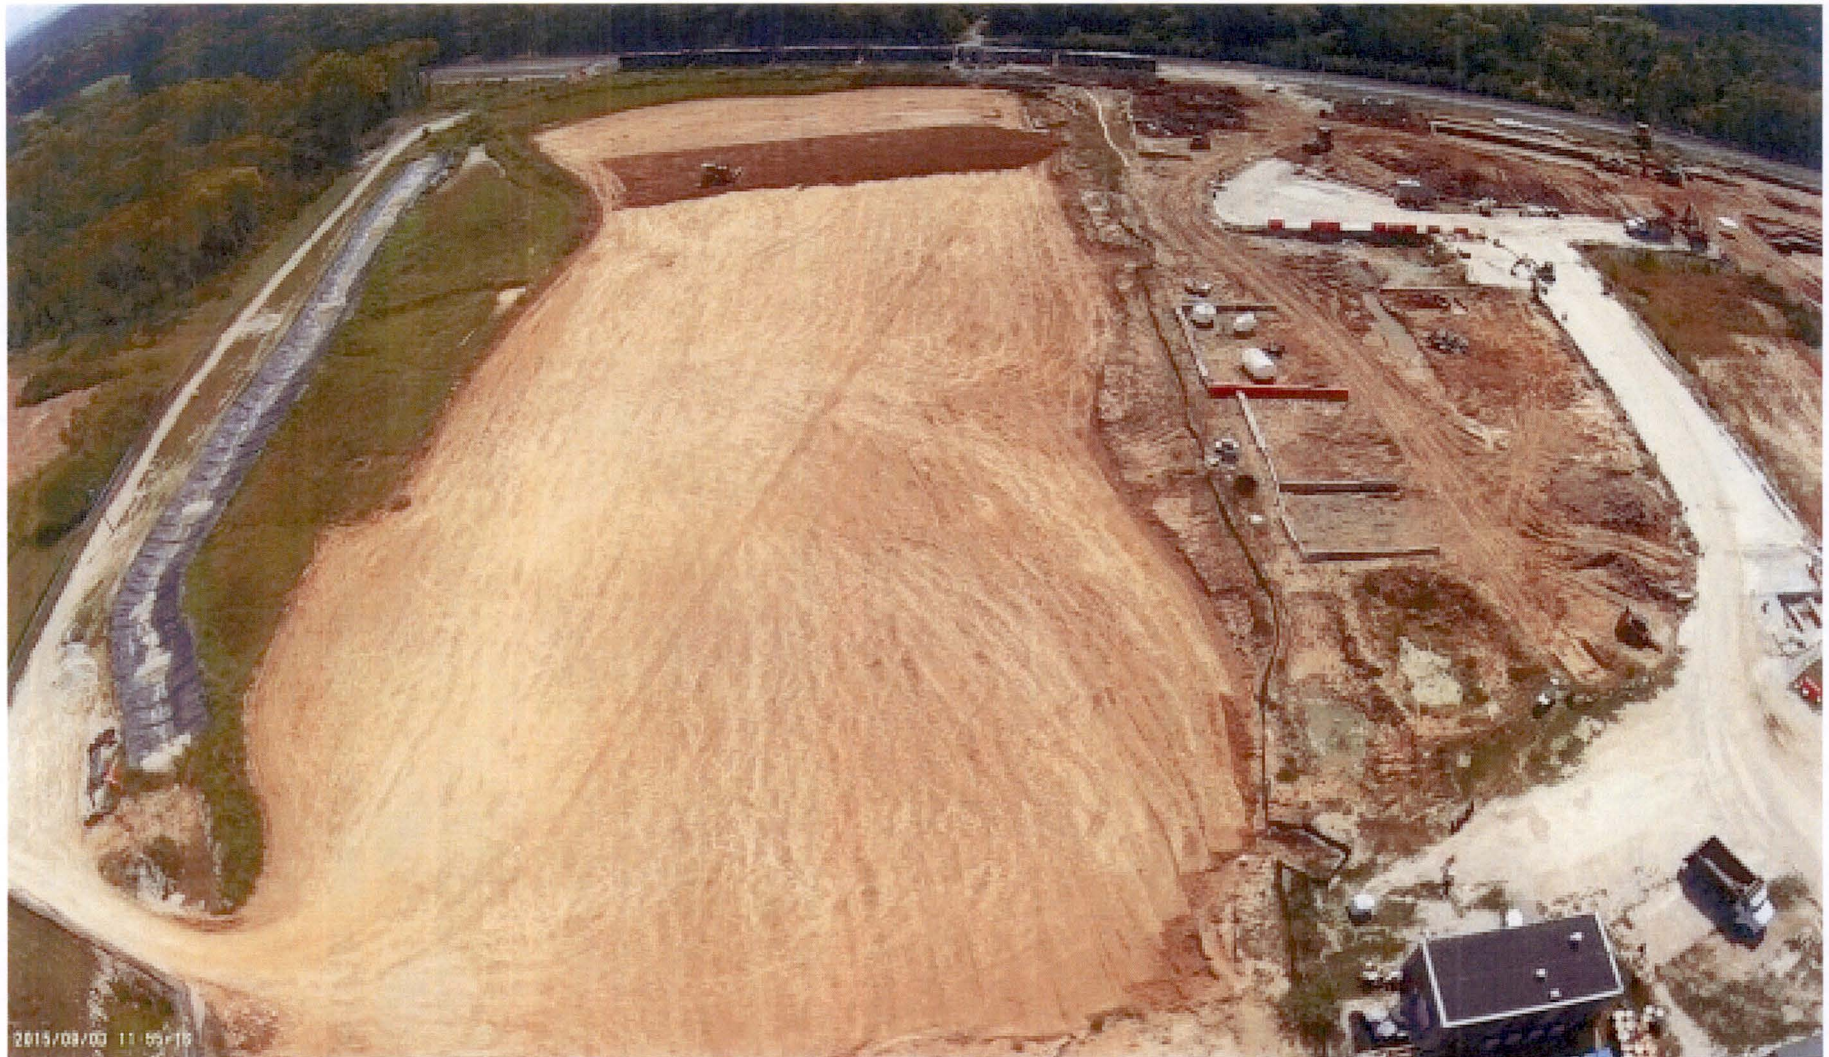
Figure 2-17
Burial Pit Area September 2015 (Looking SE)
Backfill Operations in the Burial Pit Area

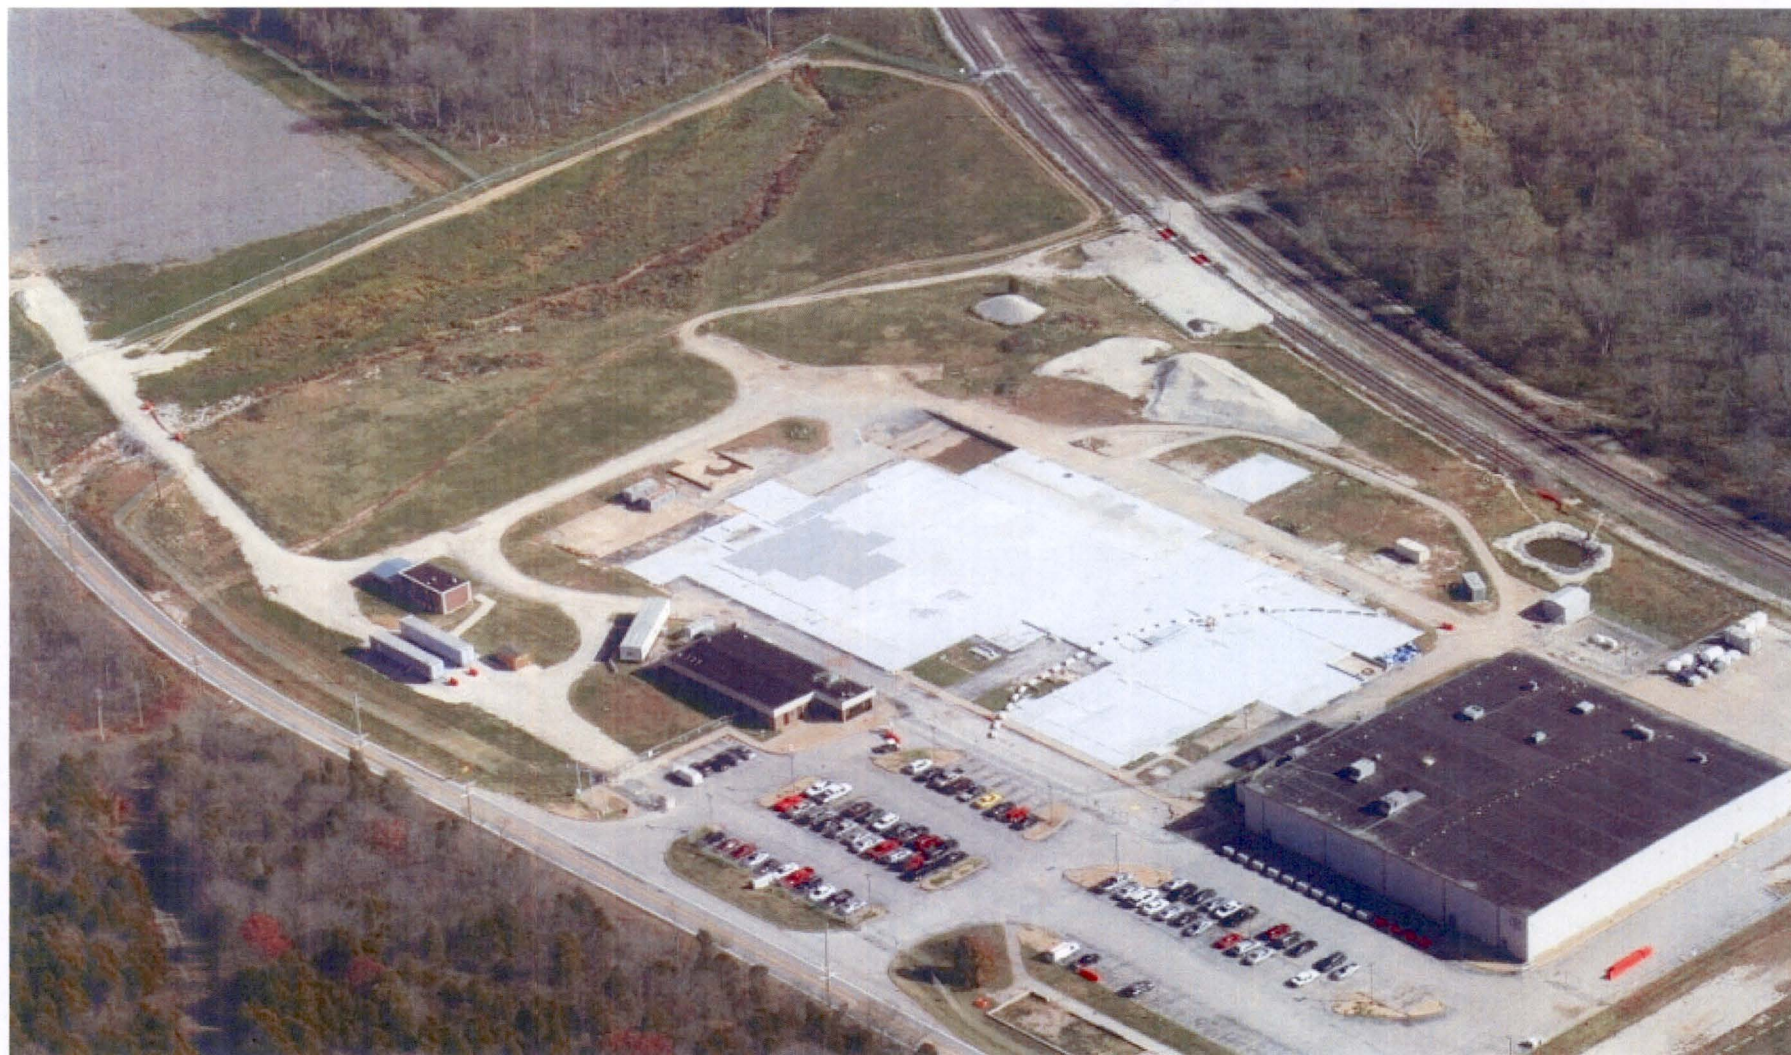
Figure 2-37
Process Building Slab with Process Building Removed - August 2011 (Looking East)

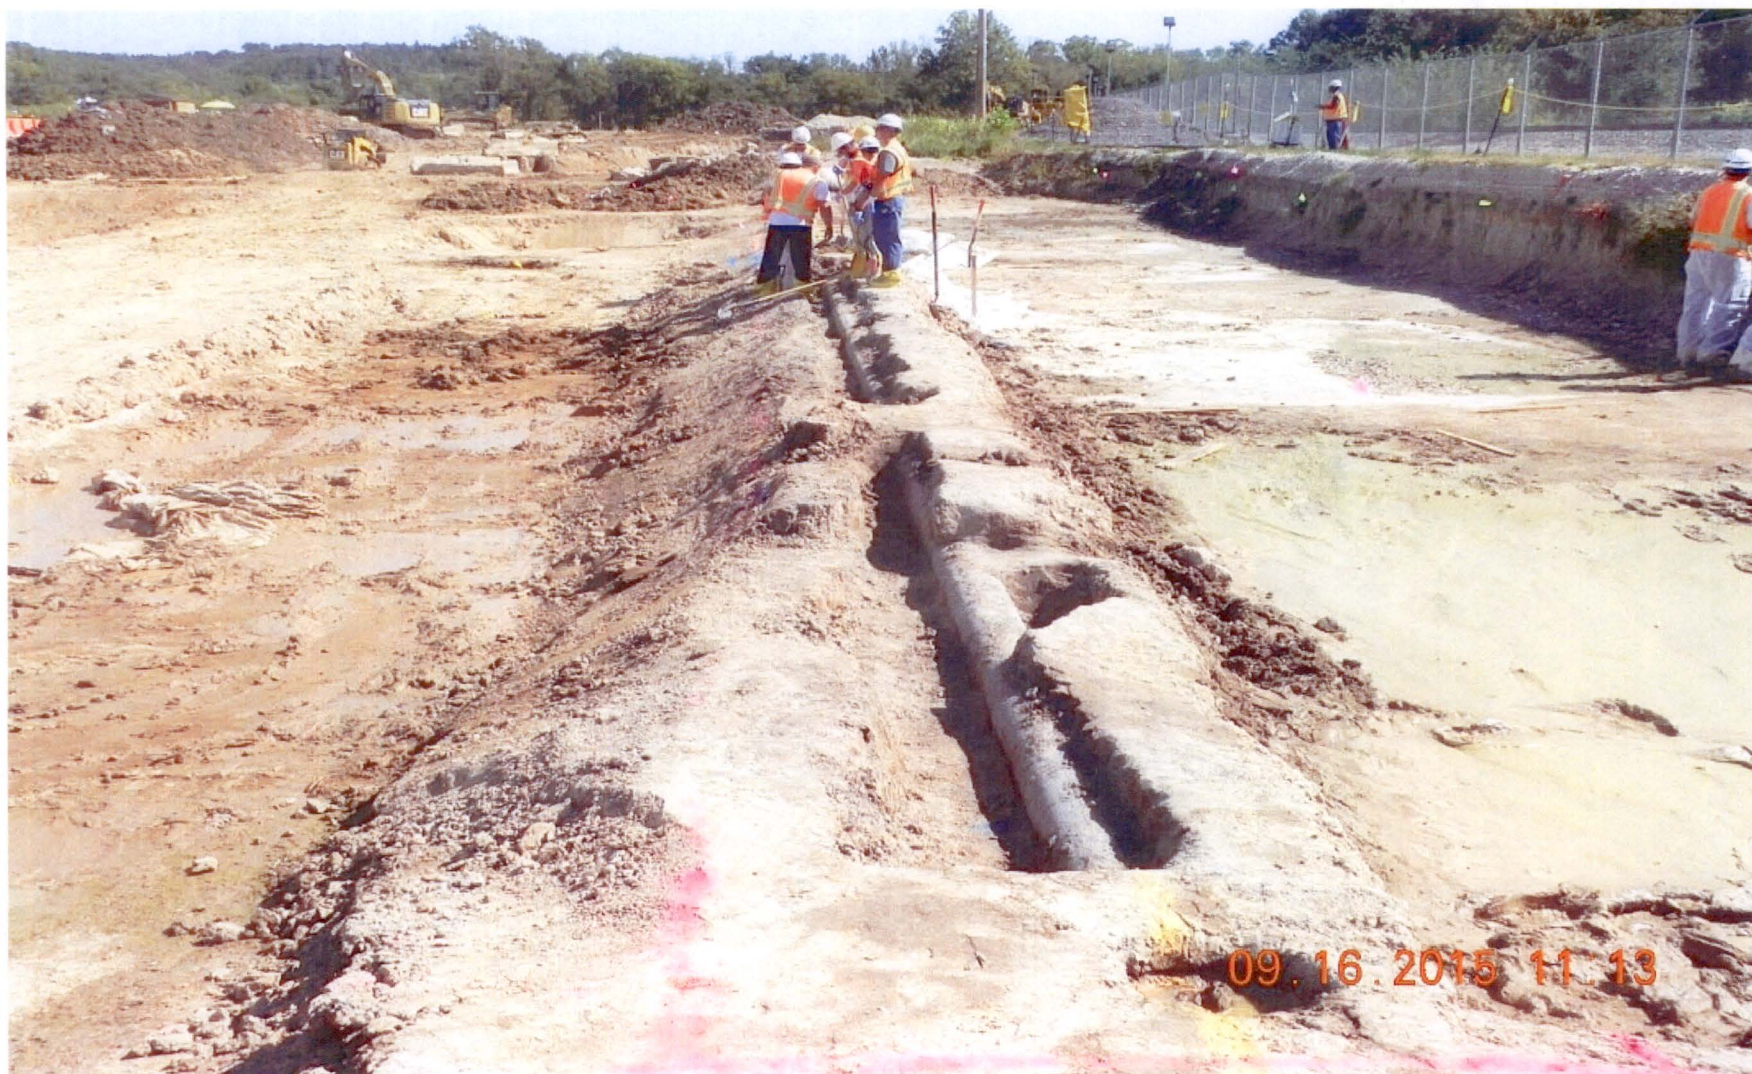
Figure 2-44
Remediation Activities at the Natural Gas Pipeline (Looking NE)

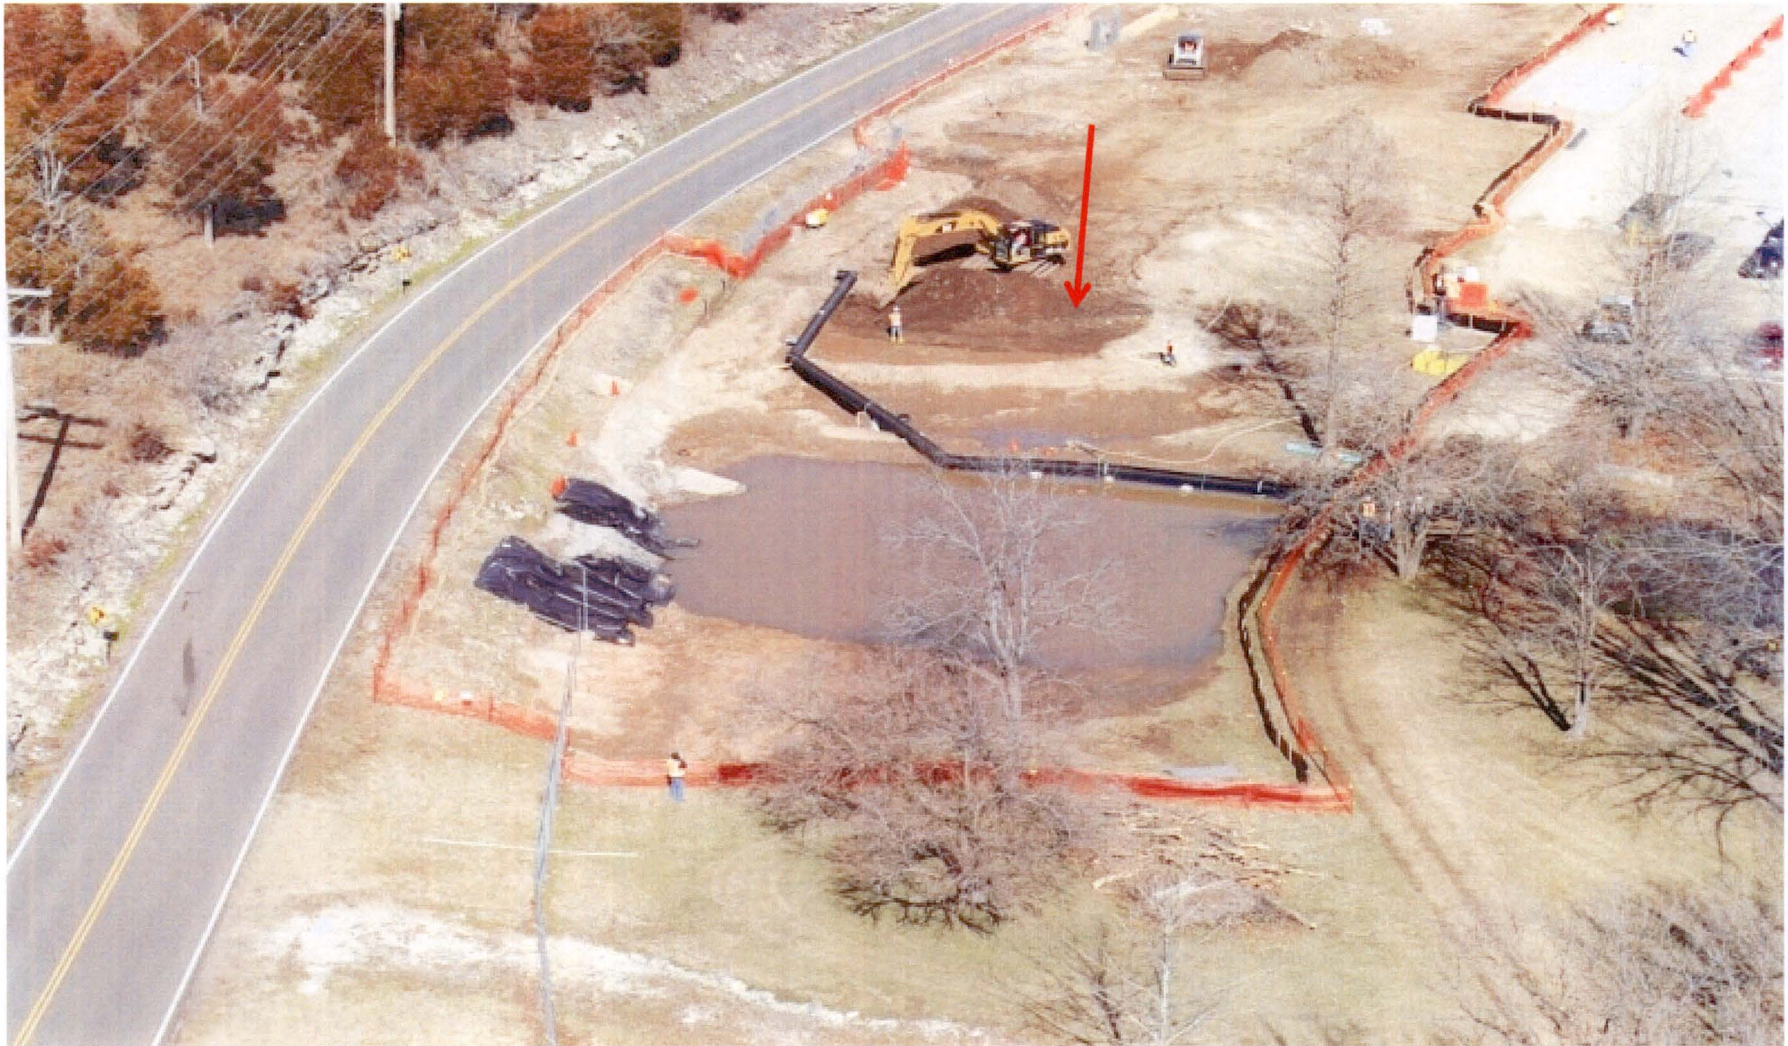
Figure 2-53
February 2013 - Remediation of the Red Room Roof Burial/Cistern Burn Pit Area (Looking NE)

The Red Room Roof Burial/Cistern Burn Pit Area was remediated following the remediation of the Barns Area. Remediation proceeded as expected with no widespread contamination of the soil in the Red Room Roof Burial/Cistern Burn Pit Area identified. Figure 2-53 shows remediation of the Red Room Roof Burial Area.
