Subject: Westinghouse Hematite Decommissioning Project - Request for NRC Review of
Final Status Survey Final Report Volume 3, Chapter 1, Land Survey Areas (LSA)
Overview, Revision 3 (License No. SNM-00033, Docket No. 070-00036)

Final Status Survey Final Report Volume 3, Chapter 1

Land Survey Areas (LSA) Overview, Revision 3

Westinghouse Electric Company LLC, Hematite Decommissioning Project

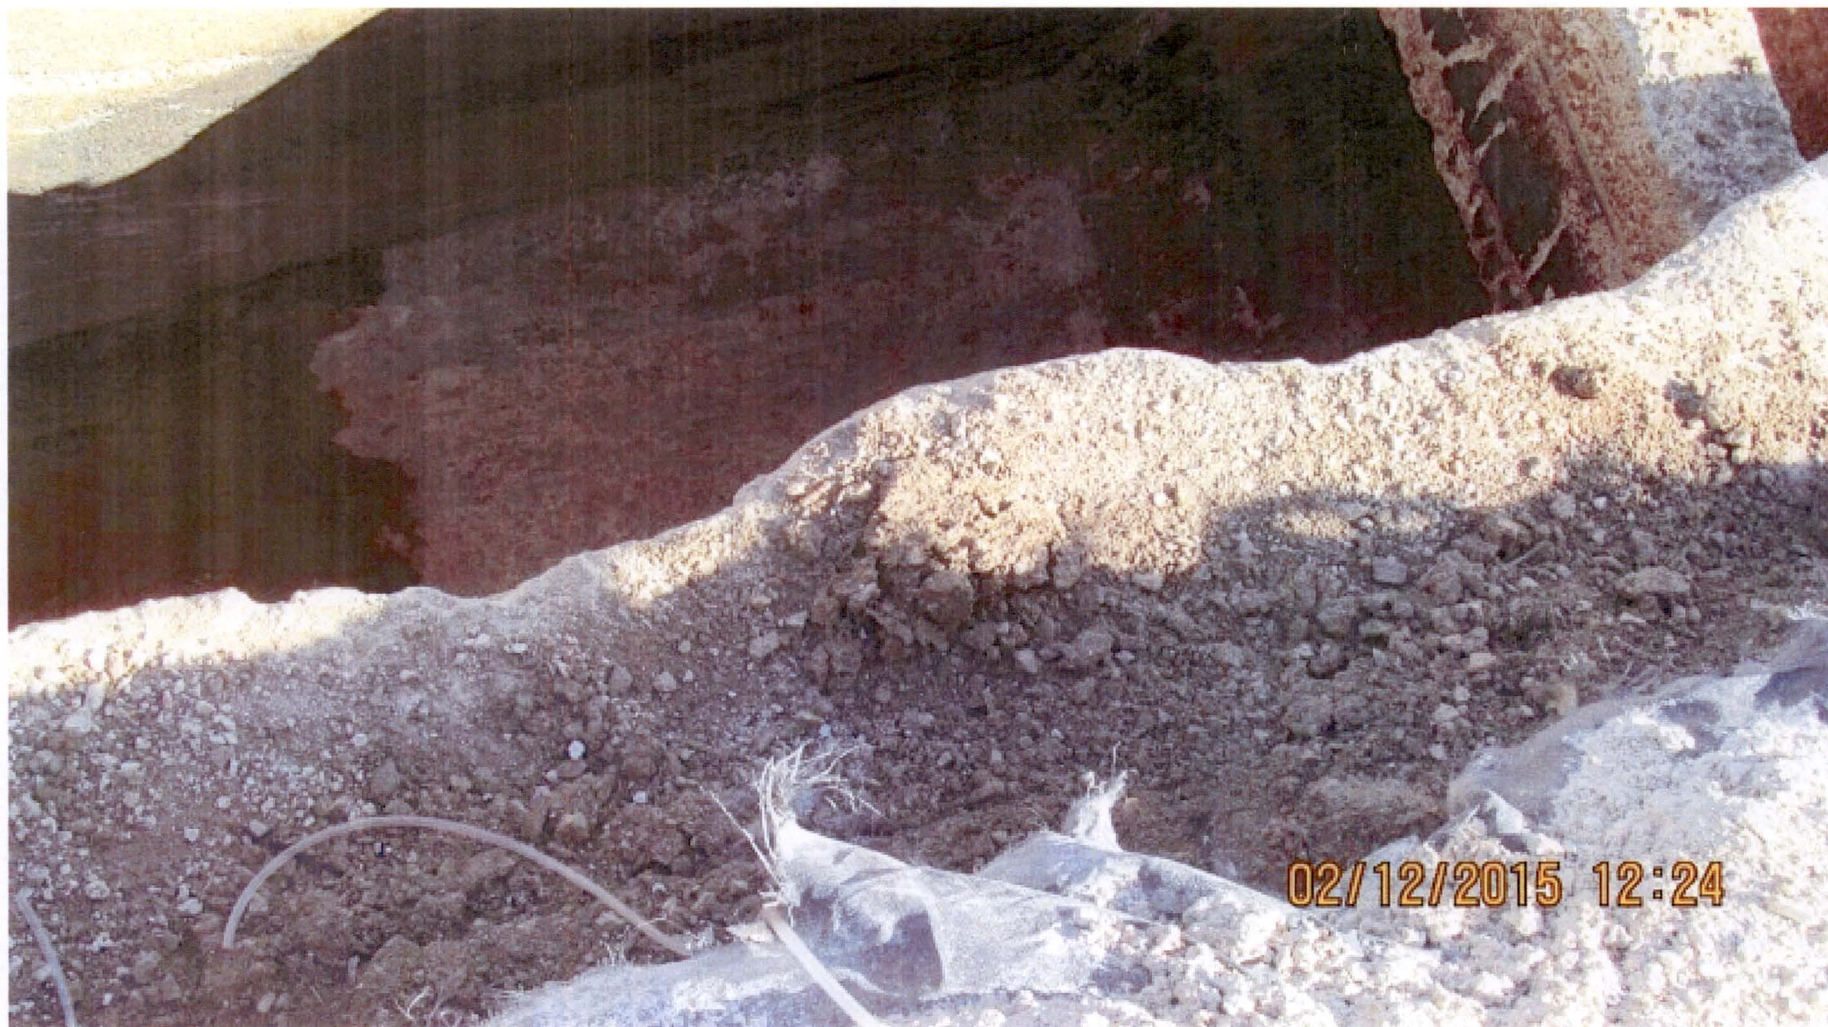
Figure 2-55
Interior of the Septic Tank

Figure 2-54 shows the concrete slab covering the location of the abandoned septic tank. Below this slab was the septic tank with a separate prefabricated concrete cover that was removed and disposed. Due to the close proximity of the septic tank to the foundation of Building 230, it was only partially removed so the structural integrity of the building would not be compromised. All piping associated with the original septic tank and leach field was removed as part of remediation. Figure 2-55 shows the interior of the septic tank. The construction of the septic tank was such that should there have been any transport of a discrete quantity of SNM it would have settled to the bottom of the septic tank. The septic tank was remediated using conventional methods such as power washing and scabbling. Radiological surveys and sampling of the septic tank only identified low levels of fixed residual contamination with no removable contamination identified. No discrete or recoverable quantities of SNM were found during remediation of the septic tank. FSS surveys conducted on the portion of the septic tank that remains showed 17% of the DCGL for systematic samples and 50% to 90% of the DCGL for biased samples. All smears were less than the MDA. The radiological data for the septic tank (BSA 04-02) will be included in the survey area release record for LSA 08-17, the survey unit in which it resides.

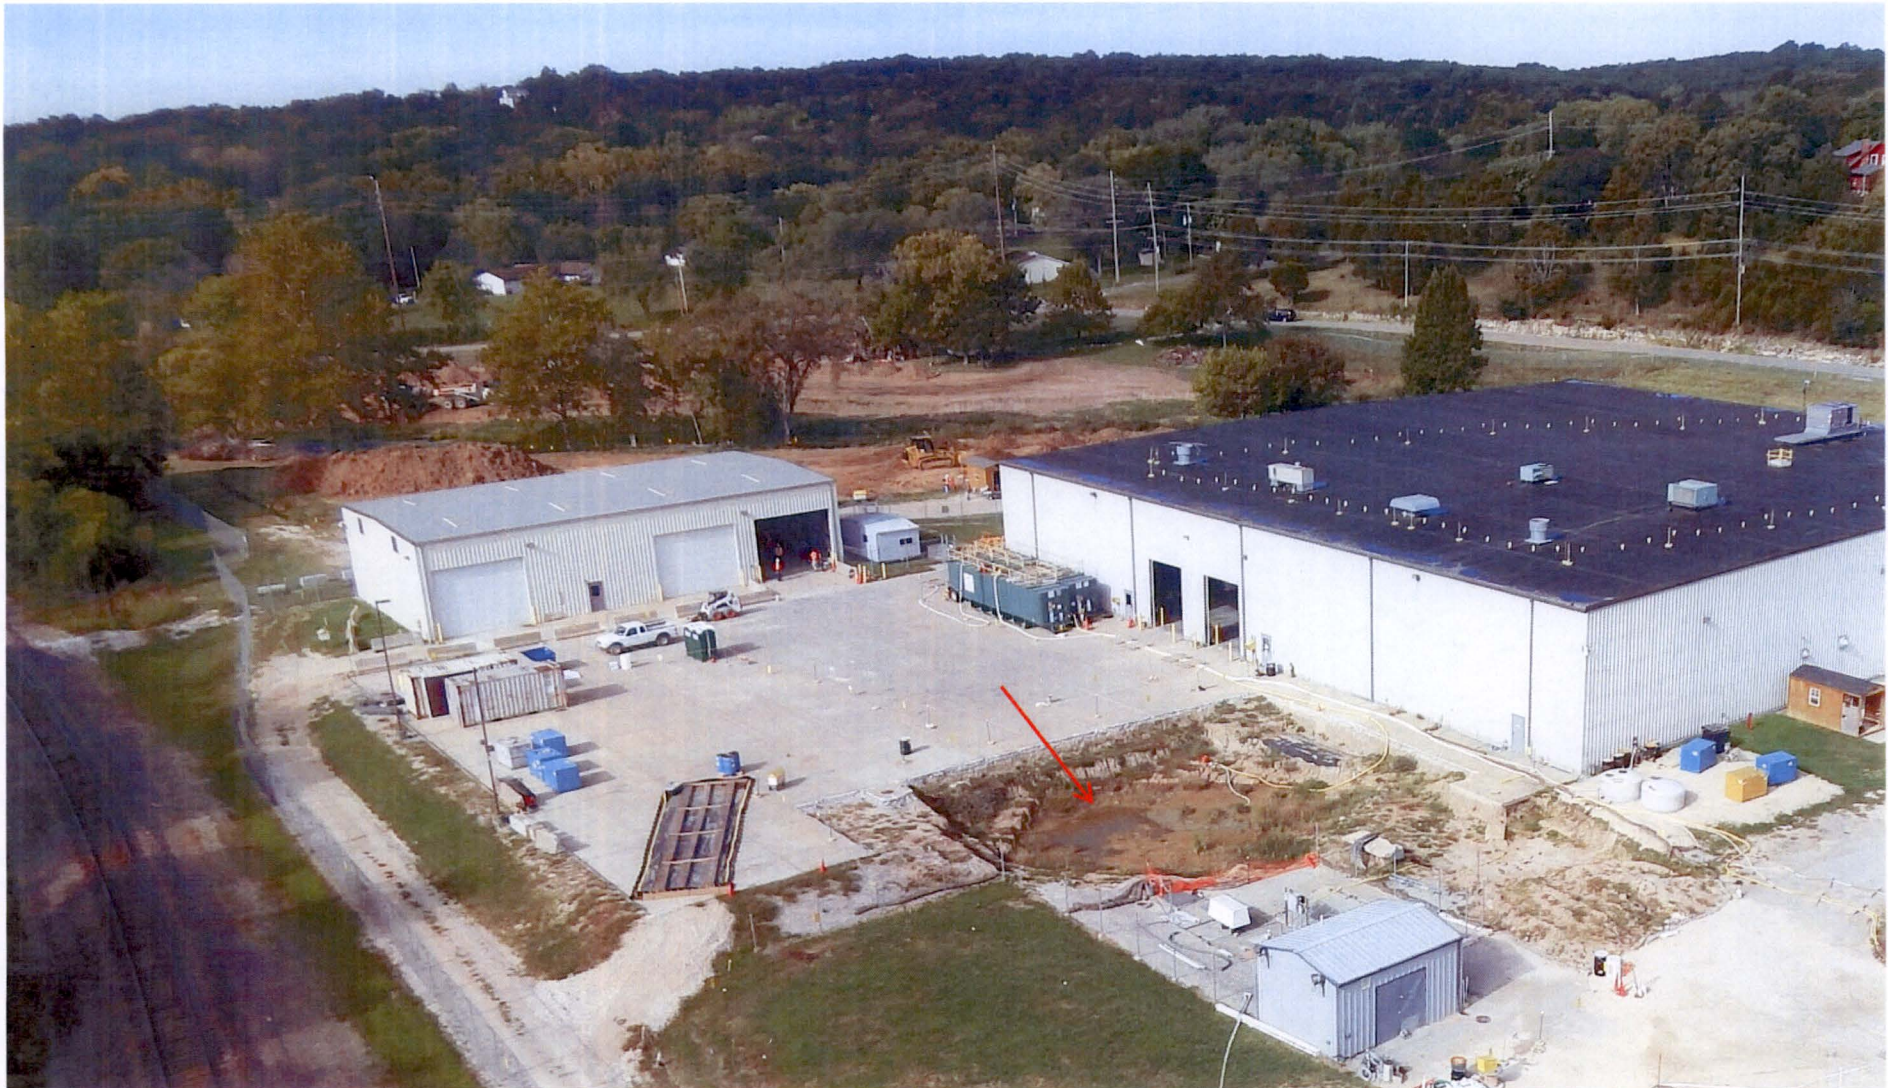
Figure 2-56
Excavation of Leach Field (Lower Right) (Looking W)

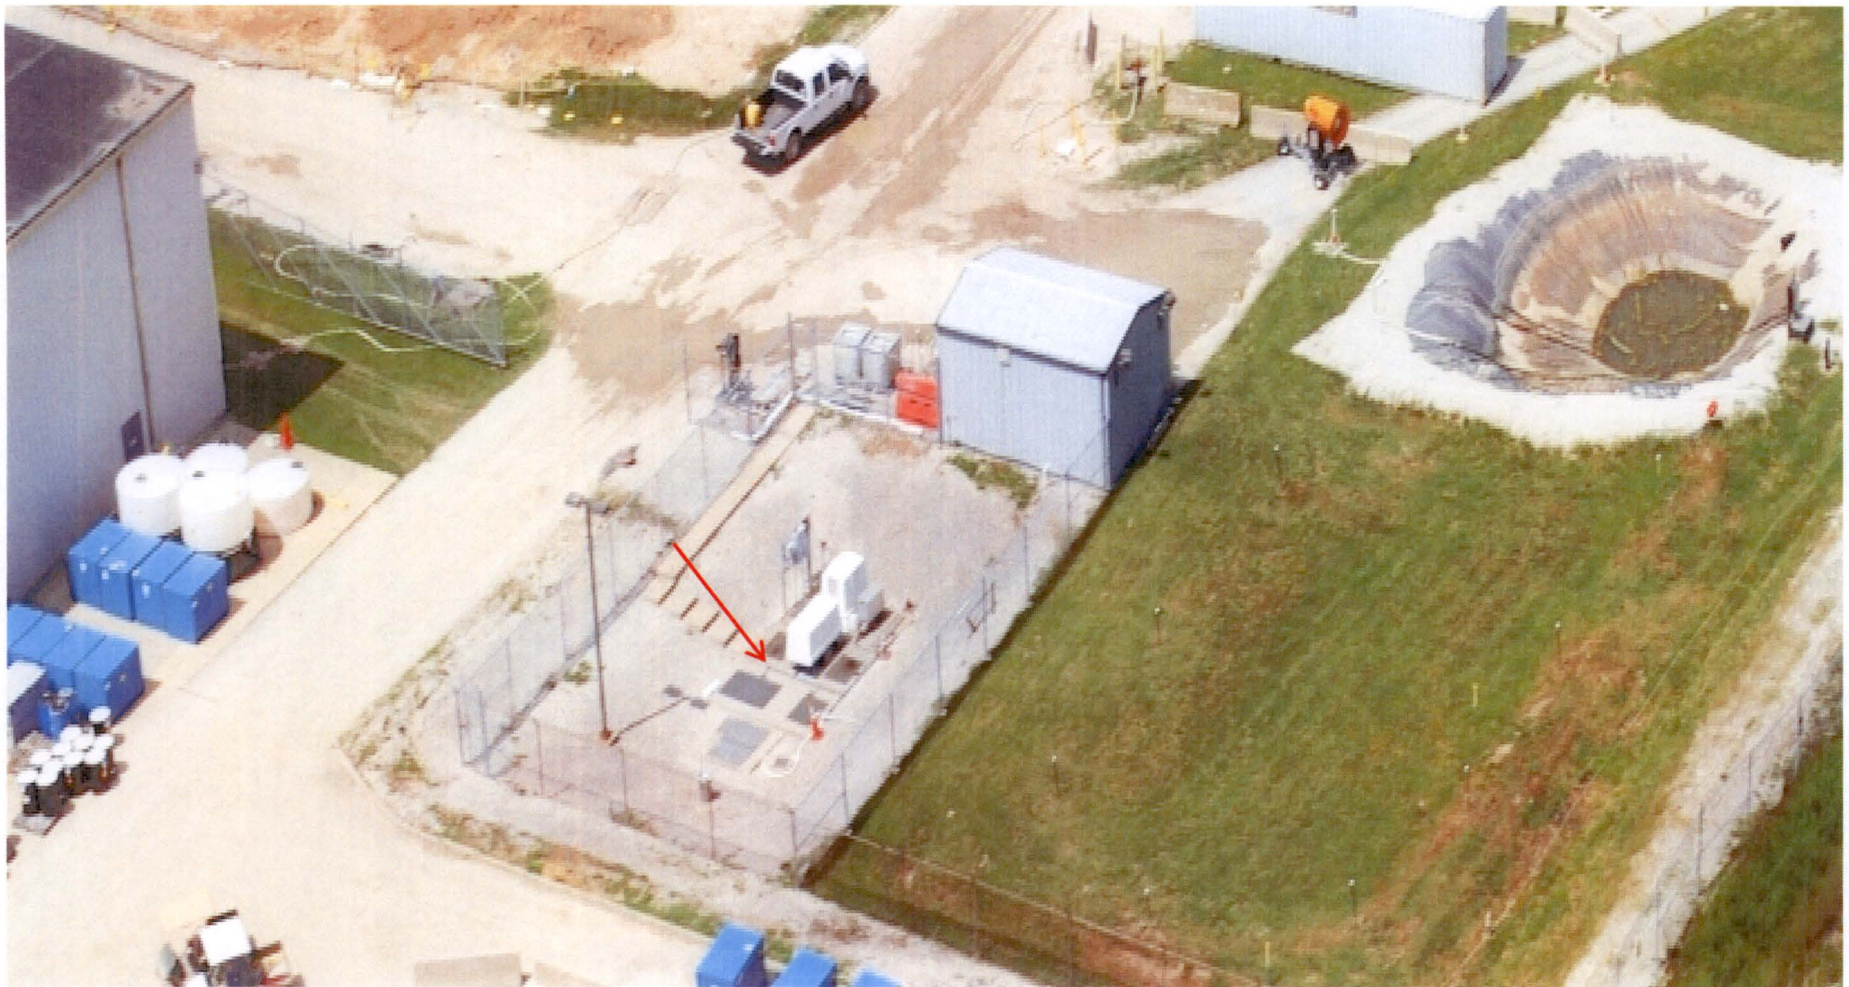
Figure 2-57
The SWTP Tanks Location Prior To Demolition and Removal (Looking NE)
(Between Building 230 to the Left and the Evaporation Ponds on the Right)

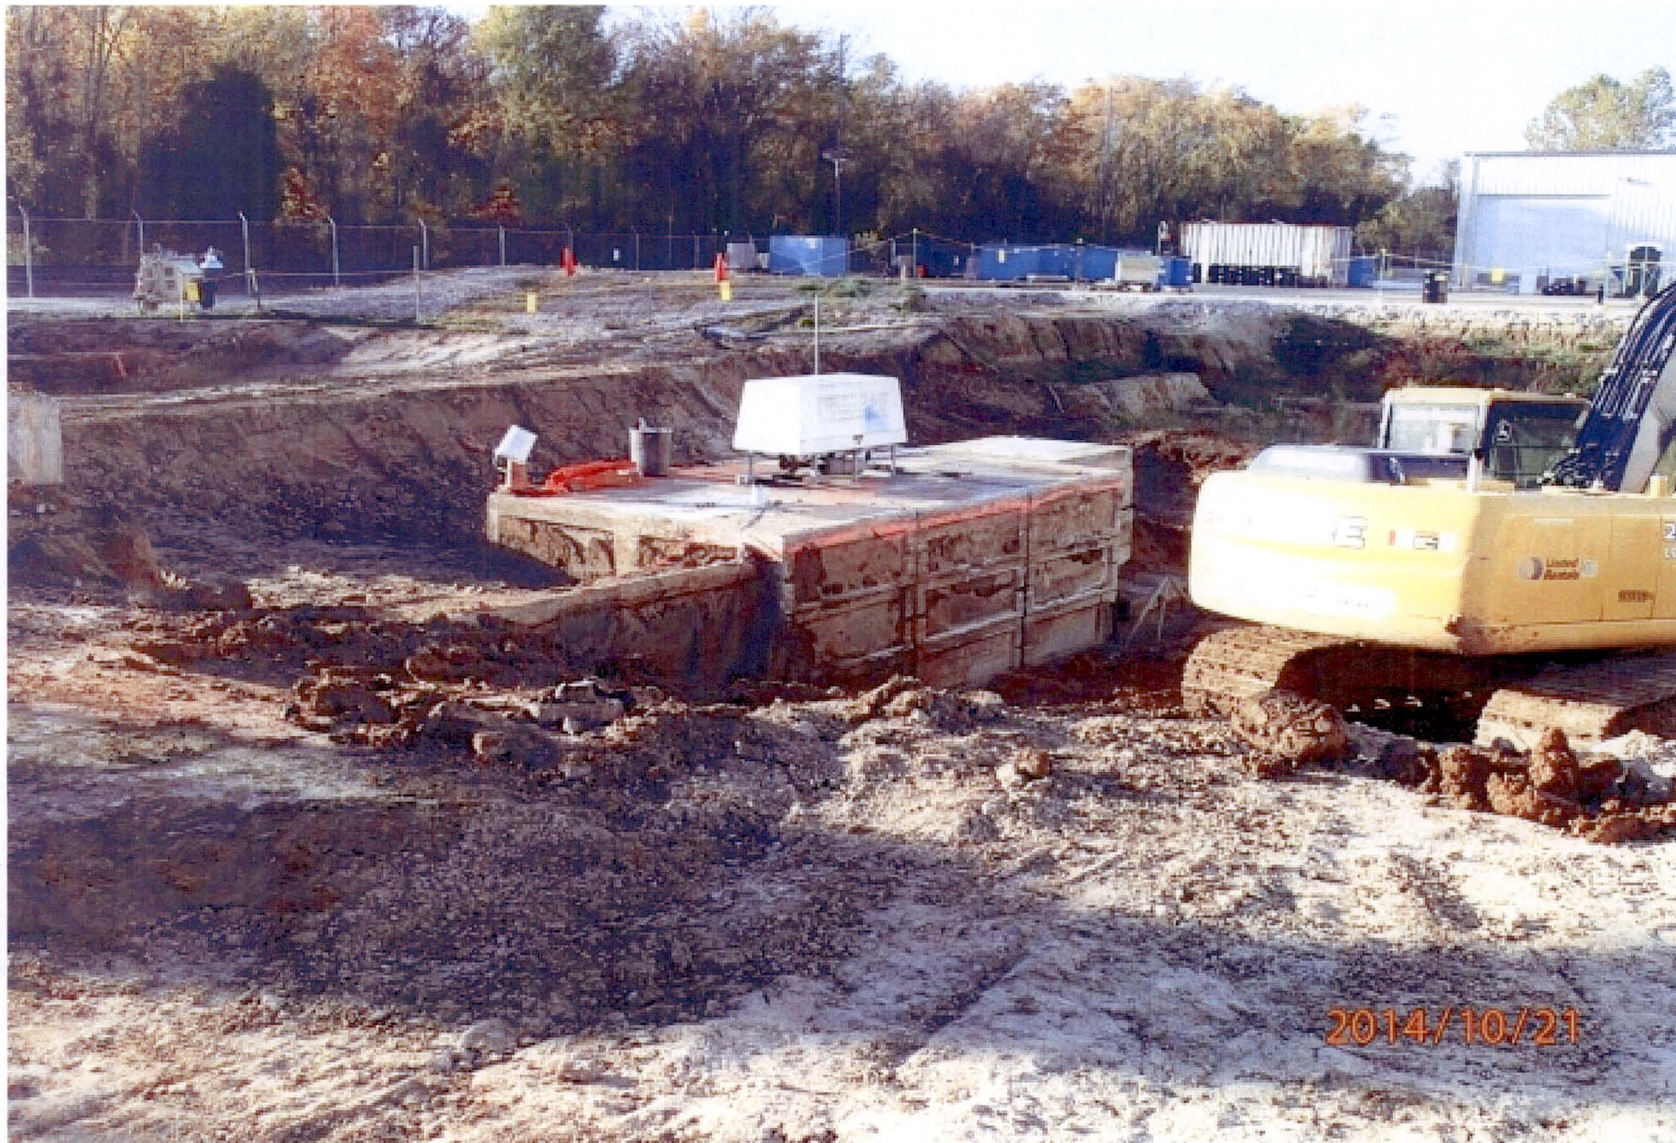
Figure 2-58
Sanitary Wastewater Tanks (Looking SW)

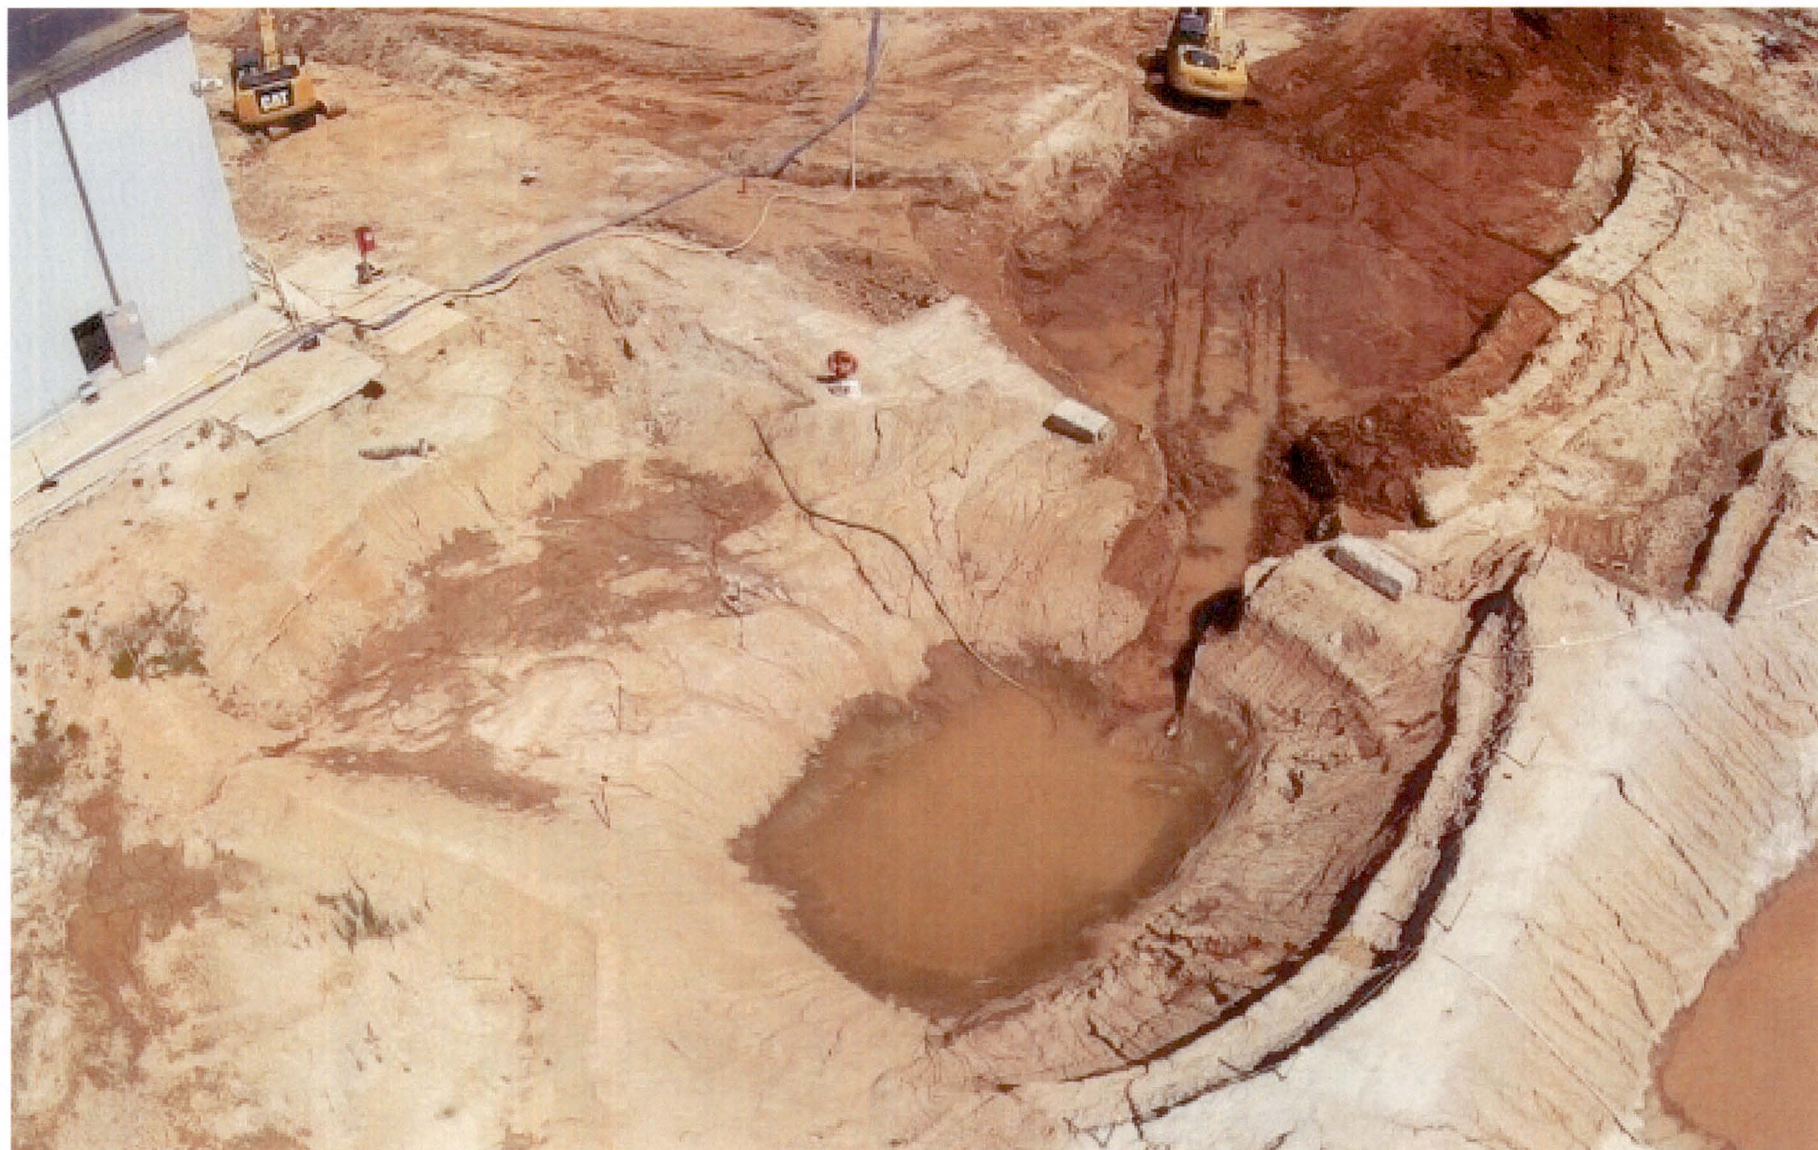
Figure 2-59

Excavation Remaining After Demolition and Removal of the SWTP Tanks

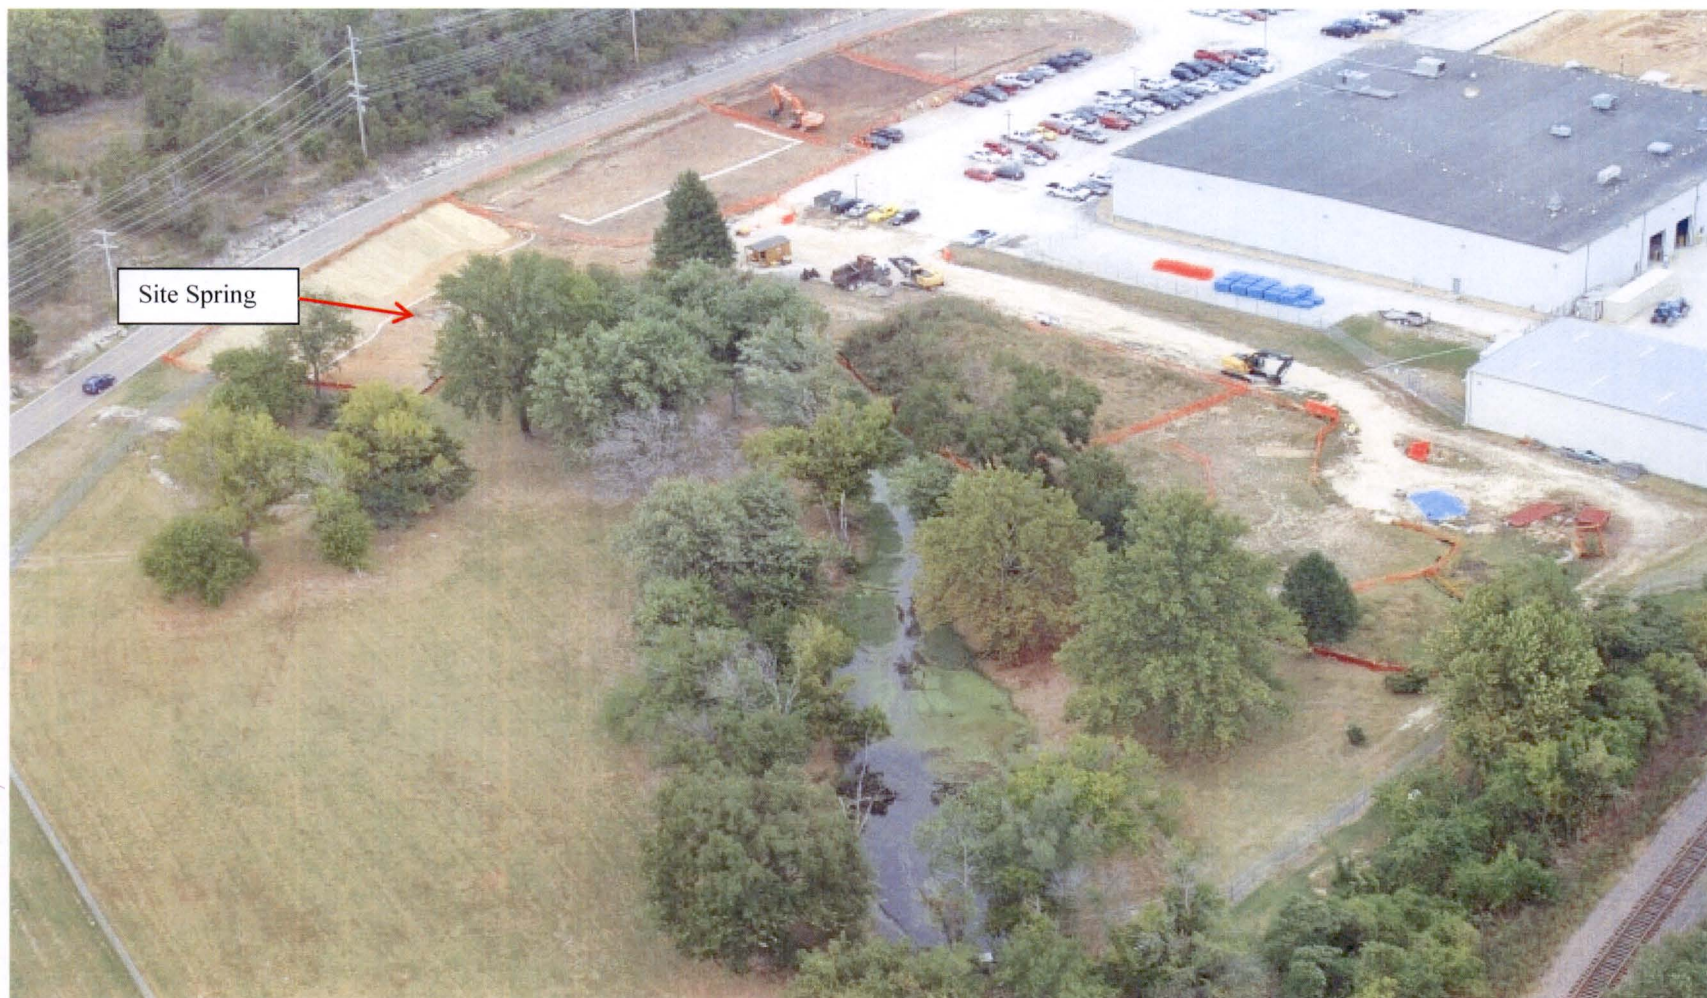
Figure 2-60

Site Pond Prior to Excavation and Remediation (Looking NE)

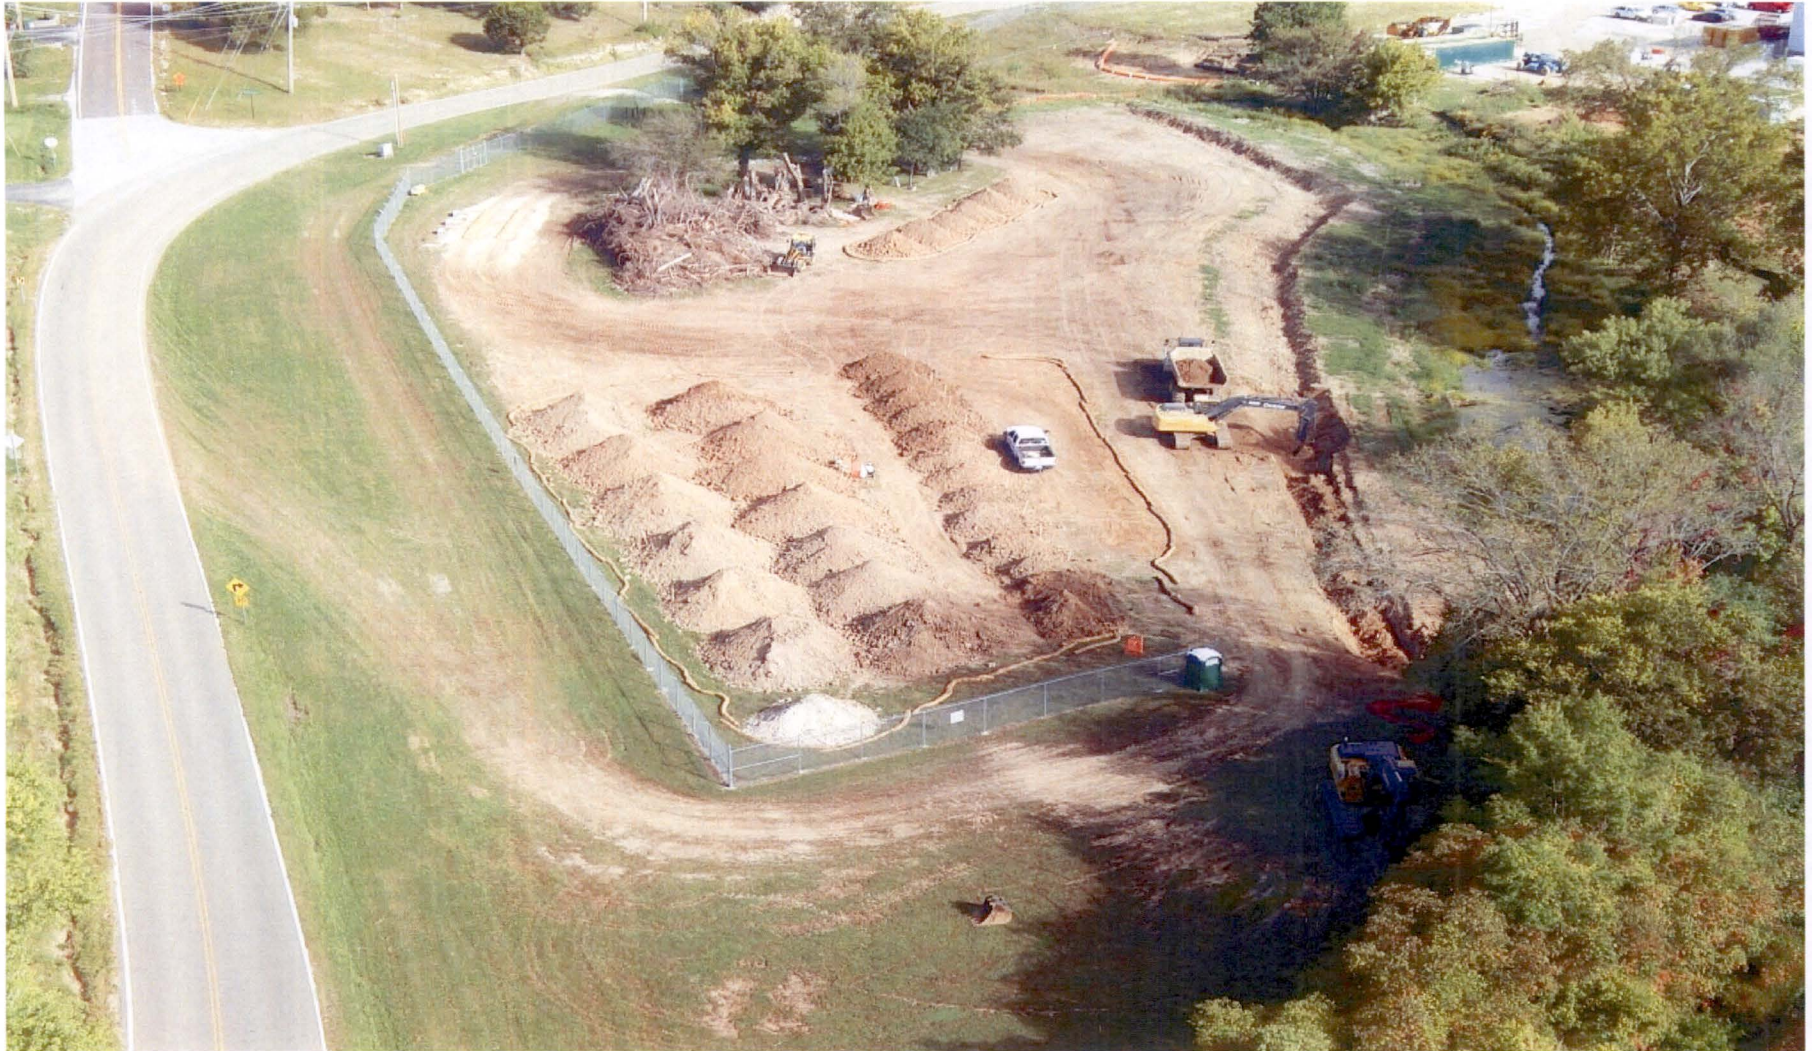
Figure 2-61
Installation of the Site Pond Diversion Ditch Which Was Constructed To Divert Water From The Site Spring Around And Downstream Of The Site Pond (Looking N)

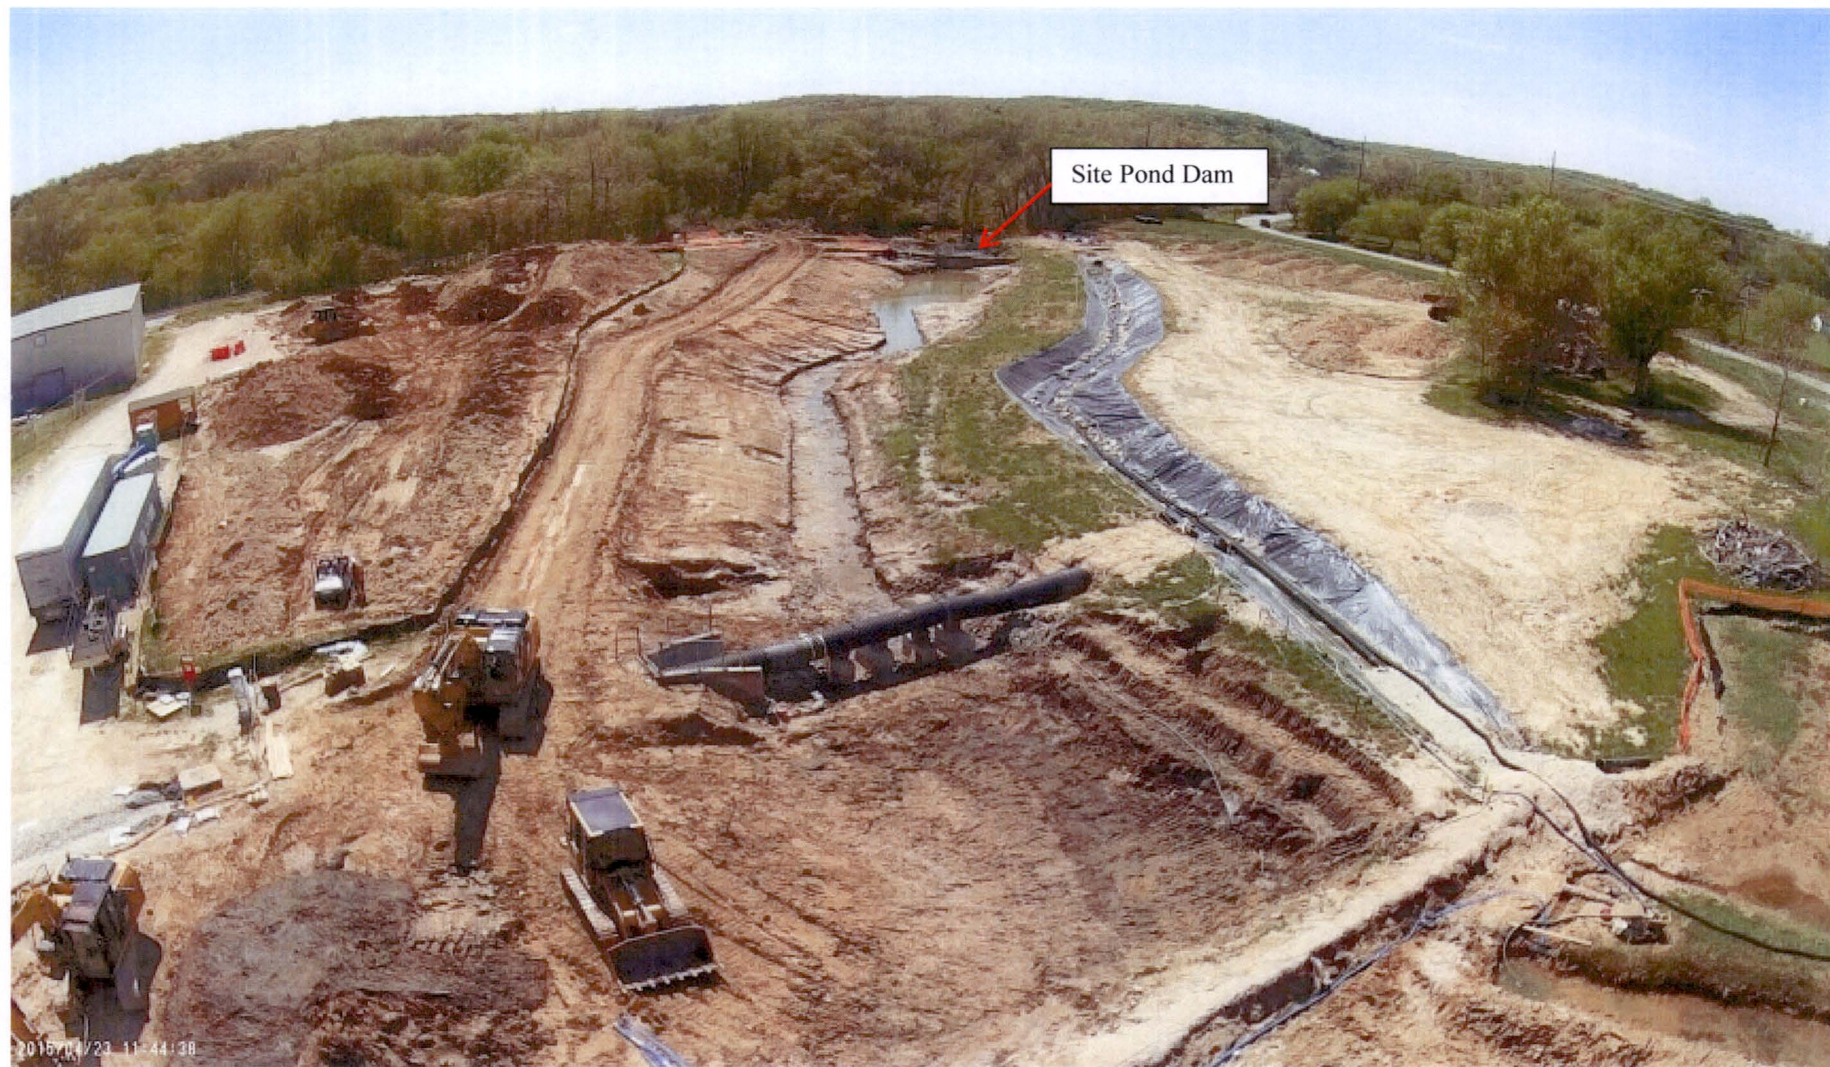
Figure 2-62
Site Pond Excavation and Remediation Nearing Completion (Looking S)
