**TMI-2 Independent Spent Fuel Storage Installation  
Application for  
10 CFR 72 Specific License Renewal**

**Special Nuclear Materials License Number SNM-2508  
(Docket No. 72-20)**

Revision 0

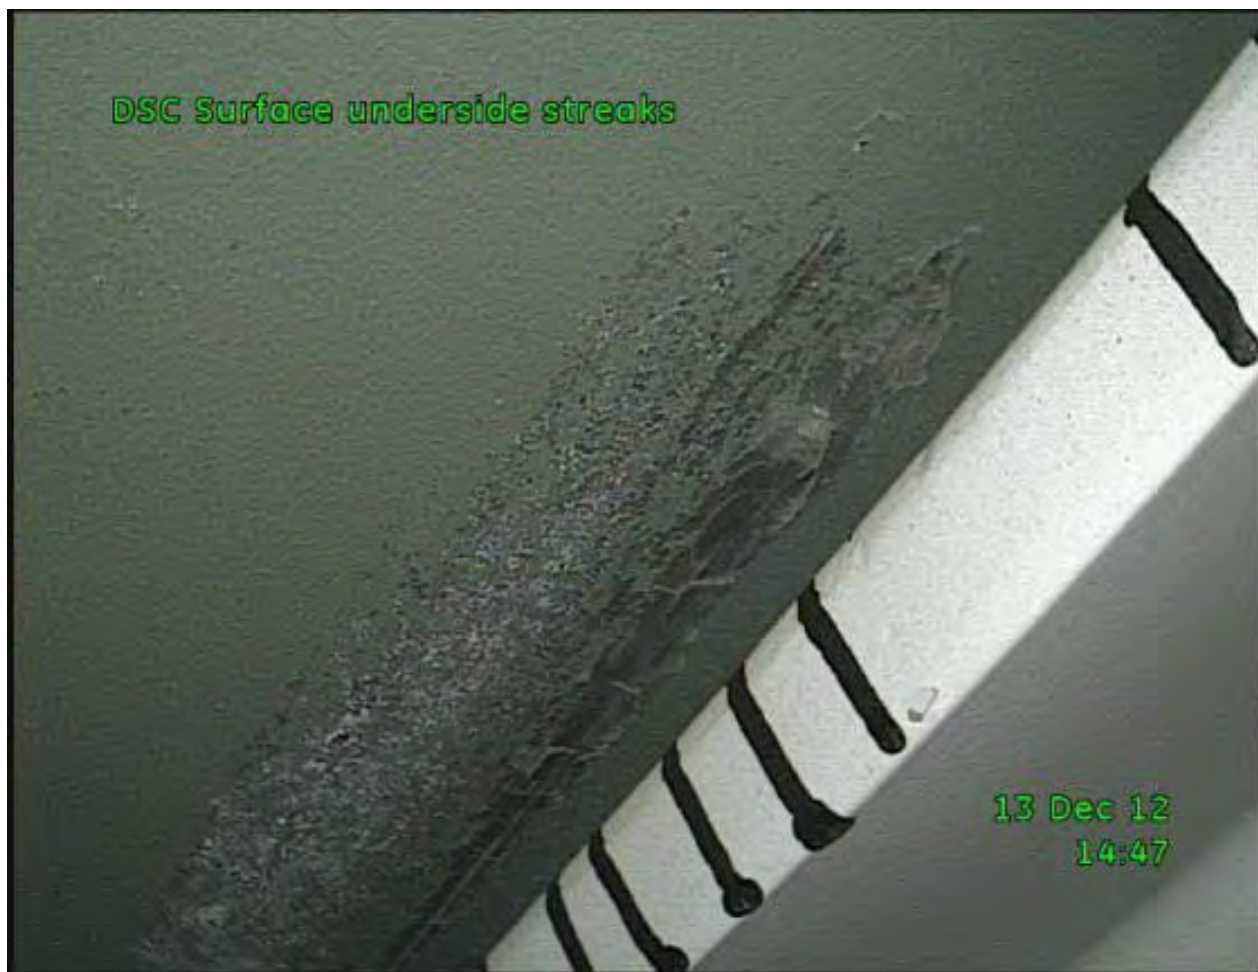
Figure 3-4: Scrape Shown on Underside of DSC S/N DOE12T-002 Inside of HSM-16 [3.11.83]

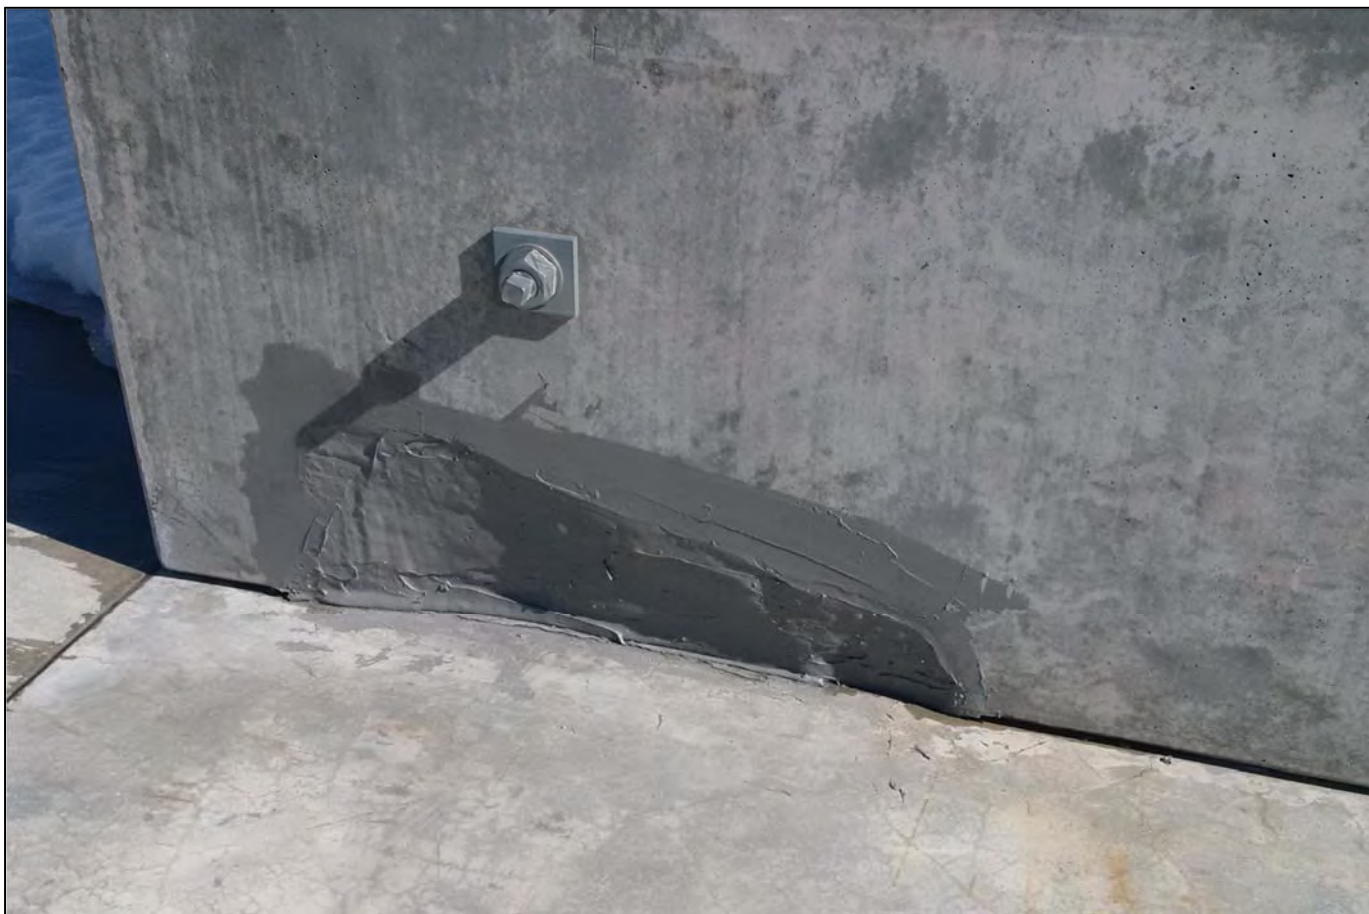
**Figure 3-10: Southwest Shield Wall – Left Panel (March, 2016)**
