Upper Head Inspections

Stephen Cumblidge and Jay Collins
NRC / Industry NDE Technical
Information Exchange Meeting
January 16-18, 2018

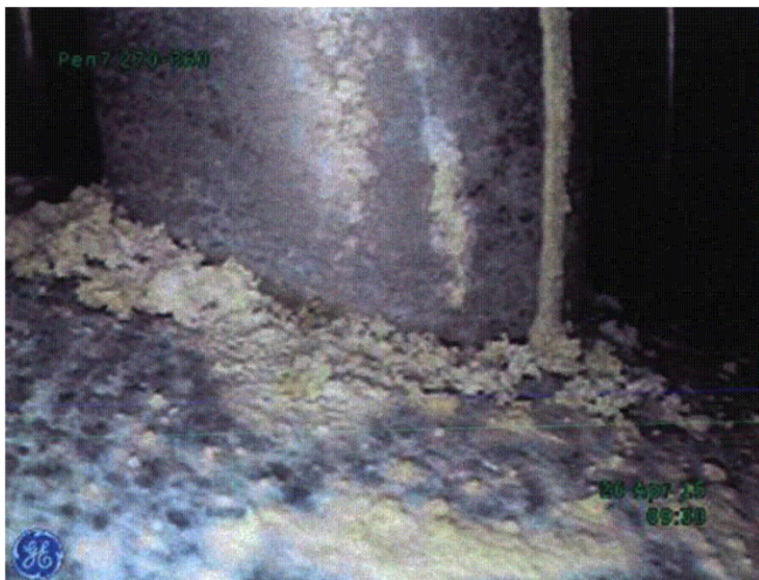
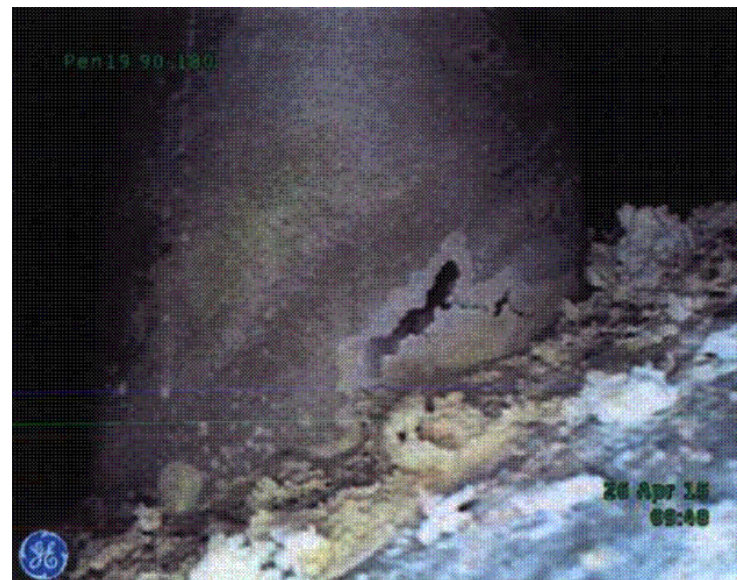
In a licensee, which had replaced their head with a resistant head, claimed that significant boric acid deposits were all leakage from above, power-washed the head without performing any supplemental examinations. Other discussions with other licensees have since followed.

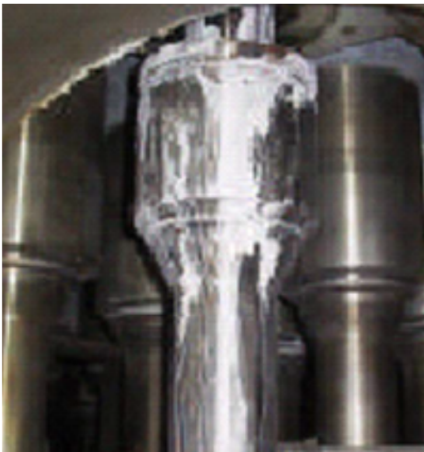
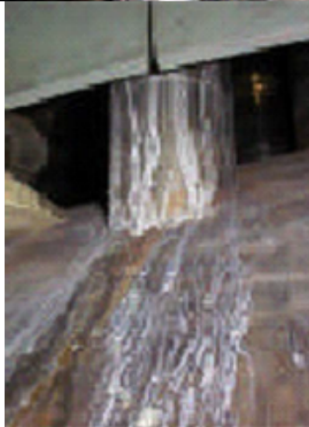
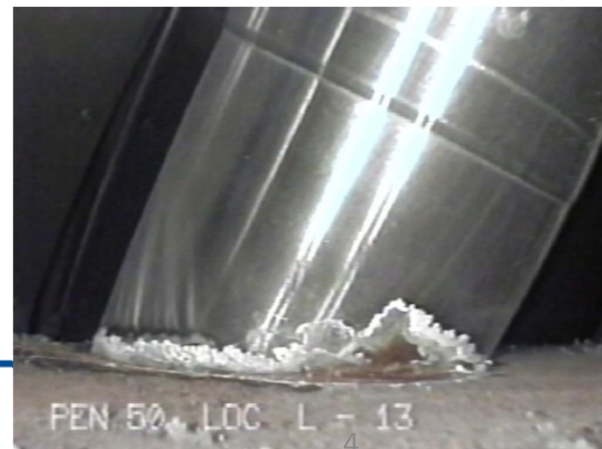
Photographs from EPRI Report 1007842

Boric acid on the upper head can come from two main sources

- Leakage from seals or weld leaks in the CRDM housings
- Leakage through the annulus from PWSCC of the nozzle
- Both

Determining the source of the boric acid can be challenging
