**FORM HDP-PR-HP-311-1 RADIOLOGICAL SURVEY REPORT**[illegible]

Hematit  
Decommissi  
Project

<b>Purpose of Survey:</b>	Survey of exterior accessible surfaces of storm water drain basin located in LSA 05-02						<b>Log Number:</b>		3065 C 130814	
<b>Technician(s):</b>	S. Jenkins <i>[Signature]</i> 8/15/13				<b>Reviewed by:</b>		Michelle Bresnahan <i>[Signature]</i> 8/22/13			
<b>Print/Sign/Date</b>					<b>Print/Sign/Date</b>					
<b>Instrument</b>	<b>Serial Number</b>	<b>Calibration Due</b>	<b>Probe Area (cm<sup>2</sup>)</b>	<b>Alpha Bkg (cpm)</b>	<b>Alpha Efficiency</b>	<b>Alpha MDA (dpm)</b>	<b>Beta Bkg (cpm)</b>	<b>Beta Efficiency</b>	<b>Beta MDA (dpm)</b>	<b>Date:</b> 08/14/13
Tennelec LB 1 GFPC	68819	9/25/13	N/A	0.9	26.3%	23.4	3.0	31.0%	28	<b>Time:</b> 11:35
Lud 2360 43-89 D	276928	7/27/14	125	6.0	13.2%	87.3	192.0	8.6%	628	<b>Smear Area:</b> ~ 100 cm2
N/A	N/A	N/A	N/A	N/A	N/A	N/A	N/A	N/A	N/A	<b>Batch #:</b> 32792
N/A	N/A	N/A	N/A	N/A	N/A	N/A	N/A	N/A	N/A	<b>RWP:</b> RP-13_G009
N/A	N/A	N/A	N/A	N/A	N/A	N/A	N/A	N/A	N/A	<b>Misc:</b> N/A

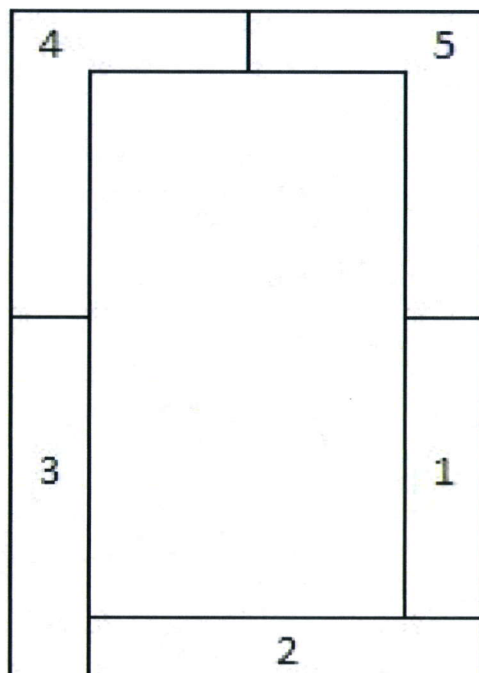
**Remarks:** Average GA BKG was 4 alpha / 350 beta. IAL CPM based on FSS instructions was 31 alpha / 567 beta. No areas noted above IAL. See attached map for location information.
