**2015 Remediation Effectiveness Report  
for the U.S. Department of Energy  
Oak Ridge Reservation  
Oak Ridge, Tennessee**

**Data and Evaluations**

Date Issued—September 2015

Prepared by the  
Water Resources Restoration Program  
URS | CH2M Oak Ridge LLC

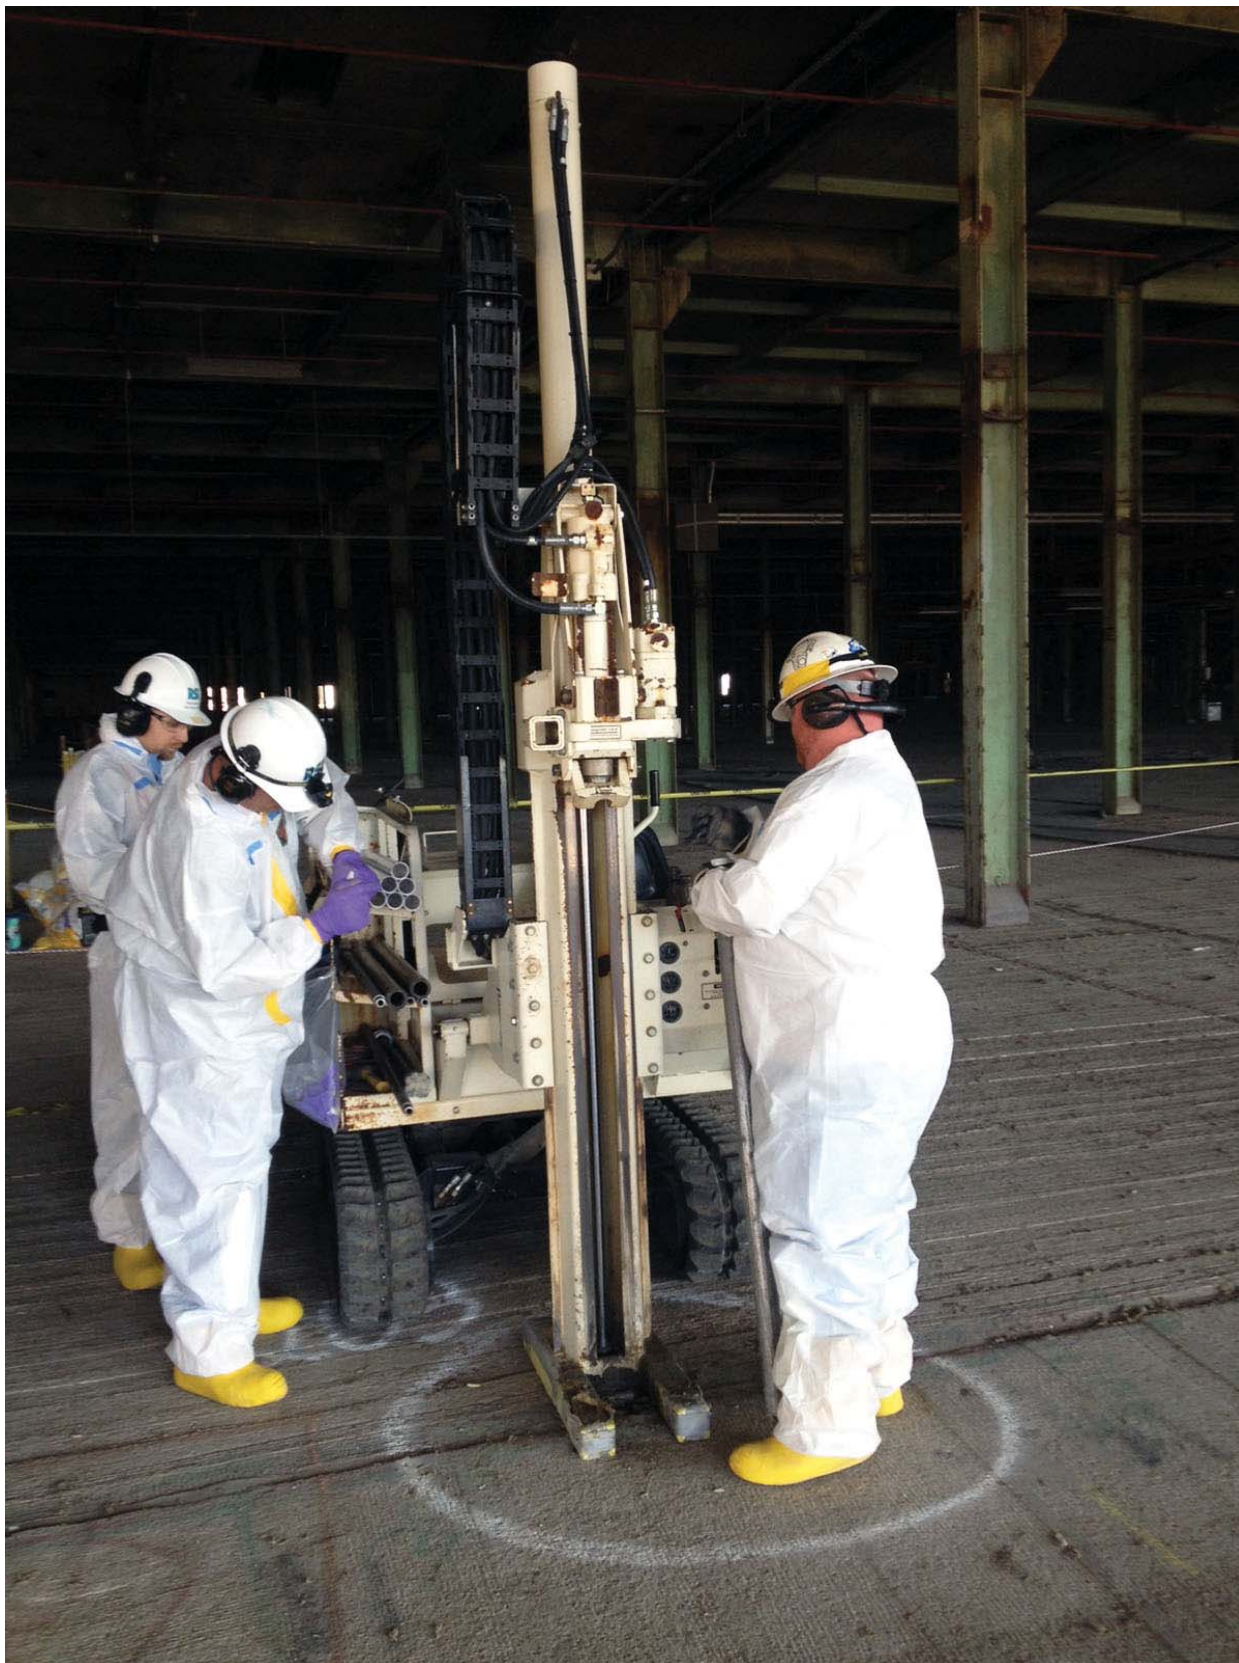
**Figure 8.5. Workers sample soil under the K-31 slab as part of characterization.**

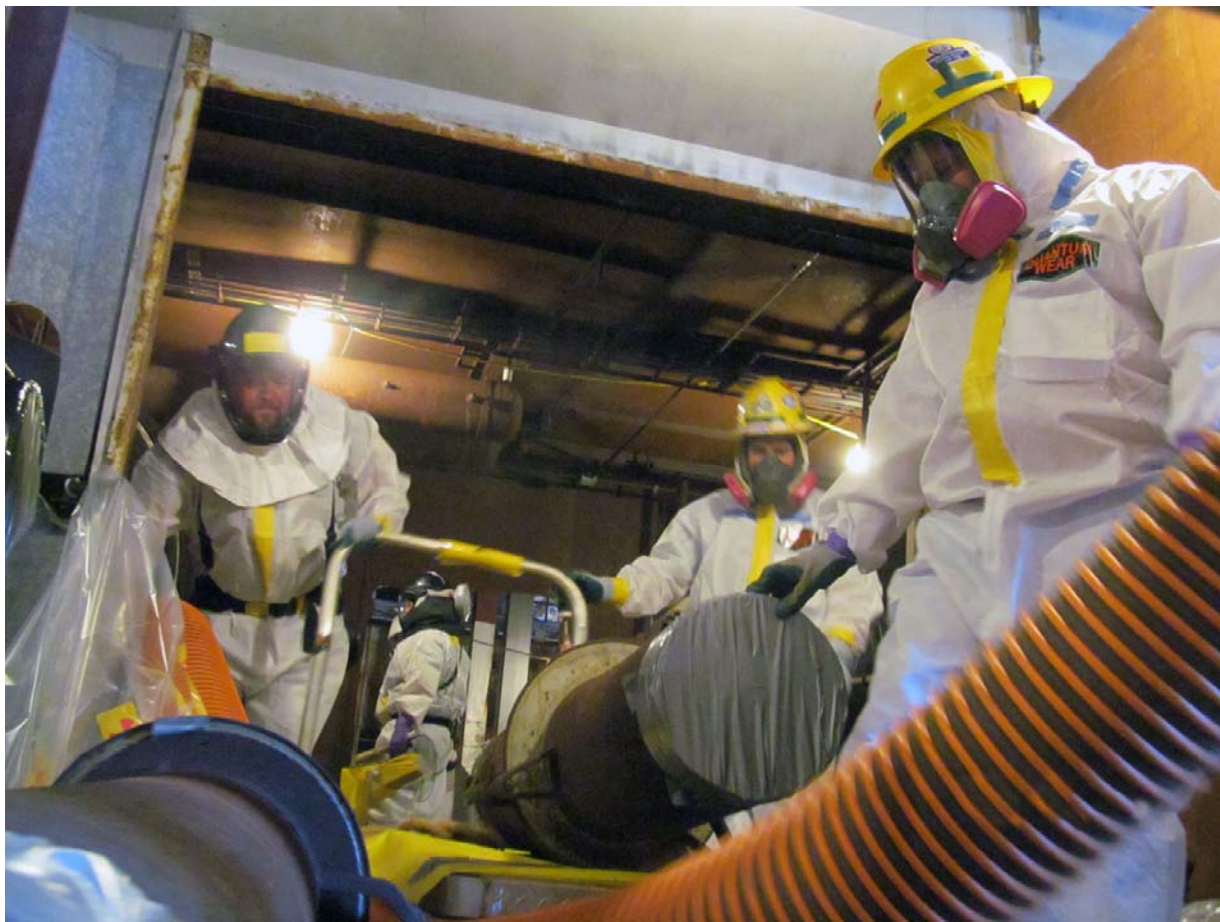
**Figure 8.7. Workers remove process piping inside Building K-27.**
