**Rancho Seco ISFSI
License Renewal Application,
Revision 0 (non-proprietary version)**

**Sacramento Municipal Utility District
(SMUD)**

**Rancho Seco ISFSI
License Renewal Application**

Revision 0

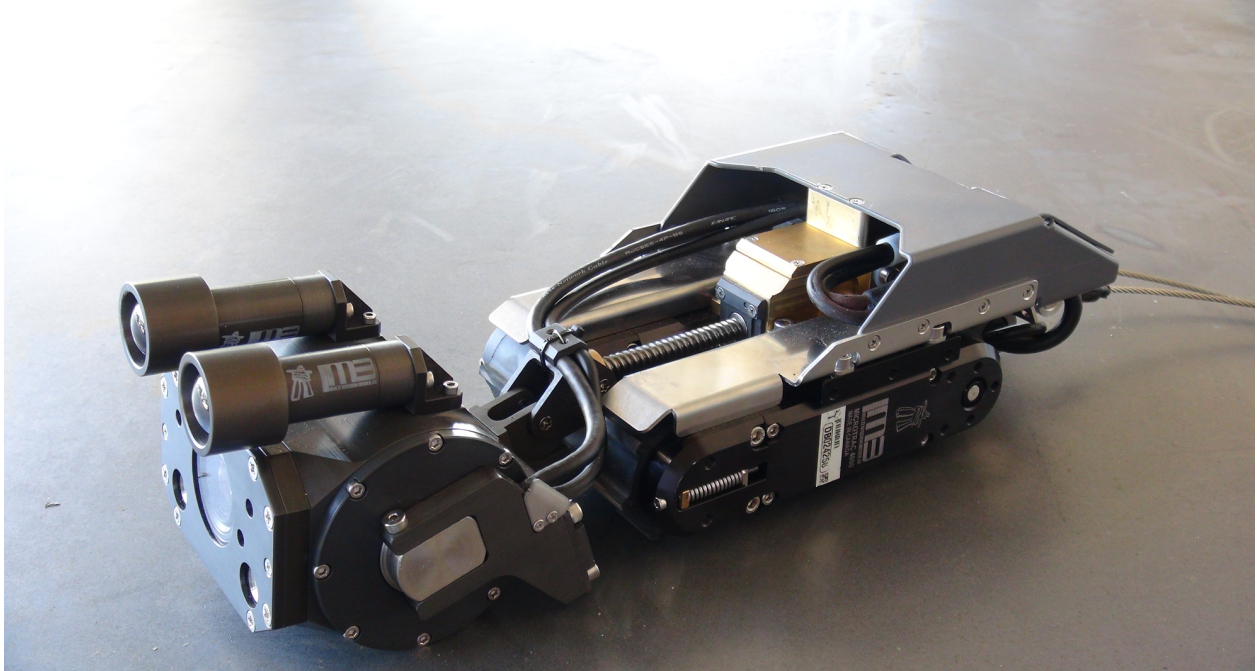
Crawler with the Camera module

Remote inspection of the HSM-20 interior was performed using a remote controlled MaggHD™ crawler. A tether cable attached the crawler to the controller and transmitted videos, photographs and temperature data to a computer.

The southeast inlet vent was used to access the HSM-20 interior using the crawler. The crawler was equipped with a camera module that is capable of displaying and recording of photographs and videos having VT-3 quality resolution. Four LED lights of adjustable intensity are also mounted on the crawler camera module to provide adequate illumination for the VT-3-level inspection of the interior of HSM-20. An infrared sensor capable of measuring surface temperature was also mounted on the camera module. Thermographic accuracy of the infrared sensor was verified by using a contact pyrometer. A picture of the crawler is shown below:

The camera module could be articulated through 120 degrees, which allowed the crawler to record footage in front, directly overhead, and slightly to the rear. The crawler video camera was verified to be VT-3-capable on the day of the inspection just prior to HSM entry.

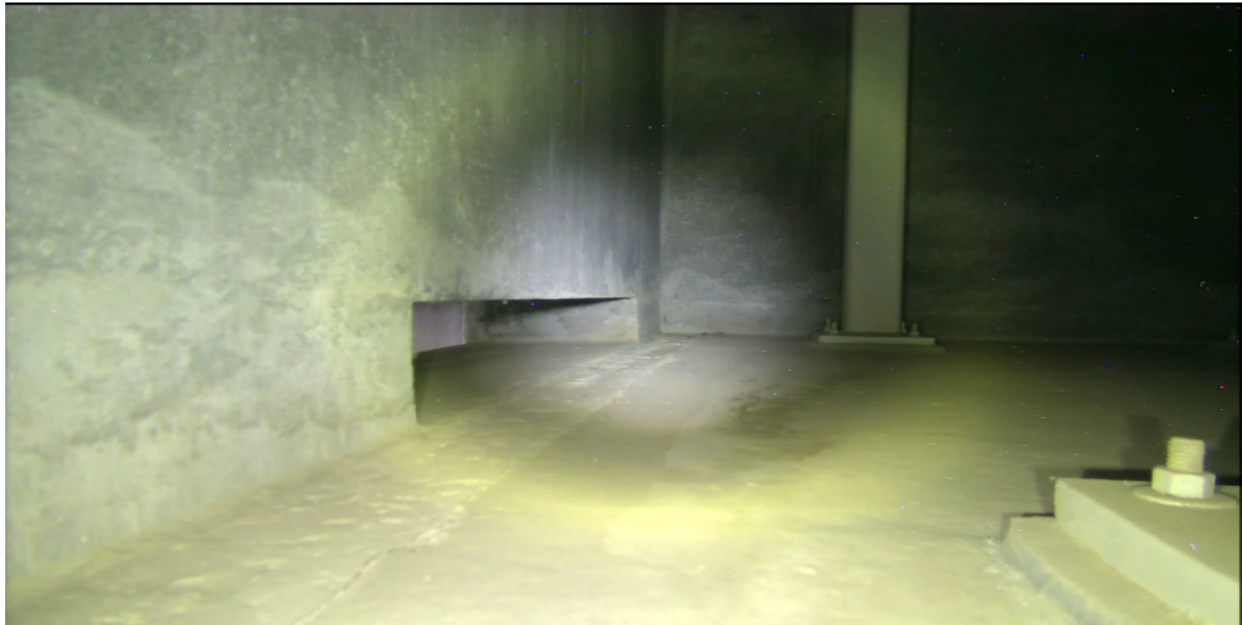
Figure 3-1
Floor at HSM Interior Northwest Corner, Looking North

No anomalies noted.

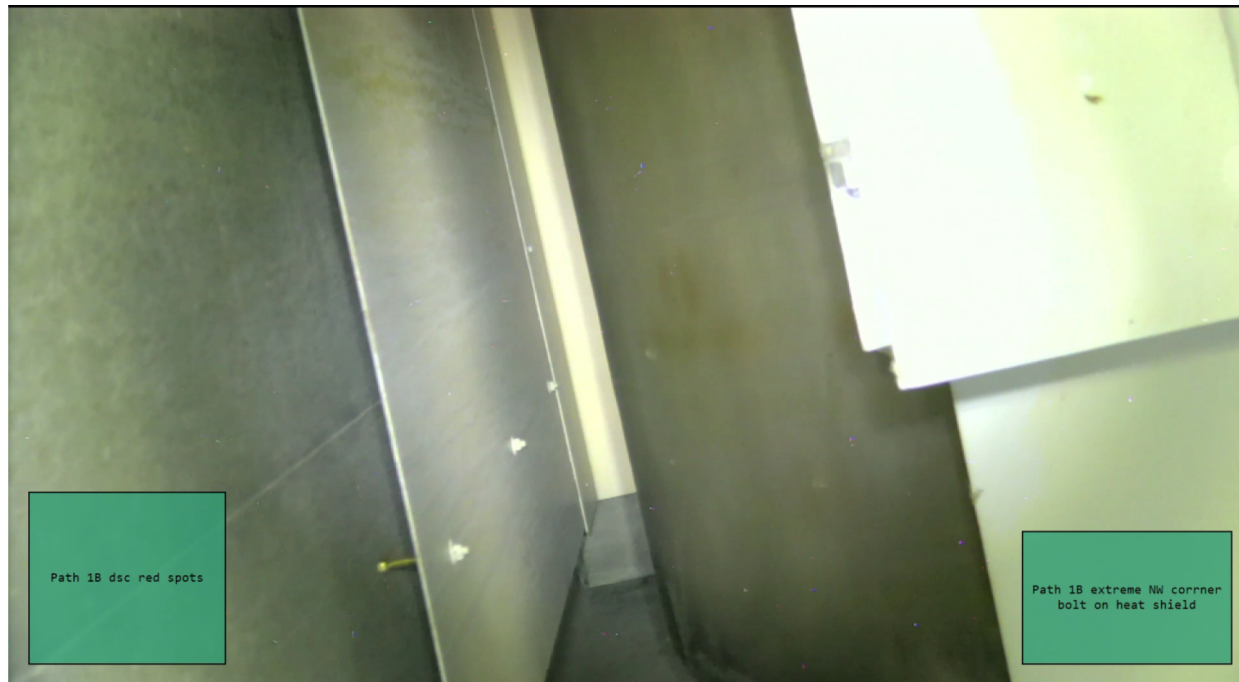
Figure 3-2
Northwest Corner

Shown in the picture are the left and upper heat shields and DSC (dark gray) at right. The DSC support rail is at the far right.

No anomalies noted.

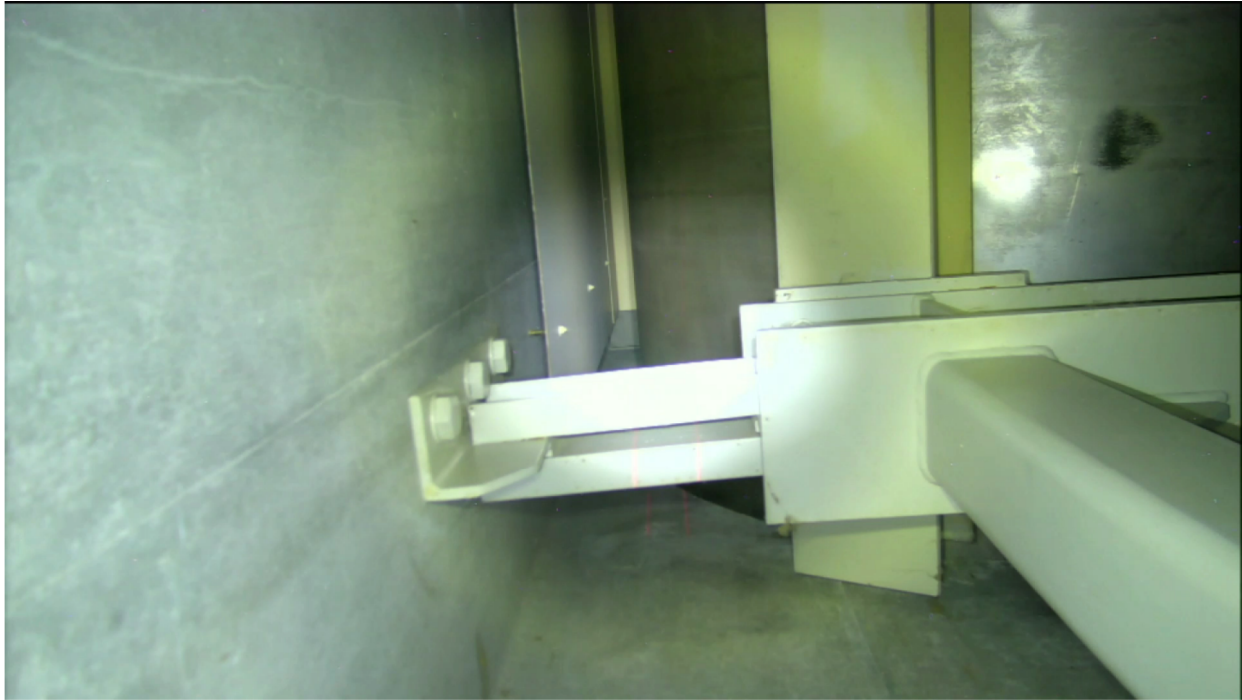
Figure 3-3
Ceiling, South East Corner

The bolts shown in the middle left of the photo are fasteners attached to the east wall. The camera is looking south with support post #1 in view. No degradation of the bolts, supports, support rail, support welds, heat shield, or DSC was observed. There are circular shaped shiny and dark spots on the right of the support rail. The shiny spot is the glare of the crawler's lights. The "dark" spot appears to be a burnish mark on the DSC, which appears to be darker than the surrounding. It does not appear to be a result of degradation.

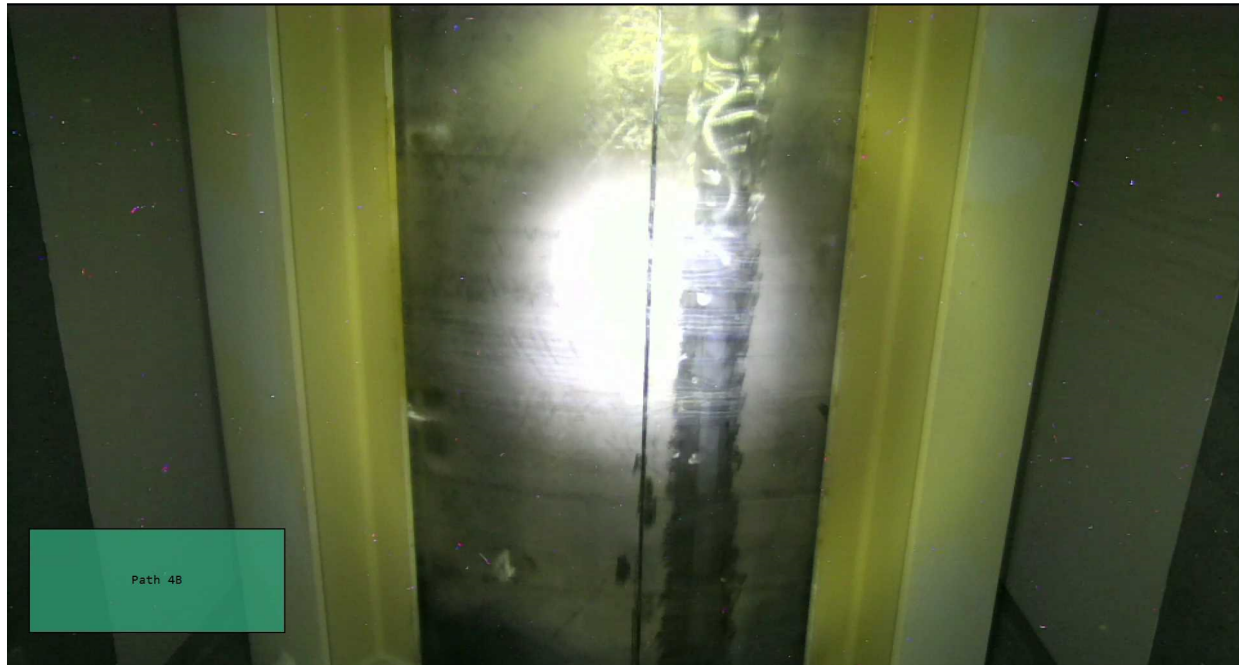
Figure 3-4
Scrape on DSC Bottom

This photo was taken approximately 4 feet from the south (plug) wall and in the middle of the HSM.

Note: The scrape extends from approximately 6 inches from the south HSM door to the middle of the DSC along an axial line. No indication of deterioration is observed.

As noted in DQ No. 01-0052, DSC P01 had received a scrape along the bottom due to contact with the TC during its insertion test performance in 2001. As shown, this scrape is clearly evident.

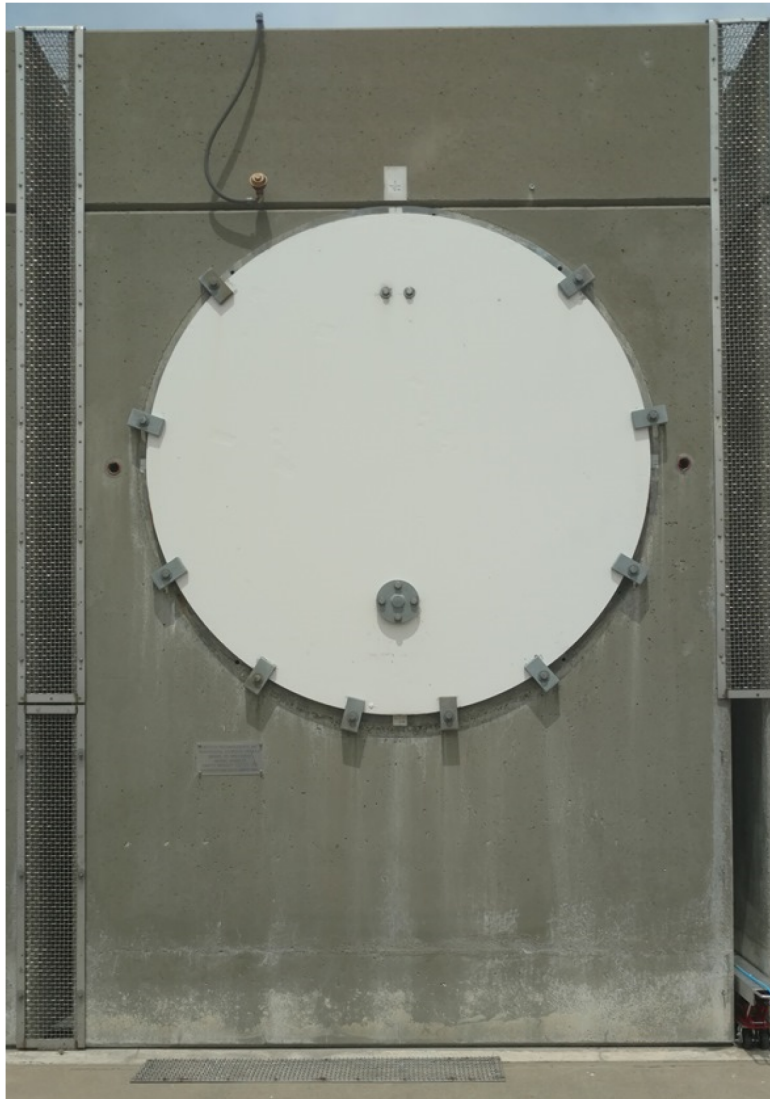
Figure 3-7
HSM-20 Front Face

Minor cracks in the concrete as defined in this report are crack widths of up to 0.013 inch on exterior surfaces, which is acceptable per ACI 224 [3-40]. Random hairline shrinkage or tensile cracks may occur in the cement film on the surface of modules.

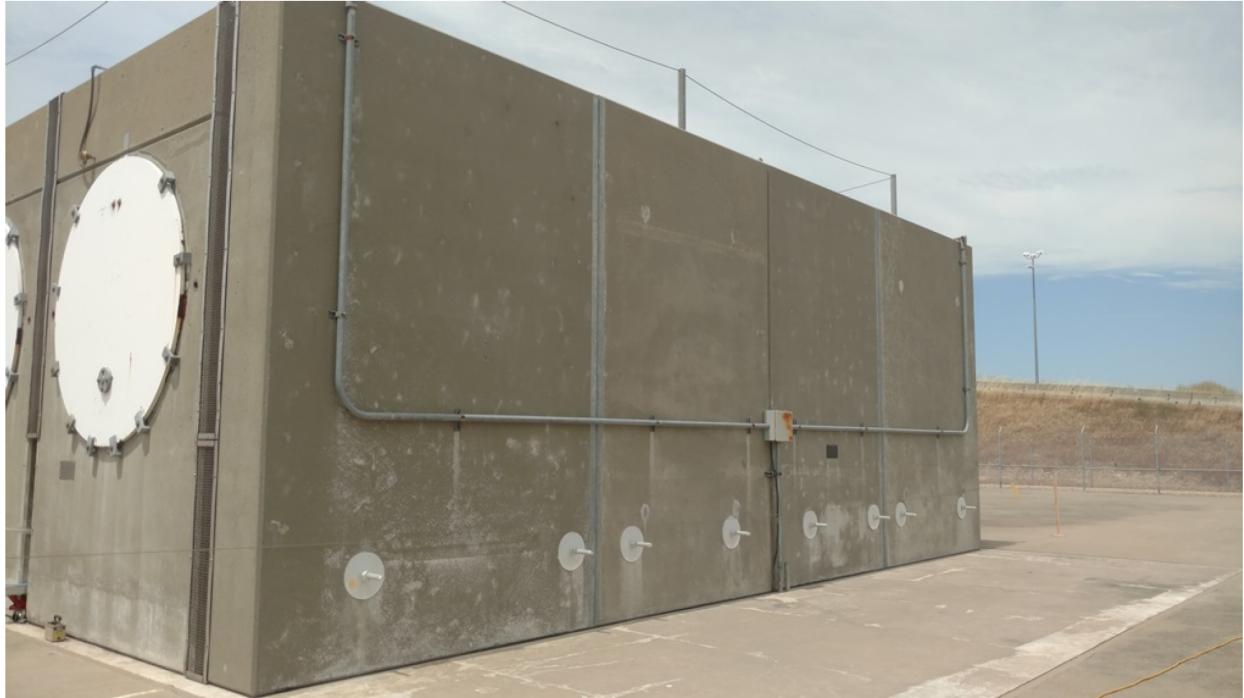
Figure 3-9
West End Shield Wall South Panel

The end shield walls consist of four vertical slabs attached to the end modules with through-studs at the bottom and metal straps at the top. The concrete surface has minor superficial map cracking that is not deleterious. There are no spalls. The grout patches for filling the lifting embeds are sound. The light discolorations are superficial and appear to be part of the original construction.

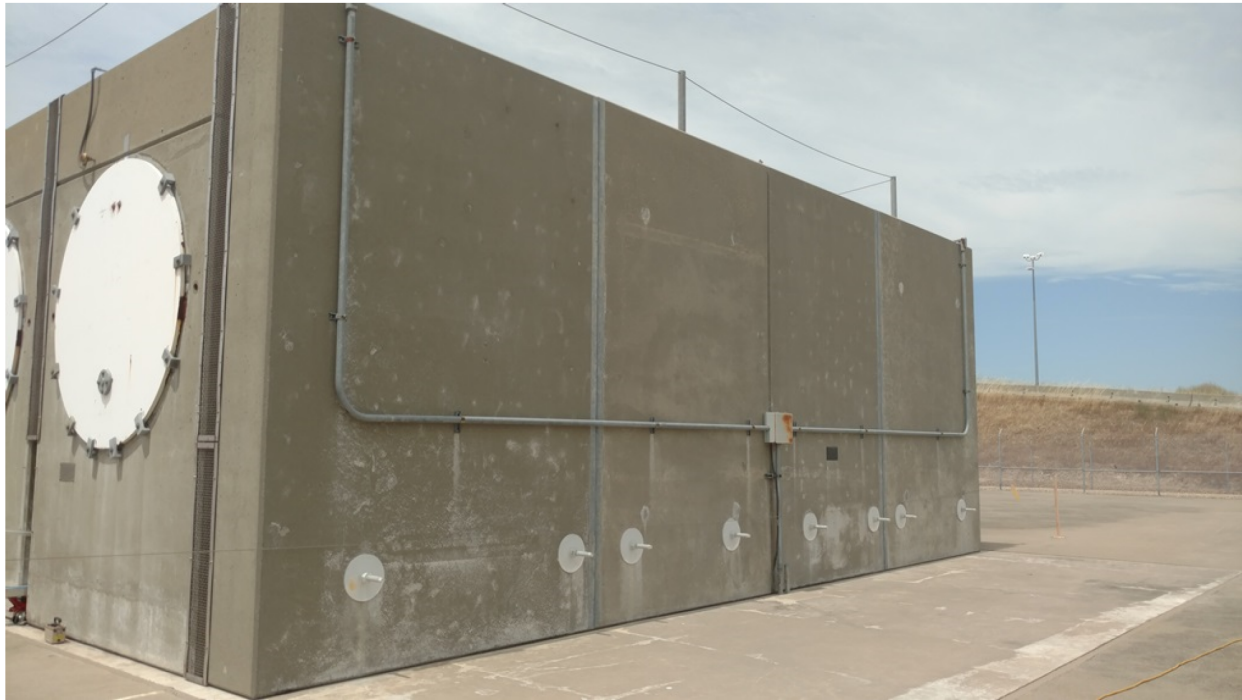
Figure 3-10
End Shield Walls East Side

The east shield walls are identical to the west panels. There are two shear keys reinforced with galvanized angles at the corners. The shear keys are intact. There are no spalls and the visible cracks are typical and minor. The grout patches for filling the lifting embeds are sound. The light discolorations are superficial and appear to be part of the original construction.

The east shield wall has the conduit for the temperature monitoring system. The junction box has corrosion on the outer cover. The temperature system quality class is not important-to-safety (NITS).

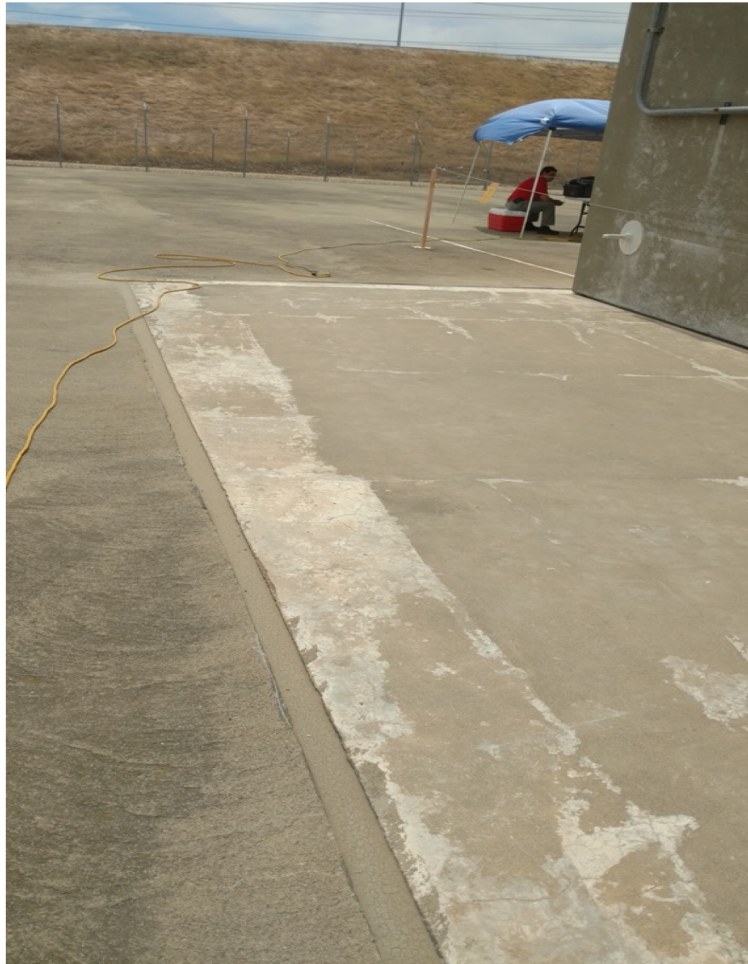
Figure 3-11
Basemat East Side Facing South

The basemat is a 2-foot thick slab for the HSM assembly. The basemat extends beyond the front face of the east and west end wall. The basemat has superficial discoloration around the edges. The joint between the basemat and apron is intact. The construction joint between the apron and basemat is level with random wear at the edges.

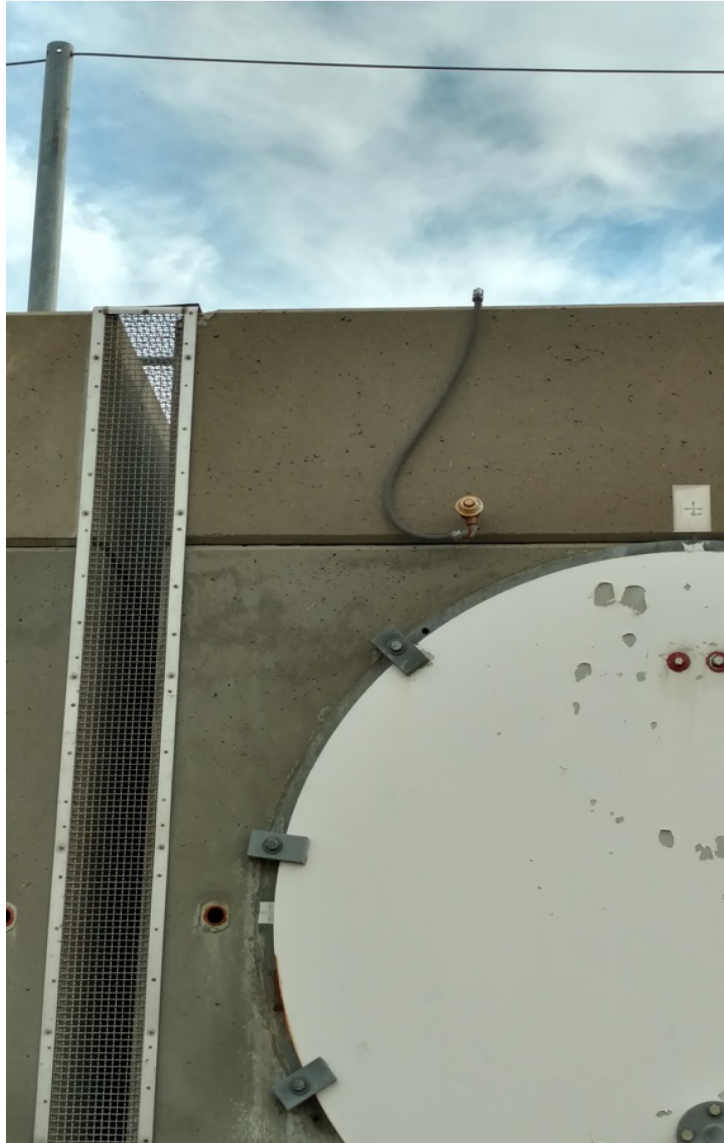
Figure 3-12
HSM-16 Spall at Roof Left Corner

HSM-16 had a spall at the upper left corner. The spall likely occurred during transport and assembly of the HSMs. The spall did not appear to be associated with active deterioration.
